Jericho Diamond Mine, 2AM-JER0410

Type A Water License Renewal

Public Hearing – Community
Presentation
Kugluktuk, NU
Nov. 30 – Dec. 1, 2011

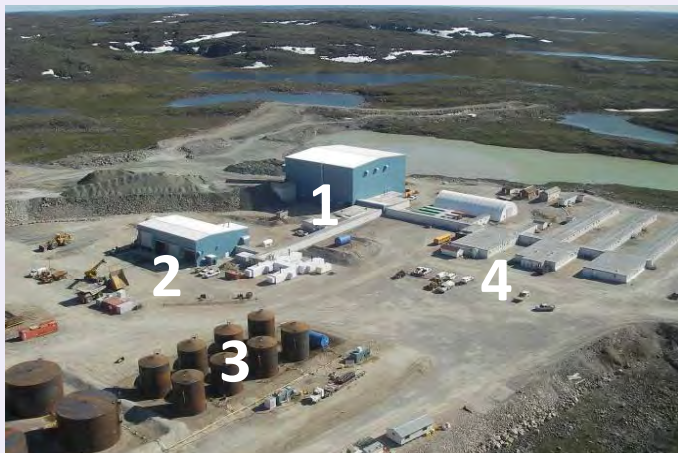
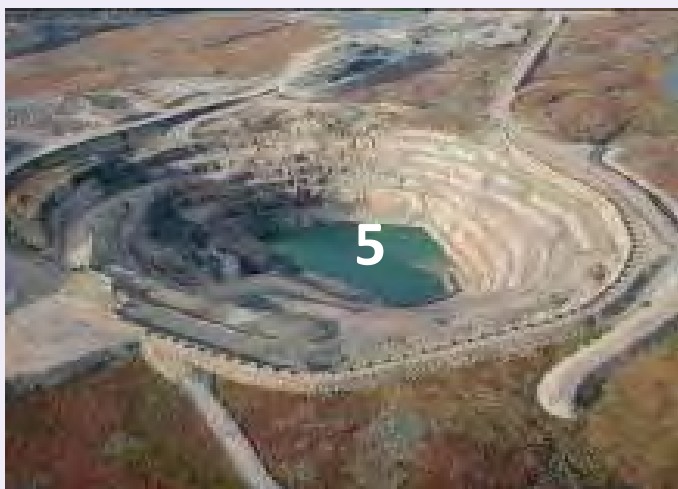
Jericho Project Existing Infrastructure

- **C\$200 Million in infrastructure**
 1. 2,000 tpd diamond processing plant
 2. Maintenance shop
 3. Fuel farm
 4. Staff Offices & Accommodations for 225
 5. Jericho open pit mine
 6. Year round airstrip
- **Excellent project access via air and winter road**
- **Operating permits in place**

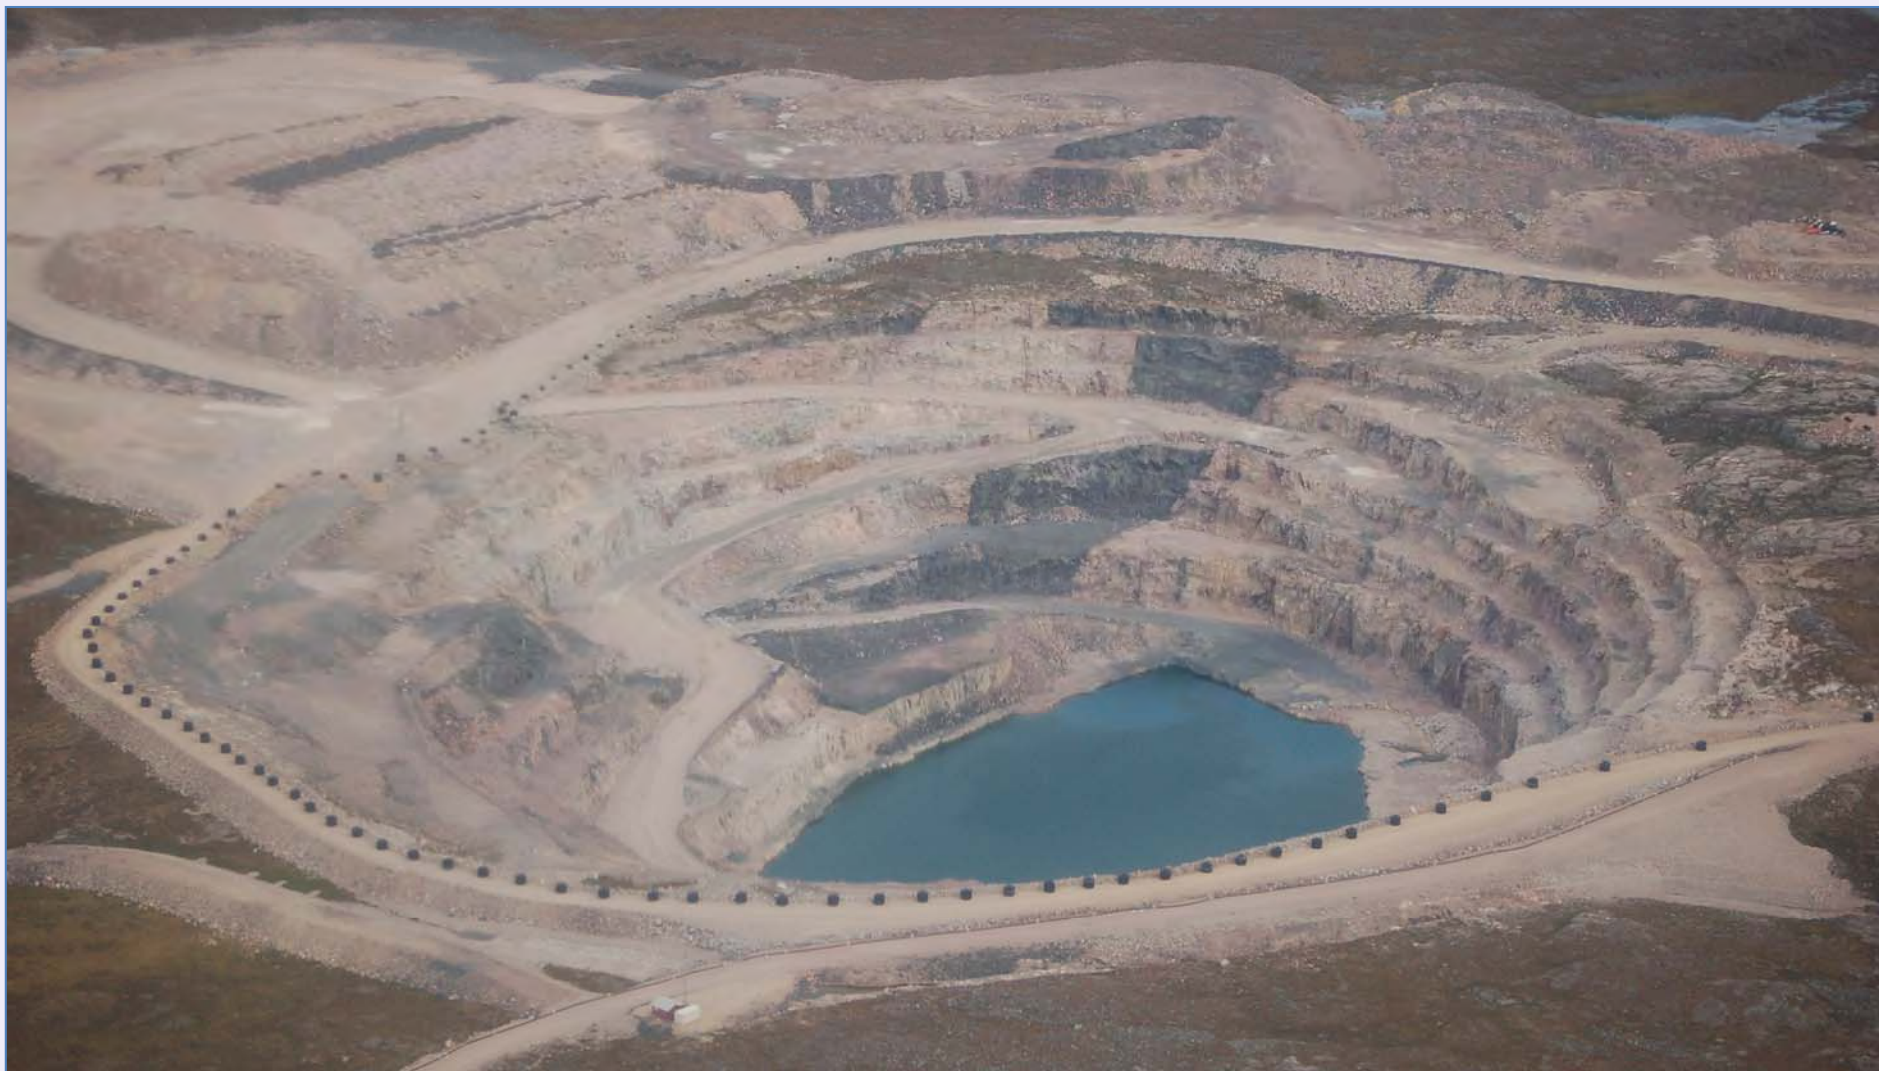
Open Pit

- Granite
- Diabase

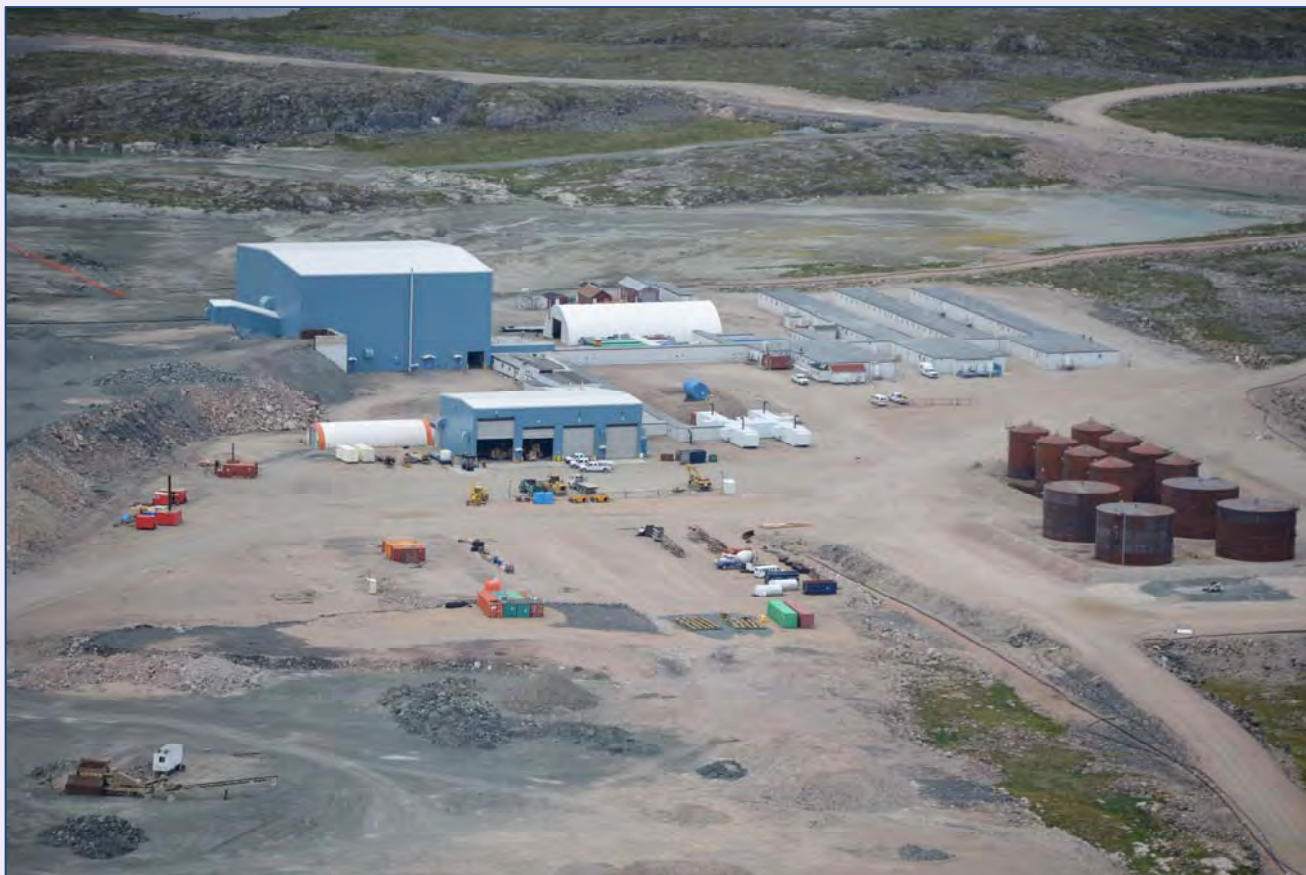
Process Plant

Kimberlite Crushed

- Coarse PK - 81%
 - Gravelly Sand
- Recovery Rejects - 4%
 - Sand and Gravel

- Fine PK - 15%
 - <0.1 mm
 - 70 – 85% Silt
 - 15 to 30% Clay sized
 - Balance is sand

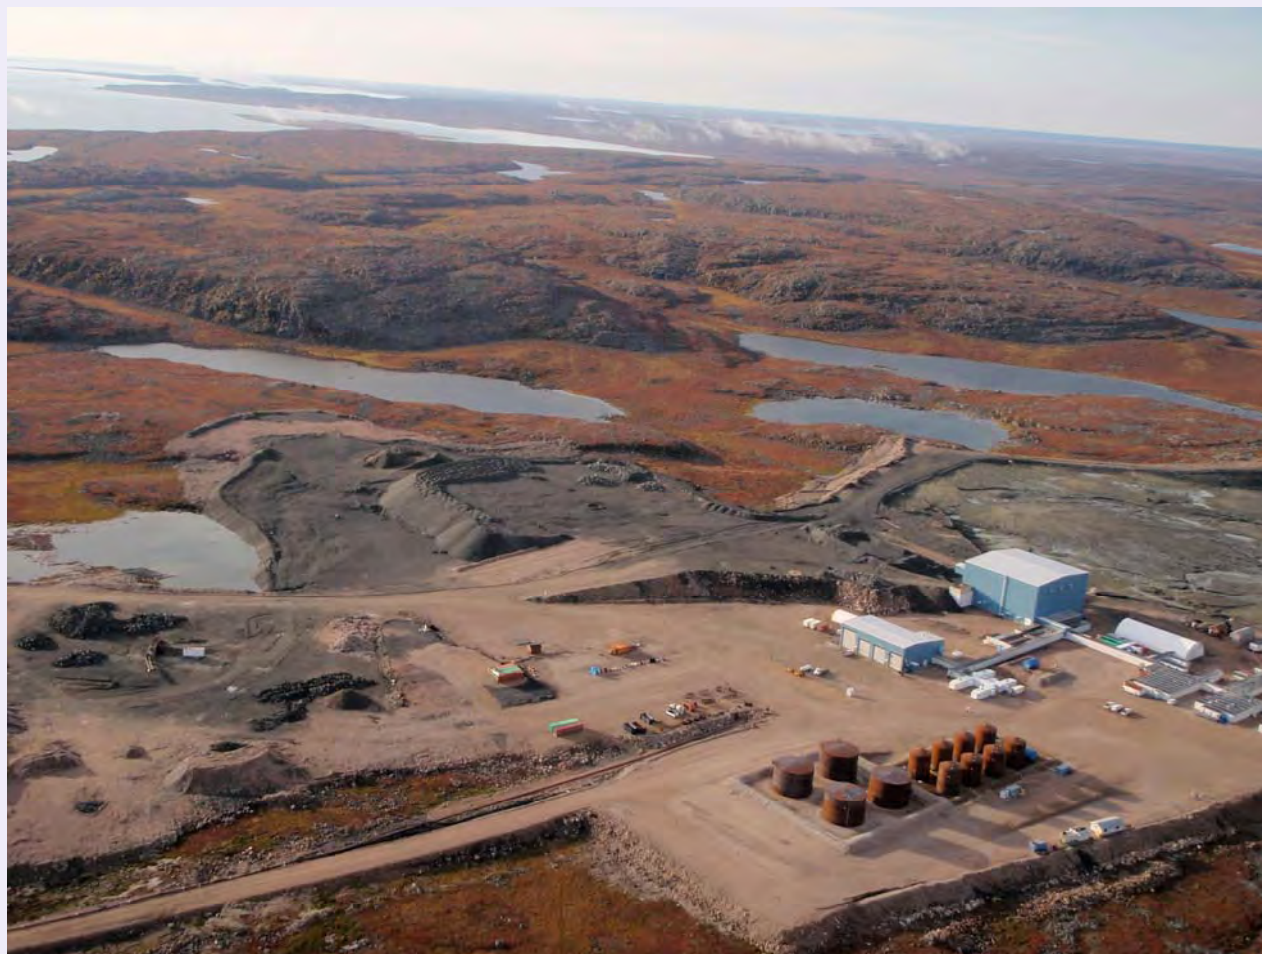
Verification of Dilution Factor

- Environment Canada recommended:
 - A plume delineation study be done late in the discharge season, which examines the extent and behaviour of the plume in three dimensions. Water quality objectives should be stated, and comparisons drawn for where they are expected to be met in Lake C3 (based on tracer concentrations)
- Shear's response:
 - Shear has started and will continue to monitor the water quality in the Lake C3 mixing zone;
 - Shear will directly verify the dilution factor in the Lake C3 mixing zone once mining operations resume;
 - Shear will also undertake a plume delineation study within two years following commencement of mining operations

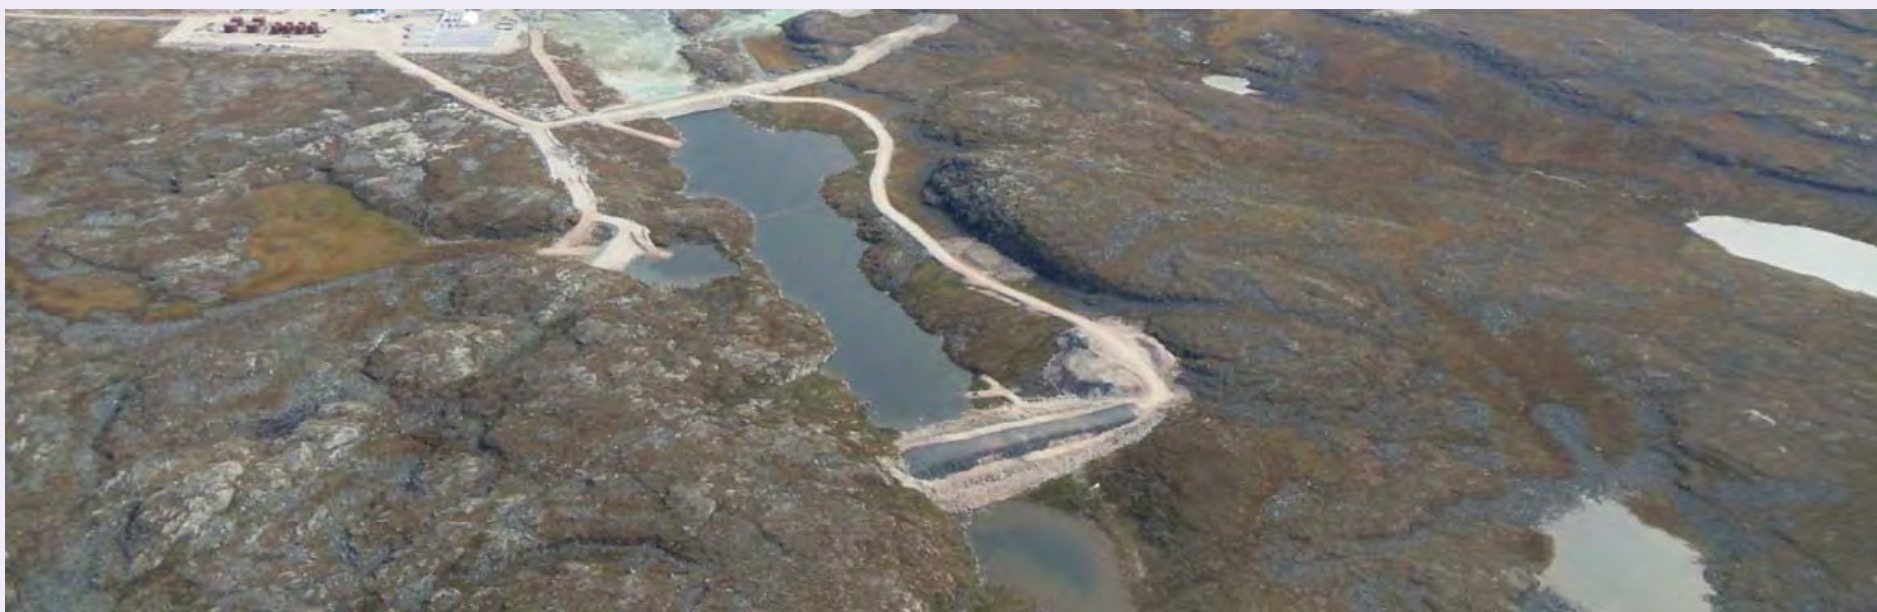
Effluent Quality Criteria

- Shear proposed no changes to the current effluent criteria limits in the submissions to the Nunavut Water Board
- Environment Canada has recommended:
 - Reductions in the effluent discharge limits for nitrate and nitrite
 - The addition of discharge limits for Total Extractable Hydrocarbons (TEH)
 - The removal of discharge limits for TDS and chloride, instead, monitoring these parameters within 24 months of resuming mining operation
 - The removal of discharge limit for oil and grease if not depositing of untreated camp waste directly into the PKCA

Parameter	Unit	2004 Water Licence Limits		Recommended Limits By Environment Canada	
		Max. Grab	Max. Average	Max. Grab	Max. Average
pH	-	6 - 8.8	6 - 8.8	6 - 8.8	6 - 8.8
Total Dissolved Solids (TDS)	mg/L	4,000	2,000	Monitoring	Monitoring
Total Suspended Solids (TSS)	mg/L	25	15	25	15
Chloride (Cl)	mg/L	1,000	500	Monitoring	Monitoring
Ammonia (N)	mg/L	12	6	12	6
Nitrate (N)	mg/L	56	28	40	20
Nitrite (N)	mg/L	5	2.5	2	1
Phosphorus (P)	mg/L	0.4	0.2	0.4	0.2
Aluminum (Al)	mg/L	Total – 3.0 Diss. – 2.0	Total – 1.5 Diss. – 1.0	Total – 3.0 Diss. – 2.0	Total – 1.5 Diss. – 1.0
Arsenic (As)	mg/L	0.10	0.05	0.10	0.05
Cadmium (Cd)	mg/L	0.0024	0.0012	0.0024	0.0012
Chromium (Cr)	mg/L	0.17	0.087	0.17	0.087
Copper (Cu)	mg/L	0.04	0.02	0.04	0.02
Lead (Pb)	mg/L	0.02	0.01	0.02	0.01
Molybdenum (Mo)	mg/L	1.5	0.73	1.5	0.73
Nickel (Ni)	mg/L	0.10	0.05	0.10	0.05
Uranium (U)	mg/L	1.0	0.5	1.0	0.5
Zinc (Zn)	mg/L	0.50	0.25	0.50	0.25
Oil and Grease	mg/L	5.0	3.0	Removed	Removed

- Shear's Response:
 - Shear accepts the reduction of nitrite
 - Shear accepts the addition of Total Extractable Hydrocarbons (TEH)
 - Shear accepts the removal of the discharge limit for oil and grease
 - Shear proposes maintaining TDS and chloride as licence criteria, as opposed to just monitoring them
 - Shear proposes no change to the current nitrate limit and that the company hold a Technical Meeting following two year of operations to review the water quality data

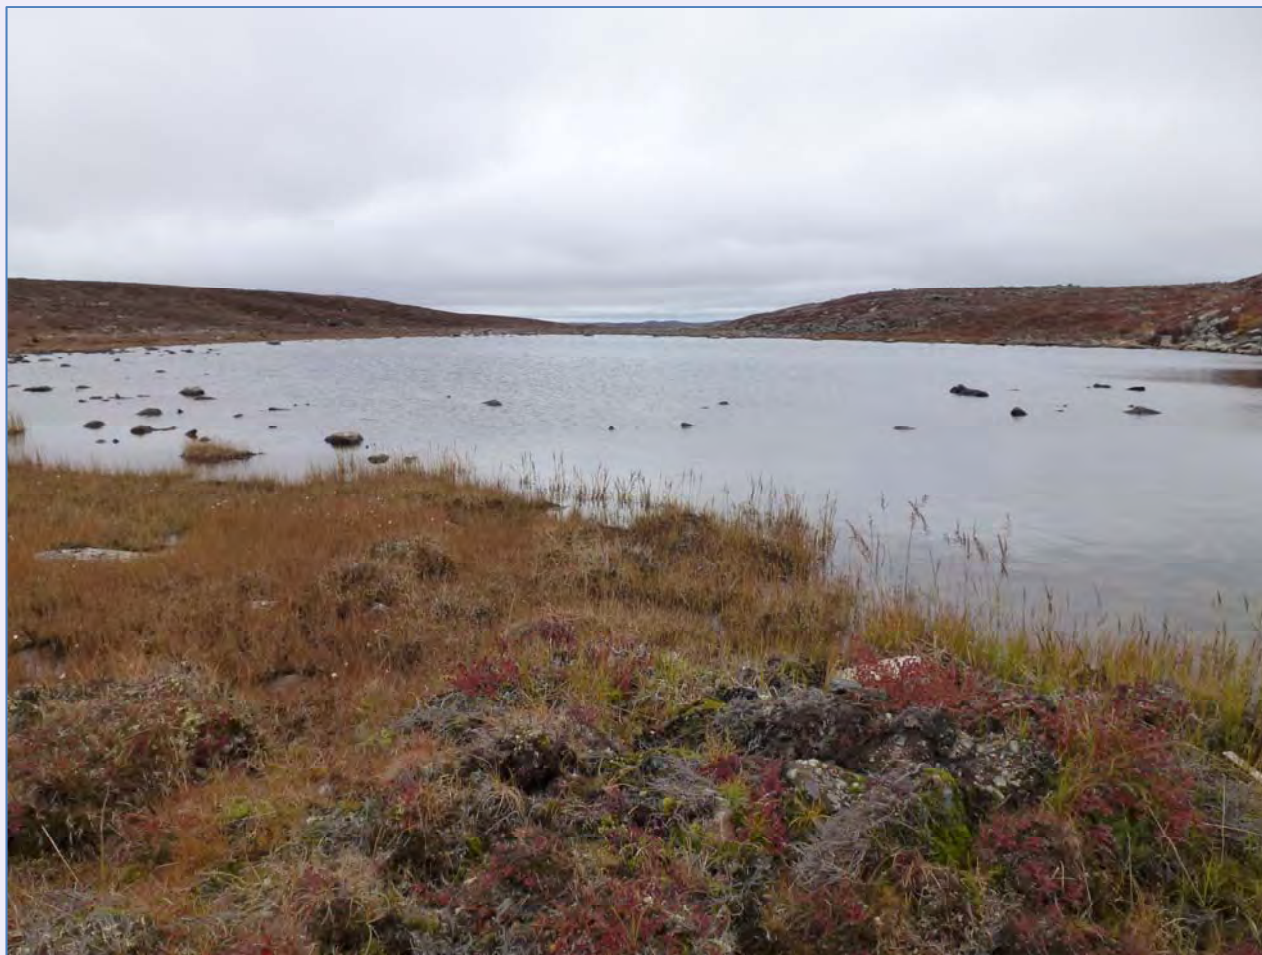
Site Water Quality & Management

- A number of comments were received with regard to site water quality and management
- In 2011, Shear gained a better understanding of site water
- Shear will revise and submit the Site Water Management Plan by end of year 2012
- Shear will incorporate the recommendations from intervenors and the knowledge that Shear has gained through monitoring and sampling in 2011
