shear
diamonds

Jericho Diamond Mine, 2AM-JER0410
Type A Water License Renewal

Public Hearing -
Kugluktuk, NU
Nov. 30 – Dec. 1, 2011

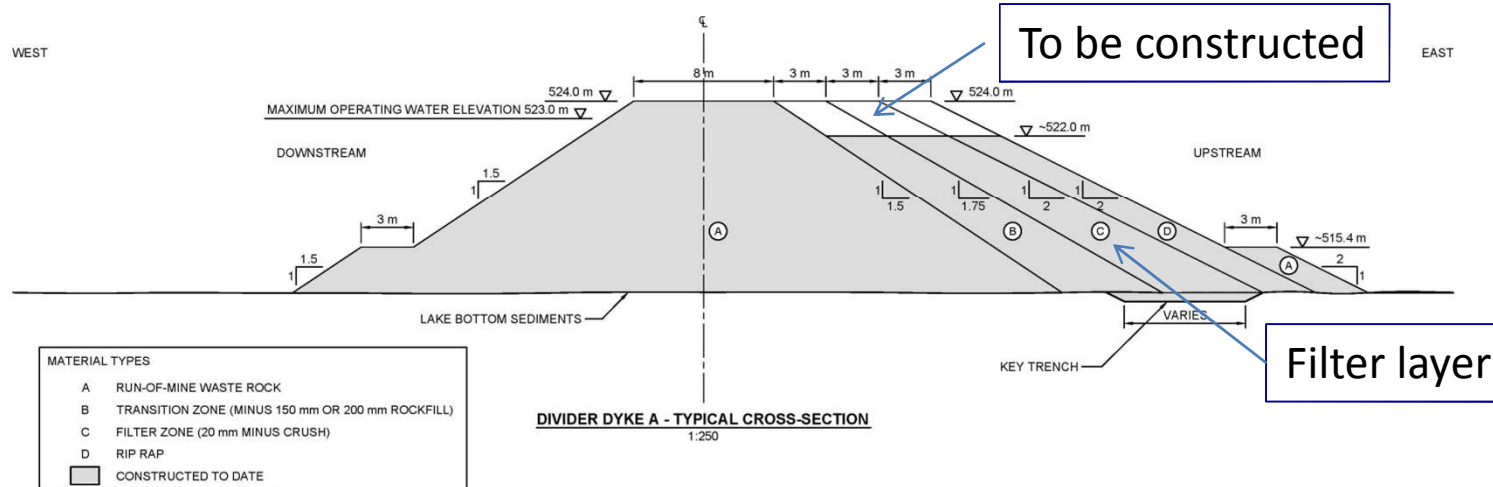
DIVIDER DYKE A - PROFILE
1:1000

DIVIDER DYKE A - TYPICAL CROSS-SECTION
1:250

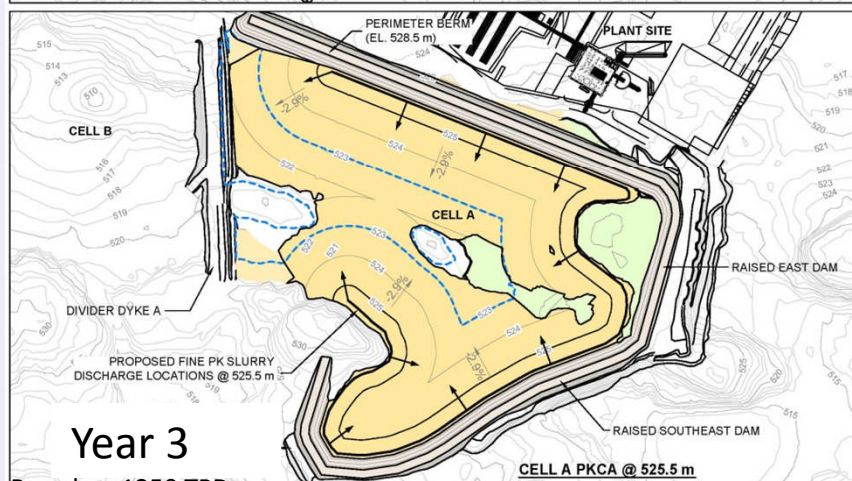
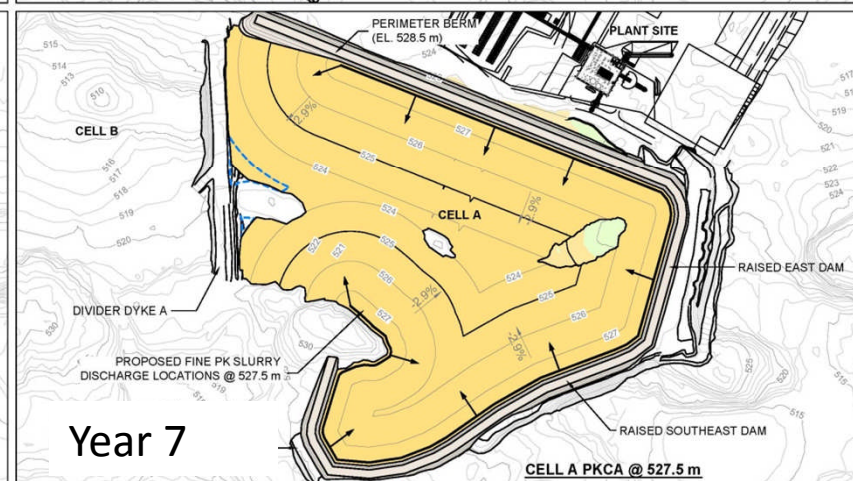
PKCA – Fine PK Distribution – Cell A

Based on 1250 TPD

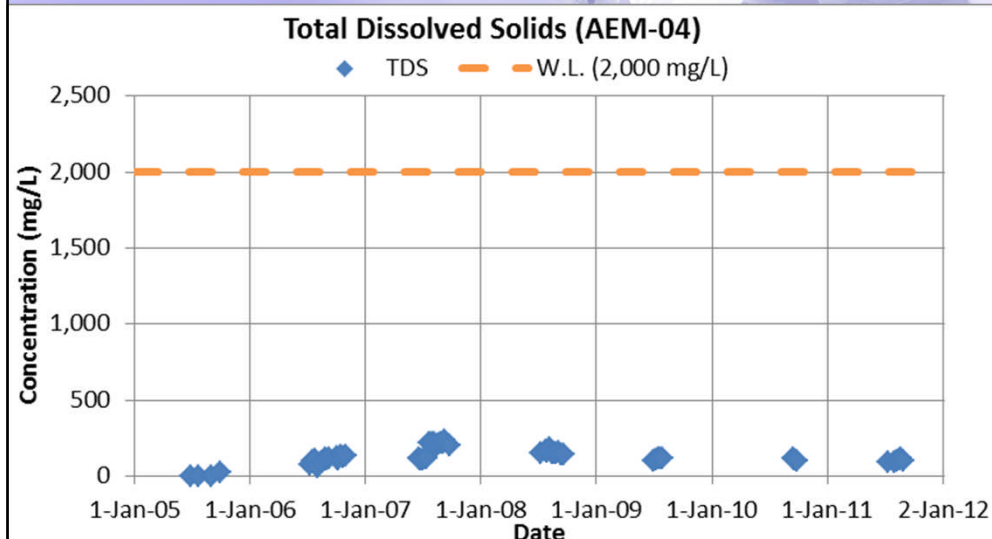
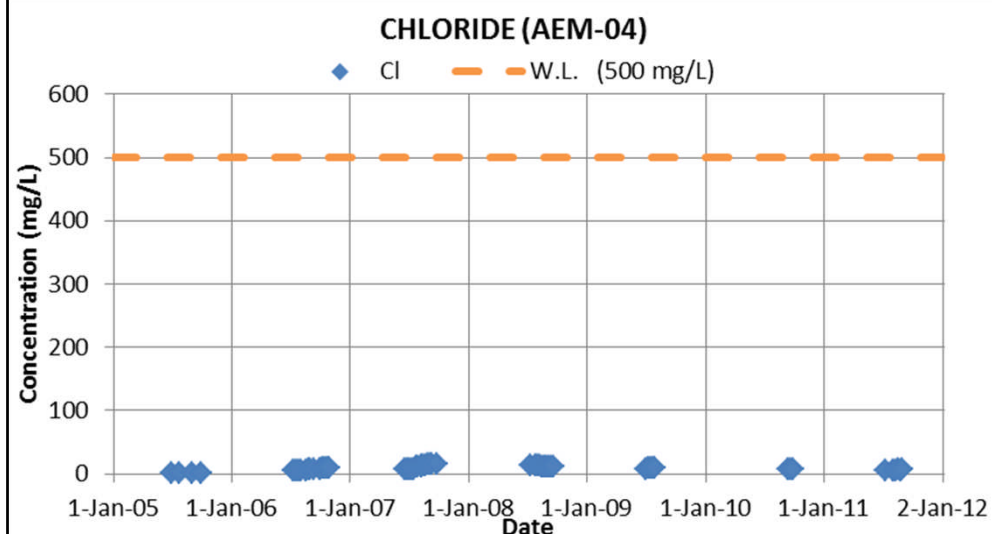
Effluent Quality Criteria Development for TDS and Chloride

- Both TDS and Chloride showed increasing trend from 2006 to 2007 during previous operations;
- However, the maximum concentrations of both parameters were insignificant comparing to the current discharge limits;
- In addition, concentrations of both parameters showed rapid reduction after the suspension of the mining operation;

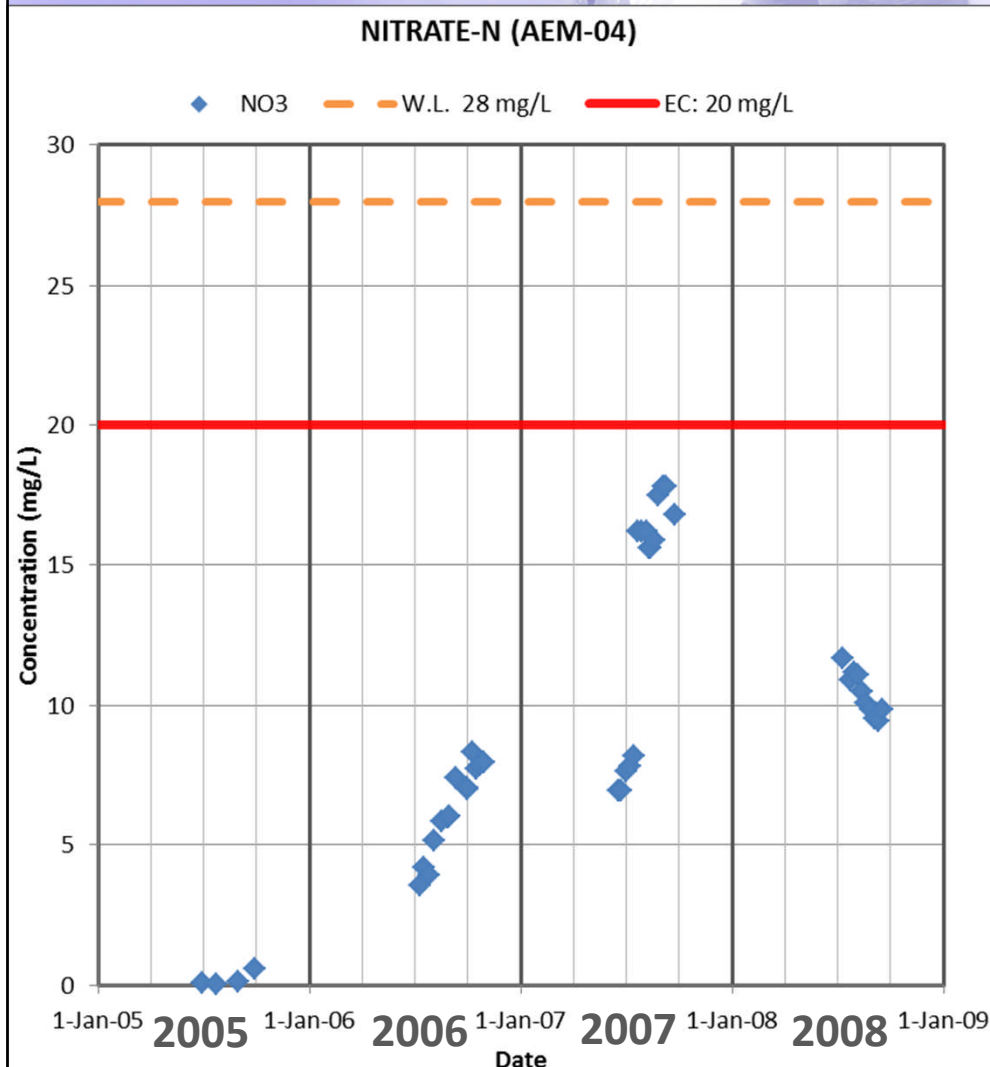
Effluent Quality Criteria Development for Nitrate

- Environment Canada recommended lowering the discharge limit for nitrate from 28 mg/L to 20 mg/L
- During previous operations, the nitrate concentration in grab samples increased from less than 0.05 mg/L in 2005 upto 17.8 mg/L in September 2007;
- The Maximum Average Concentration (MAC) of nitrate from August 27 to September 24, 2007 was 17.5 mg/L
- If mining operations had continued in 2008 (Year 3), it is possible that nitrate in the effluent may have exceeded the discharge limit currently being recommended by EC

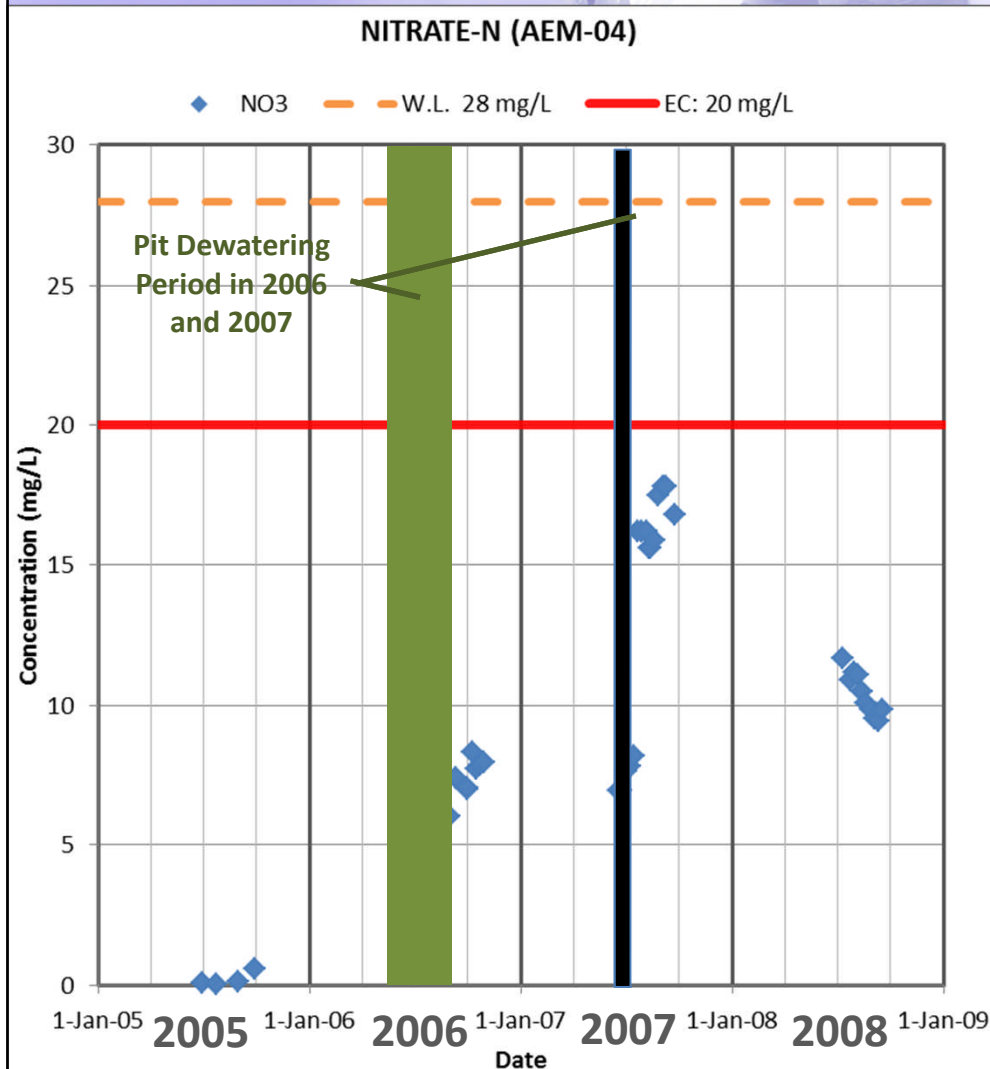
Effluent Quality Criteria Development for Nitrate

- Based on the current review of the site water quality data, elevated nitrate in the PKCA effluent mainly originated from pit dewatering during operations;
- Nitrate in the pit water ranged from 46 mg/L to 121 mg/L between June 2006 and August 2007
- The source of the nitrate in the pit water is the residual ammonium nitrate dissolving in the pit sump from blasting activities

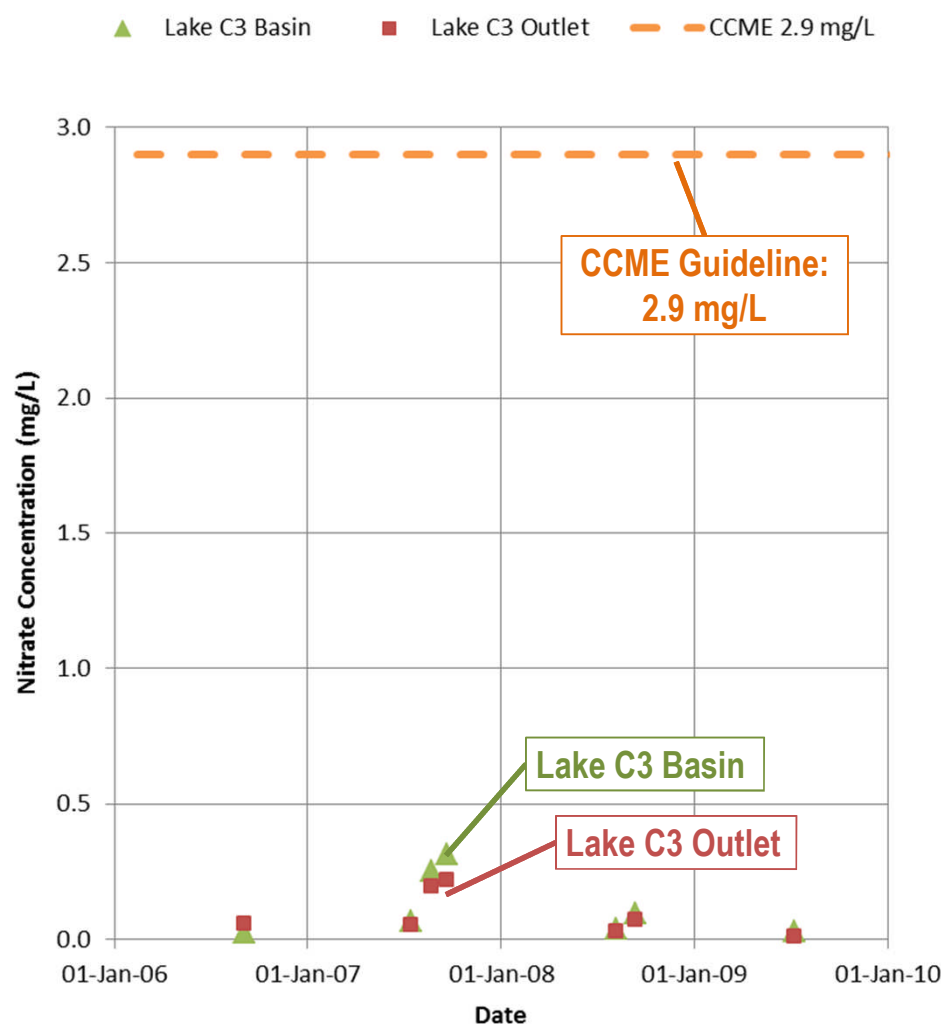
Effluent Quality Criteria - Nitrate

- Nitrate concentrations in Lake C3 were well below the aquatic threshold limit during previous mining operations, despite an increasing trend in the PKCA discharge, which approached the discharge limit being recommended by EC;
- Nitrate concentration is controlled by physical dilution and biological consumption;
- Maintaining the effluent concentration at the current water licence limit of 28 mg/L will keep the nitrate concentration below aquatic threshold in Lake C3
