Jericho Diamond Mine, 2AM-JER0410

Type A Water License Renewal

Public Hearing -
Kugluktuk, NU
Nov. 30 – Dec. 1, 2011

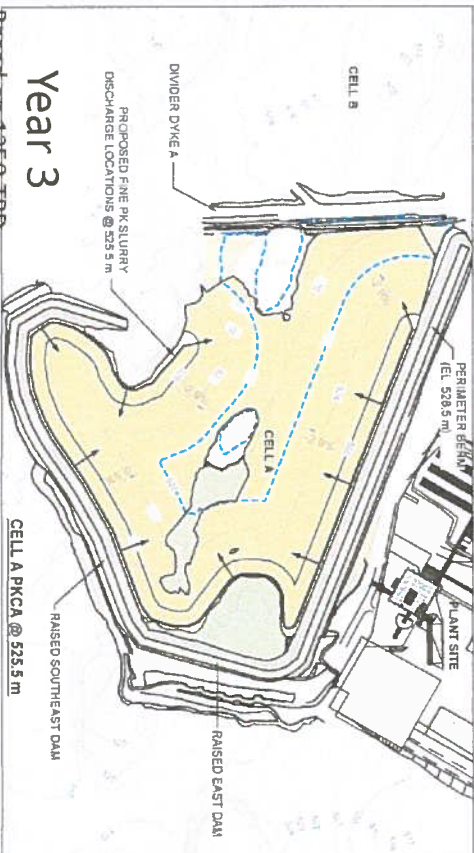
PKCA – Fine PK Distribution – Cell A

Based on 1250 TPD
