## Jericho Diamond Mine, 2AM-JER0410

Type A Water License Renewal

Public Hearing -  
Kugluktuk, NU  
Nov. 30 – Dec. 1, 2011

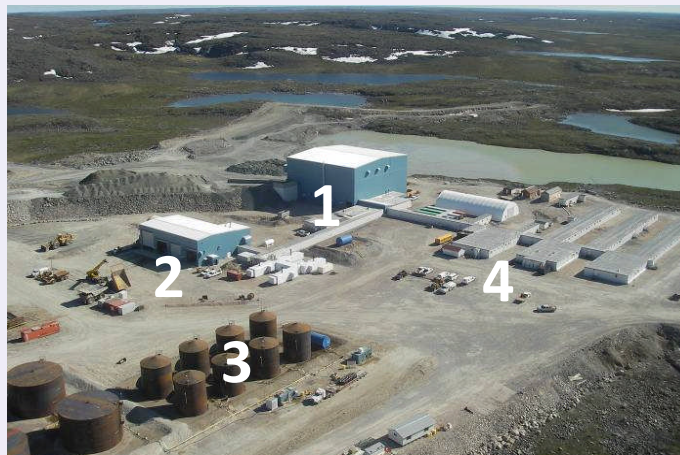
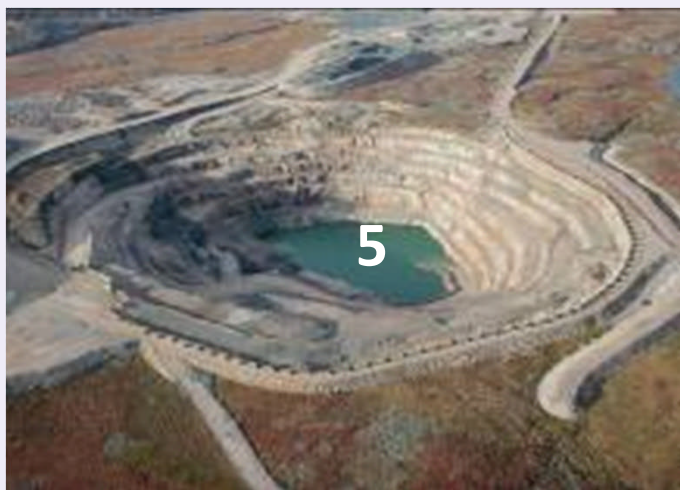
# Jericho Project Existing Infrastructure

- **C\$200 Million in infrastructure**
  1. 2,000 tpd diamond processing plant
  2. Maintenance shop
  3. Fuel farm
  4. Staff Offices & Accommodations for 225
  5. Jericho open pit mine
  6. Year round airstrip
- **Excellent project access via air and winter road**
- **Operating permits in place**

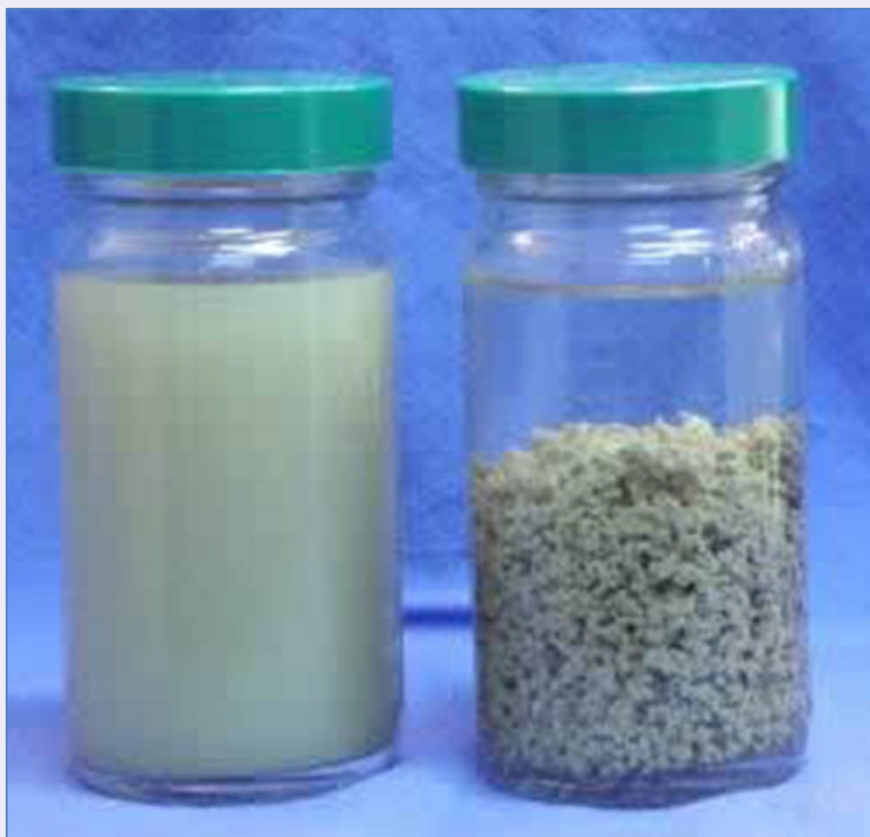
# Flocculent

- The name flocculent comes from the woolly appearance of the floc
- Flocculent clumps suspended solids together making them heavy so that they settle out in the PKCA
