Airborne Deposition of FPK  
Jericho Diamond Mine  
Technical Meetings  
Cambridge Bay, NU  
June 20-21, 2011

# Issue Identified

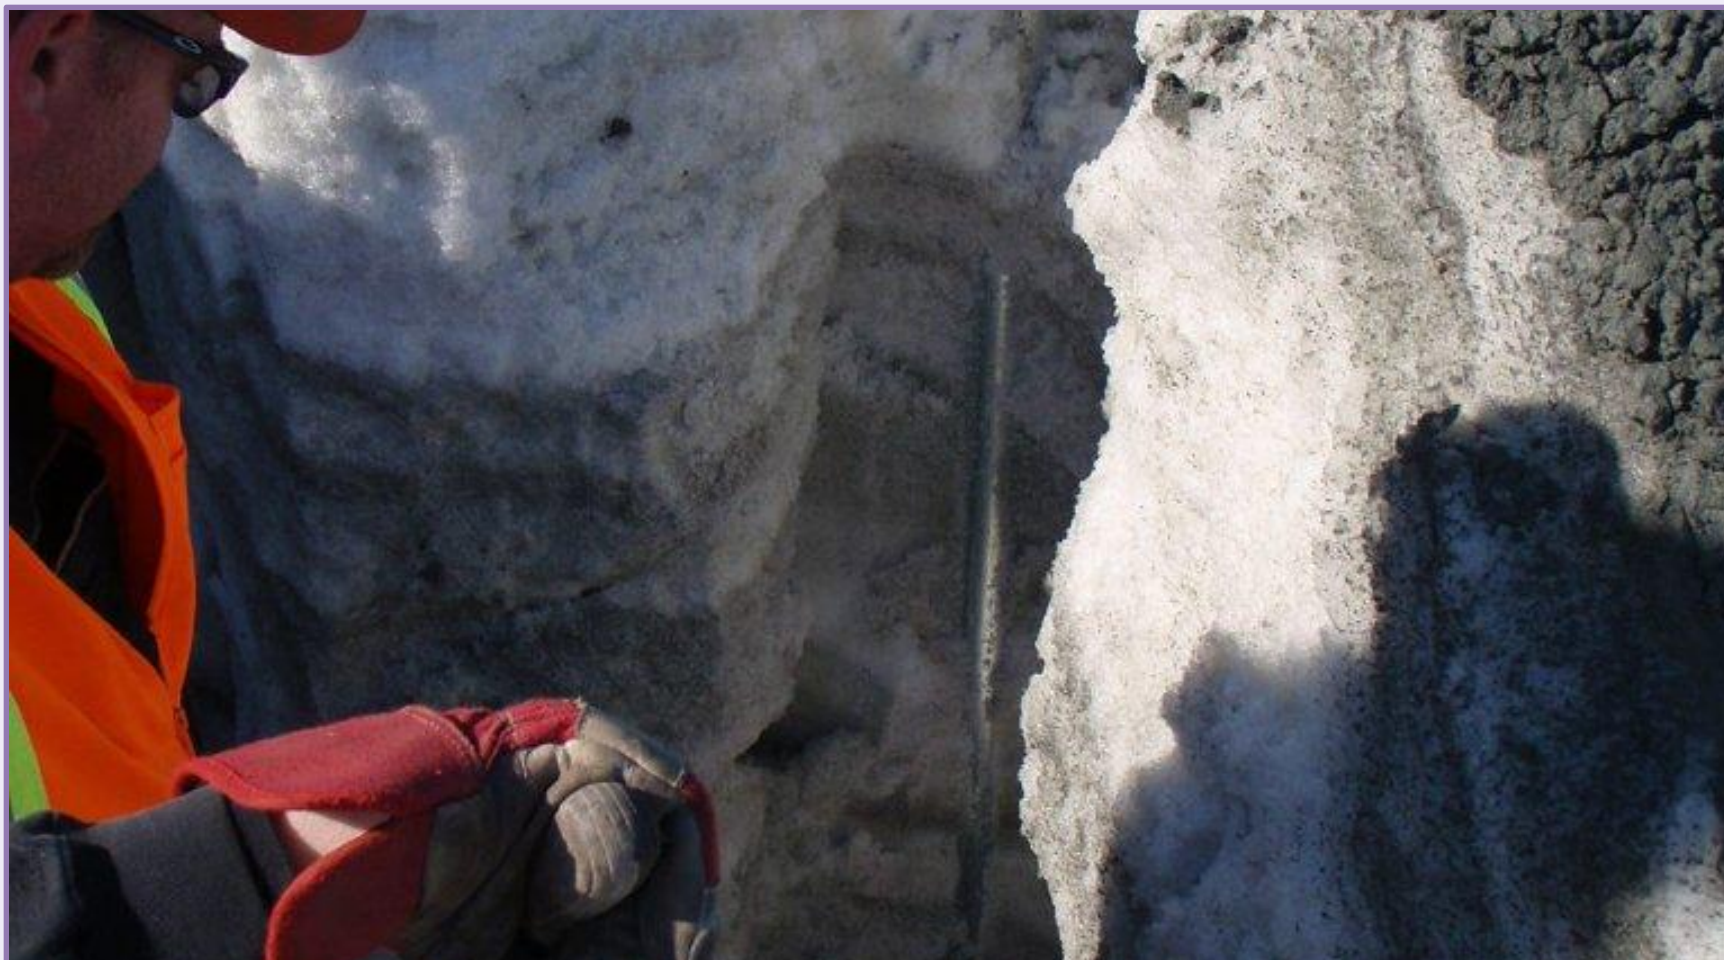
# FPK Stratification

- An area of approximately 4 m<sup>2</sup> was excavated to bottom (1.7 m) to expose a clean face to see stratification
- Two snow core samples were collected from top of snow to ground level and sent for analysis for particle size and total particulate
- A sample was collected from the top layer of the consolidated FPK and sent for chemical composition and shake flask analysis
- Approximately 35 m<sup>3</sup> of FPK snow was excavated from the banks of southeast dam and placed inside the PKCA

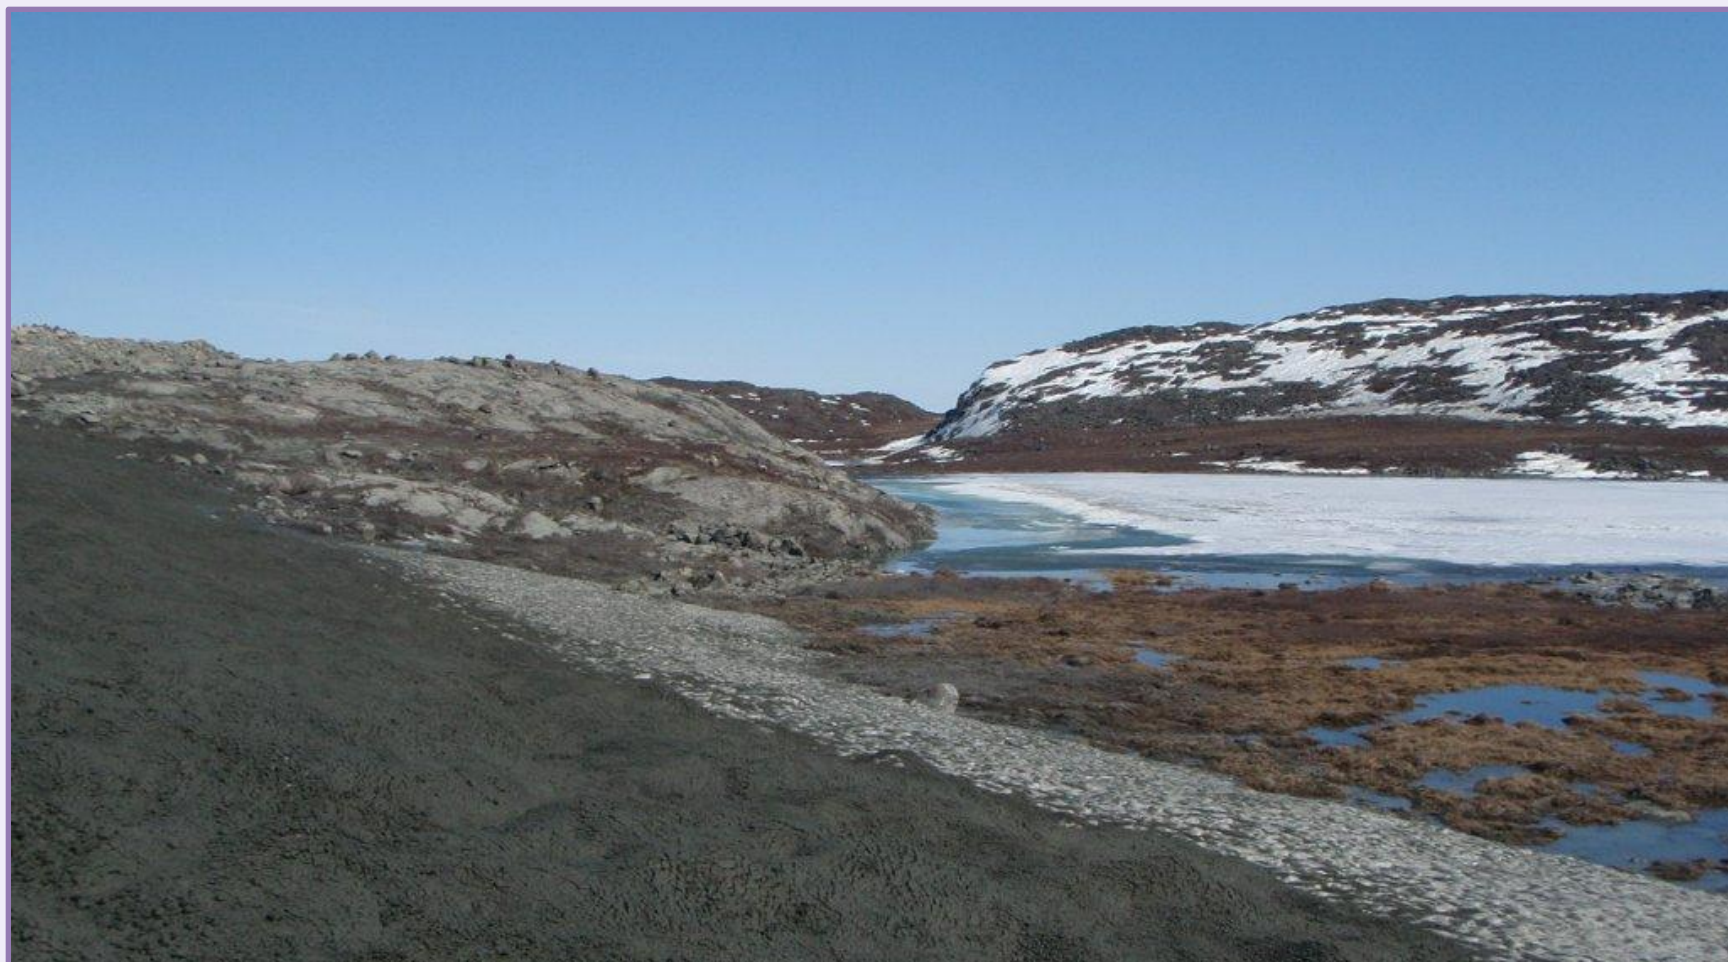
# FPK – Leeward Side of Southeast Dam

- Observations were made by EBA on June 2, 2011
- The key observations were:
  - The upper area of the PK facility showed evidence of material transport by wind.
  - The middle and lower areas did not.
  - Sandy material is being transported up and over the dams and is being captured in the leeward windbreak.
  - The observed wind affected area of the PKCA has an approximate area of 40,000m<sup>2</sup> (4 hectares) which is approximately 40% of the total PK covered area.

- Install snow fencing on upper, high wind, area.
- Use on-site materials to create wind breaks.
- Begin discussions with regulators on dust suppressant products for areas which continue to exhibit high erosion.
- Document observations for report to be submitted at the end of the trial period (1 year)

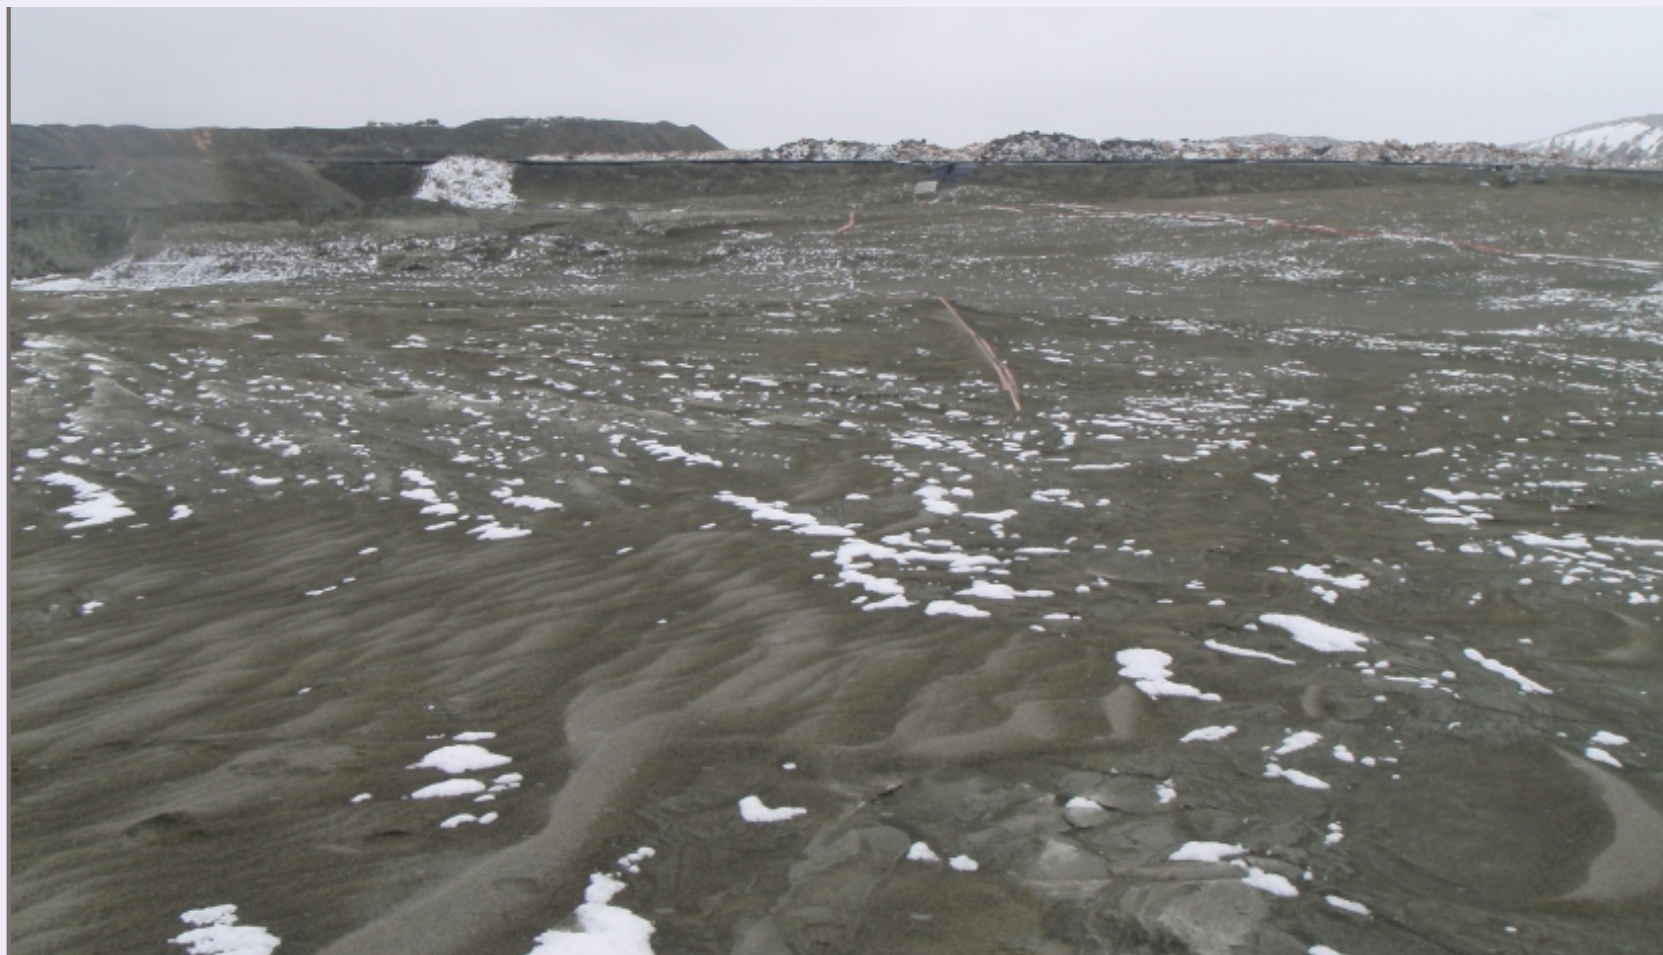
# Upper Area

- Samples were collected from:
  - The upper area
    - Predominantly fine sands
  - The middle area
    - Silty material
  - The leeward side
    - Sandy mixed with snow
