Dear Eva:  
RE: Follow up for spill #12-158 reported May 1, 2012

### **Summary**

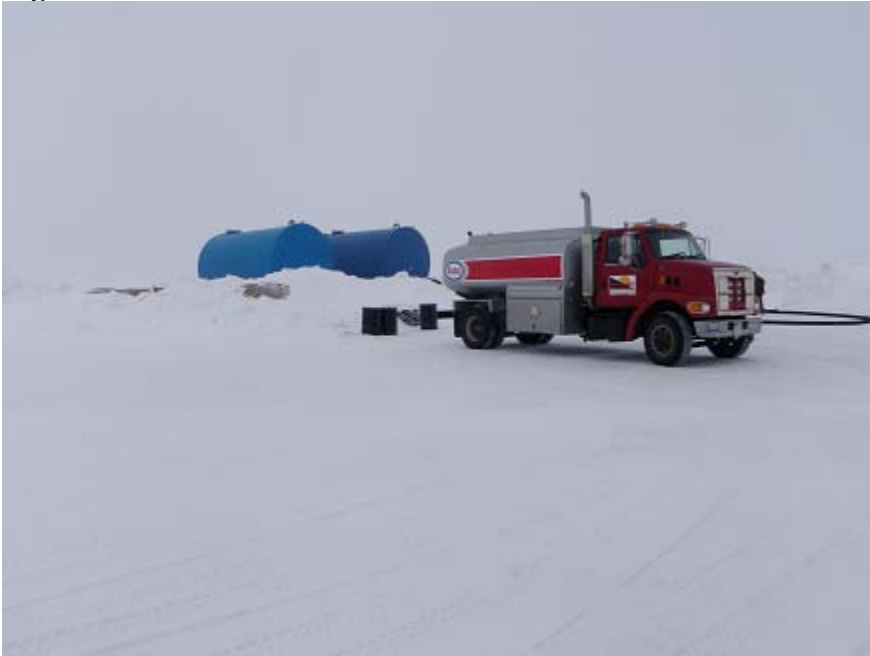
**Figure 1**

On May 1st, 2012, at 1:15 pm, approximately 100L of diesel was spilled while filling up the fuel truck at the airstrip. The fuel truck was being filled from storage tank EC-00016028. The fuel truck is filled from the top and during fueling the worker who was on top of the truck holding the fuel line slipped and almost fell. Coincidentally, the fuel line was removed from the truck for a short time and diesel sprayed all over the worker, the truck and the ground. The spill was reported to the Site manager and personnel were able to remove the diesel contaminated snow and ice with a loader and dump it into the containment berm. The worker was brought in to clean up and the truck was wiped down with absorbent pads. Figure 1 shows the fuel truck at the place of the incident after the clean up was finished.

The spill coordinates are N 66deg 0min 1.1628sec W 111deg 28min 1.589sec, approximately 500m east of Carat Lake. The area of the spill was approximately 4 square meters.

This spill brought to light two issues faced while conducting this activity. The first issue is safety. Currently, there is nowhere for workers to tie off (using fall arrest safety gear) on while filling the fuel truck from the top. Shear is investigating how to install a hand-rail on top of the truck, allowing safer maneuverability while also providing somewhere to attach fall protection. This would greatly reduce the chance for workers to sustain an injury while performing this task.

The second issue was that the worker has little control over the flow of fuel in the line during fueling. Shear is ordering an automatic shut off valve for that particular fuel line that is used for fuel transfers into the fuel truck. The automatic shut off valve will stop the flow of fuel immediately if the line is released.

An investigation into the cause of this particular spill has determined that it was due to improper fuel handling practices and an unsafe work environment. Fuel handling procedures are being reviewed with all applicable staff and everyone is taking part in a refresher on spill reporting and clean up procedures.

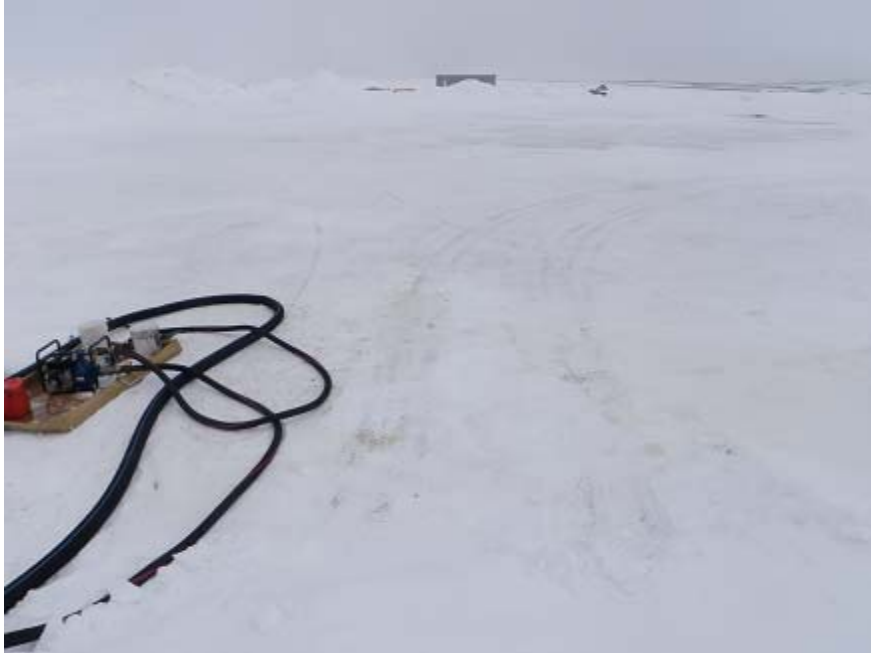
**Figure 2**

The spill was contained following the Diesel Spill Response Procedure outlined in Appendix A of Shear's Contingency Management Plan. As soon as the spill happened the pump was stopped and clean up began. The area after clean up can be seen in Figure 2.
