FPK Update Jericho Diamond Mine Shear Diamonds Ltd.

May 22, 2012

FPK Clean Up Activities

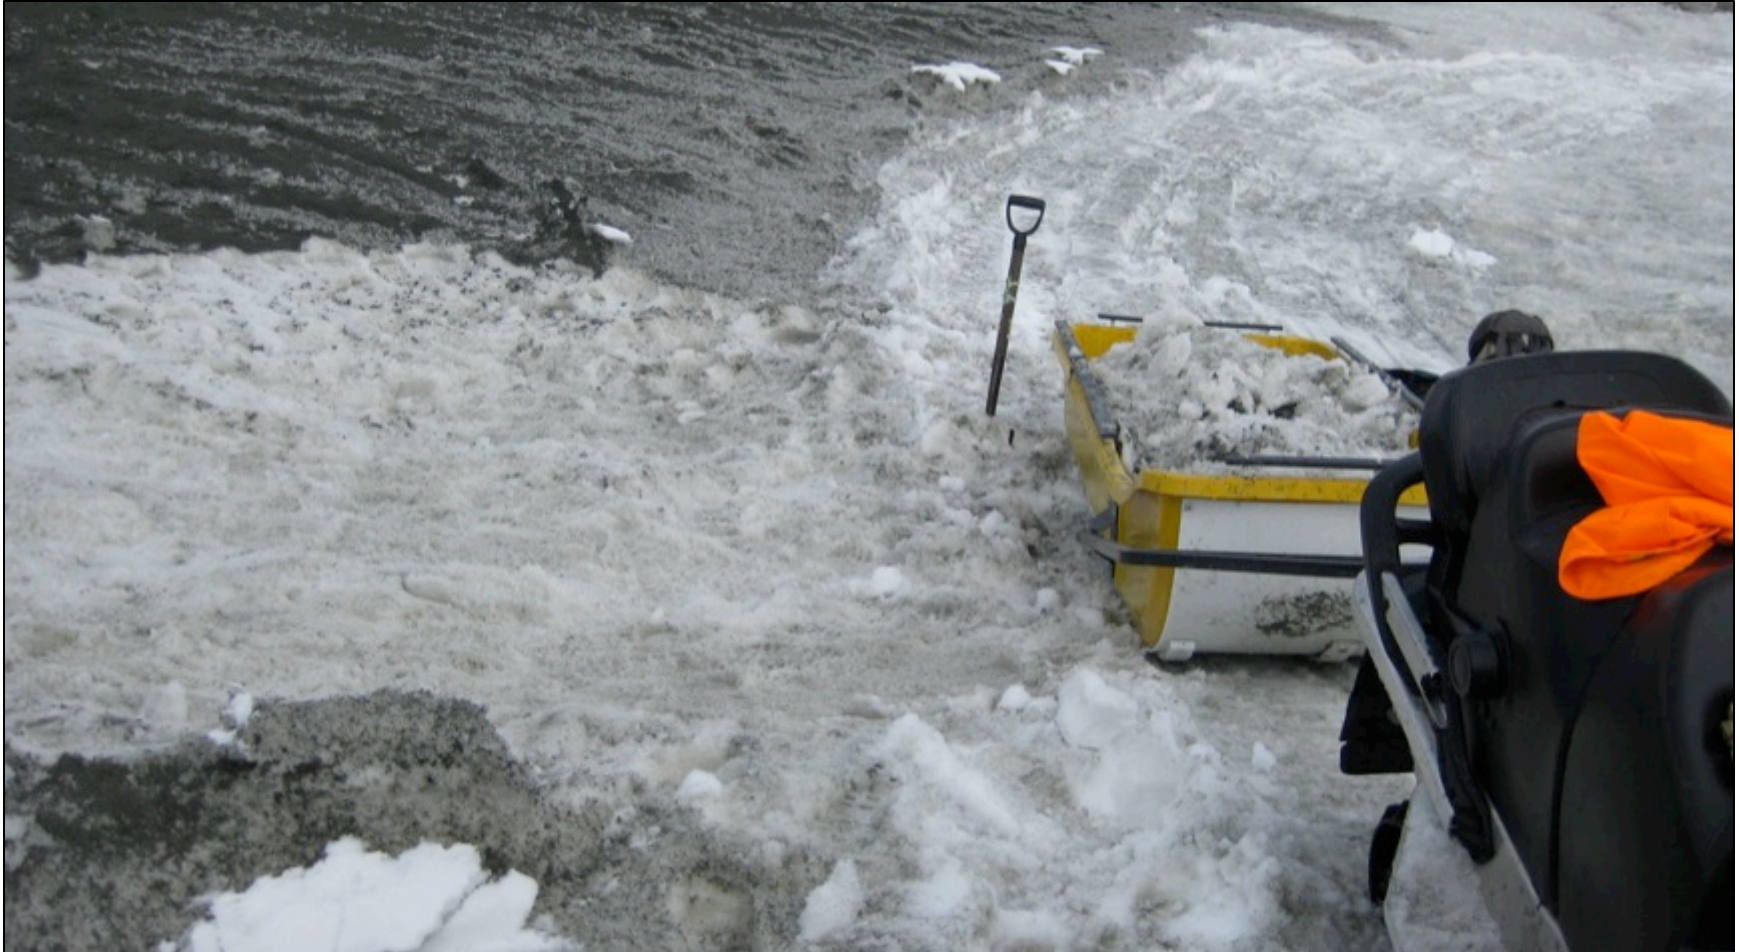
- May 17, 2012 a crew began hand shoveling the FPK into sleds pulled by snowmobiles.
- The sleds were filled and driven to the PKCA where they were dumped.

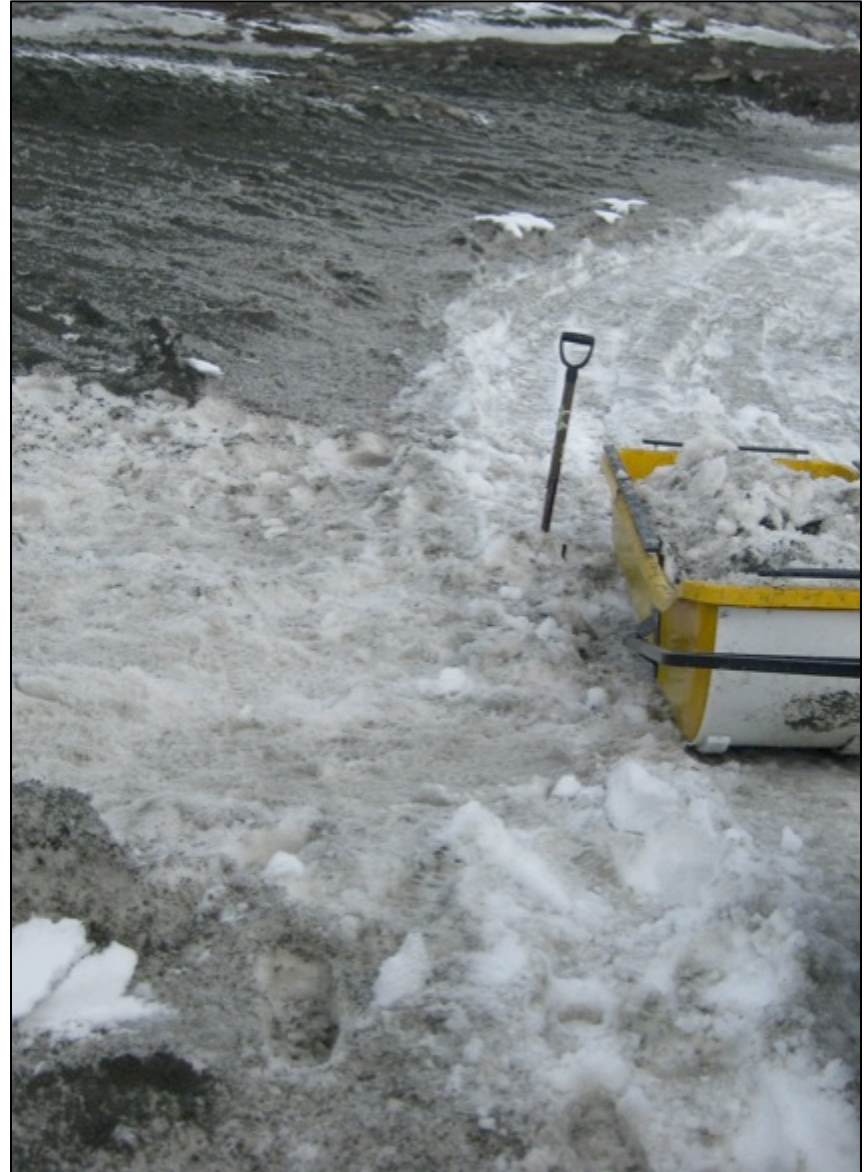
- The first couple of days the FPK was frozen solid along with the top layer of snow.
- The material had to be 'chiseled' then shoveled into the sleds.

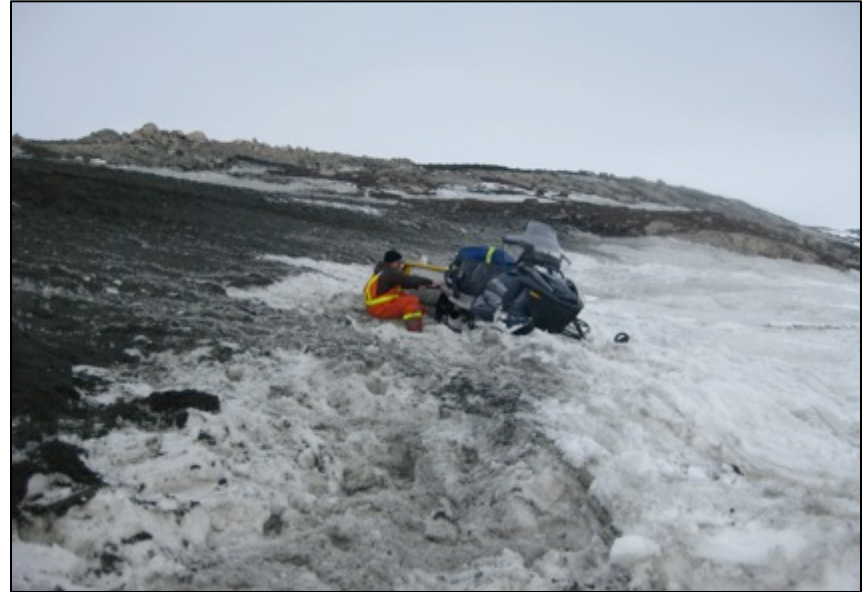
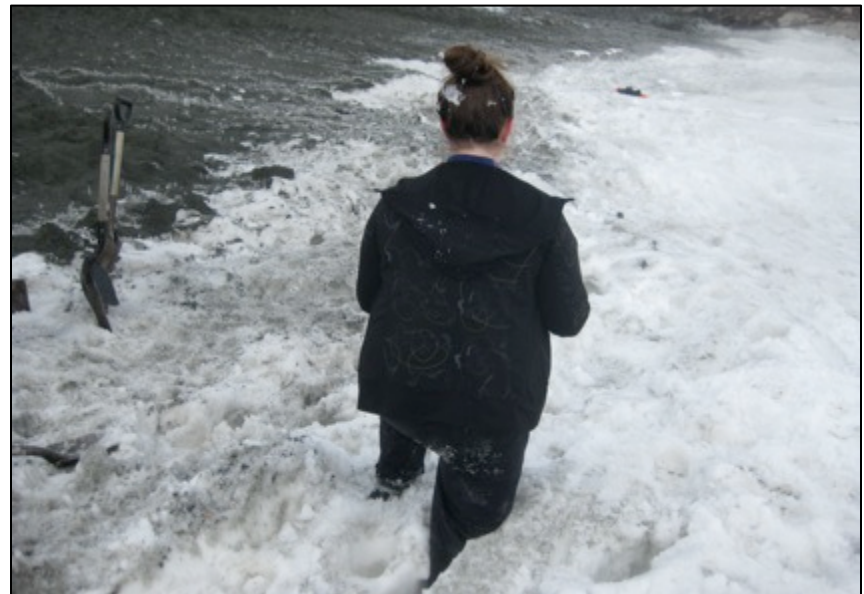
- Challenges included:
- Snowmobiles getting stuck and bogged down;
- Breaking through the snow while shoveling once the top hard layer was removed.

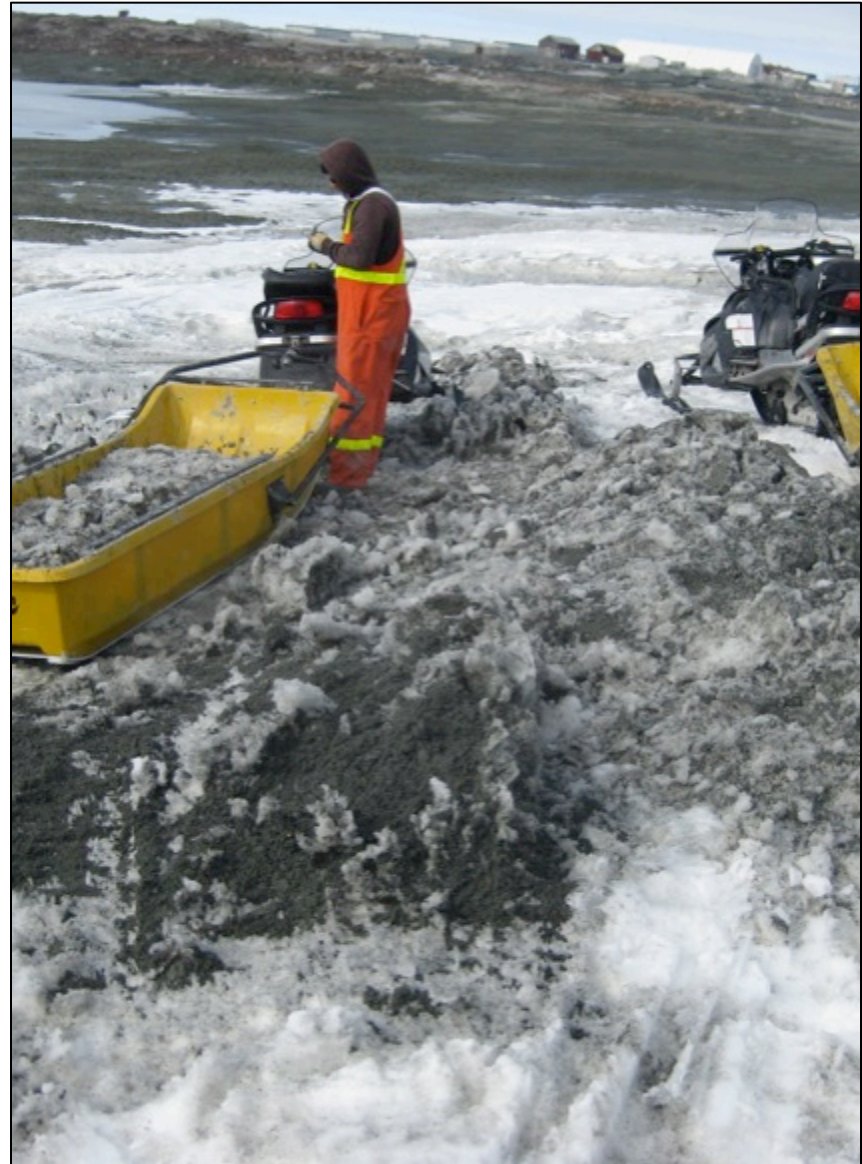
- Another challenge was the weight of the sleds when they were full.
- This is a photo showing where the FPK was dumped in the PKCA.

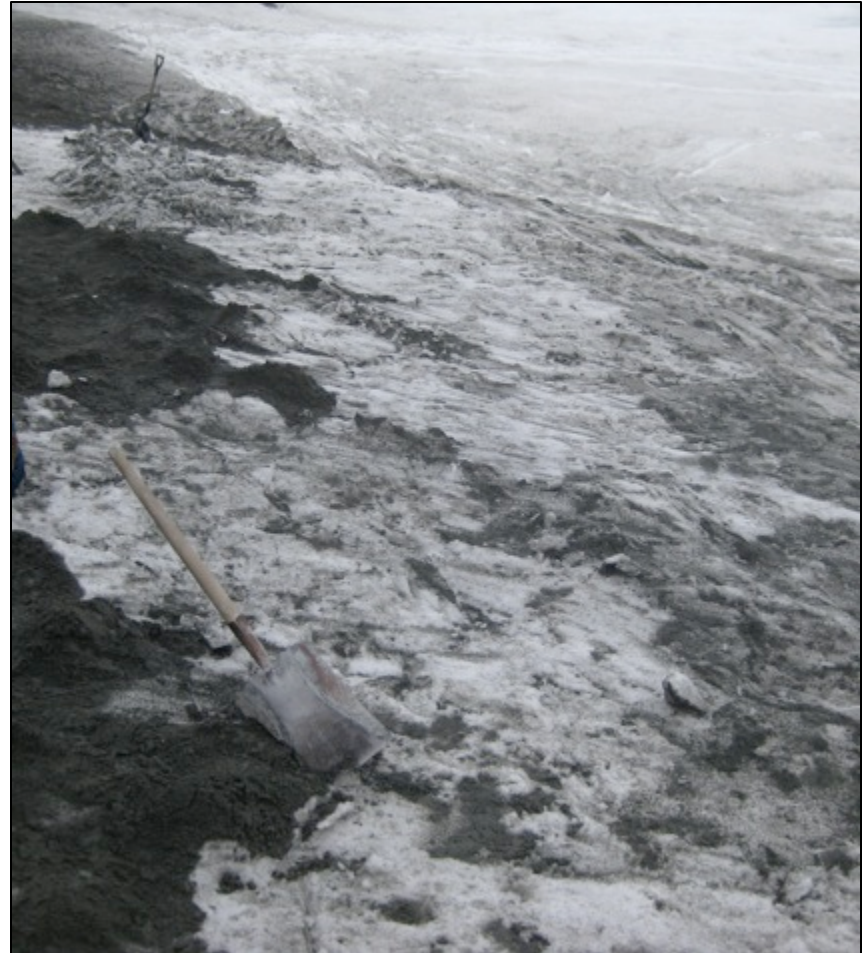
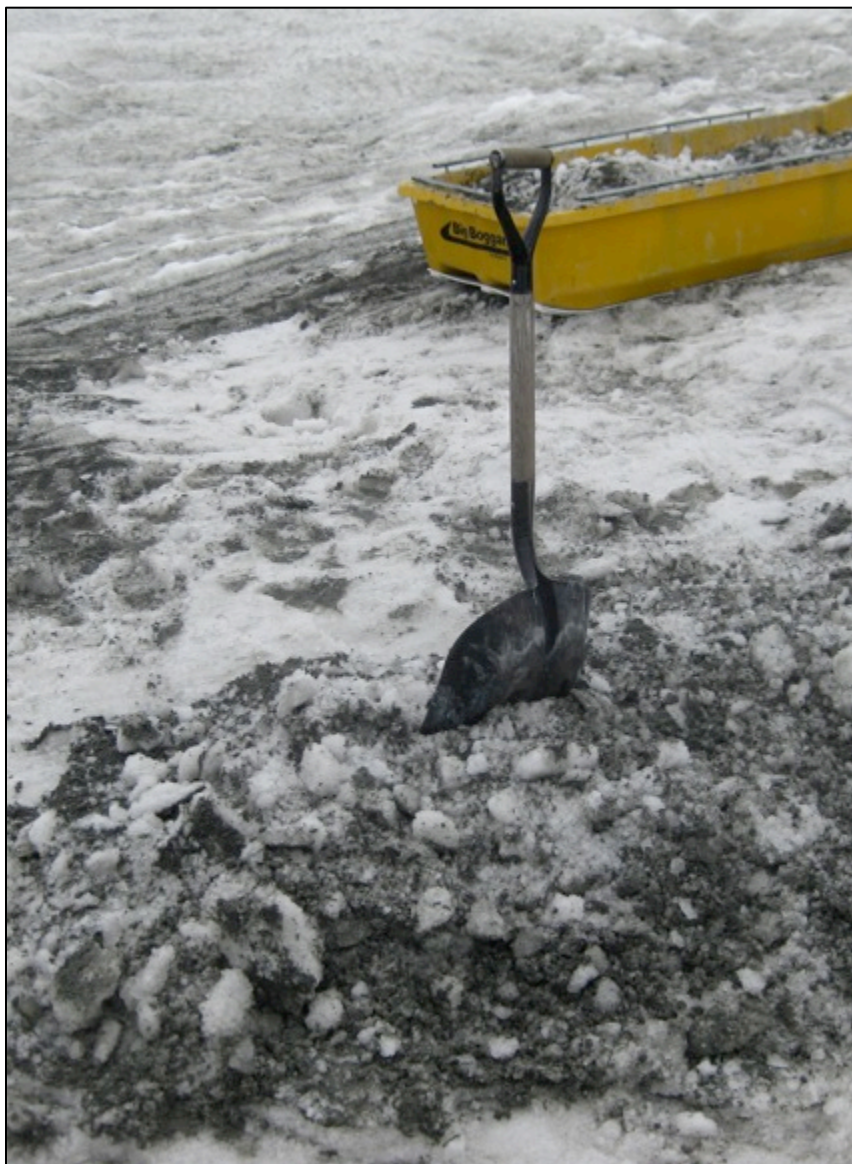
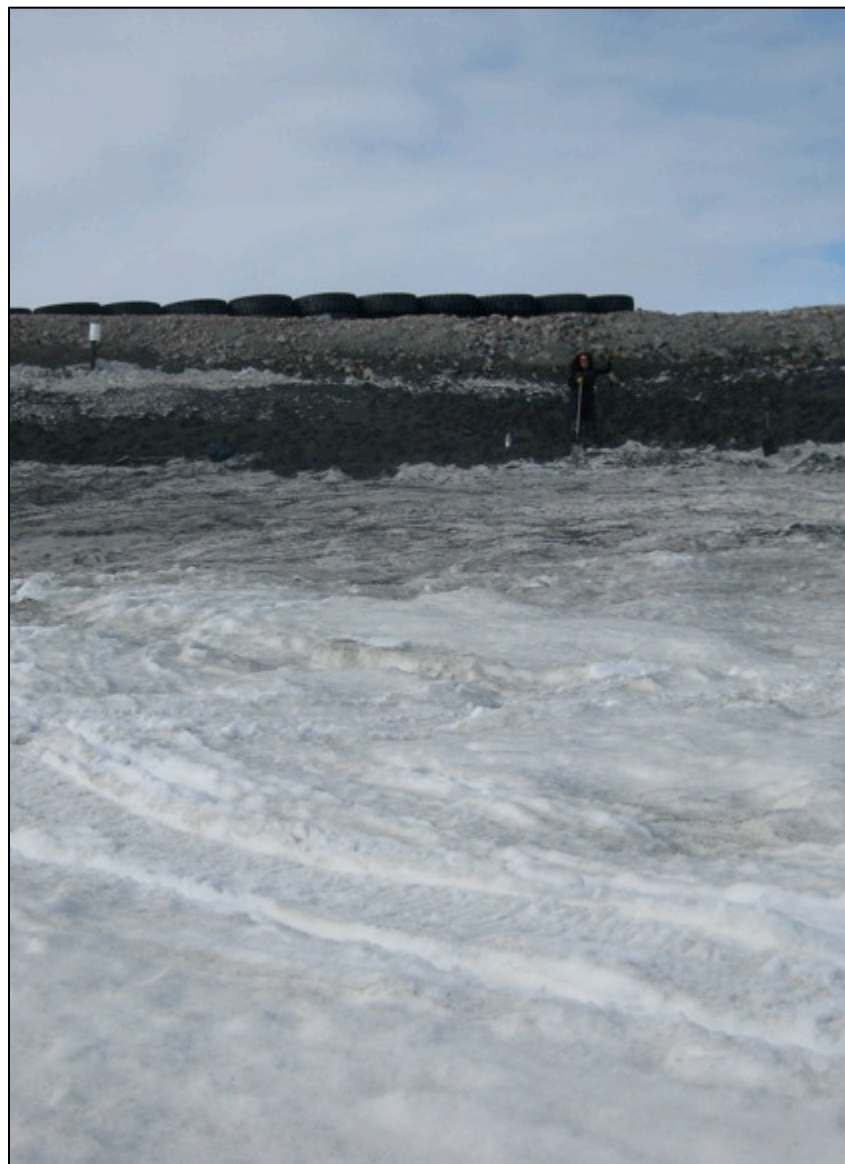
- Warming temperatures led to snow compaction.
- On May 21st the excavator was able to get down onto the snow without getting stuck.
- The excavator shoveled the FPK and placed it up high on the Southeast Dam.

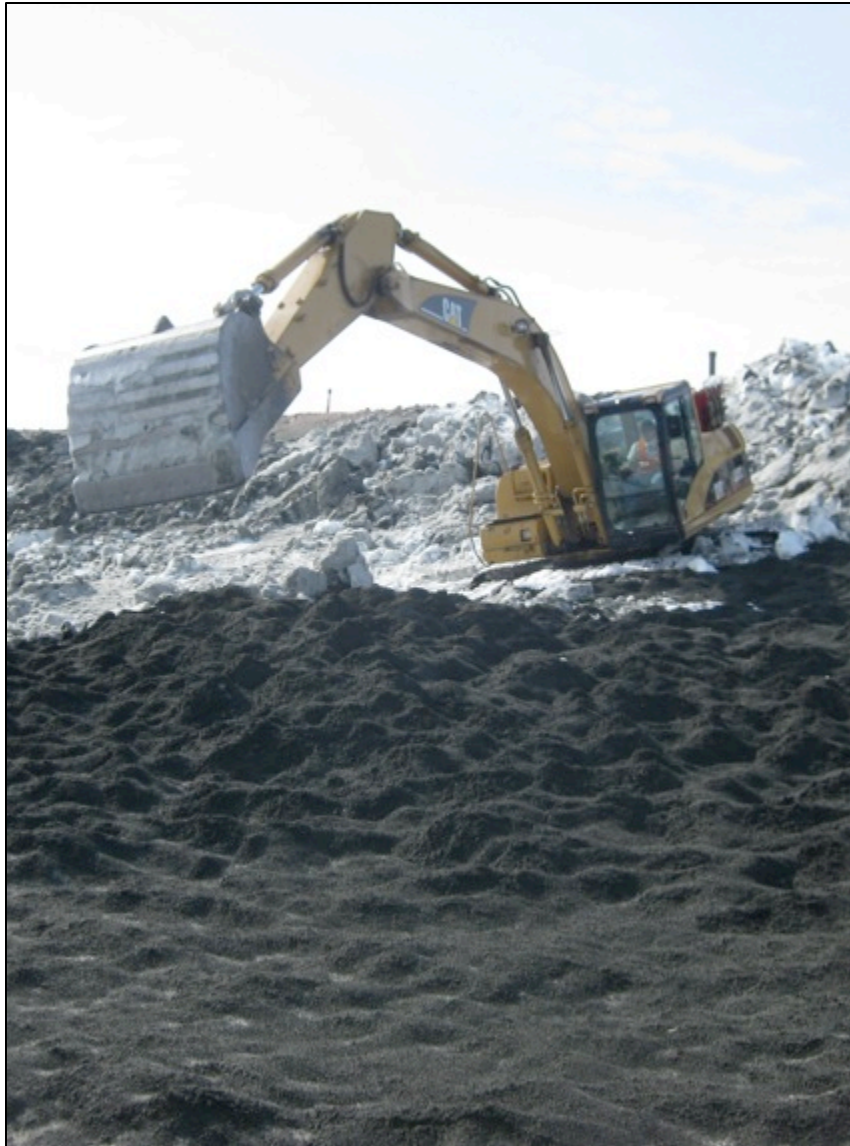
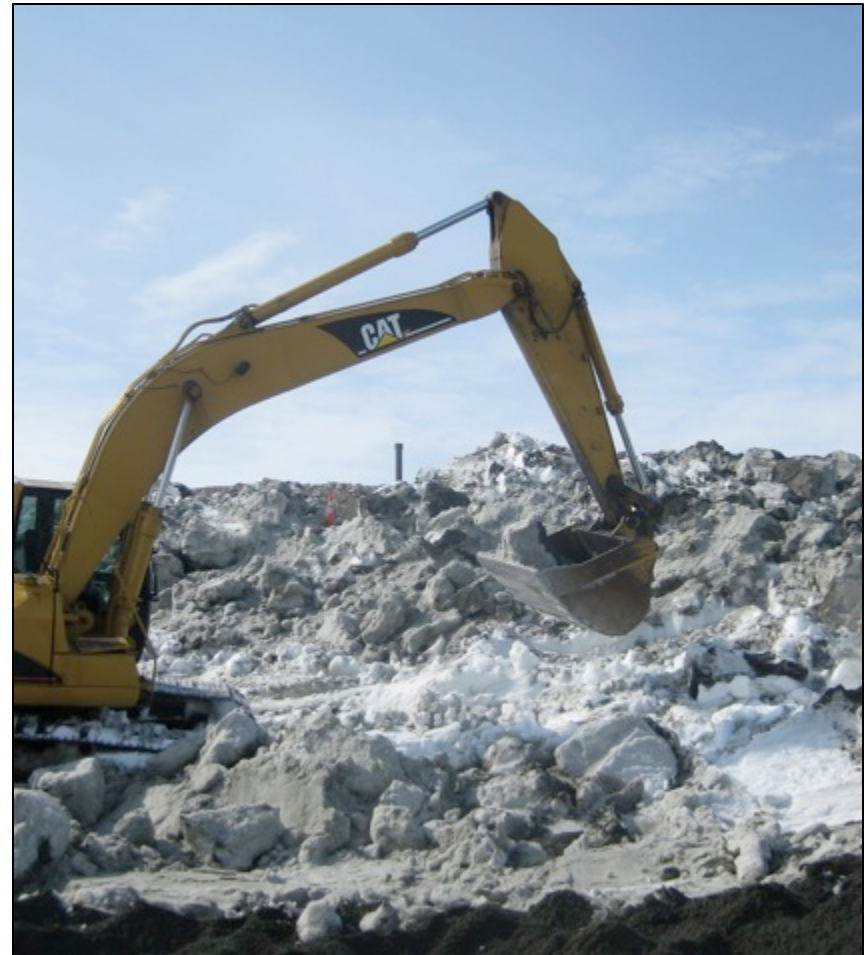
- The FPK/snow was scooped up and put in a dump truck and taken to the PKCA.

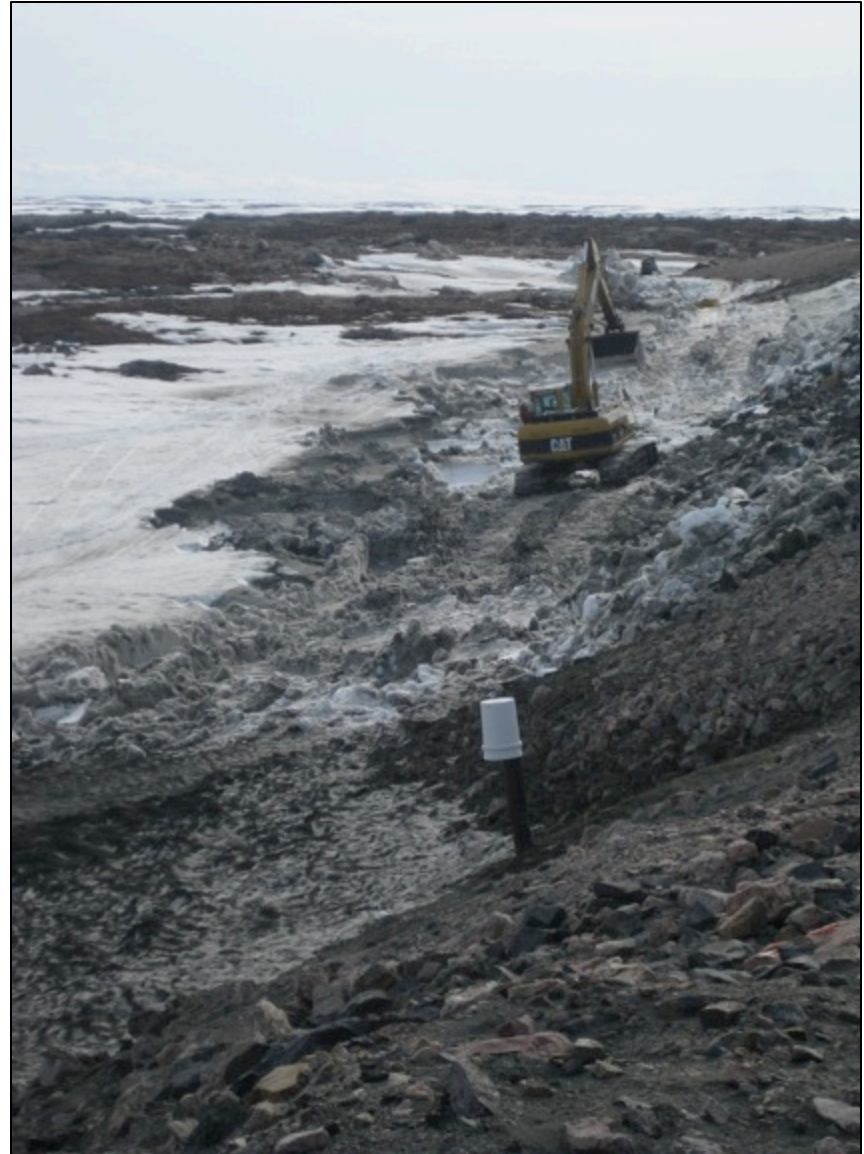
- At the time of this submission (May 22nd), the excavator has made it through the length of the impacted area along the Southeast Dam.
- We estimate that it will take another day or two to complete the clean up with the excavator.

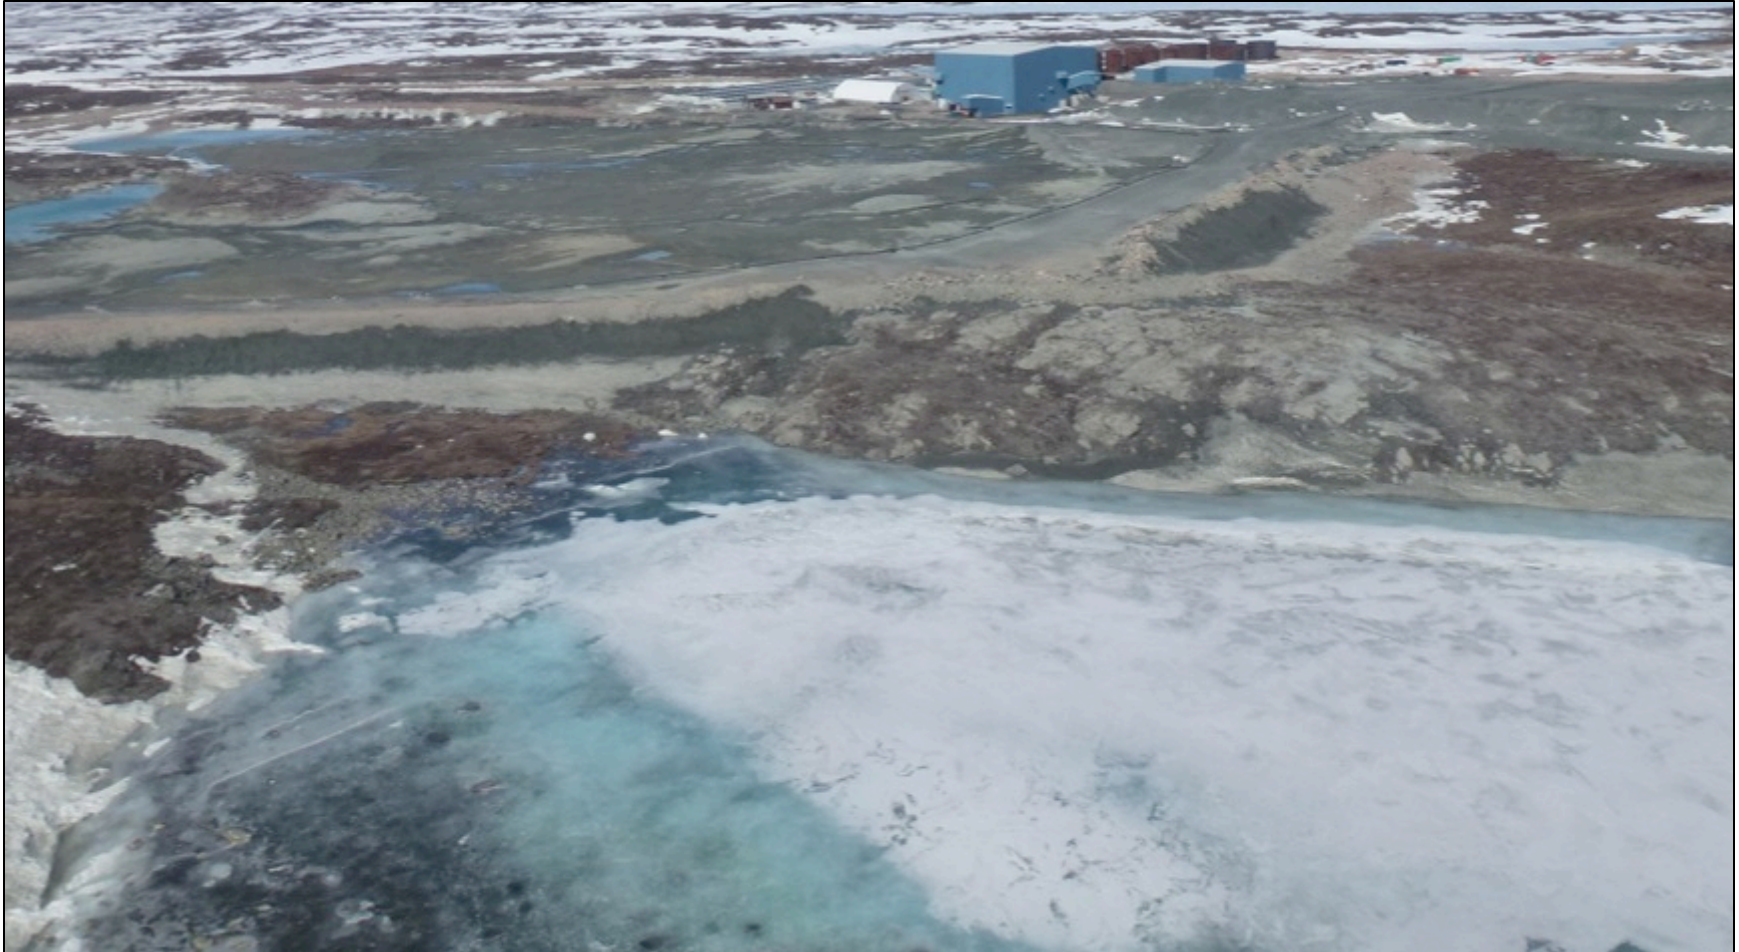
Proposed Location of Silt Fences

- There are seven (7) 100' lengths of silt fencing on site.
- Efforts were made to hammer rebar into the ground to support the silt fencing. This was not successful.
- Once the ground has thawed enough that the rebar can be hammered in, the silt fences will be installed in the drainage areas and along the shoreline.
- There are also a number of silt curtains on site. Depending on the depth of the water, silt curtains may be employed.

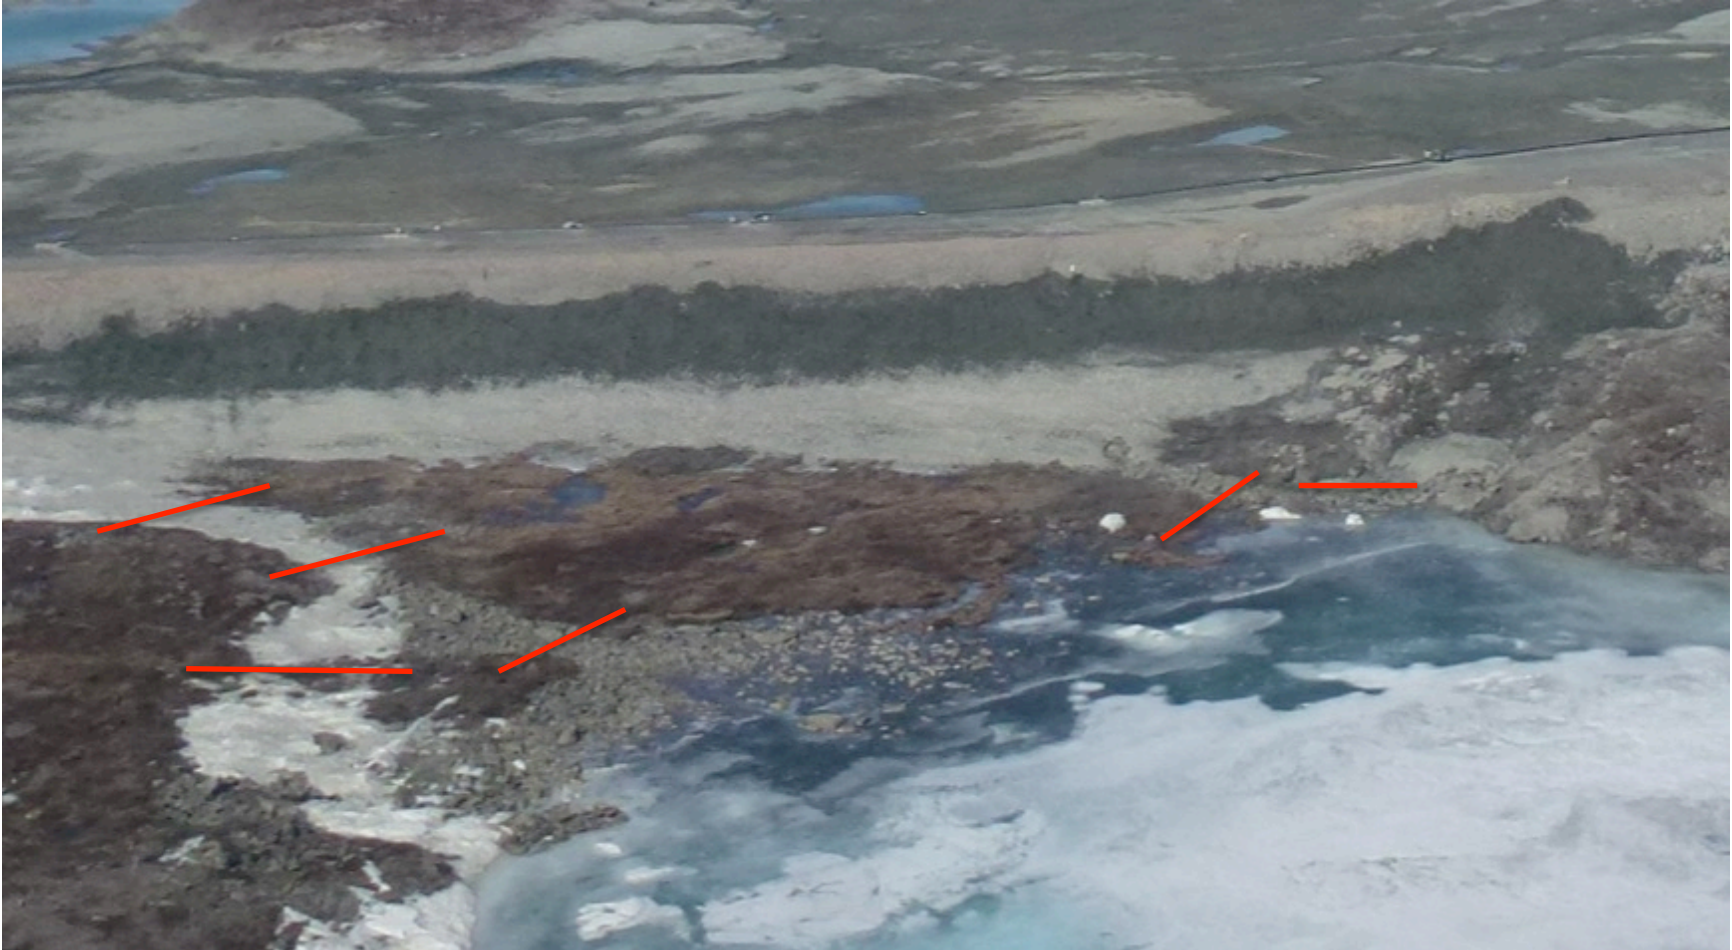
- There are 30 seven foot triangular erosion dikes on site.
- A trench was dug out and efforts were made to install the dikes on May 21st. There was too much water beneath the snow and the ground was still frozen solid making it impossible to secure them.
- Once the excavator has finished along the Southeast Dam, these erosion dikes will be installed along the toe of the decline,

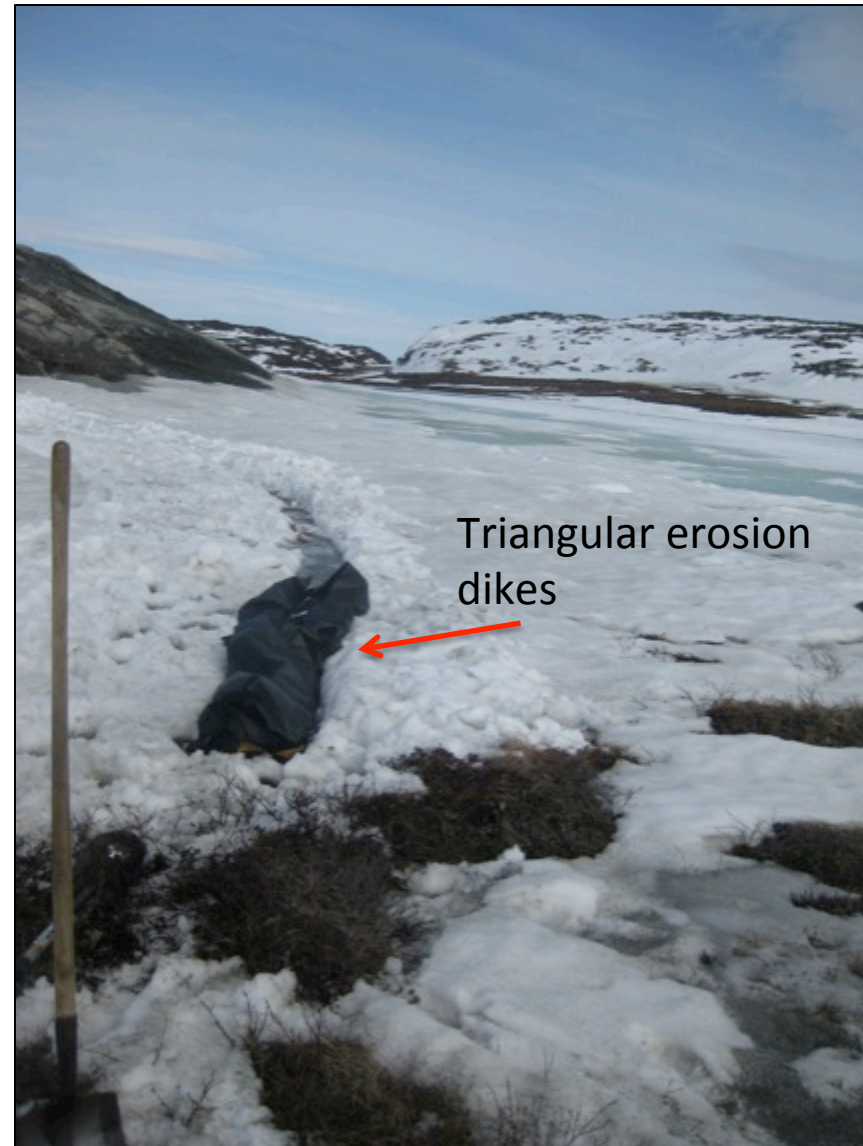
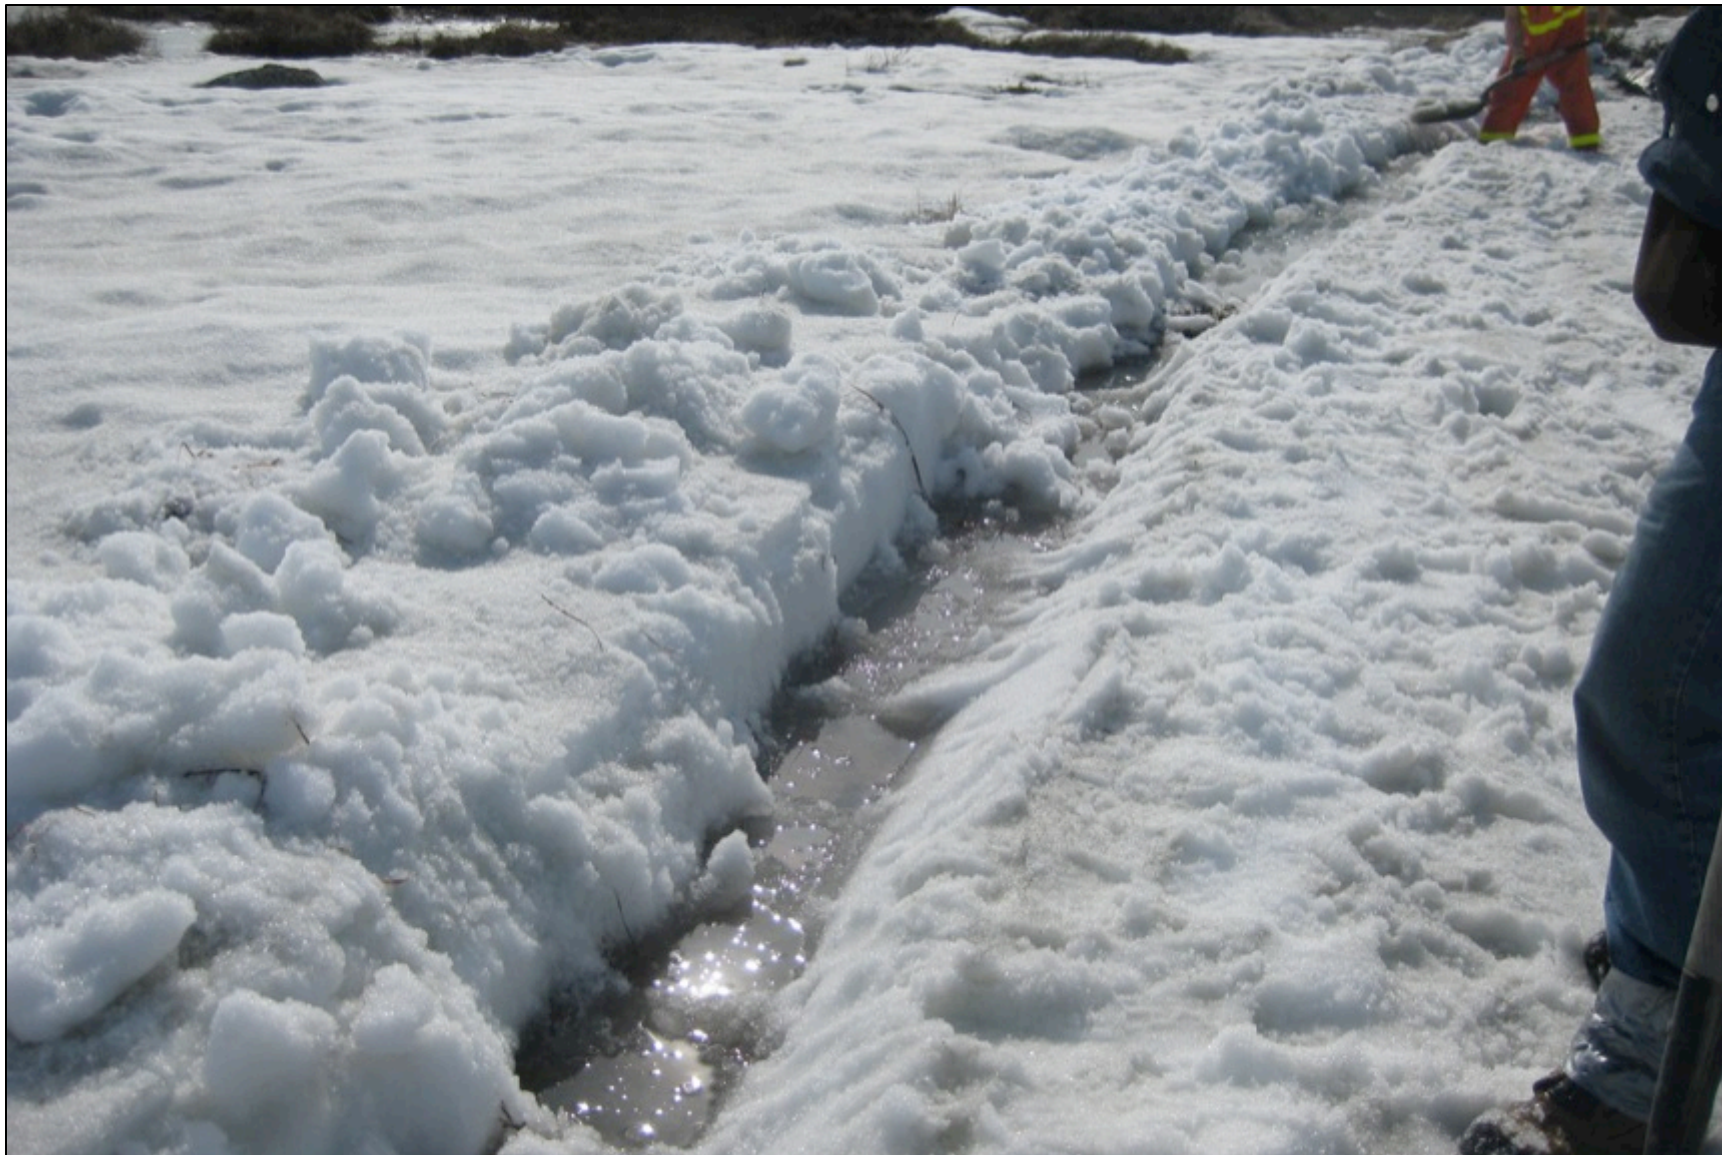
The trench that was hand dug.
