EBA File: 1100060.006

**Subject: C1 Diversion - Geotechnical Design
Jericho Diamond Project, NU**

Further to a request by Tahera Diamond Corporation (TDC), EBA Engineering Consultants Ltd. (EBA) has prepared a design for C1 Diversion Structure and C1 Diversion Channel at the Jericho Diamond Mine in Nunavut.

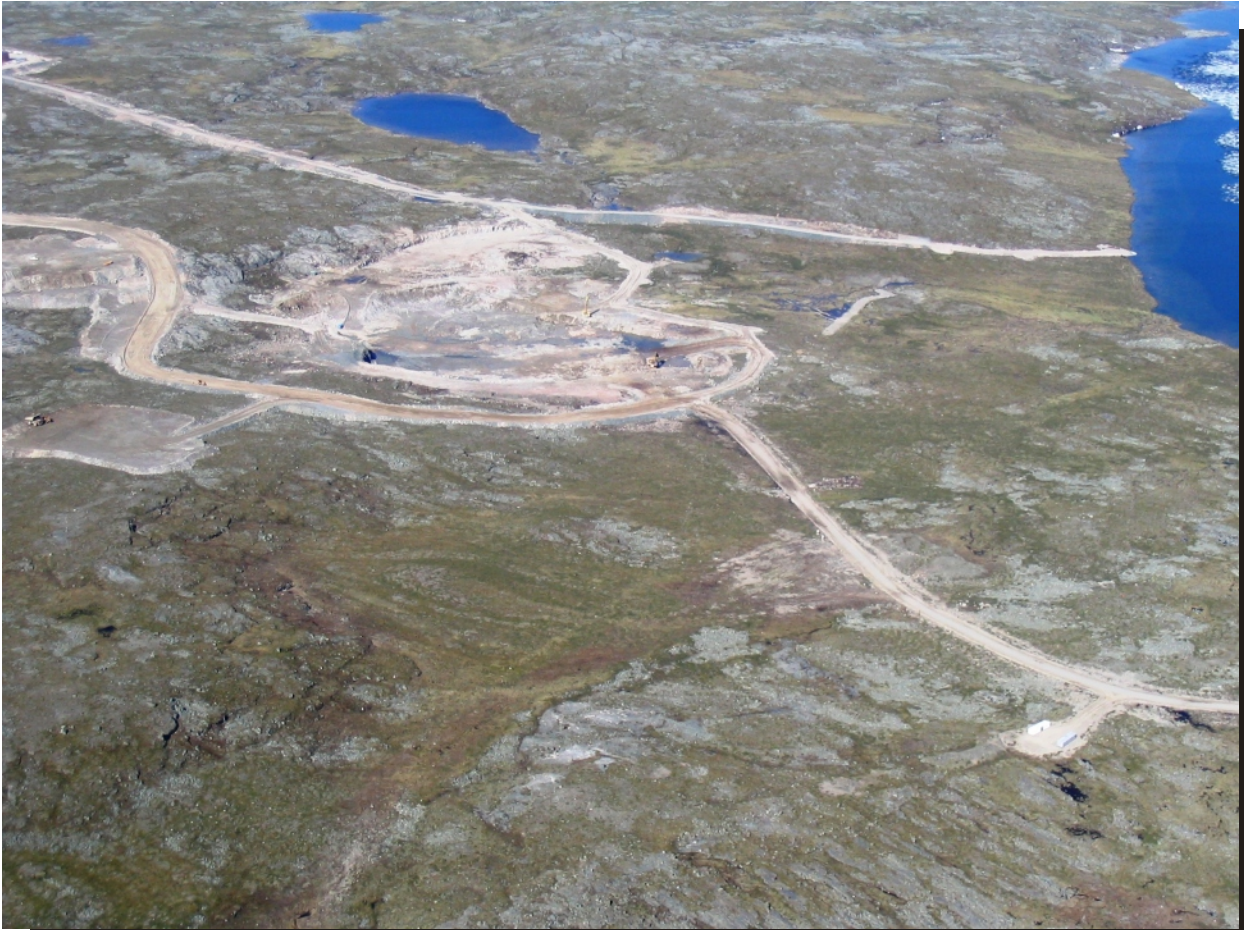
Photo 1

Aerial view looking west at pit and C1 Lake drainage system July 6, 2005

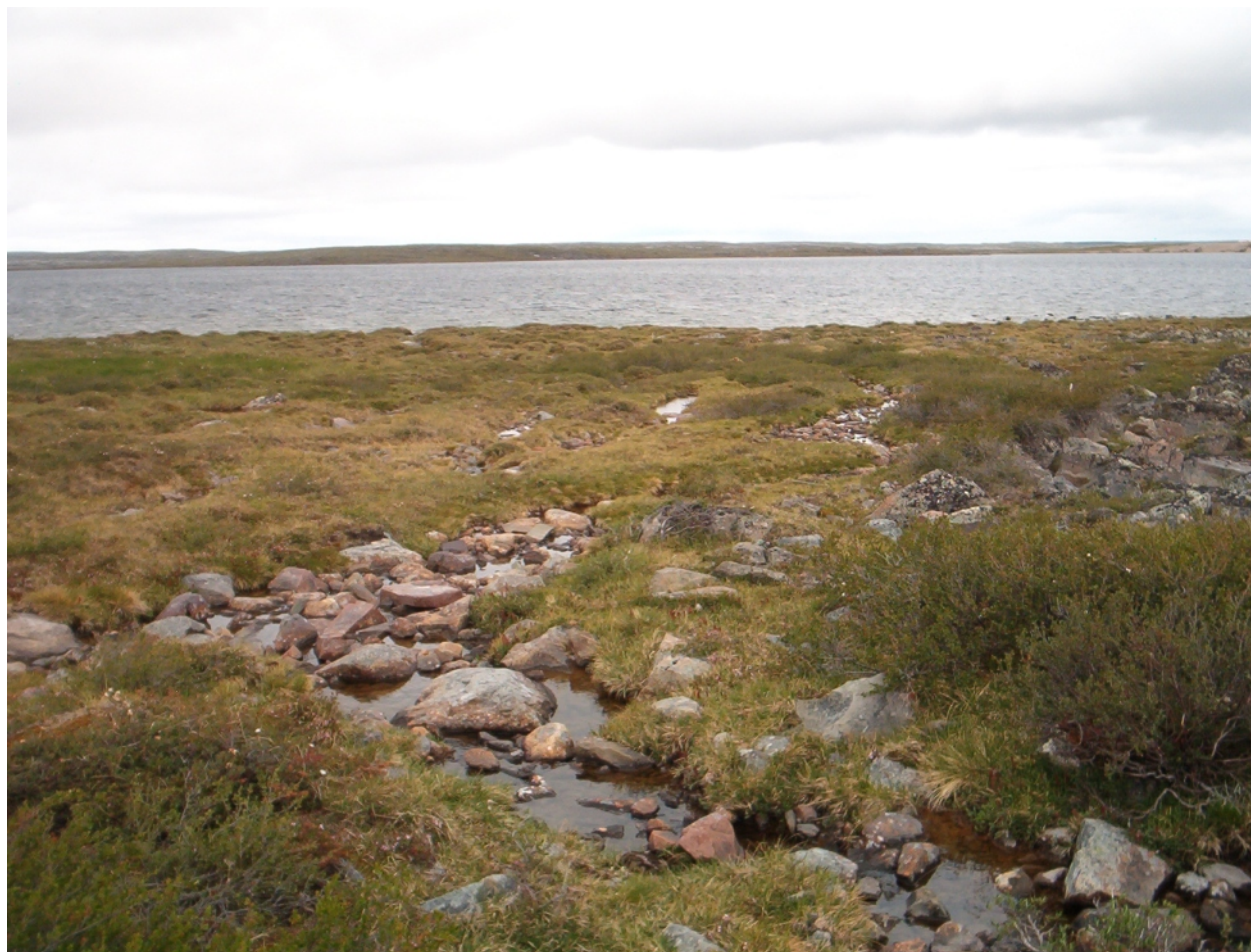
Photo 2

Looking north toward Carat Lake from C1 Stream. View of lower reach of C1 Stream on July 21st, 2005

Photographs 2 through 5 show surface flows observed in Reaches 1 and 2 of the C1 drainage on July 21. A detailed description of the channel conditions associated with the natural channel was reported by MAL previously and pertinent information from the MAL (formerly R. L& L Environmental Services Ltd.) report is attached in Appendix A. The MAL report that in 5 years of baseline studies by TDC, fish use of Stream C1 was limited to the first 100 metres upstream from Carat Lake (December 18, 2003 MAL Memorandum to DFO).

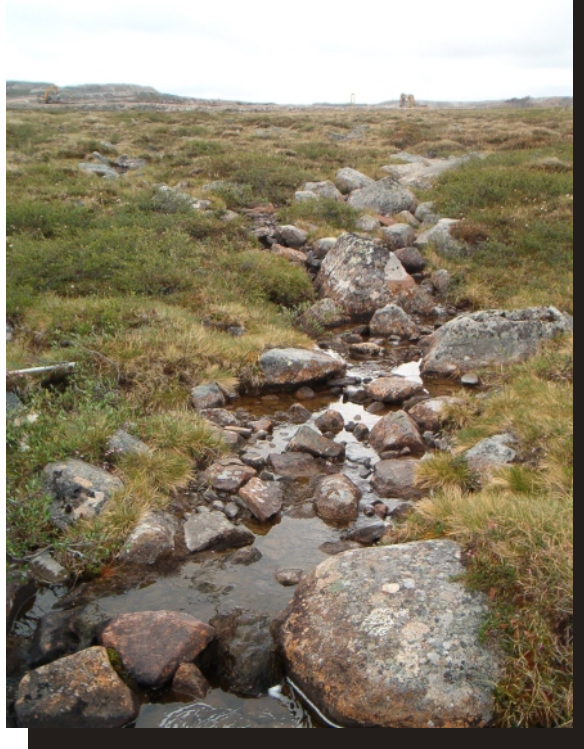
Photo 3
Looking south from C1 Stream. View of typical Reach 2 section

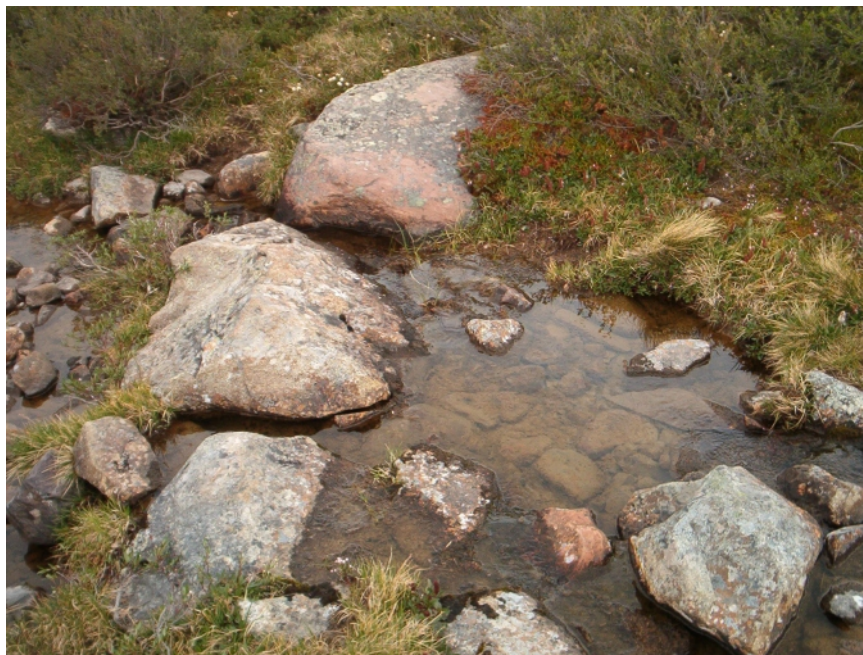
Photo 4
Typical step in channel in Reach 2 during low flow

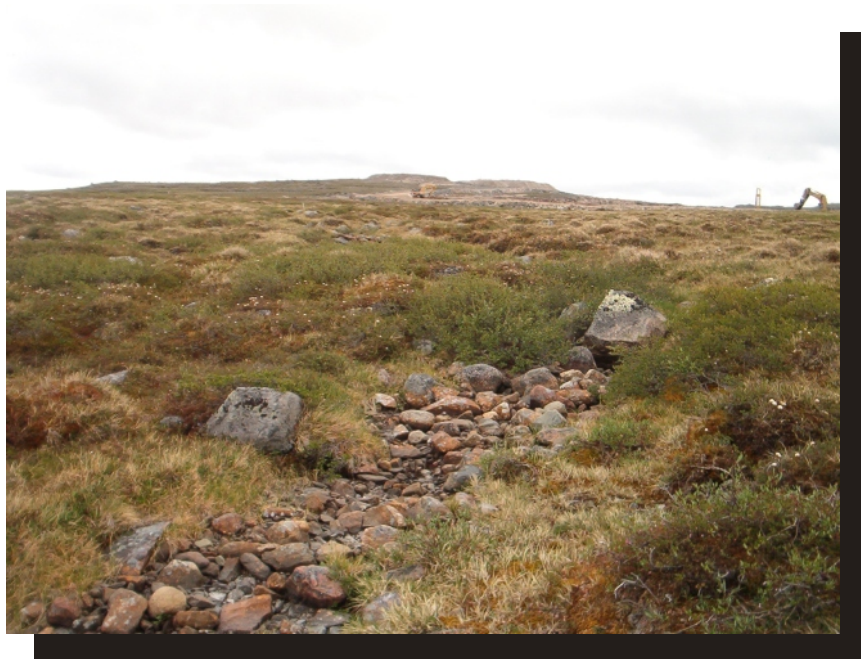
Photo 5

"Dry" C1 Stream channel bed. C1 Stream consists of multiple channels

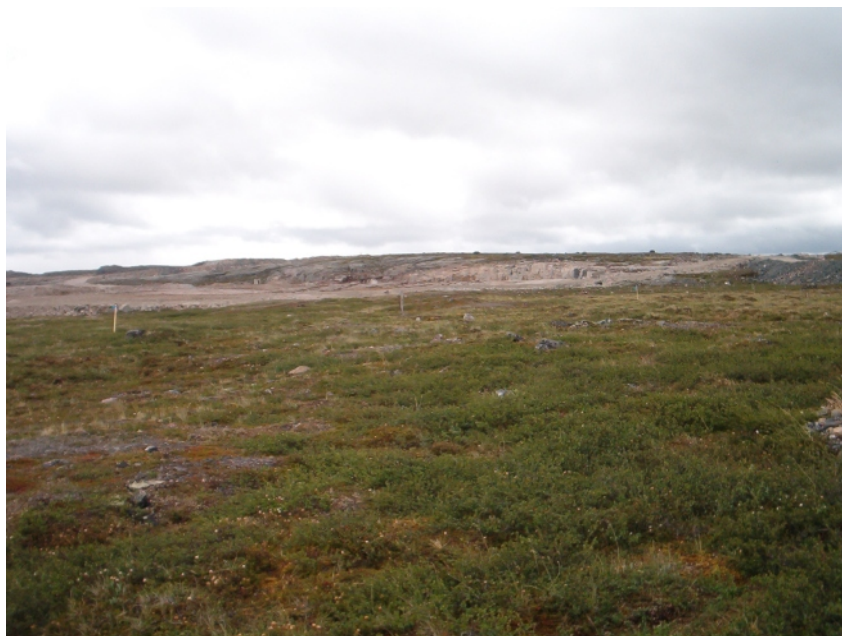
Photo 6

Looking west from Reach C. Extensive rock outcrop upslope of Carat Lake Road is visible and is typical of Reach A. Stakes with blue ribbon mark a 30m setback from the pit boundary

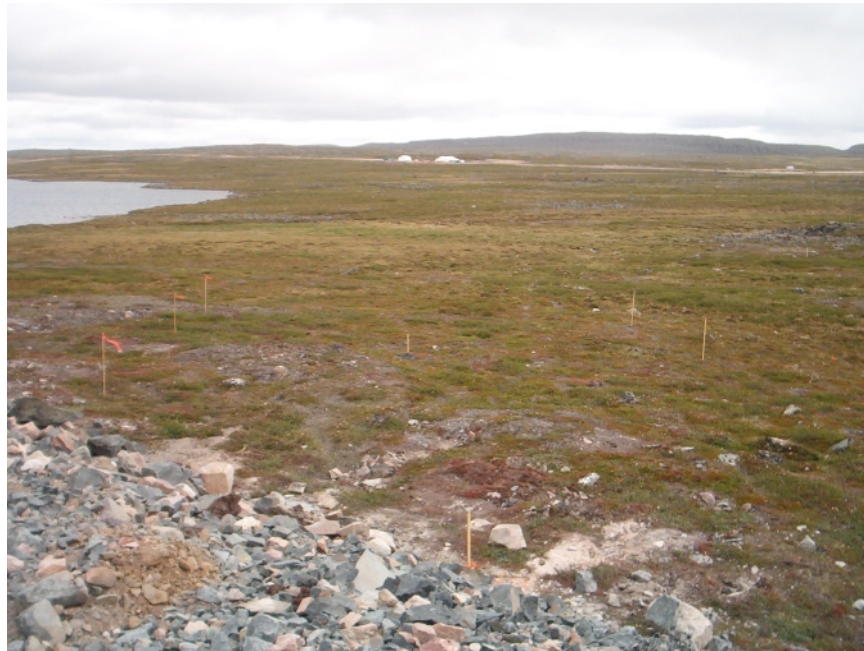
Photo 7

Looking downslope from Carat Lake Road in northeast direction. Stakes are in terrain that is typical of Reach B down-gradient of the proposed culvert crossing. Toe of road fillis in foreground.

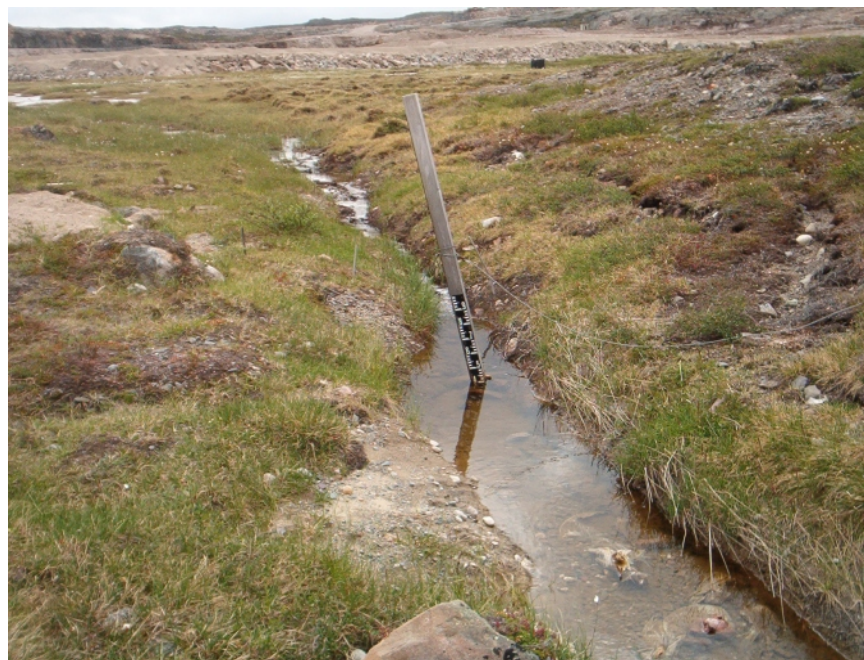
Photo 8

In pit view of 1996 exploration diverted flow - looking south

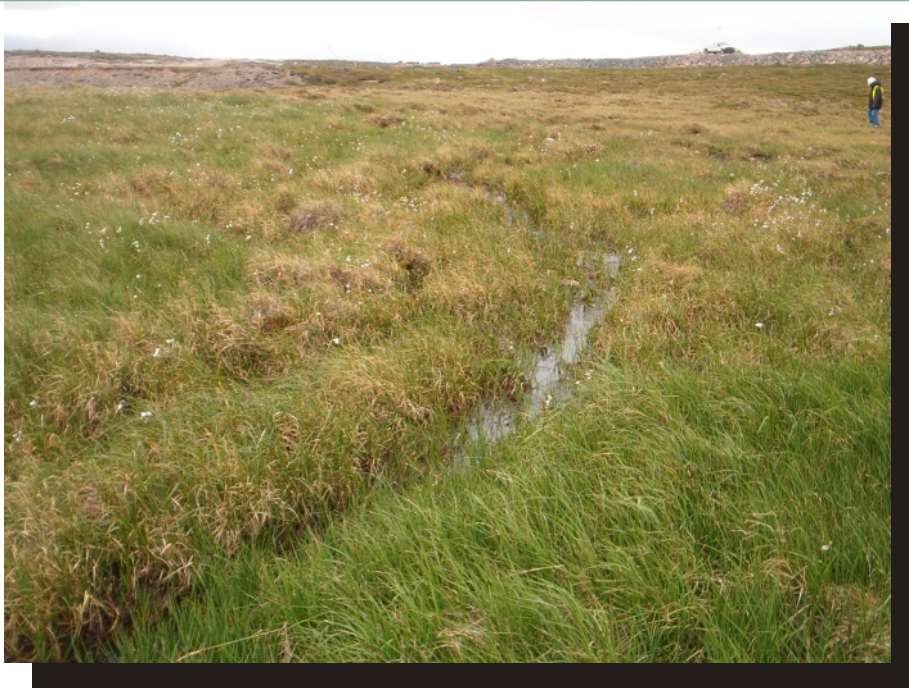
Photo 9

Looking southwest from proposed Reach C area. Outflow from 1996 exploration diversion flows across Reach C. Channel has naturalized.

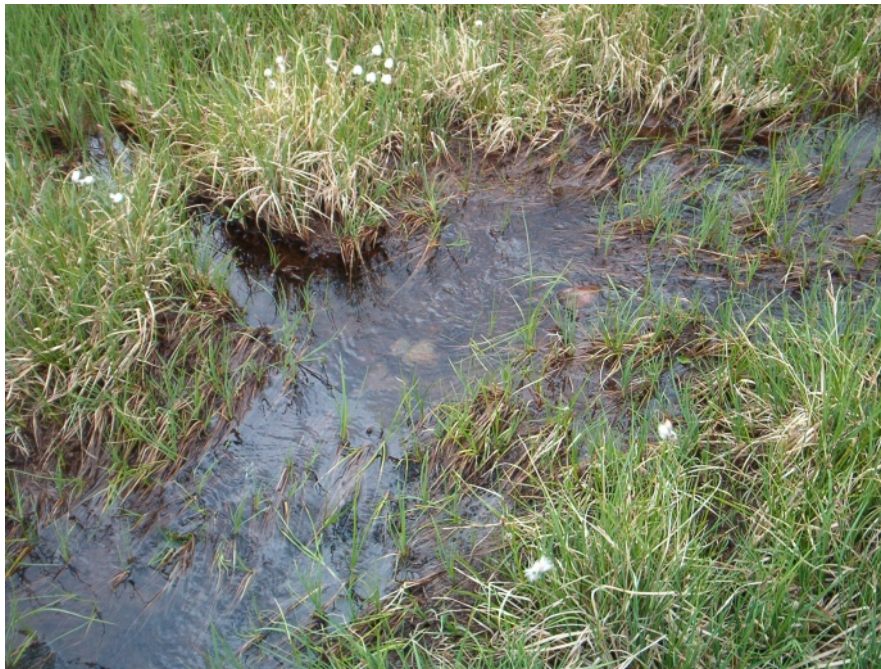
Photo 10

View of naturalized channel shown in Photograph 3

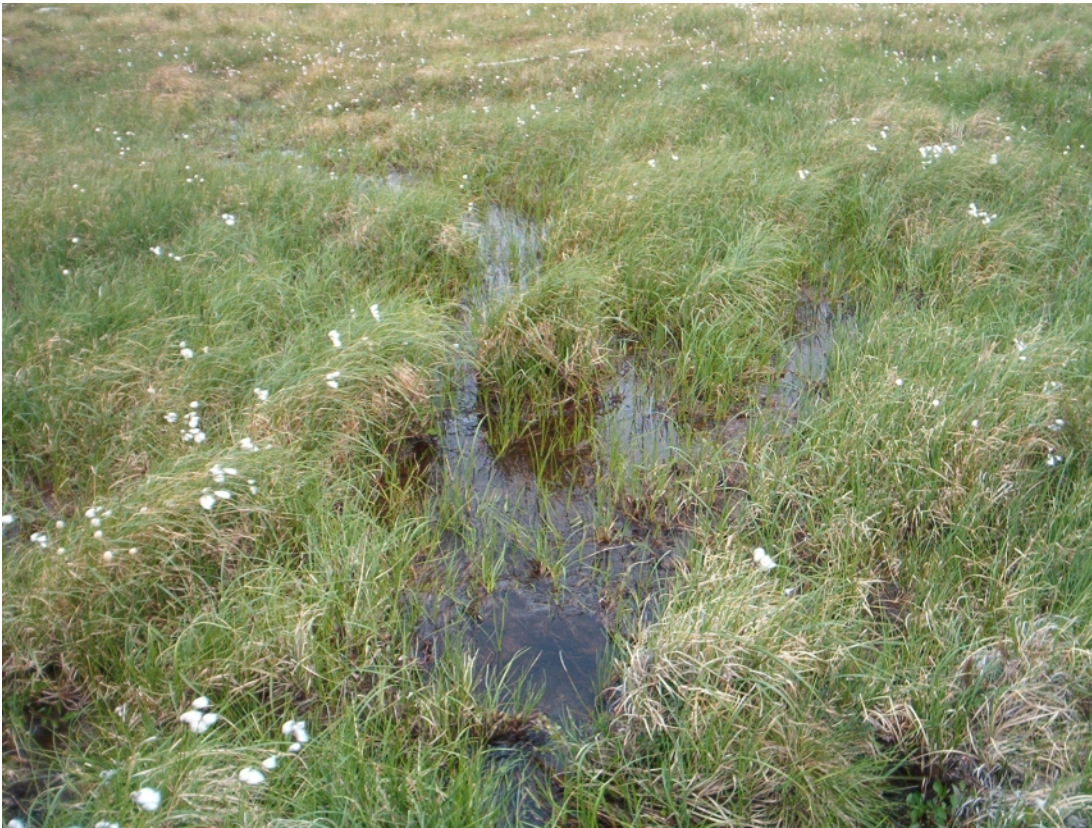
Photo 11

Looking in the north direction from downgradient of Reach C. Outflow from 1996 exploration diversion becomes more dispersed

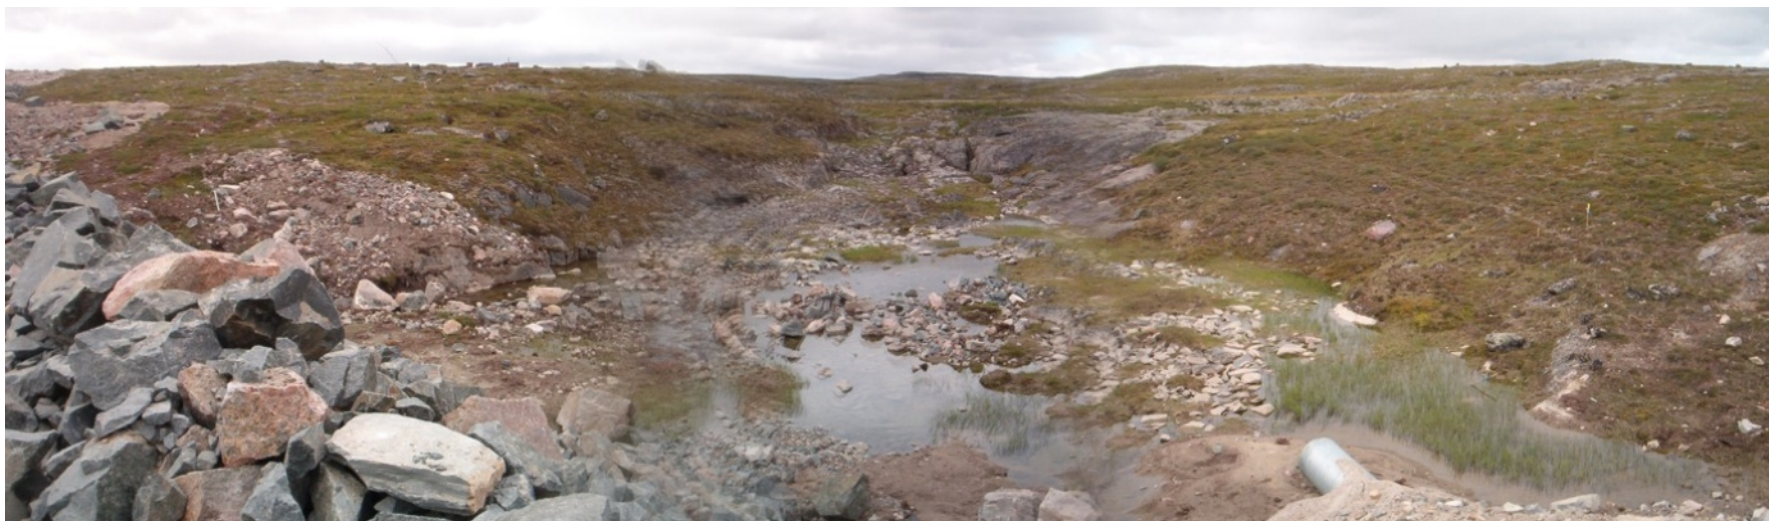
Photo 12

Panorama of Lake C1 outflow looking west from Carat Lake Road (July 21, 2005)

Photographs 12, 13 and 14 show the area of the proposed diversion structure. Although no borehole information exists in this area, there is considerable evidence of rock outcrop and subcrop. Fractured bedrock outcrops on both abutments and in portions of the base of the pool. Sand and gravel with trace to some silt mantles the slopes and possibly has filled a portion of the channel bottom. On July 21 the flow of water from C1 Lake outflow stream was partially impeded and pooled by the road embankment but not cutoff. The water level was below the invert elevation of the temporary culvert inlet and was flowing ephemerally from the pool through and/or underneath the road embankment.

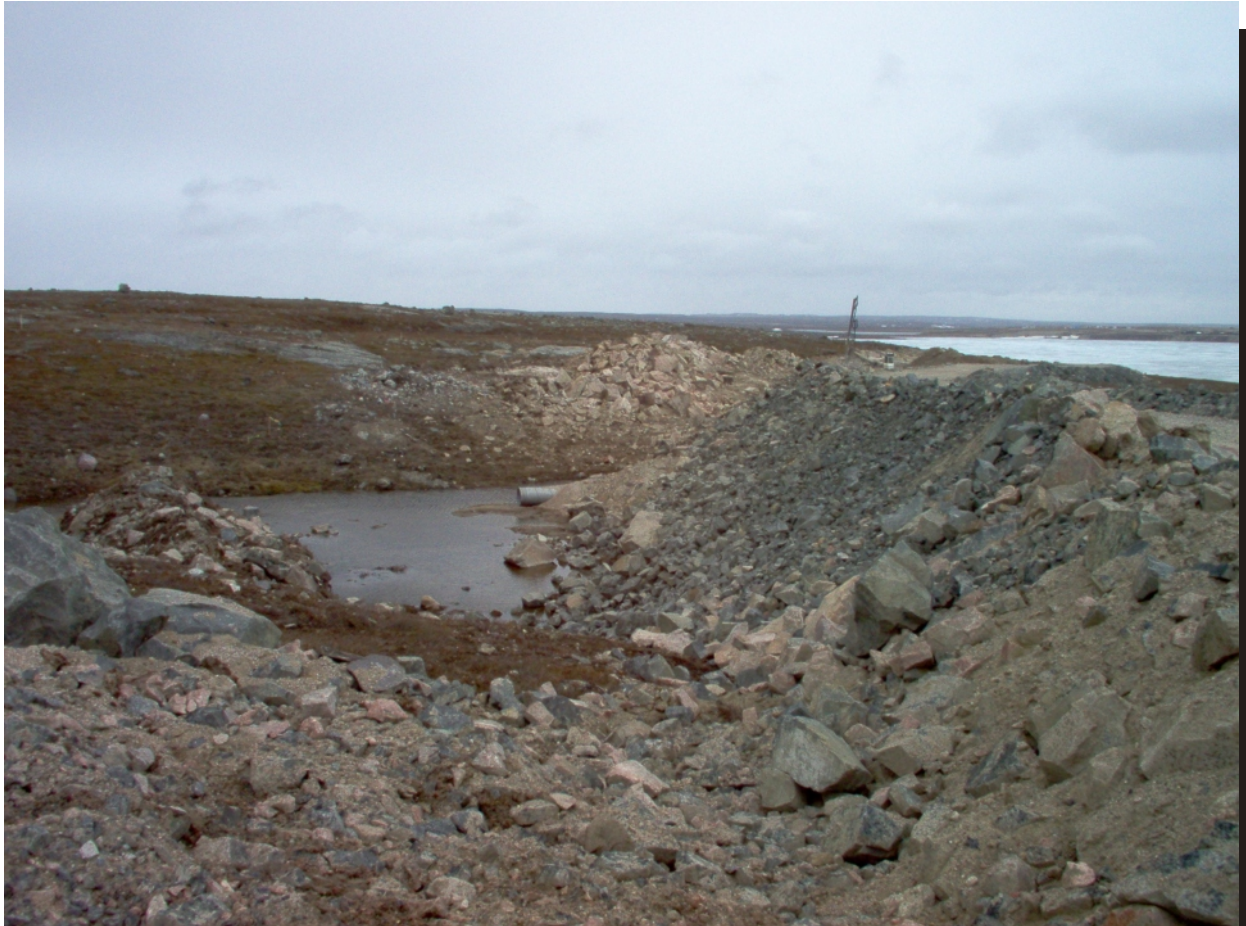
Photo 13

Looking north along alignment of proposed diversion structure key trench (June 28, 2005).
Temporary culvert is to be removed.

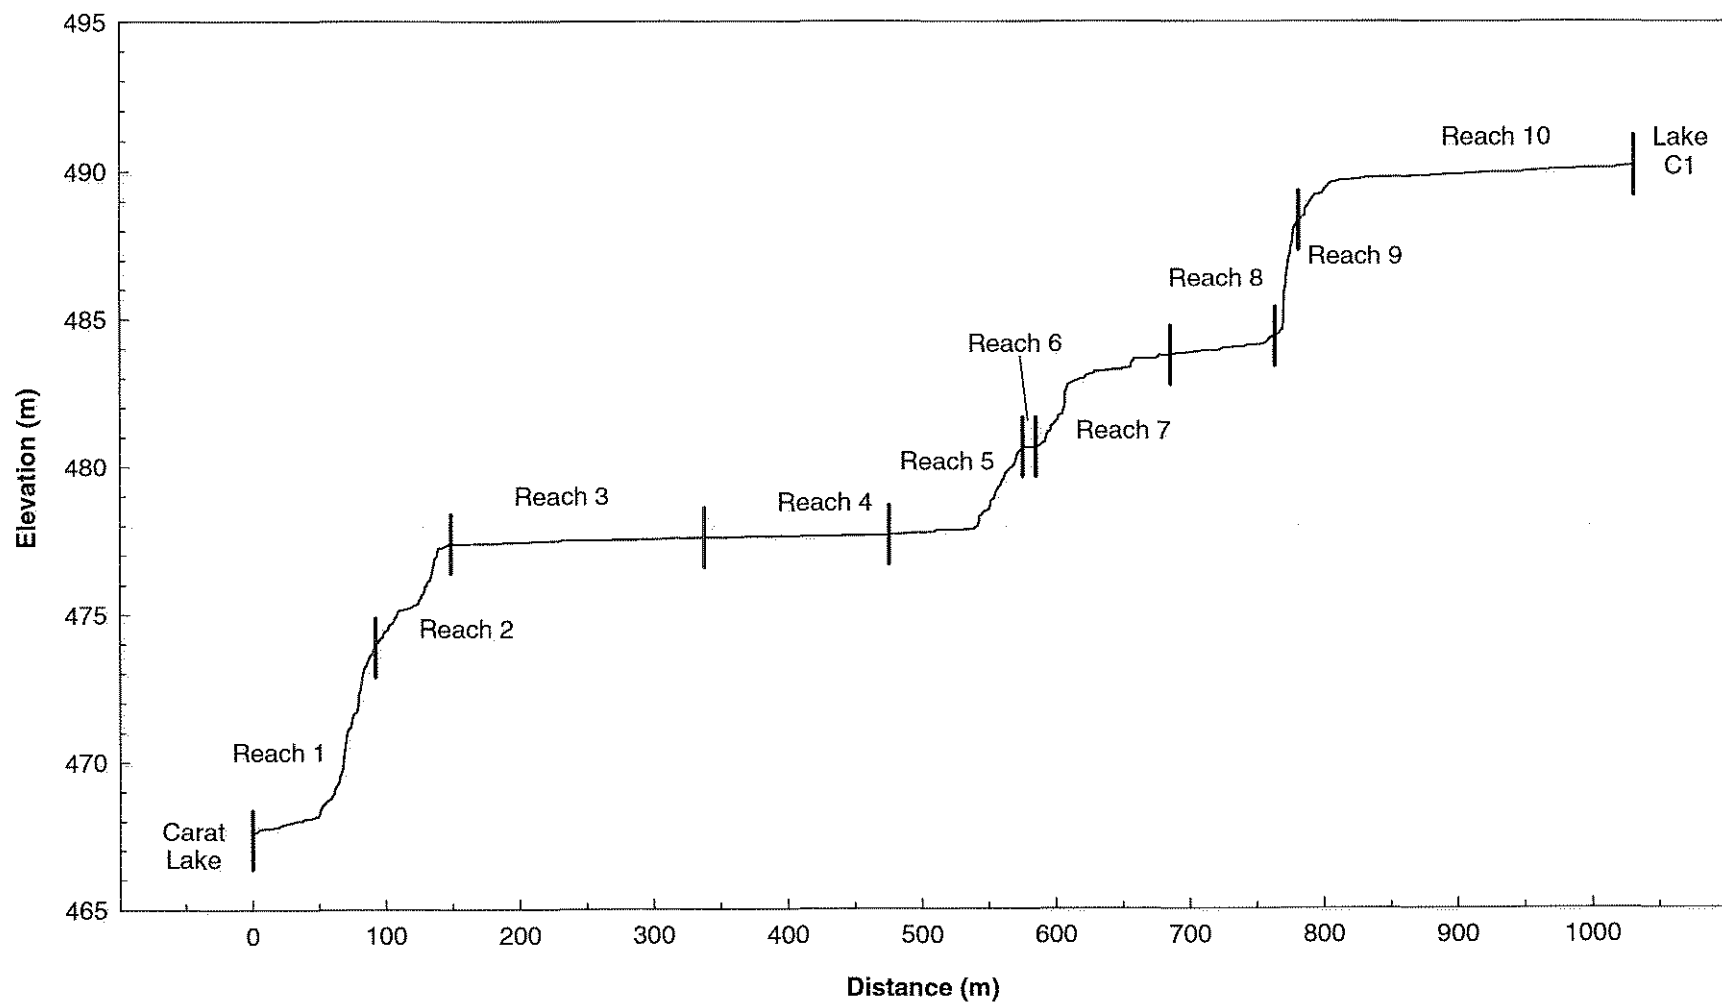
Figure 4.4 Gradient profile for Stream C1, Jericho Study Area, 1999.

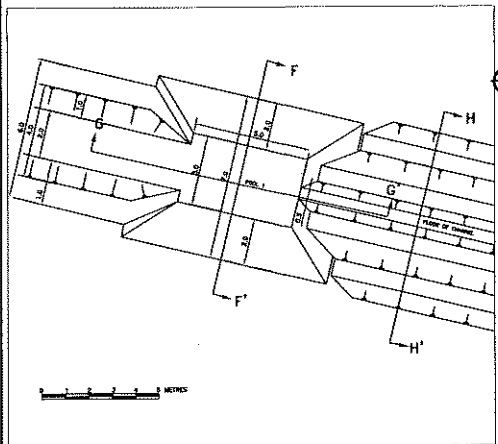
POOL 1
1:100

| RIPRAP DETAILS | | |
