Figure A4  
Stability Analysis - Upstream End of Construction - Rotational Slip Surface

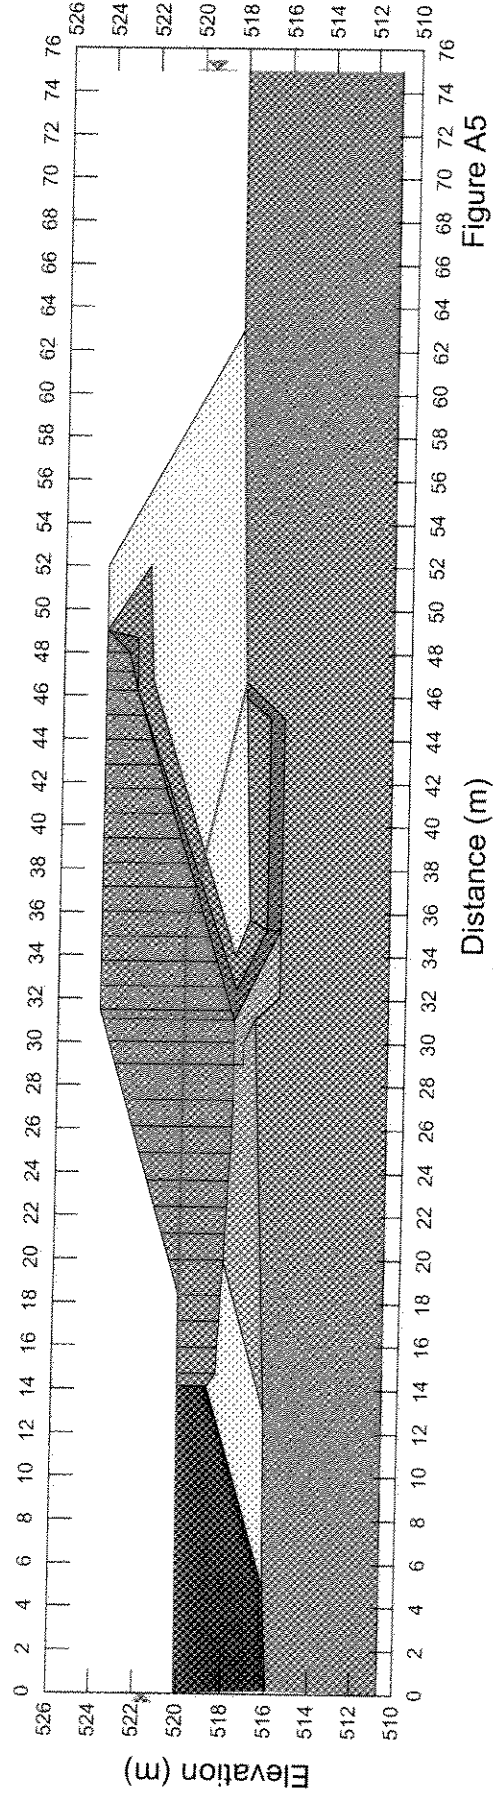
Figure A5  
Stability Analysis - Upstream, Static - Slip Surface Along Liner

FS = 1.36

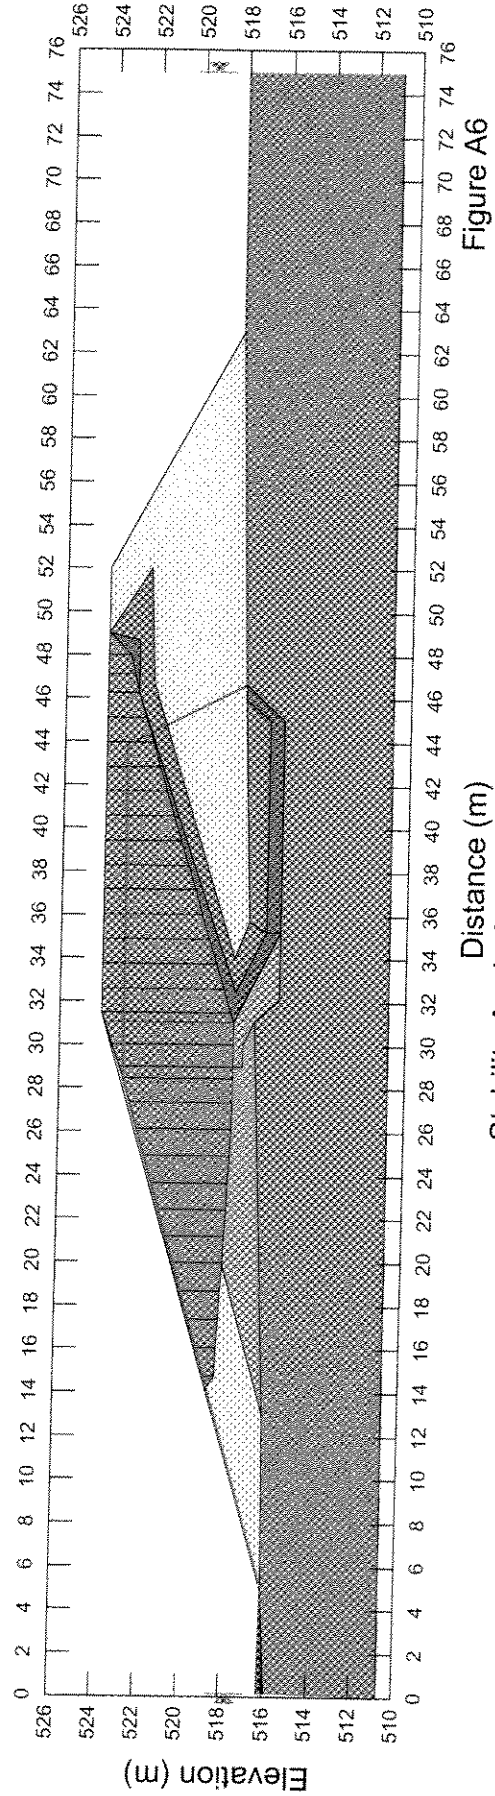
Figure A6  
Stability Analysis - Upstream, Rapid Drawdown - Slip Surface Along Liner

FS = 1.49

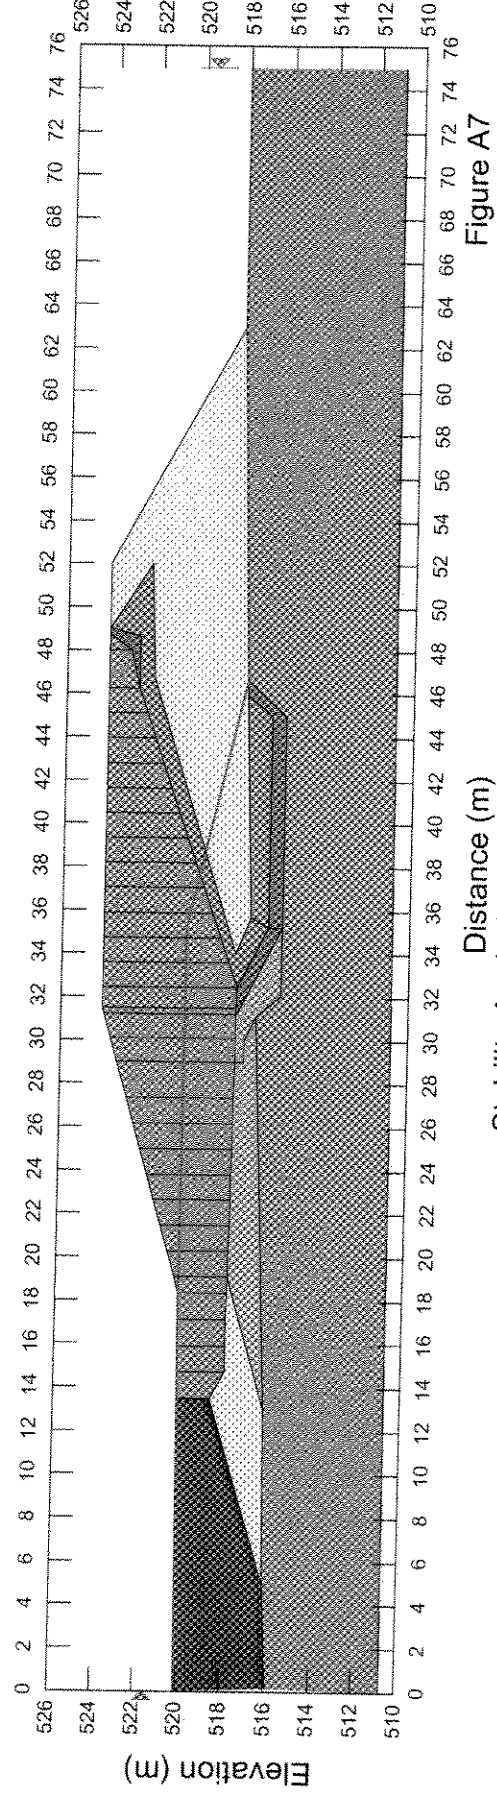
Stability Analysis - Upstream, Seismic Analysis -- Slip Surface Along Liner  
Figure A7

FS = 1.44

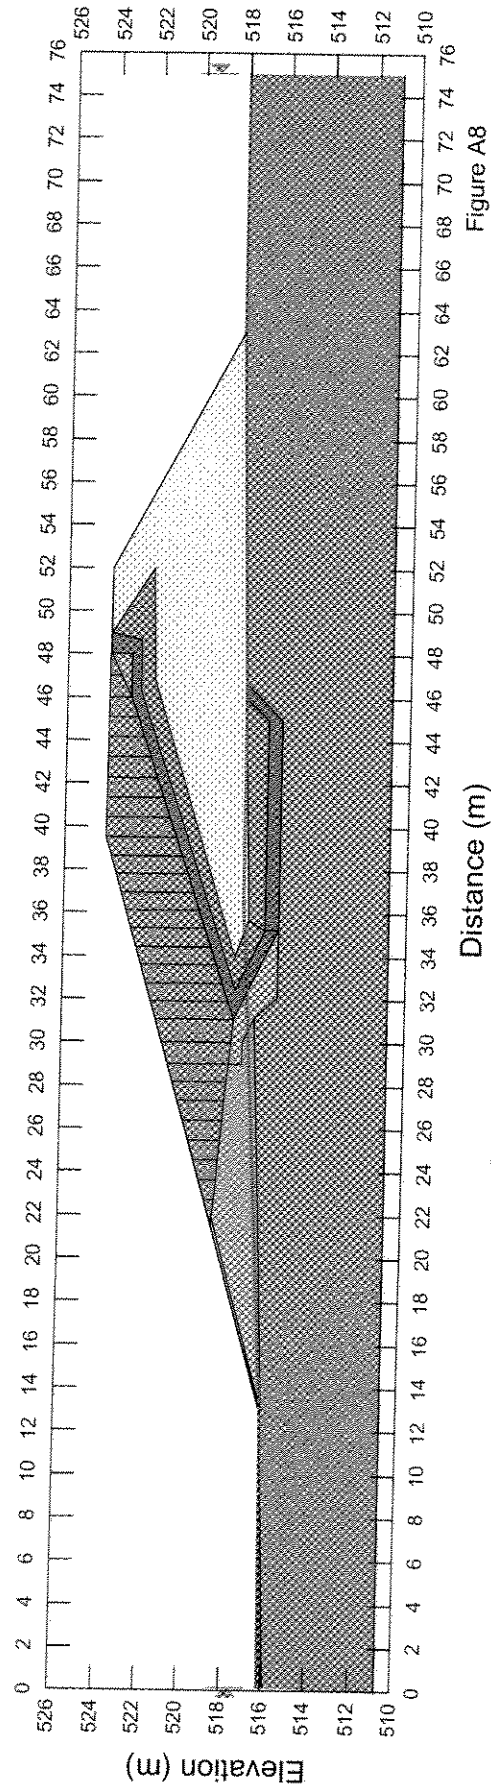
Stability Analysis - Upstream, Static, End of Construction - no coarse tailings  
Figure A8

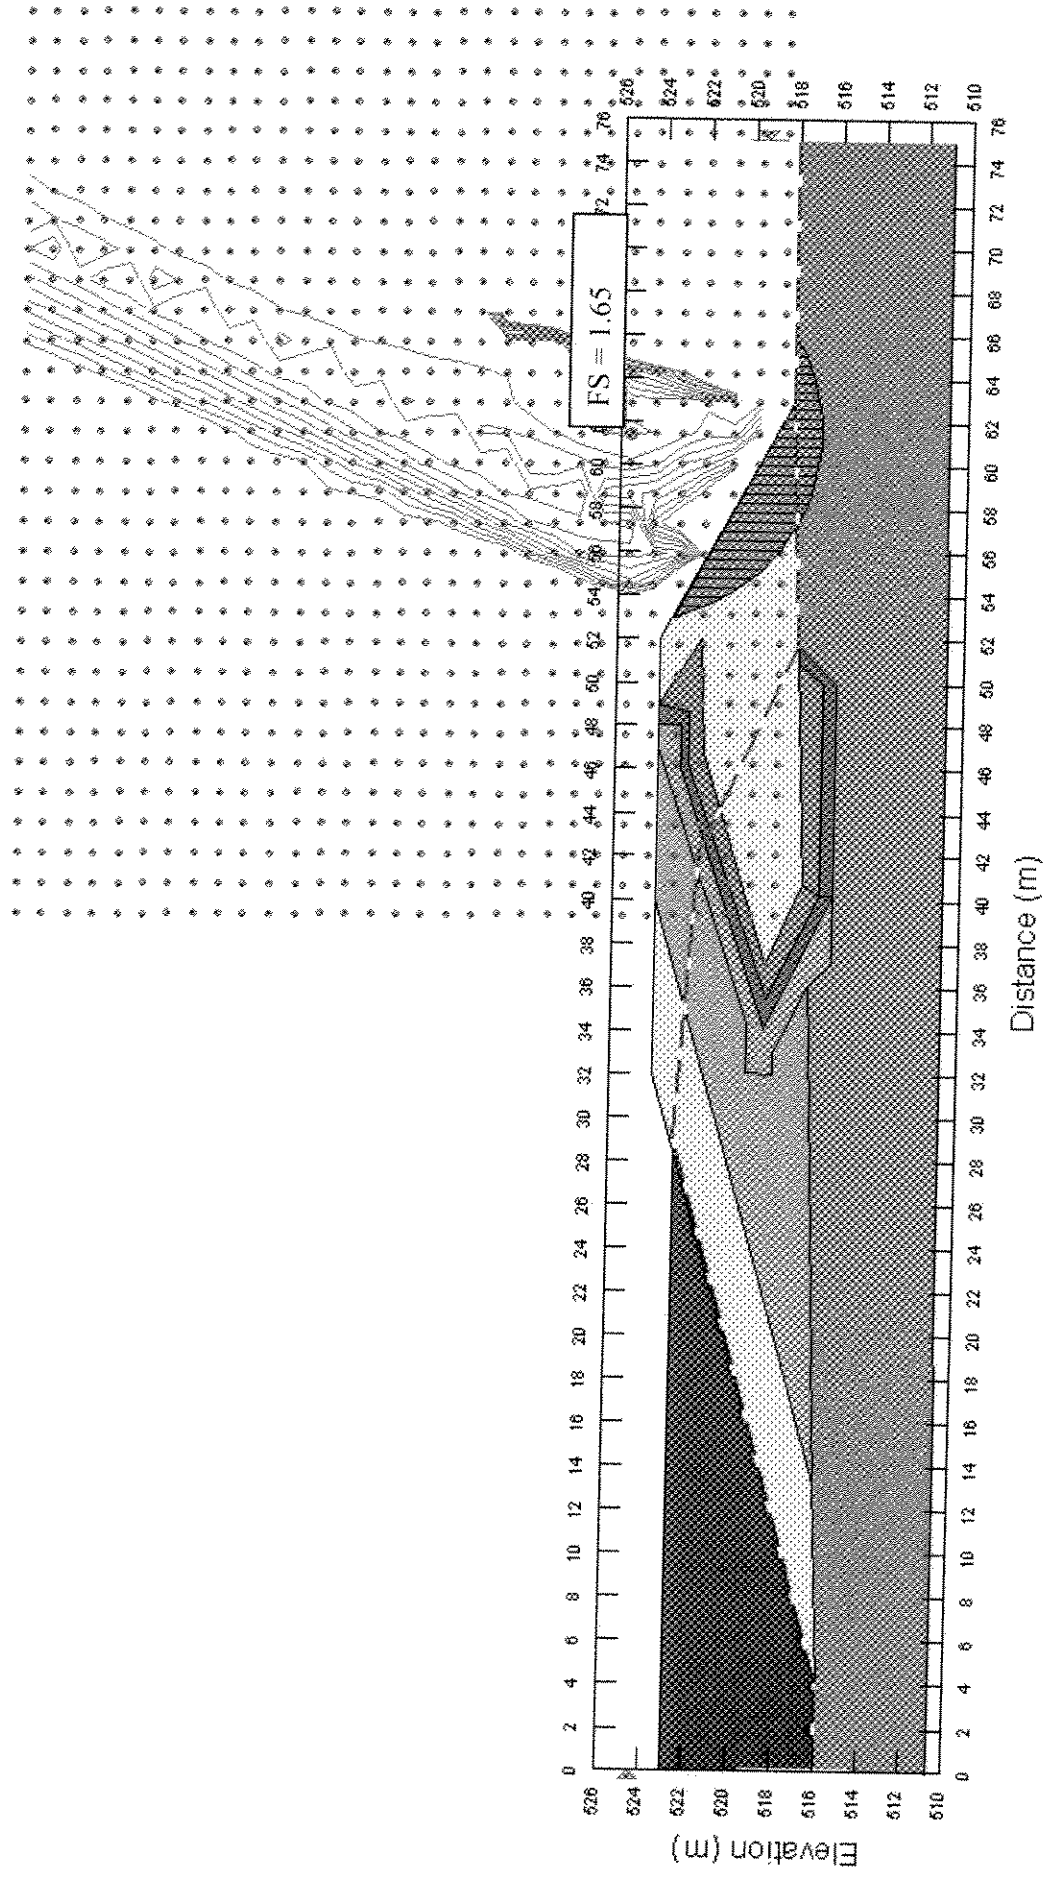
Figure A9  
Stability Analysis - Downstream, Static - Rotational Slip Surface
