Tahera Diamond Corporation 2007 Reclamation Plan Update Jericho Diamond Mine April 2007

# APPENDIX C CHAPMAN REPORT ON IN-PIT TREATMENT

Subject: Technical Memorandum R Project #: 1CT004.06

Jericho Post Closure Pit Lake Water

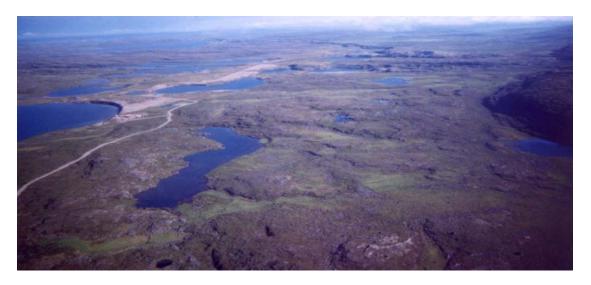
Photo 1: Airstrip Access Road and Airstrip Looking North

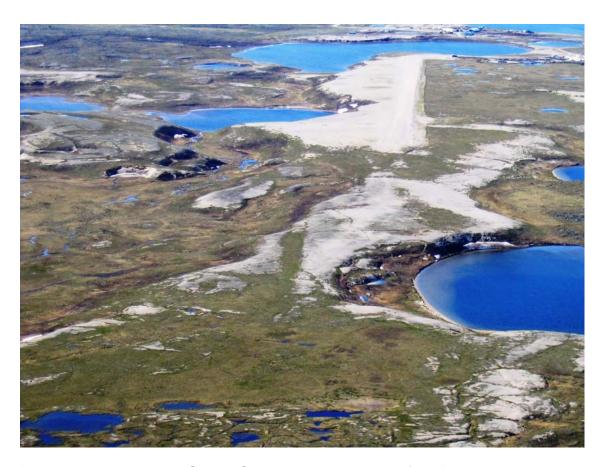
Photo 2: Airstrip Looking South. Carat Lake is at the Top of the Picture

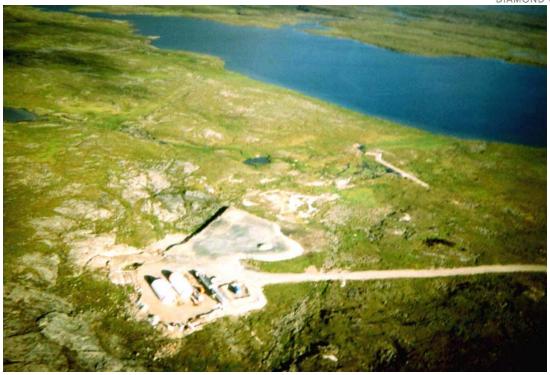
Photo 3: Exploration Portal Area. Carat Lake is in the Background

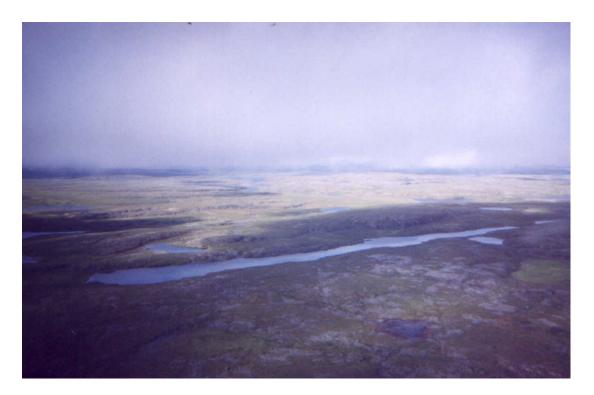
Photo 4: Long Lake (PKCA site) Looking Southwest
