PROJECT	AREVA RESOURCES INC. 2009 KIGGAVIK PRELIMINARY PIT SLOPE DESIGN			
TITLE	ANDREW LAKE GENERALIZED PIT SLOPE CONFIGURATIONS FOR STABILITY ANALYSES

## APPENDIX D - ROCK MASS STABILITY ANALYSIS

## GEOTECHNICAL RECOMMENDATIONS FOR PROPOSED MAIN ZONE AND CENTRE ZONE OPEN PITS - SUPPORT DOCUMENT FOR PERMIT APPLICATION

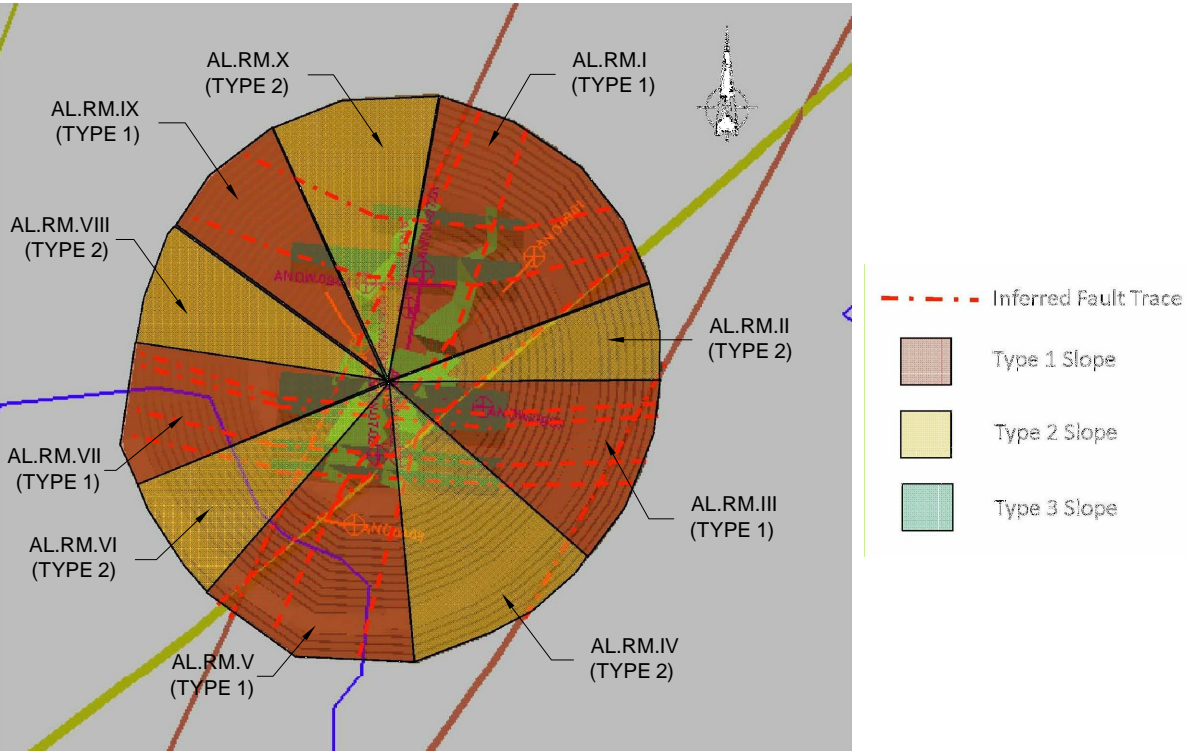
PROJECT No.	09-1362-0613	FILE No.	0913620613AB0D1.dwg
	DESIGN	11/16/2009	SCALE	AS SHOWN
	CAD	12/9/2009	REV.	A
	CHECK	12/9/2009	FIGURE	D-1
REVIEW	12/9/2009

ANDREW LAKE PIT - INFERRED ROCK MASS DESIGN SECTORS

TYPE 2: LOWER SLOPE ALTERATION

ZONE	RMR (1976)	UCS (MPa)
UPPER METASEDIMENTS	55 (fair)	30 (moderately strong)
GRANITOIDS	55 (fair)	50 (moderately strong to strong)
LOWER SEDIMENTS	65 (good)	65 (strong)
FAULT ZONE ALTERATION	50 (fair)	15 to 25 (weak)
ORE HALO ALTERATION	50 (fair)	10 (very weak to weak)

TYPE 1: FULL SLOPE ALTERATION

TYPE 3: NO SLOPE ALTERATION

The Andrew Lake pit has been divided into eight rock mass sectors as shown on Figure D1. The Andrew Lake pit is interpreted to be predominantly comprised of Type 1 or Type 2 rock mass conditions due to the numerous faults crossing the pit walls and floor, correlated to geotechnical information from 2007 to 2009 boreholes. The main fault trends at Andrew Lake strike north-south to northeast-southwest, or east-west, therefore the wall orientations on-strike with these trends have been interpreted to be to be mainly Type 1 slopes. The borehole AND09-01 is an example of a borehole assumed to entirely penetrate a Type 1, fault and/or alteration influenced slope. Similarly, the majority of the lower slopes at Andrew Lake (lower 100 m) appears to be predominantly within either fault or ore halo influenced alteration, based on cross-sections on which field estimated rock strength are plotted.

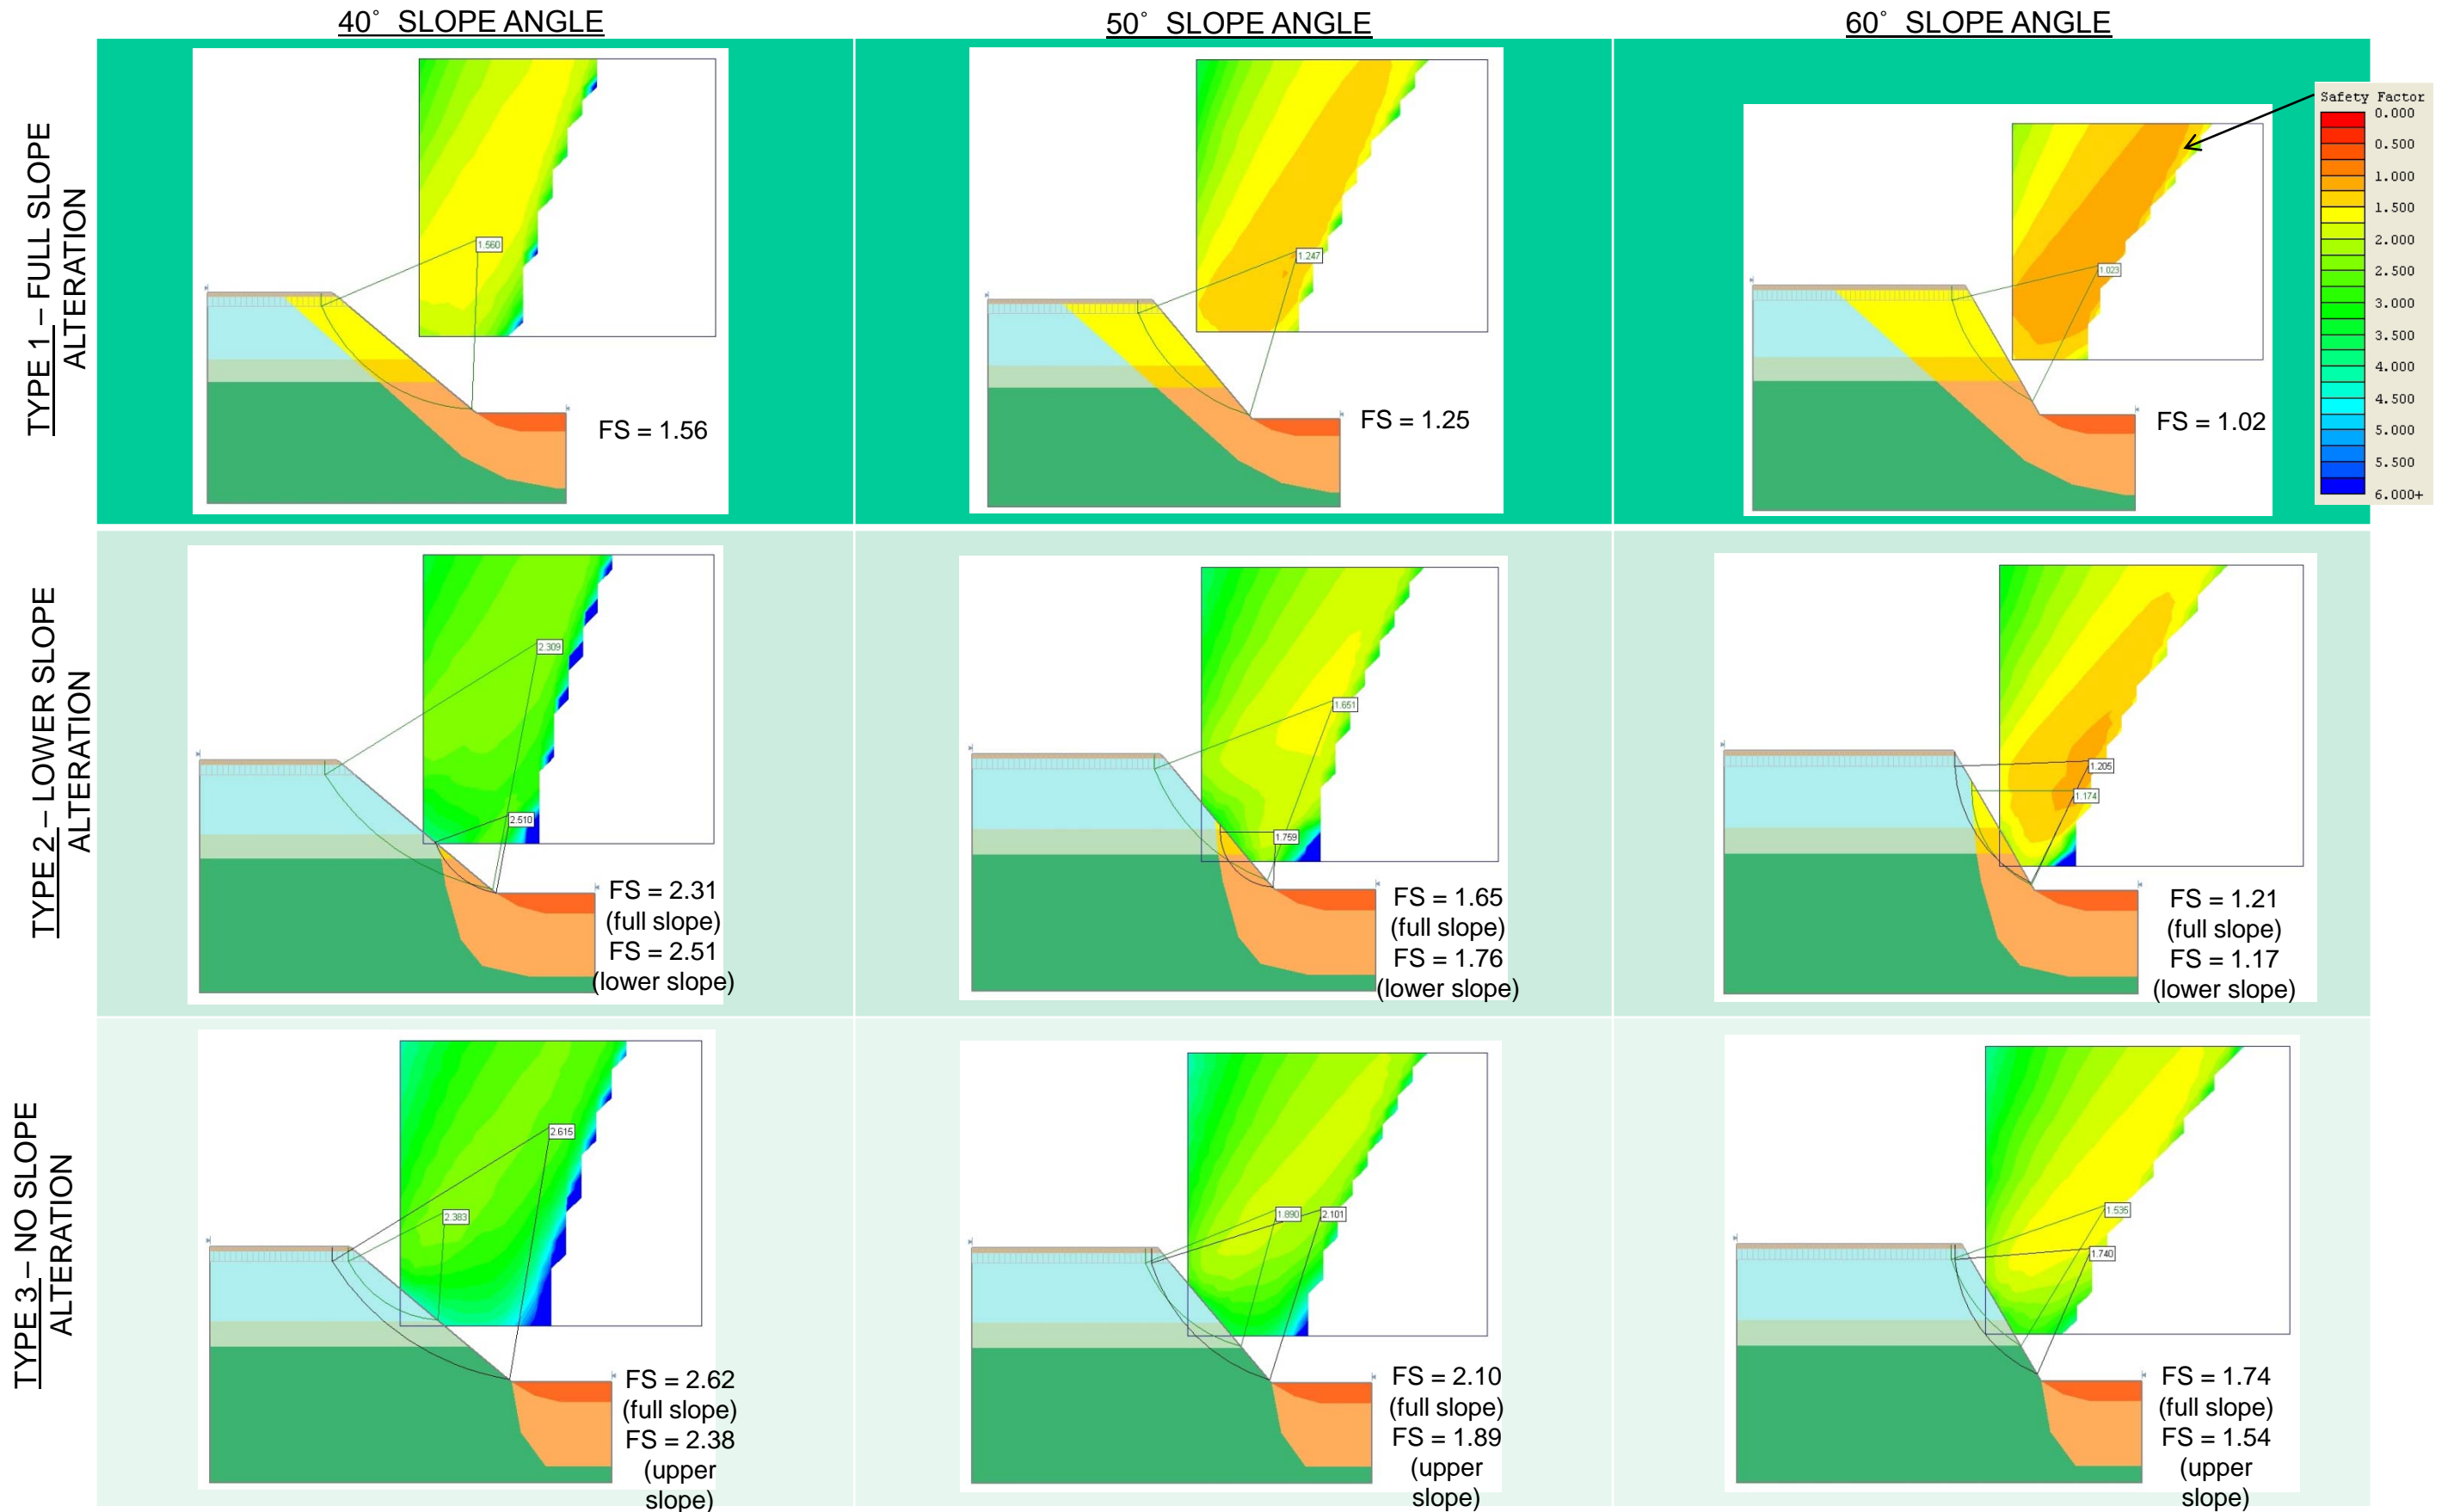
FIGURE D3

\*Slide results shown are dry, with damage factor,  $D = 0.5$ .

The Andrew Lake Type 2 model results are illustrated on Figure D3, and the results of the assessment for the various slope angles are plotted on Figure D5. The model results show the Type 2 slope configurations have two main tendencies of failure, full slope failure through the majority of the pit wall height, or lower slope failure through the altered rock mass zones in the lower one quarter to one half of the slope. Under dry conditions, the

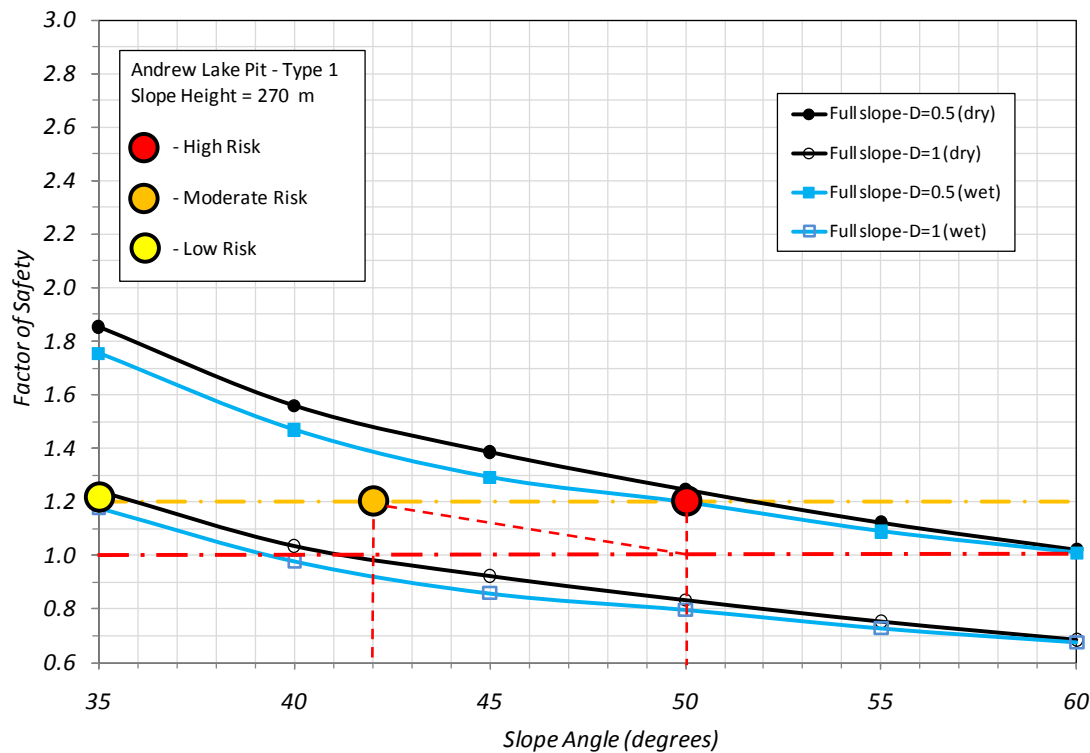
Figure D4: Andrew Lake Type 1 Slope - Slope Angle versus Factor of Safety for the Full Slope Altered Rock Mass Configuration

A 'High Risk', 'Moderate Risk', and 'Low Risk' slope angle have been highlighted on Figure D4 based on the relative FS and the design assumptions considered. Descriptions of these risk ratings are as follows:

As shown in Figure D4, the slope angles range between 35° and 50°. A 35° slope angle is likely too conservative for the open pit, although a 50° slope angle would likely be too aggressive based on the assumed disturbance factor of  $D = 0.5$ . An achievable slope angle with the Type 1 rock mass conditions would likely be around 44°, and with the adoption of good blasting practices, a slope angle of closer to 47° might be achievable.

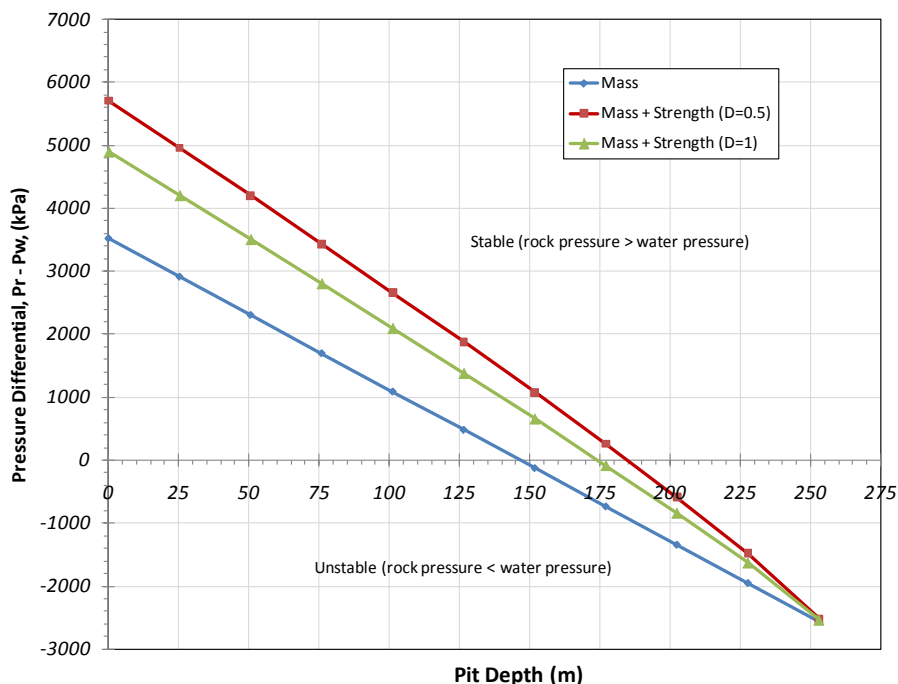
Figure D8: Andrew Lake - Floor Heave Analysis Results Showing Differential Pressure versus Pit Depth

The floor heave analysis results for Andrew Lake, plotting the differential pressure versus pit depth are shown on Figure D8. The results compare dP calculated from the mass of the rock only, as well as dP considering a rock mass shear strength component for a disturbance factor  $D = 0.5$  and  $1$ . Negative differential pressures, related to unstable conditions, are shown to occur at between 145 m and 185 m. A pit depth of 145 m is recommended for consideration of alleviation of floor water pressures, which corresponds to approximately one half of the planned pit depth.

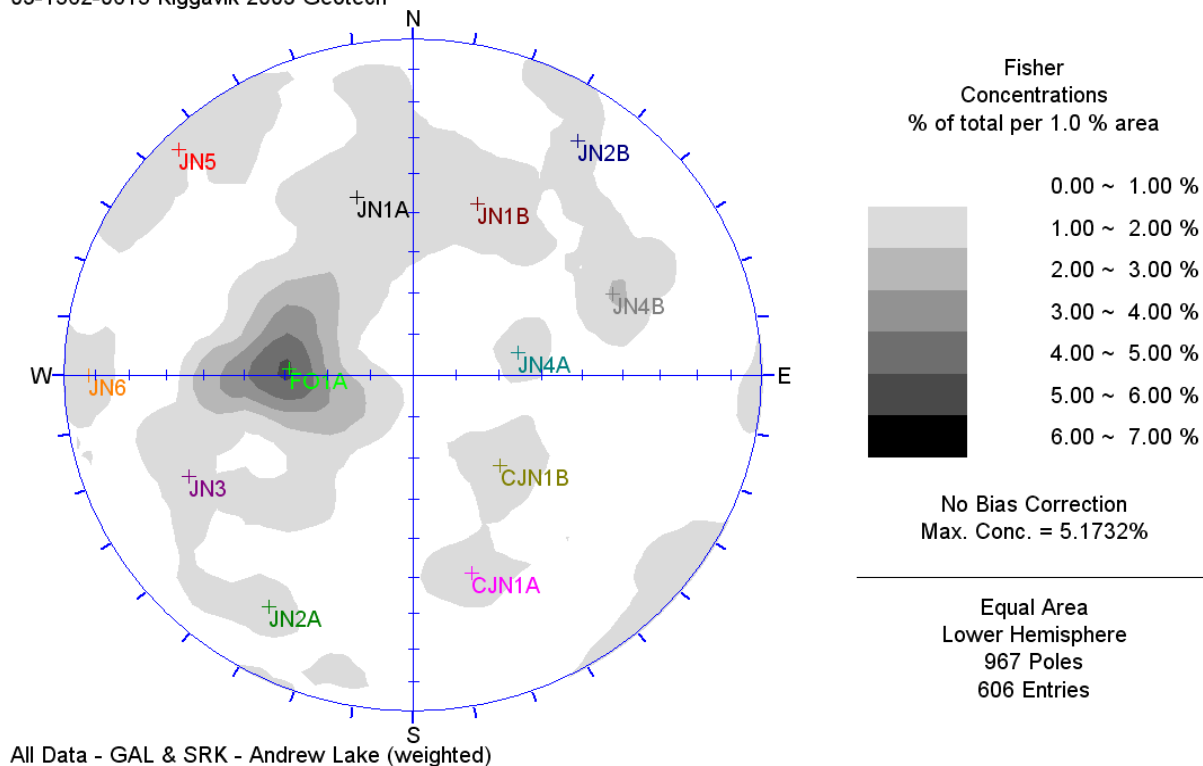
Figure E3: Andrew Lake - All Validated Oriented Core Data (contoured) with Selected Discontinuity Sets

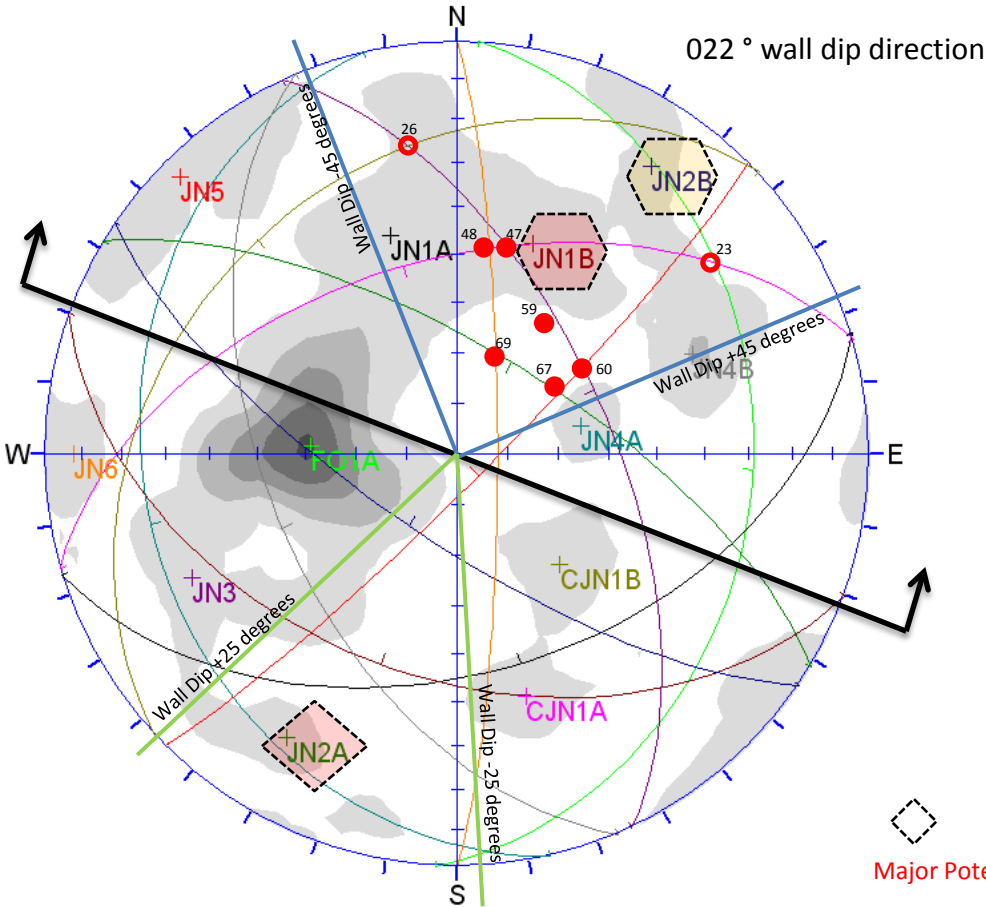
Figure E4

Wedge Analysis

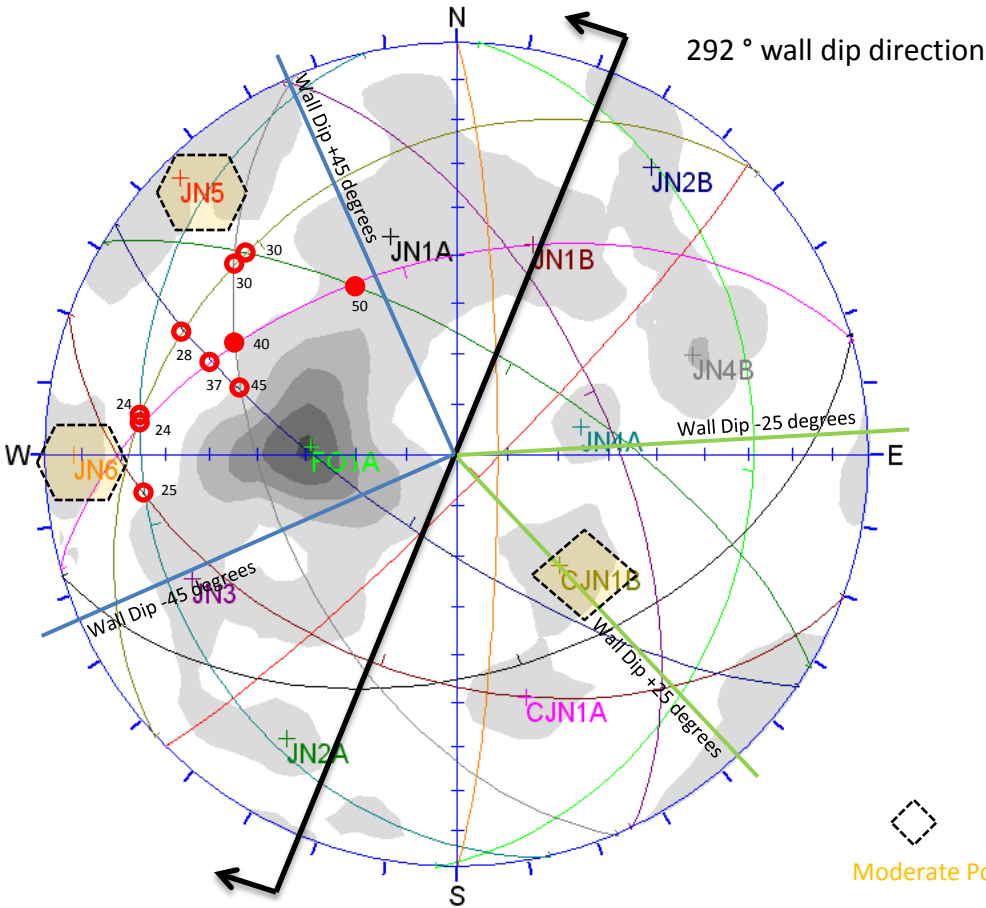
Figure E10

Wedge Analysis				
Set 1	Set 2	Plunge	Trend	FS
JN4A	CJN1B	24	277	1.43
JN4A	CJN1A	24	275	1.38
JN4A	JN1B	25	262	1.41
CJN1B	JN2B	28	295	1.50
CJN1B	JN4B	30	310	1.25
CJN1B	JN2A	30	314	1.26
CJN1A	JN2B	37	291	1.37
CJN1A	JN4B	40	296	0.94
JN4B	JN2B	45	286	1.71
CJN1A	JN2A	50	328	0.73

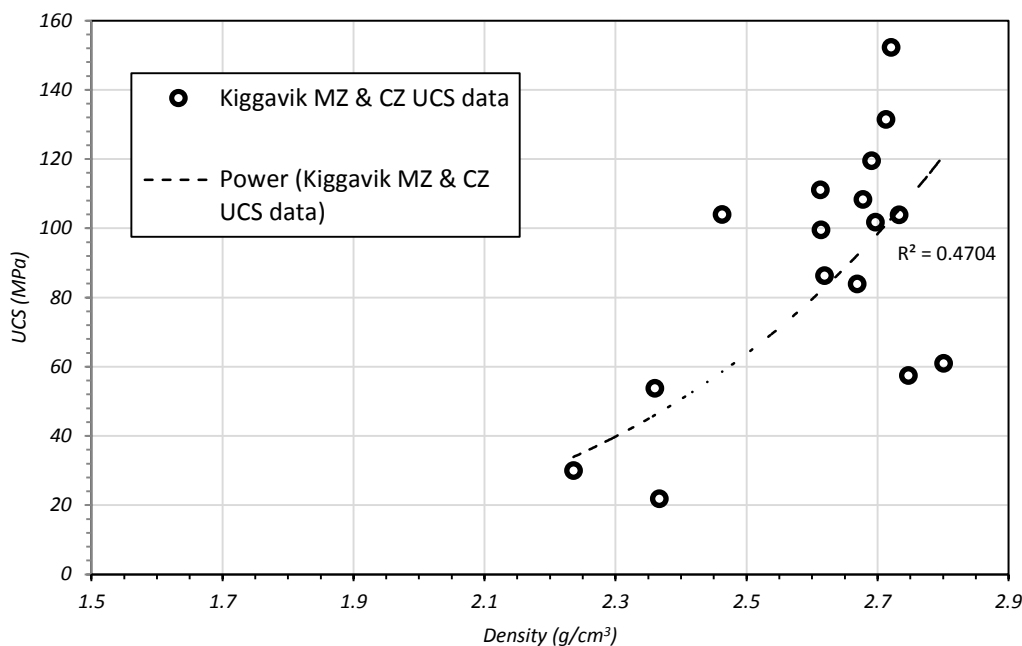
Figure 5: UCS versus Density for the 2009 Main Zone and Centre Zone Testing (see Appendix A)

The wall rocks for the Kiggavik Main and Centre pits are generally competent to very competent rocks and exhibit brittle rock characteristics. The unaltered granites and metasediment rock units showed similar strengths, ranging from strong to very strong. The metasediments were shown to be slightly weaker than the granites, but are still very competent with respect to providing a stable wall for an open pit. Altered zones related to faulting or ore zone halo alteration are expected to reduce the rock strengths considerably. The ISRM weathering index (ISRM 1981) as assessed during the borehole investigation was used for assessment of weathering/alteration at the MZ/CZ. The potentially altered zones on the final pit walls were assessed for rock mass stability considerations. Results from the laboratory strength testing program are summarised in Table 2 below.

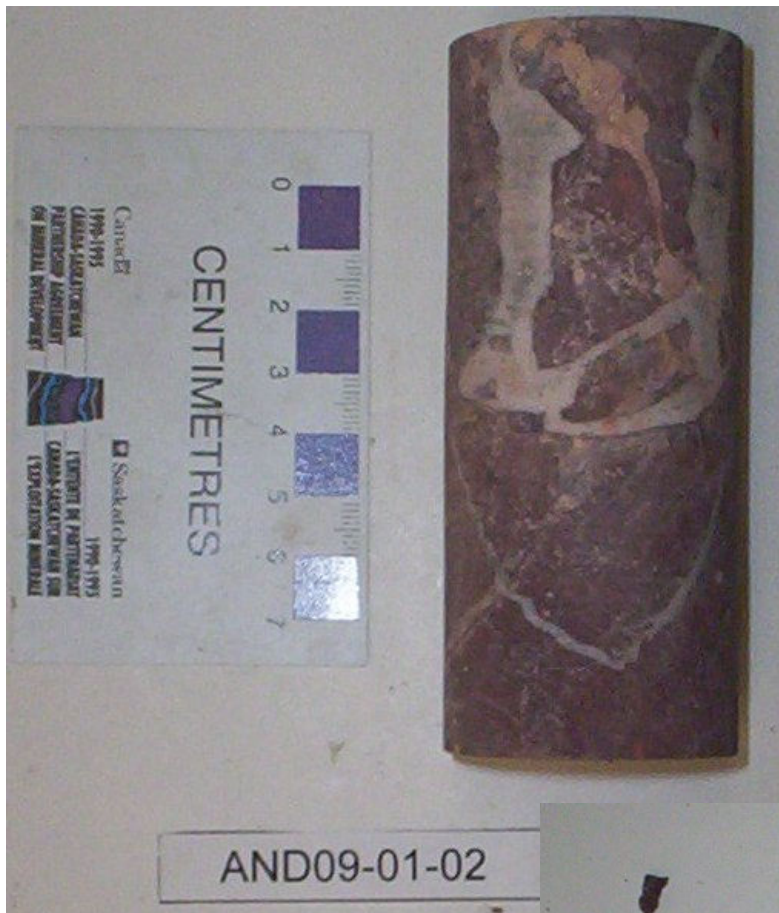
**SAMPLE: AND09-01-02**

Length: 108.03 mm

Diameter: 45.11 mm

Poisson's Ratio: 0.03

Failure Cause: Intact Rock

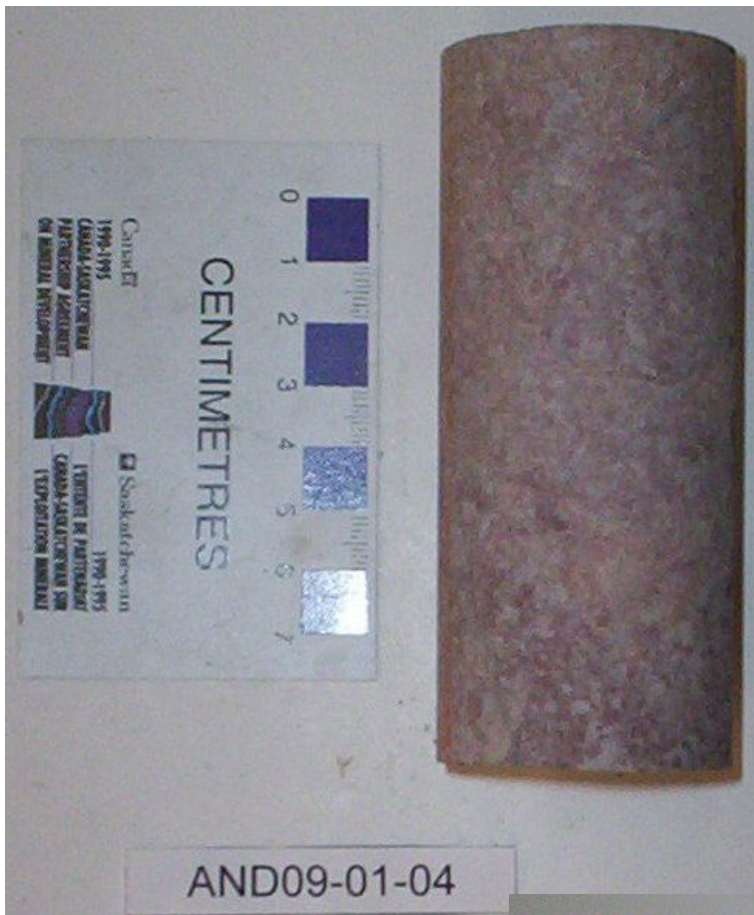
**SAMPLE: AND09-01-04**

Length: 107.81 mm

Diameter: 45.1 mm

Poisson's Ratio: 0.13

Failure Cause: Intact Rock

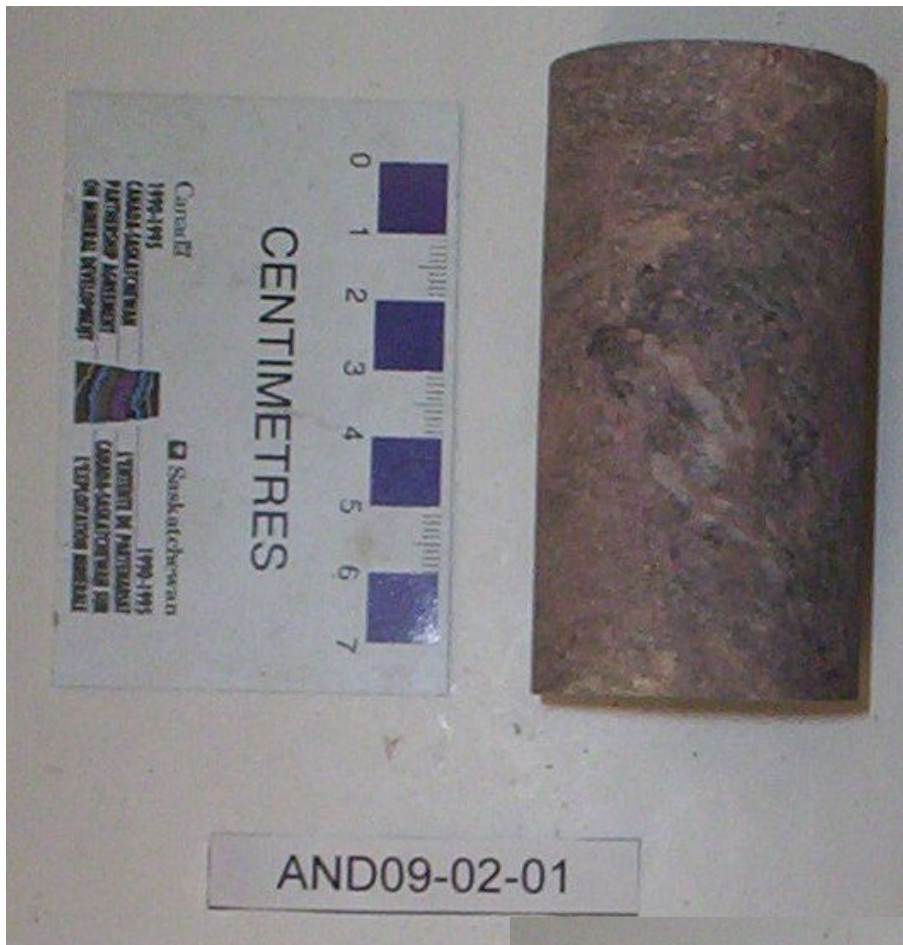
**SAMPLE: AND09-02-01**

Length: 86.53 mm

Diameter: 45.34 mm

Poisson's Ratio: 0.13

Failure Cause: Intact Rock

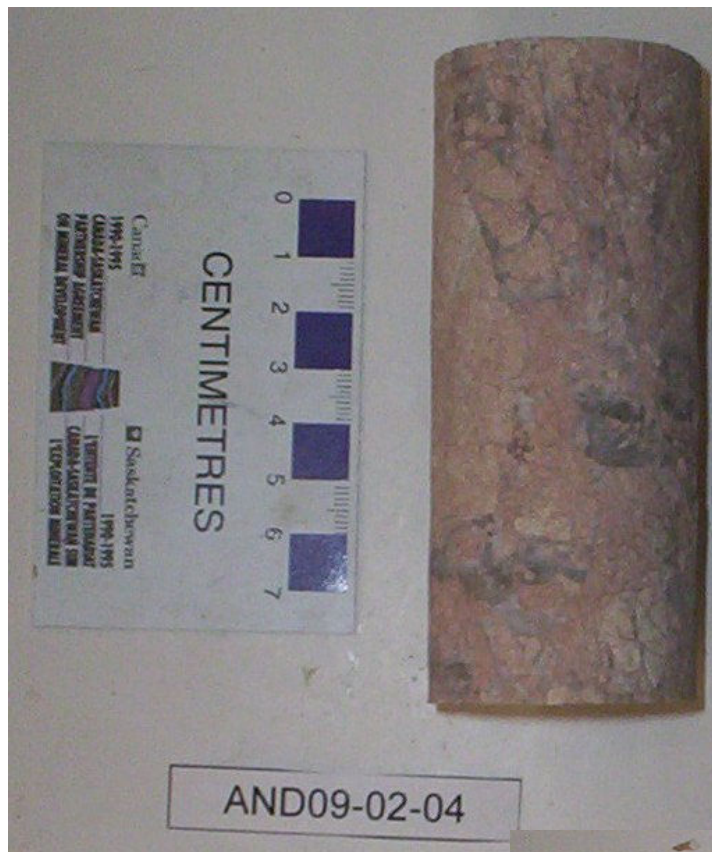
**SAMPLE: AND09-02-04**

Length: 107.82 mm

Diameter: 45.25 mm

Poisson's Ratio: 0.49

Failure Cause: Intact Rock

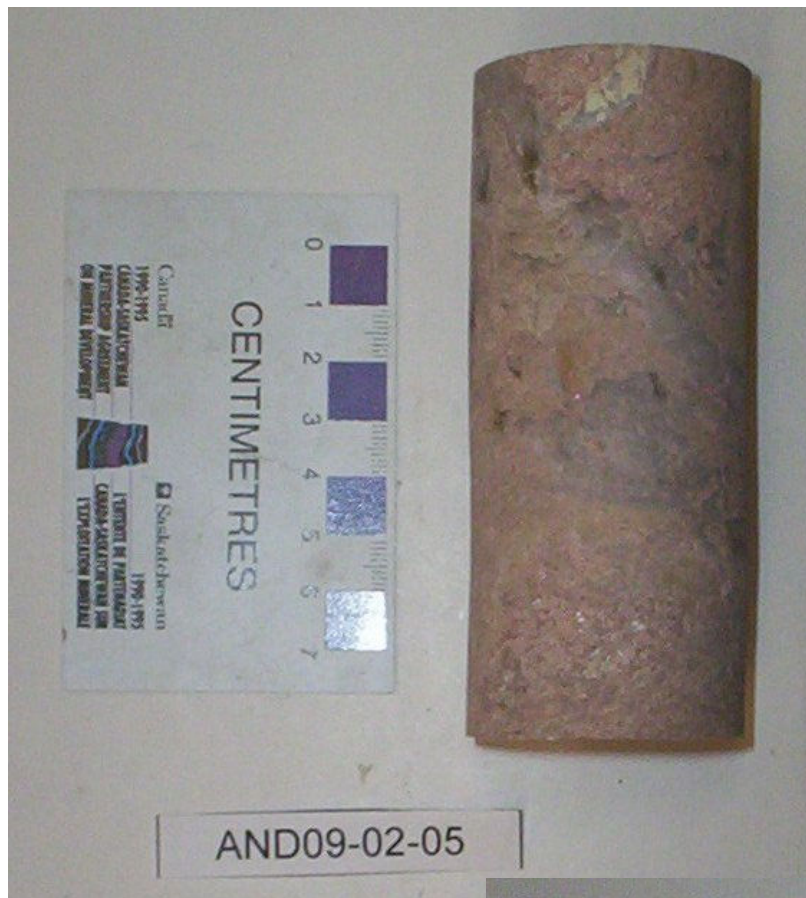
**SAMPLE: AND09-02-05**

Length: 108.76 mm

Diameter: 45.67 mm

Poisson's Ratio: 0.07

Failure Cause: Intact Rock

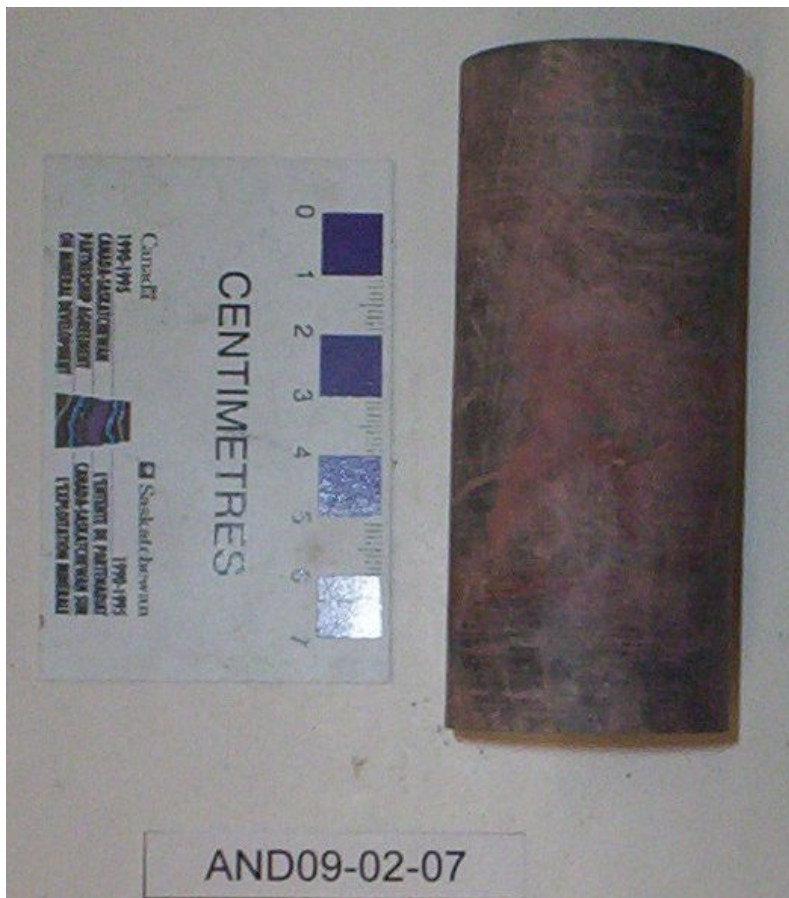
**SAMPLE: AND09-02-07**

Length: 103.18 mm  
Diameter: 44.32 mm  
Density: 2.494 g/cm<sup>3</sup>  
Peak Strength: 11.8 MPa  
Young's Modulus: 5.1 GPa  
Poisson's Ratio: 0.04  
Failure Cause: Microfracture?

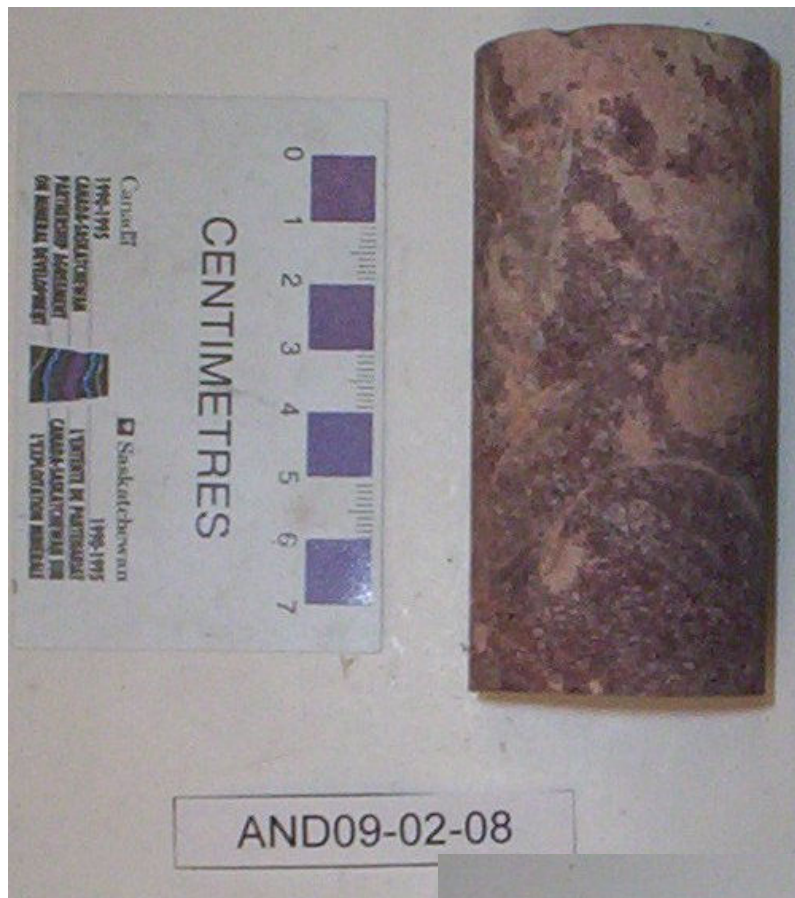
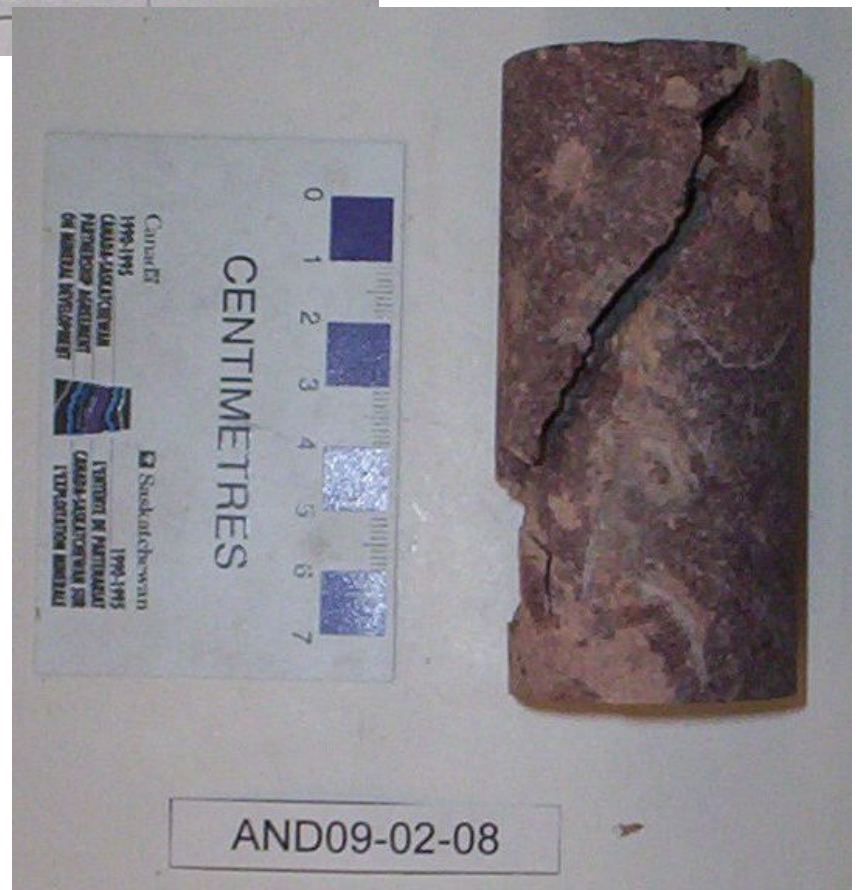
**SAMPLE: AND09-02-08**

Length: 94.50 mm

Diameter: 44.07 mm

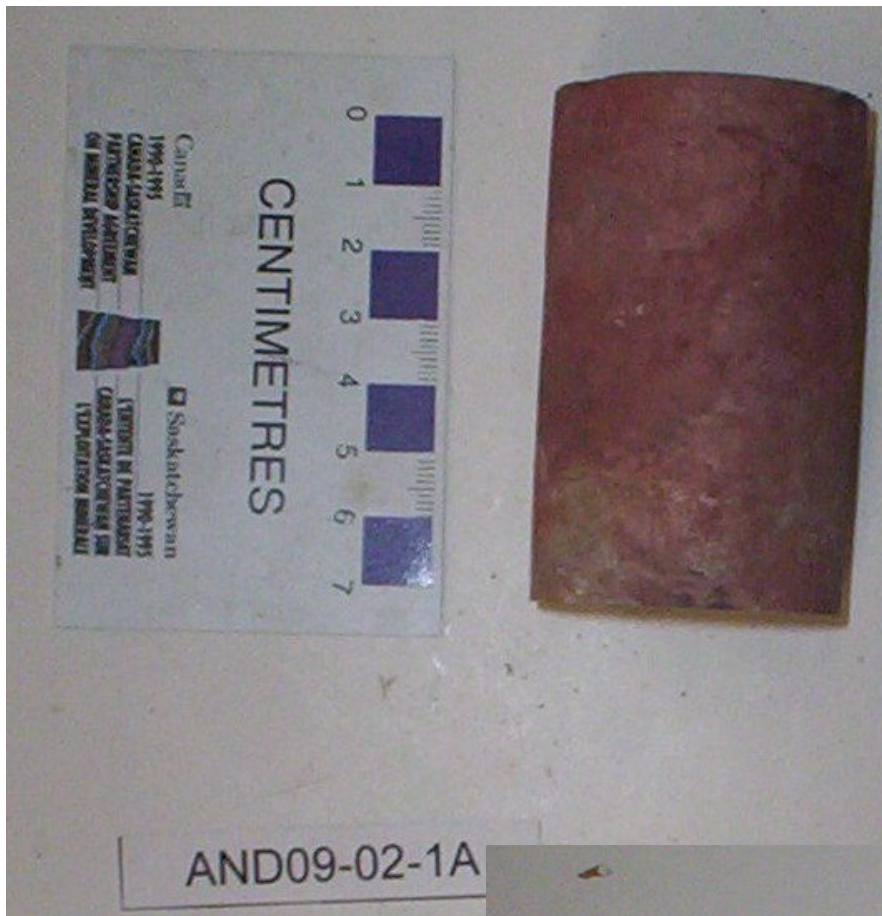
**SAMPLE: AND09-02-1A**

Length: 72.18 mm

Diameter: 45.14 mm

Poisson's Ratio: 0.10

Failure Cause: Intact
