**FIGURE 3-1**  
 FOUR POTENTIAL BARGE DOCK SITE LOCATIONS  
 ON BAKER LAKE, NUNAVUT  
 KIGGAVIK PROJECT - EIS

**FIGURE 3-2**  
FIELD DATA SUMMARY  
FOR POTENTIAL BARGE DOCK SITE 1

**FIGURE 3-3**  
 BATHYMETRY AND AQUATIC HABITAT  
 FOR POTENTIAL BARGE DOCK SITE 1  
 KIGGAVIK PROJECT - EIS

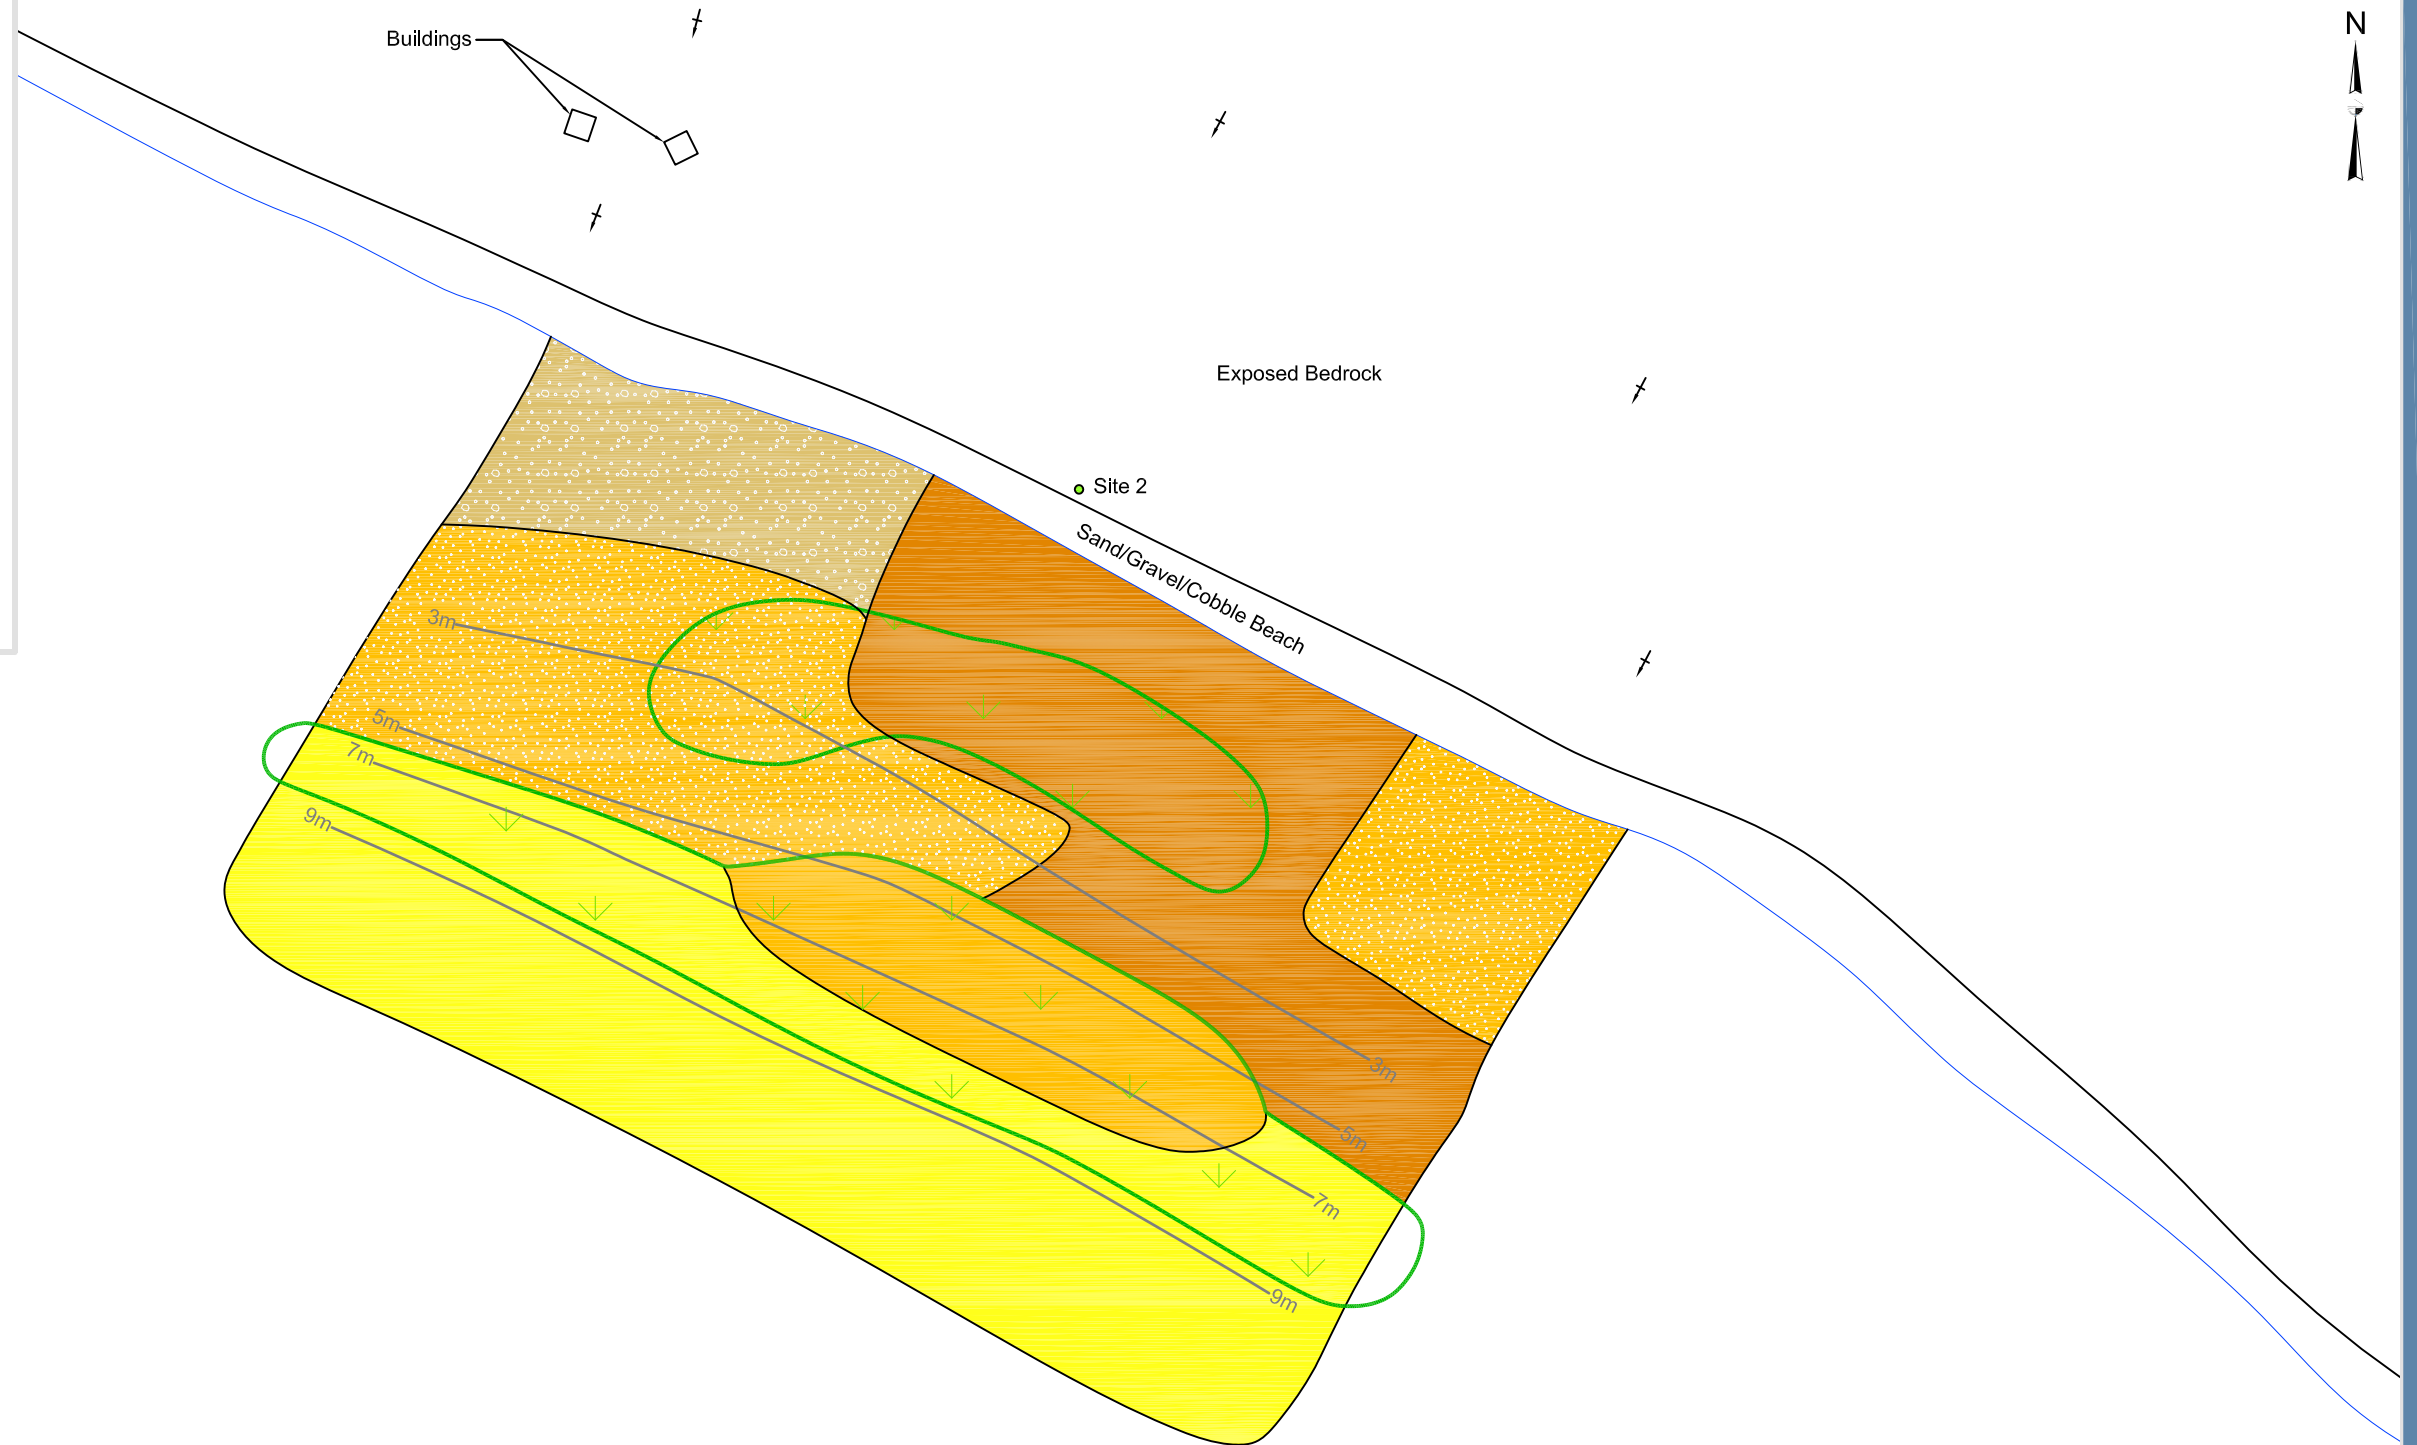
**FIGURE 3-5**  
 BATHYMETRY AND AQUATIC HABITAT  
 FOR POTENTIAL BARGE DOCK SITE 2  
 KIGGAVIK PROJECT - EIS

● Data Summary  
(waypoint/depth in metres/submergent vegetation/substrate)
