August 27, 2014

# Conceptual Design for Andrew Lake Pit Dewatering Structure, Kiggavik Project

**Reference Number:** 1213620158-004-R-Rev2-3000

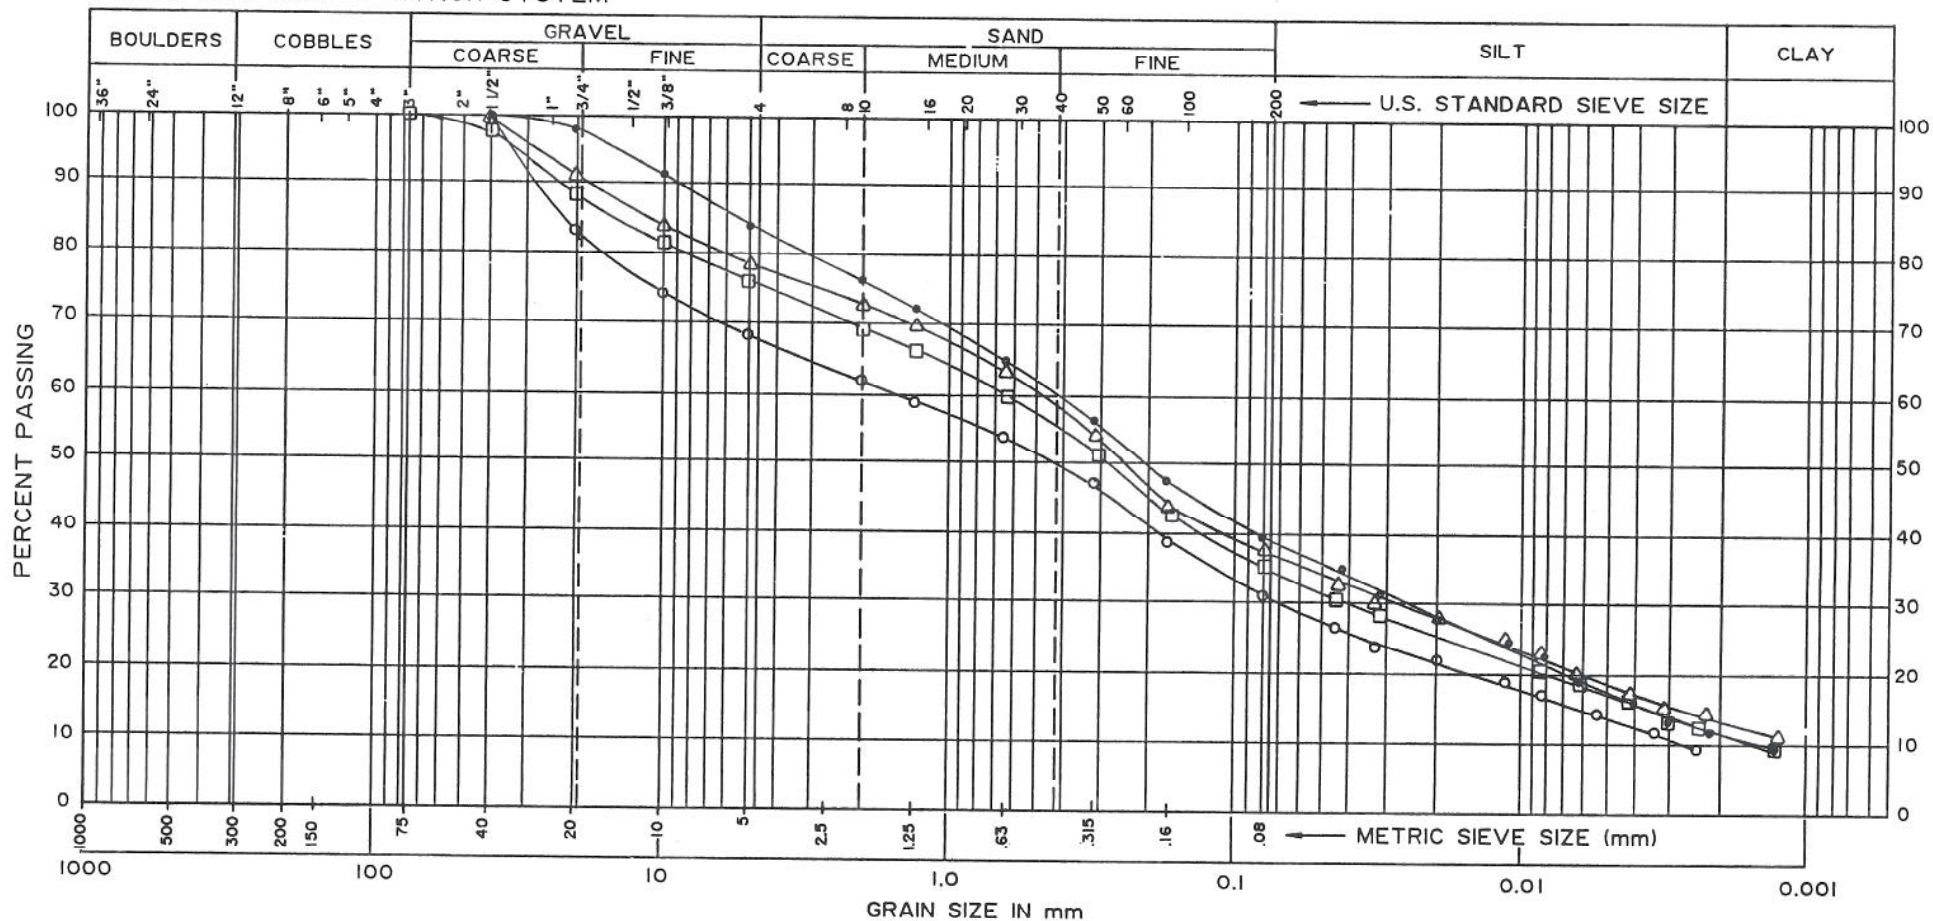
REMARKS: SILTY SAND TILL

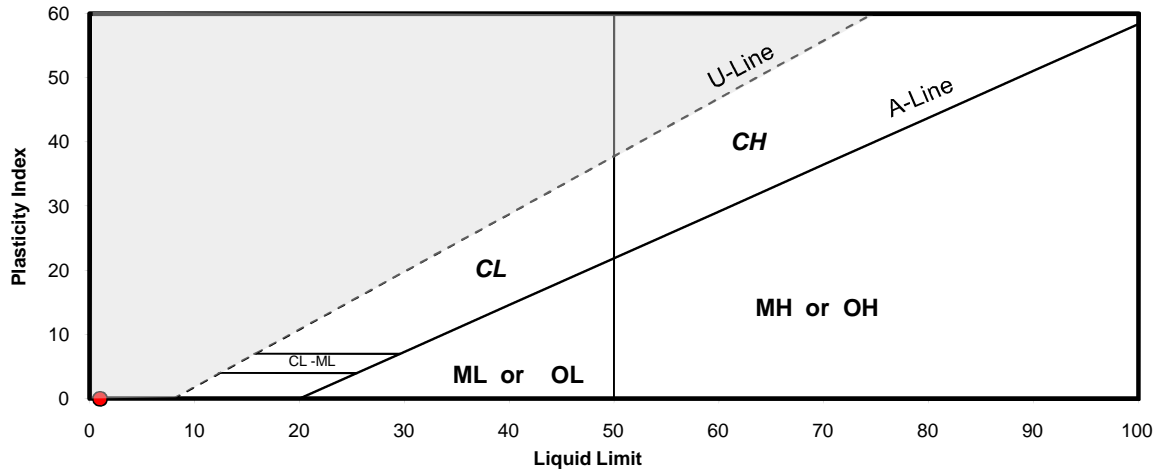
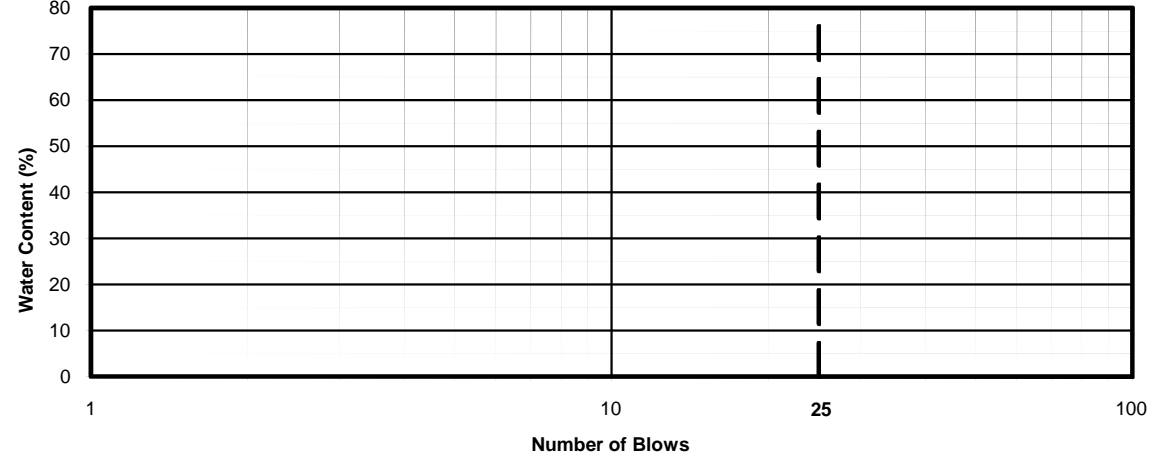
Test Summary		Remarks
Percent passing #40 Sieve (%)	N/A	Non-Plastic sample
Liquid Limit	N/A	
Plastic Limit	Non Plastic	
Plasticity Index	N/A	
Natural water content (%)	11	
Liquidity Index	N/A

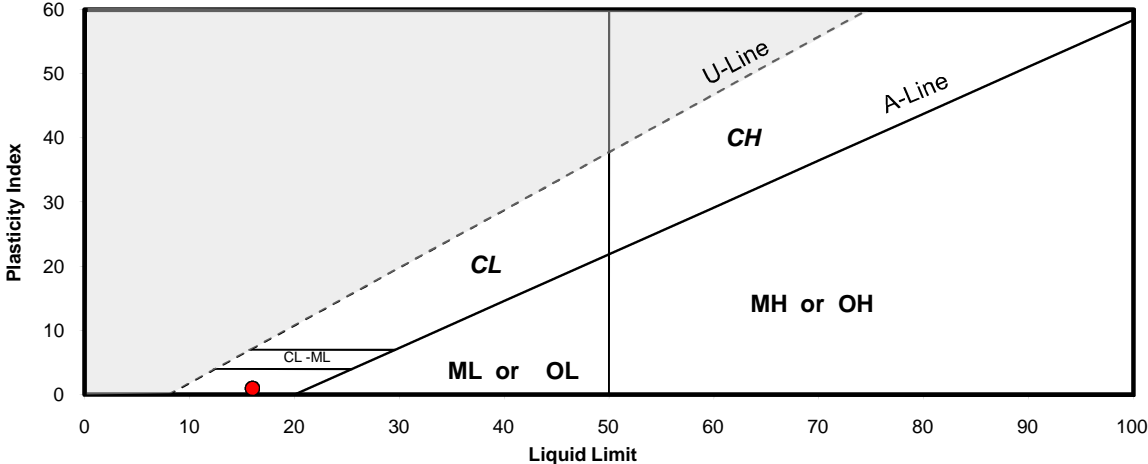
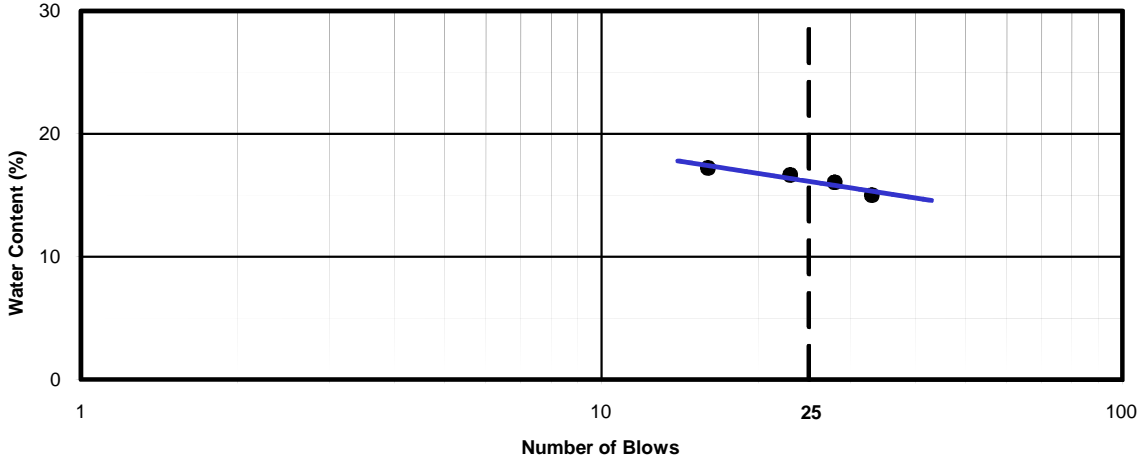
Test Summary	Remarks
Percent passing #40 Sieve (%)	
Liquid Limit <span style="float: right;">16</span>	
Plastic Limit <span style="float: right;">15</span>	
Plasticity Index <span style="float: right;">1</span>	
Natural water content (%) <span style="float: right;">15</span>	
Liquidity Index <span style="float: right;">0.0</span>

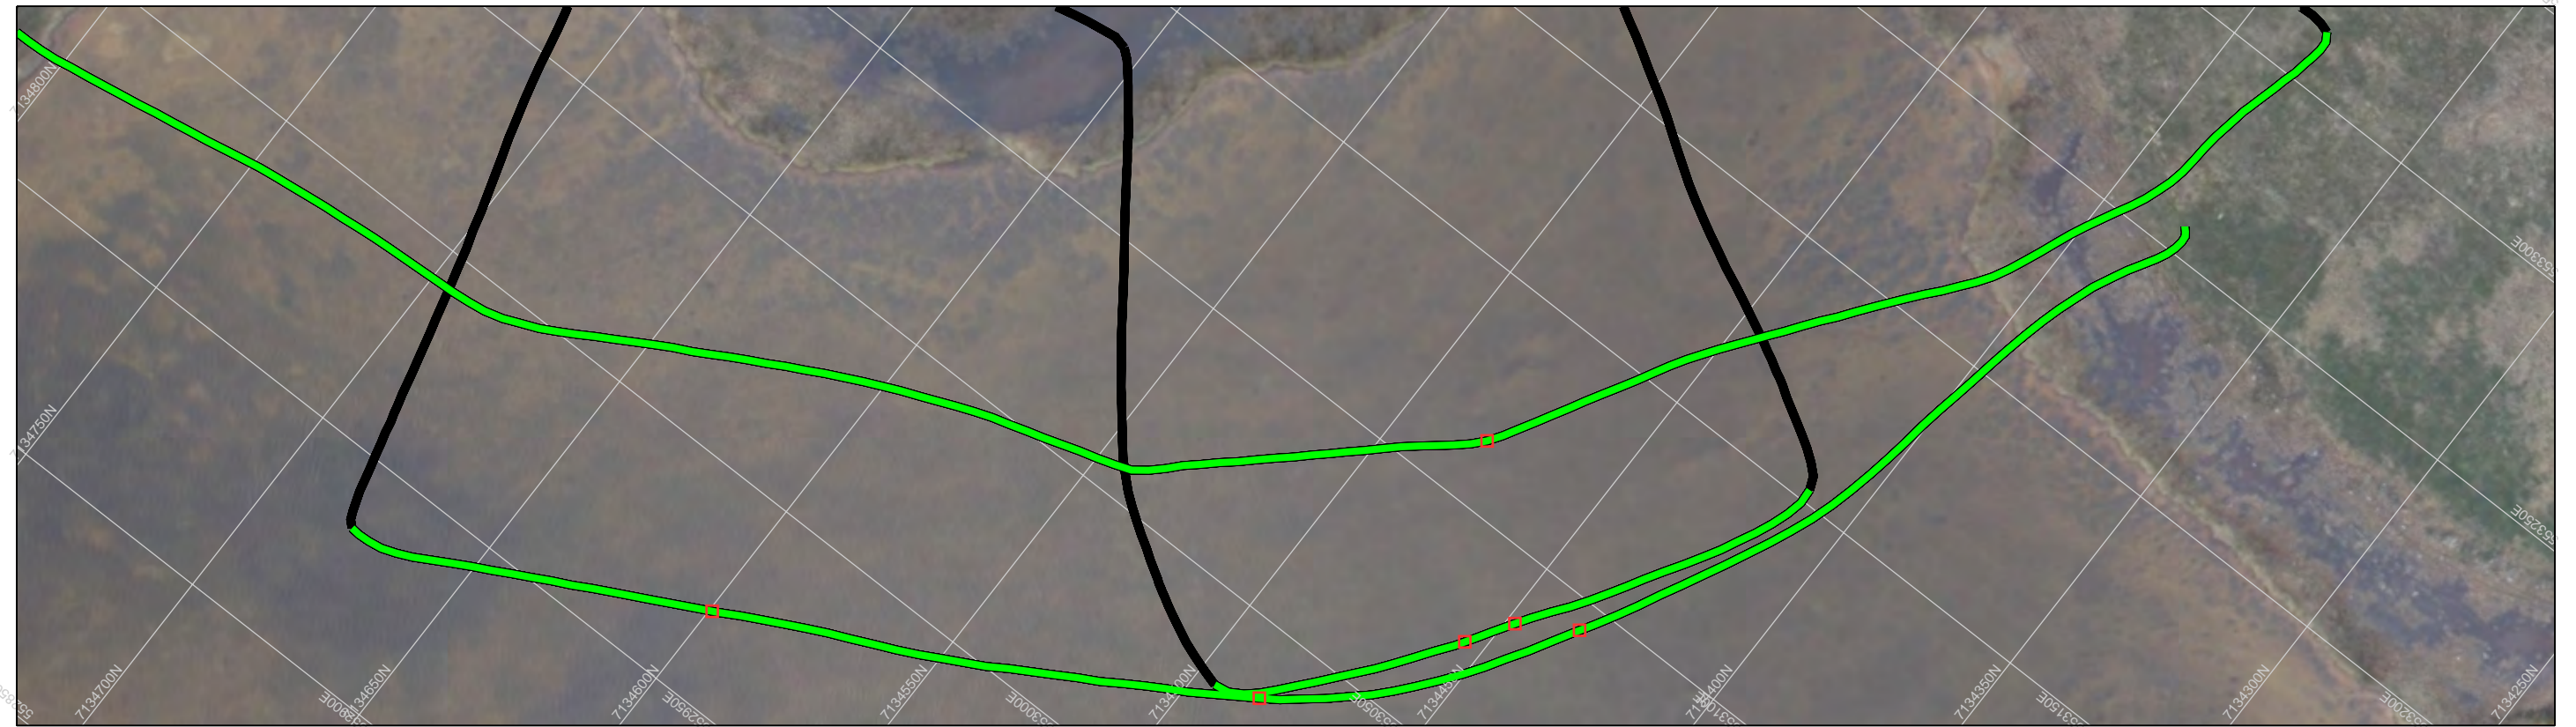
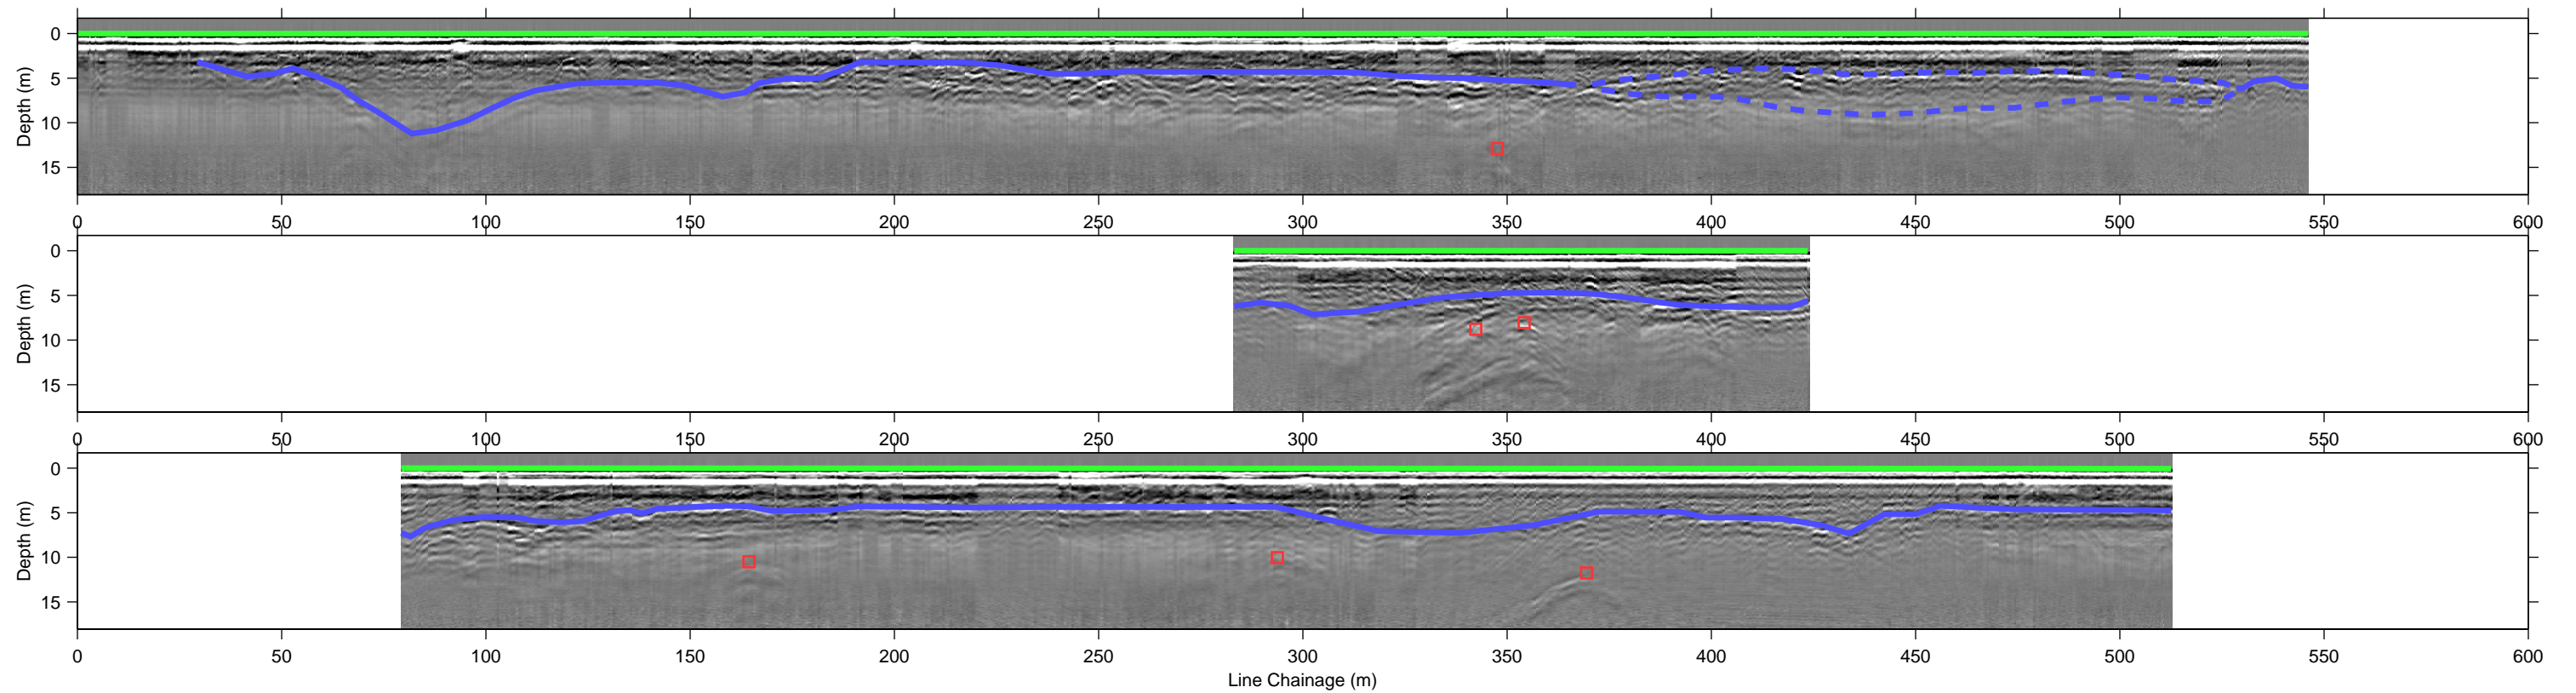
Project No. V33101016	DWN RJM	CHKD NSP	REV 0	Figure D2
OFFICE Calgary	DATE Nov. 30, 2009

- Ice/Ground Surface
- Bedrock Surface
- Uncertain Bedrock Surface
- Bedrock Anomaly

#### Proposed Andrew Lake Dyke Location GPR Profiles

It was noted by EBA field staff at the time of the investigation (April 2009) that ice on Andrew Lake in the area of the surveys was frozen down to the lakebed surface and that no distinct ice-water interface was observed in the radar data. The reflection amplitudes and material velocities calculated from diffraction events suggest frozen materials within the area covered by the investigation, which is consistent with that expected in areas where the lake ice freezes to the lakebed.

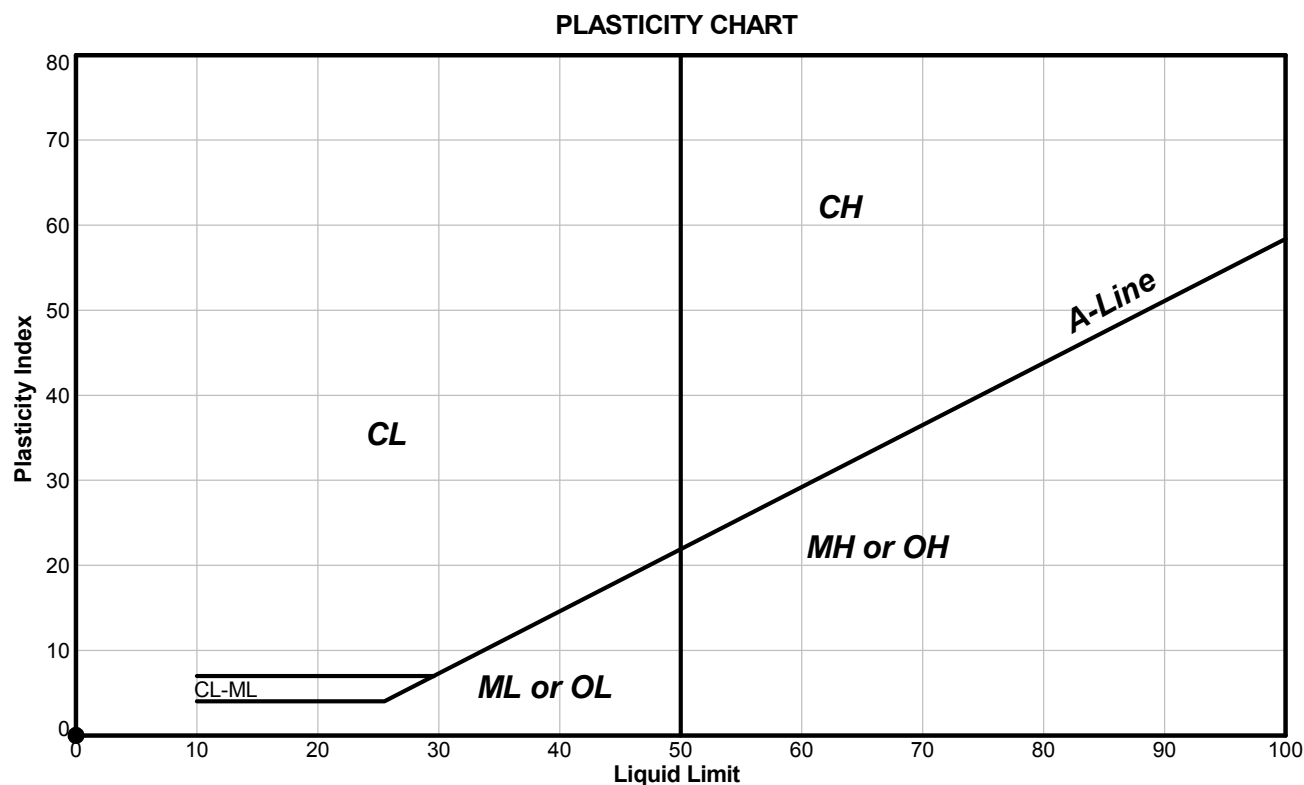
Sym.	Sample Location	Sample Number	Depth (m)	Bottom (m)	Percent Passing #40 Sieve (%)	Liquid Limit	Plastic Limit	Plasticity Index	Natural Water Content (%)	Liquidity Index
●	SD	04	0.00	0.00	71	NP	NP	NP	26.3	NP

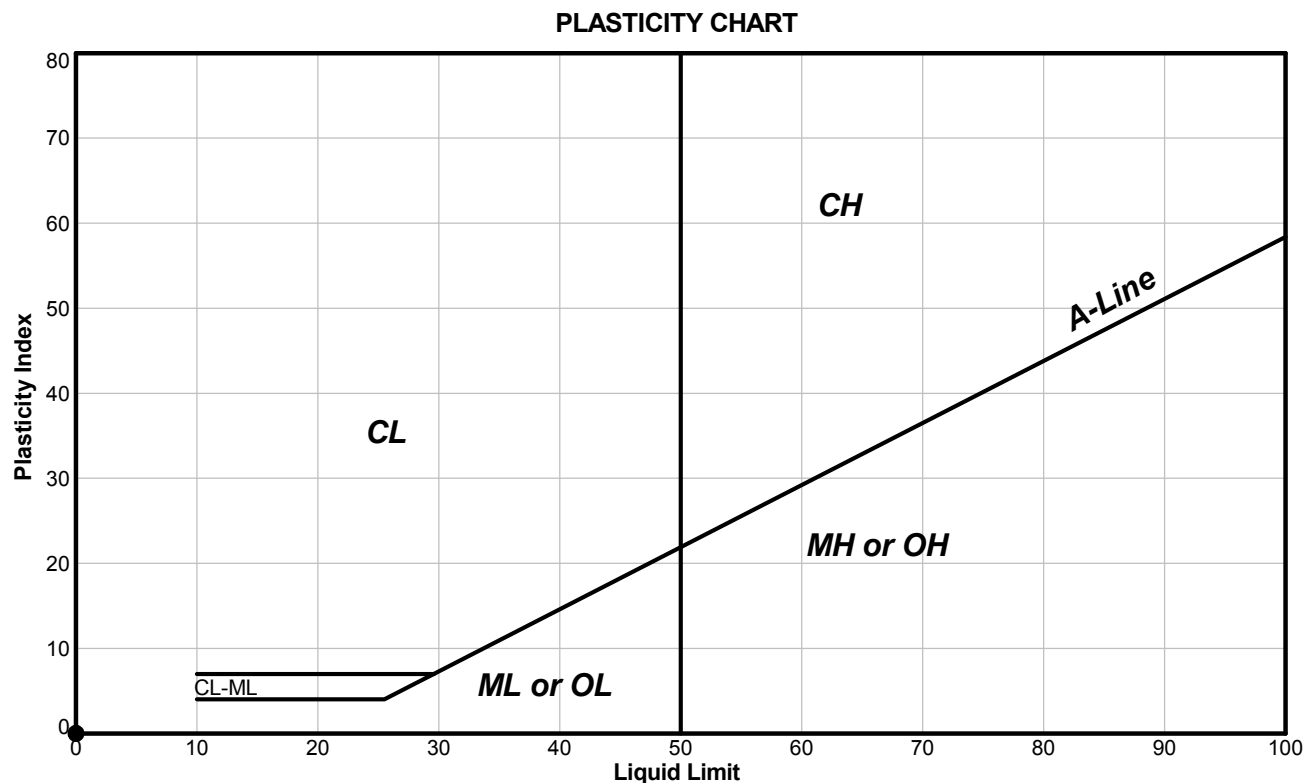
Sym.	Sample Location	Sample Number	Depth (m)	Bottom (m)	Percent Passing #40 Sieve (%)	Liquid Limit	Plastic Limit	Plasticity Index	Natural Water Content (%)	Liquidity Index
●	SD	11	0.00	0.00	67	NP	NP	NP	29.6	NP
