Kiggavik Project

Final Environmental Impact Statement

Tier 3 Volume 2V: Mine Geotechnical
Reports

Geotechnical Recommendations for the Proposed Andrew Lake Open Pit - Support Document For Permit Application

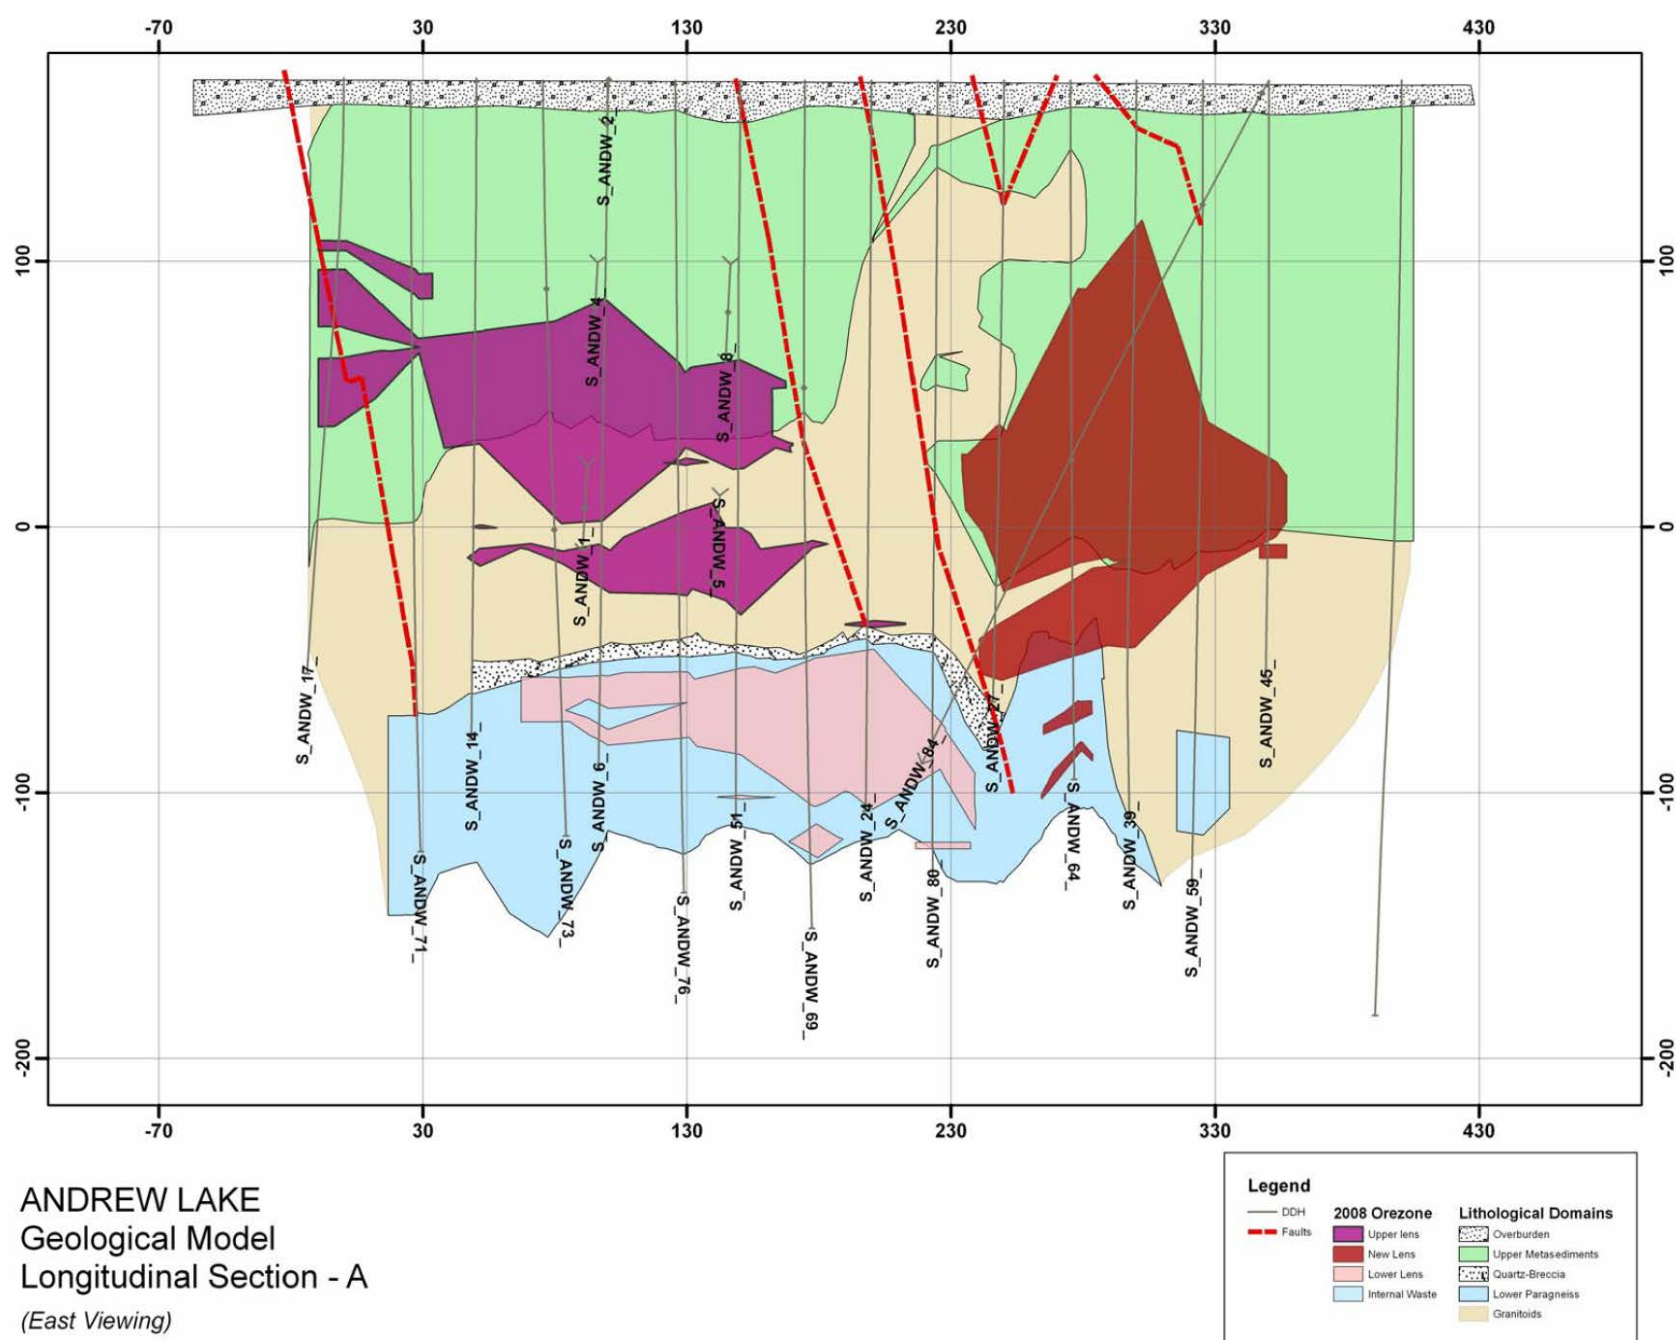
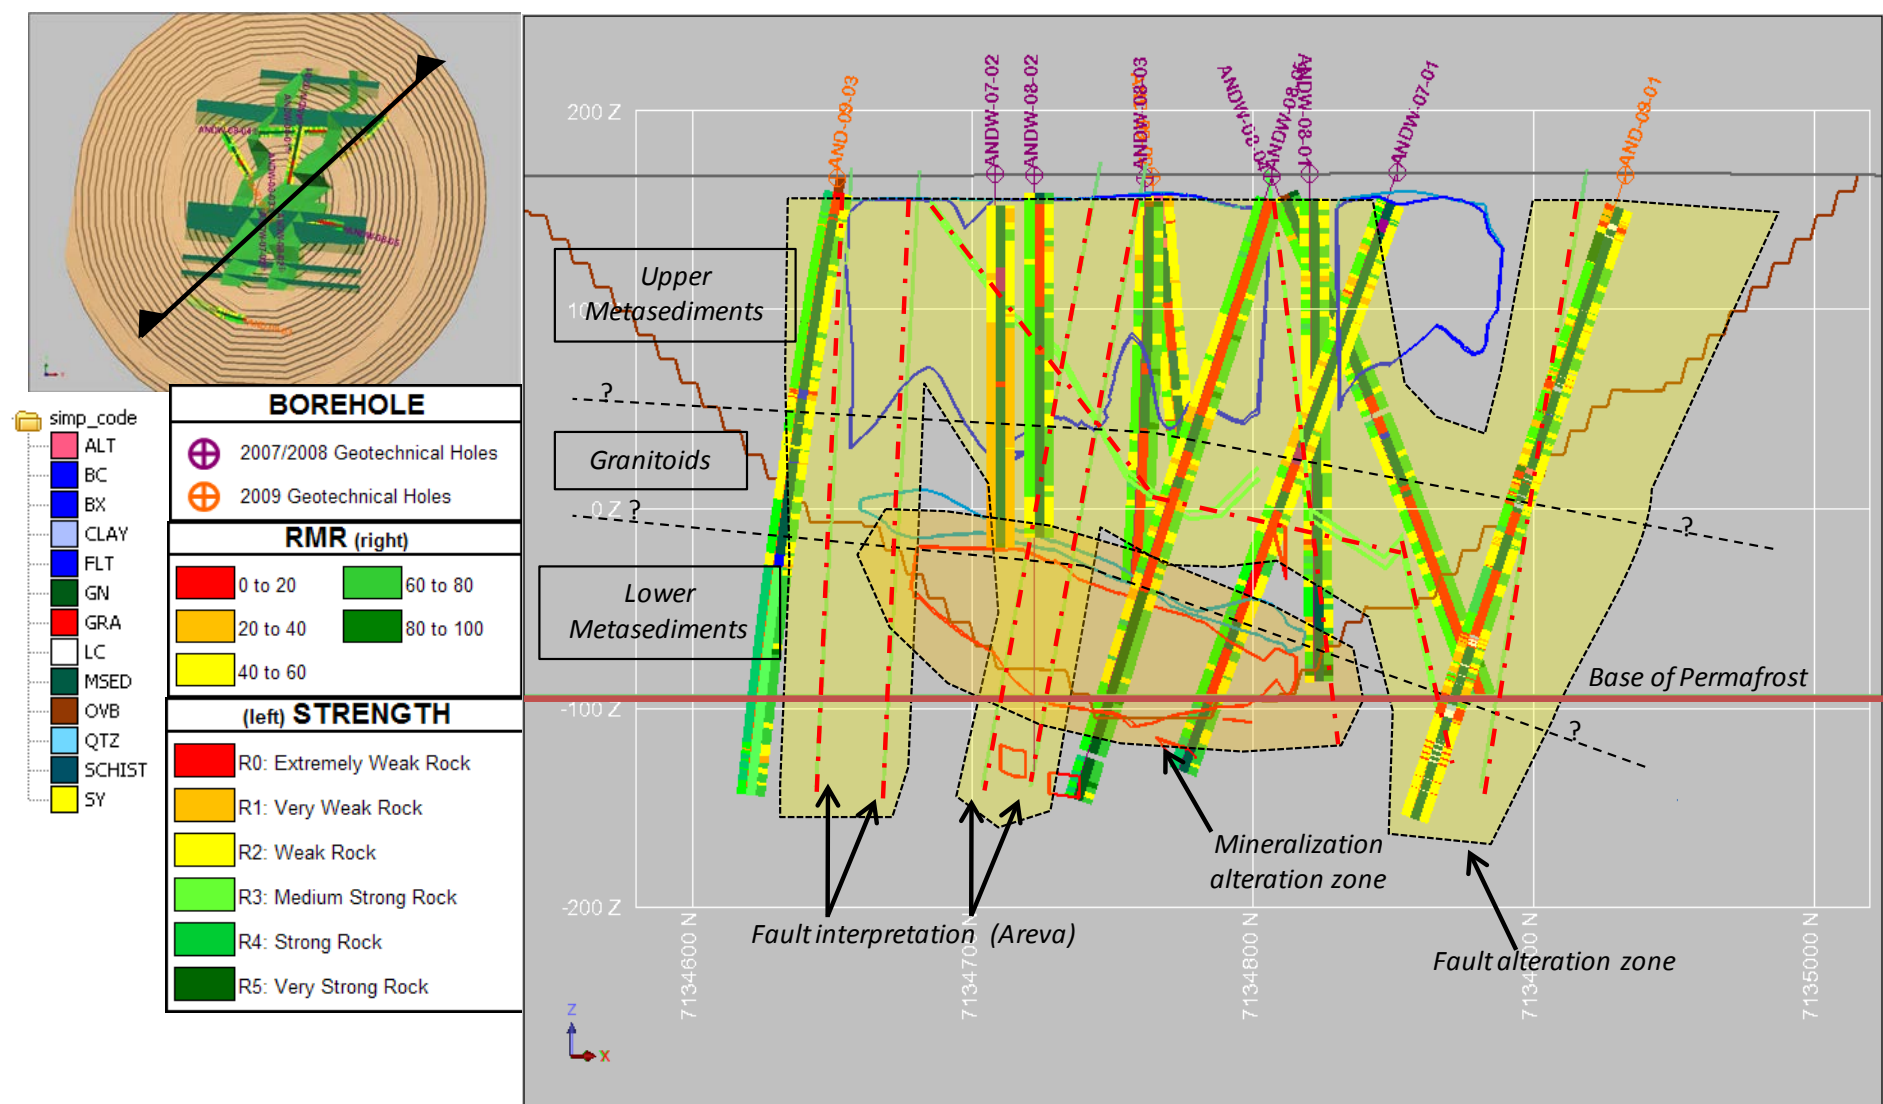
Geotechnical sections were developed based on the available 2009 data as well as 2008 holes carried out by others (SRK 2009). These sections are quite generalized due to the limited information available, particularly in the pit walls. An example section is plotted on Figure 6. A general lithological arrangement of upper metasediments, granitics, and lower metasediments (gneisses) was assumed throughout. These arrangements in rock types were not always observed in all of the 2008/2009 geotechnical boreholes, but these assumptions agree with the updated geological model (SRK 2008c) also shown on Figure 6.

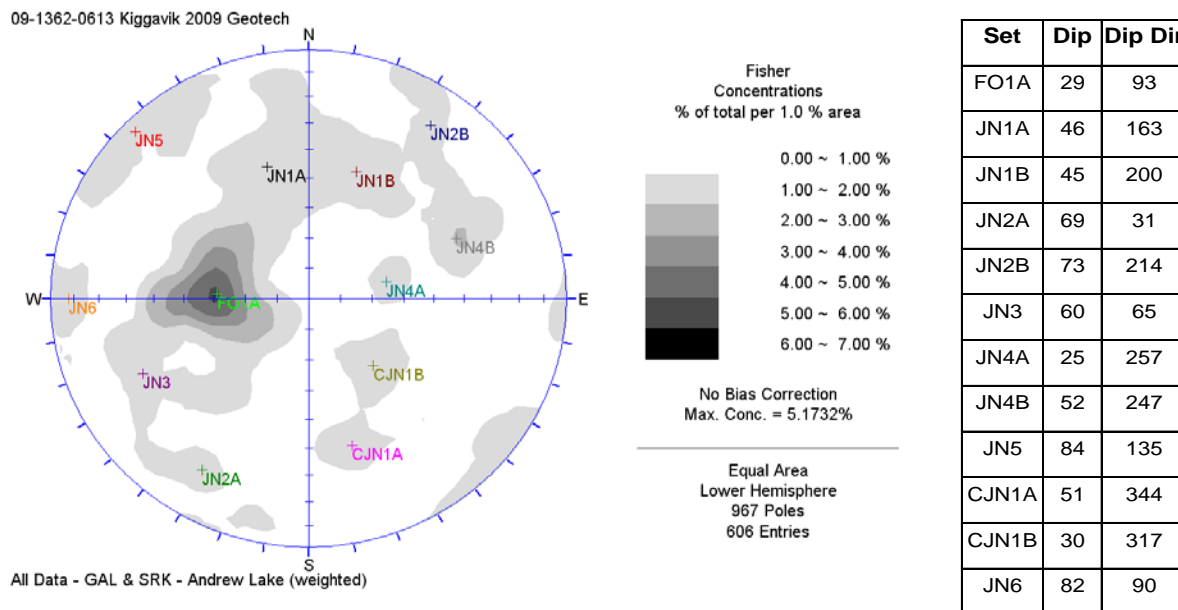
Figure 7: Andrew Lake Oriented Core Data from 2008 and 2009 (contoured) with Selected Discontinuity Sets

The selected discontinuity sets are plotted with all contoured data (2008 and 2009) in the stereonet on Figure 7. A conventional naming system was used for the various sets (i.e., FO = foliation, JN = joint, CJN = conjugate joint). The numbers related to either joint set indicate the relative degree of intensity (1 = most dominant). Sub-sets, or two sets with an apparent relation, were identified by the designation 'A' and 'B'. For the kinematic analyses, all discontinuity sets were conservatively assumed to be persistent or major, given the small data set of moderate to high confidence core orientation data for discontinuities relative to the size and extent of the pit walls. Future investigations, including detailed mapping on exposed benches should focus on better defining the rock mass structure, with possible delineation of structural domains and major/minor structures.

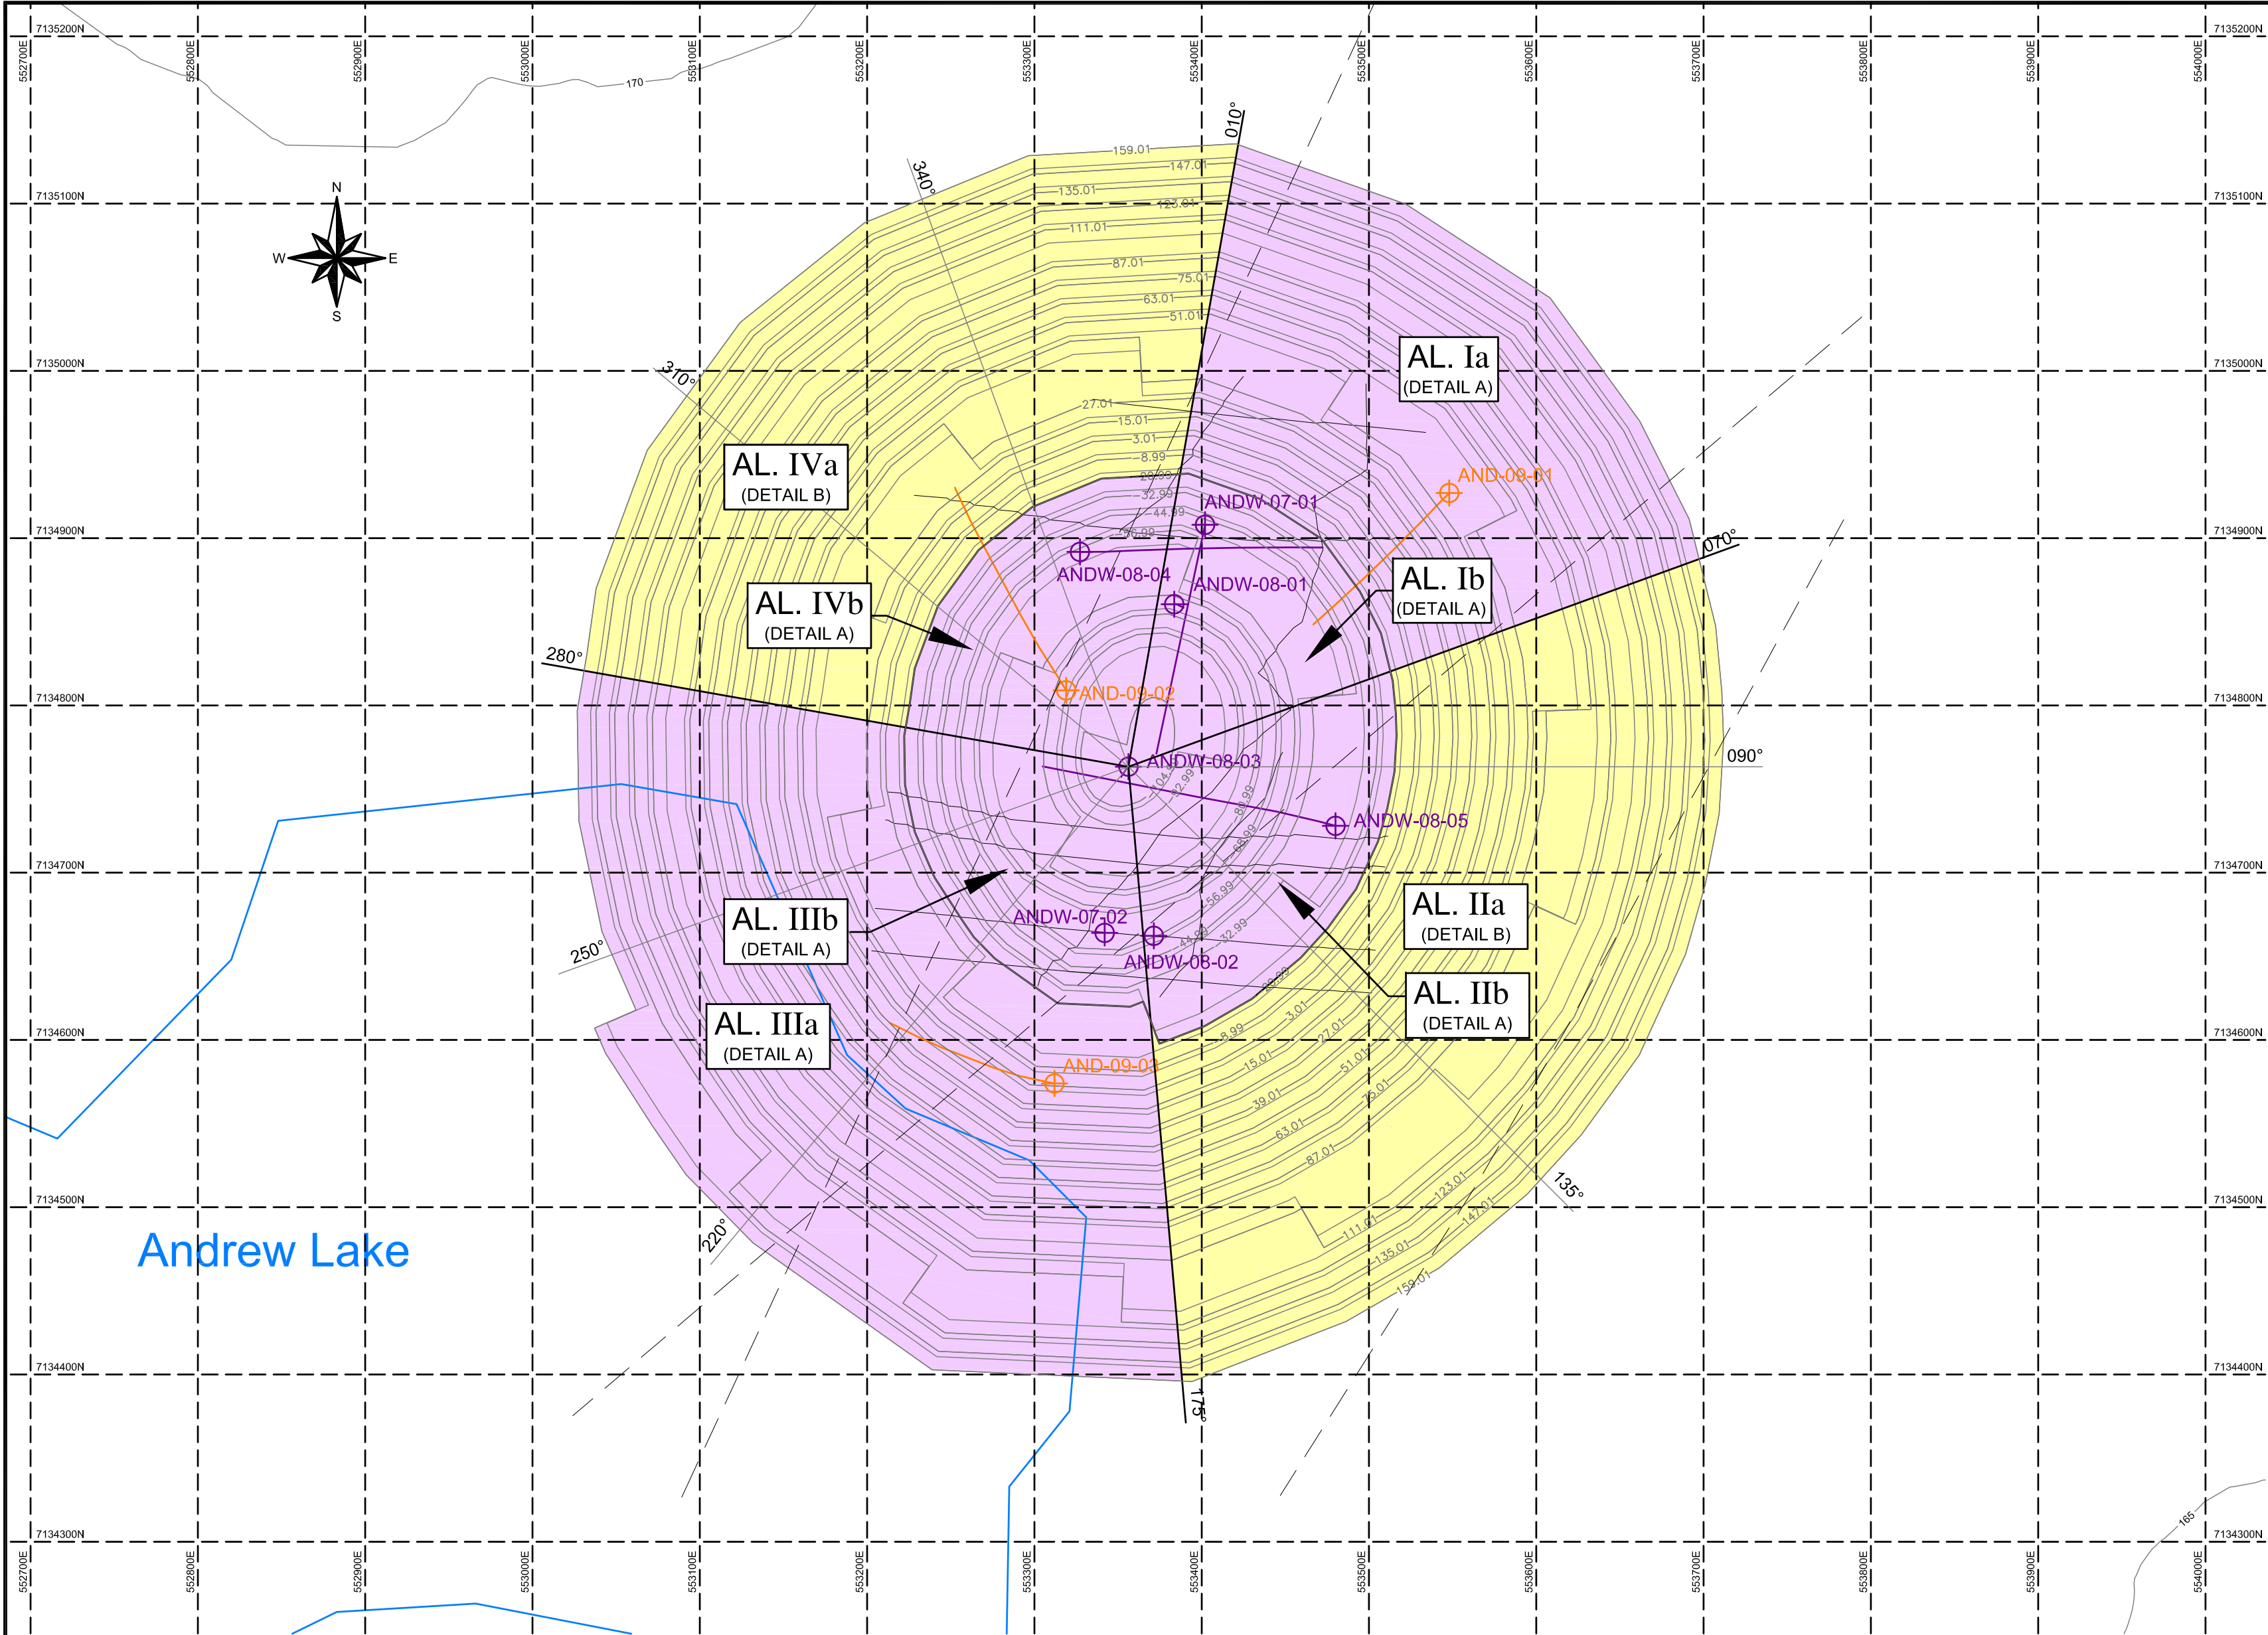
DESIGN SECTORS FOR ANDREW LAKE PIT

Design Sector	Azimuth (°)	Dip Direction (°)	Kinematic Sectors	Rock Mass Sectors	Design Detail
AL.I	010 to 070	190 to 250	K.I K.II	RM.I (Type 1)	AL.Ia (Detail A) AL.Ib (Detail A)
AL.II	070 to 175	250 to 355	K.II K.III K.IV	RM.II (Type 2) RM.III (Type 1) RM.IV (Type 2)	AL.IIa (Detail B) AL.IIb (Detail A)
AL.III	175 to 280	355 to 100	K.V K.VI K.VII	RM.V (Type 1) RM.VI (Type 2) RM.VII (Type 1)	AL.IIIa (Detail A) AL.IIIb (Detail A)
AL.IV	280 to 010	100 to 190	K.VII K.VIII	RM.VIII (Type 1) RM.IX (Type 2) RM.X (Type 1)	AL.IVa (Detail B) AL.IVb (Detail A)

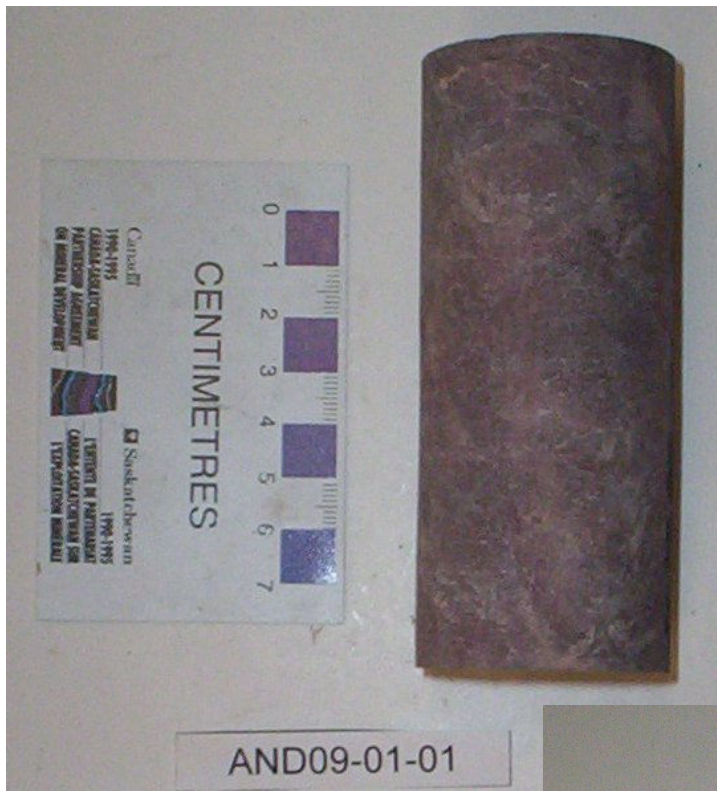
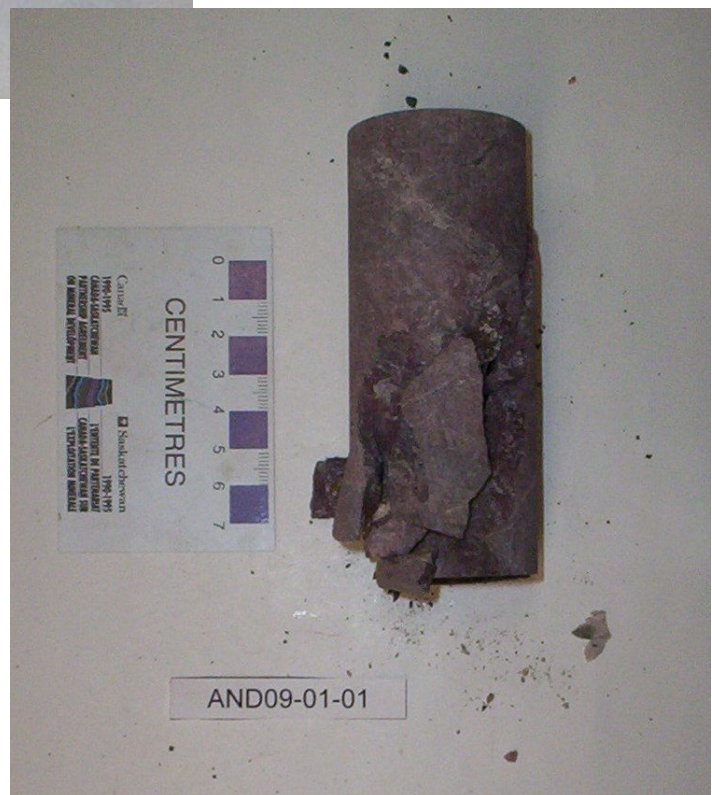
SAMPLE: AND09-01-01

Length: 108.03 mm
Diameter: 45.11 mm
Density: 2.572 g/cm³
Peak Strength: 41.8 MPa
Young's Modulus: 23.1 GPa
Poisson's Ratio: 0.08
Failure Cause: Intact Rock

AND09-01-01 Stress vs. Strain

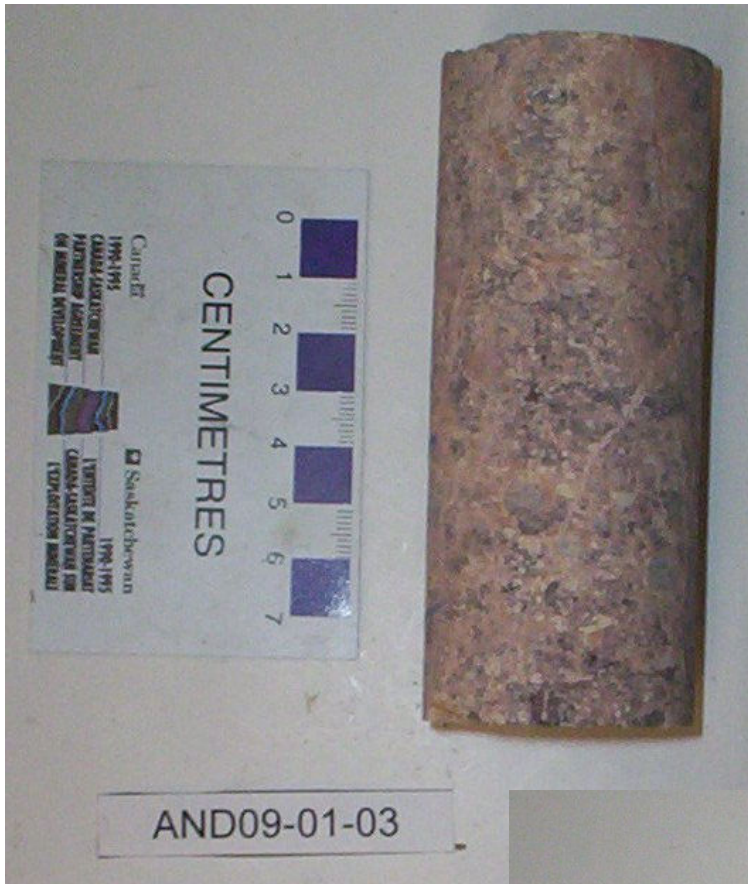
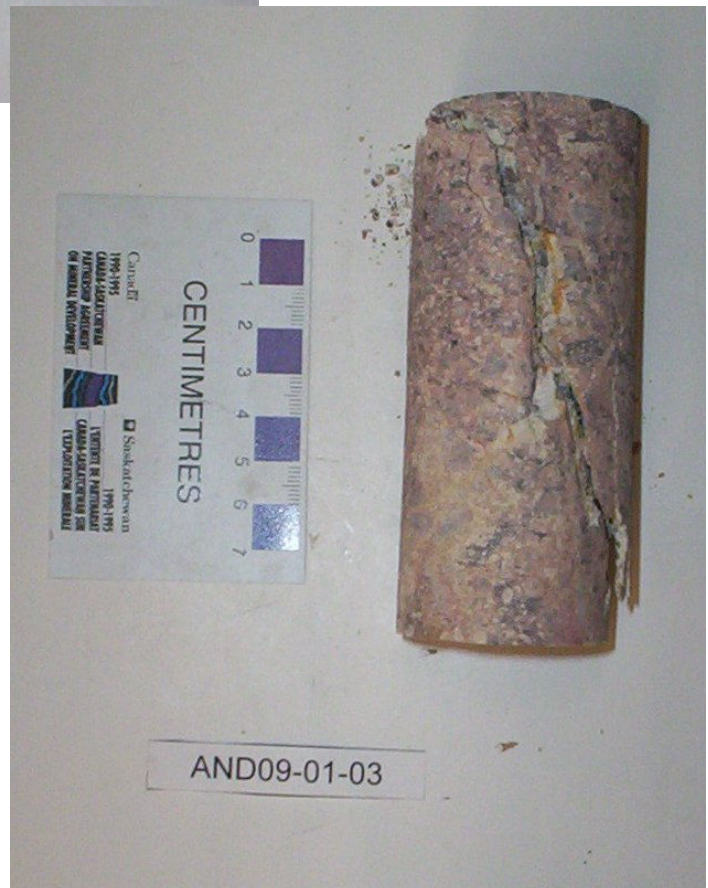
SAMPLE: AND09-01-03

Length: 110.13 mm
Diameter: 45.16 mm
Density: 2.445 g/cm³
Peak Strength: 24.7 MPa
Young's Modulus: 6.1 GPa
Poisson's Ratio: 0.24
Failure Cause: Intact Rock

AND09-01-03 Stress vs. Strain

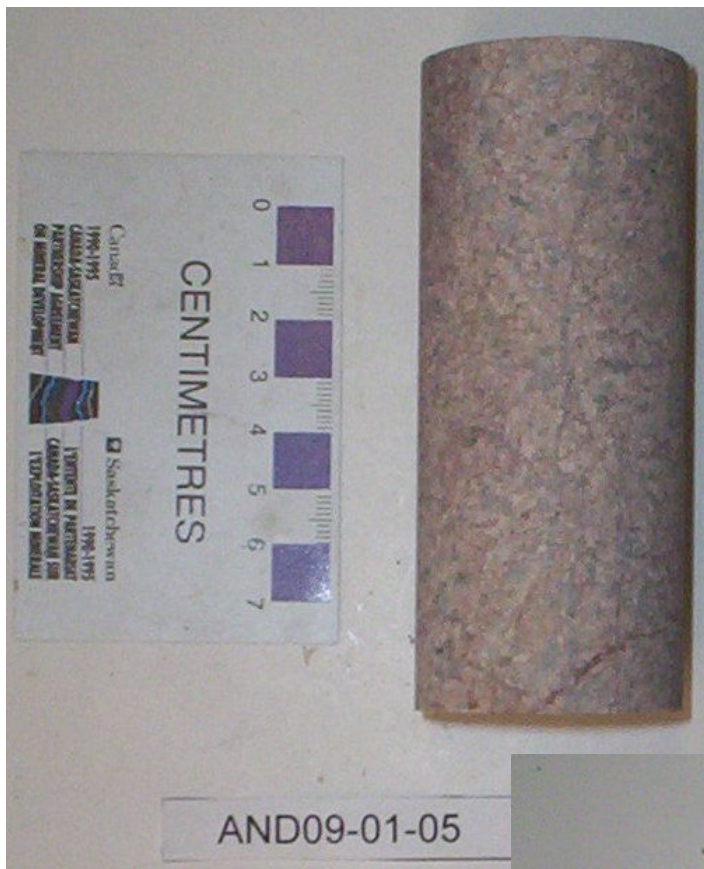
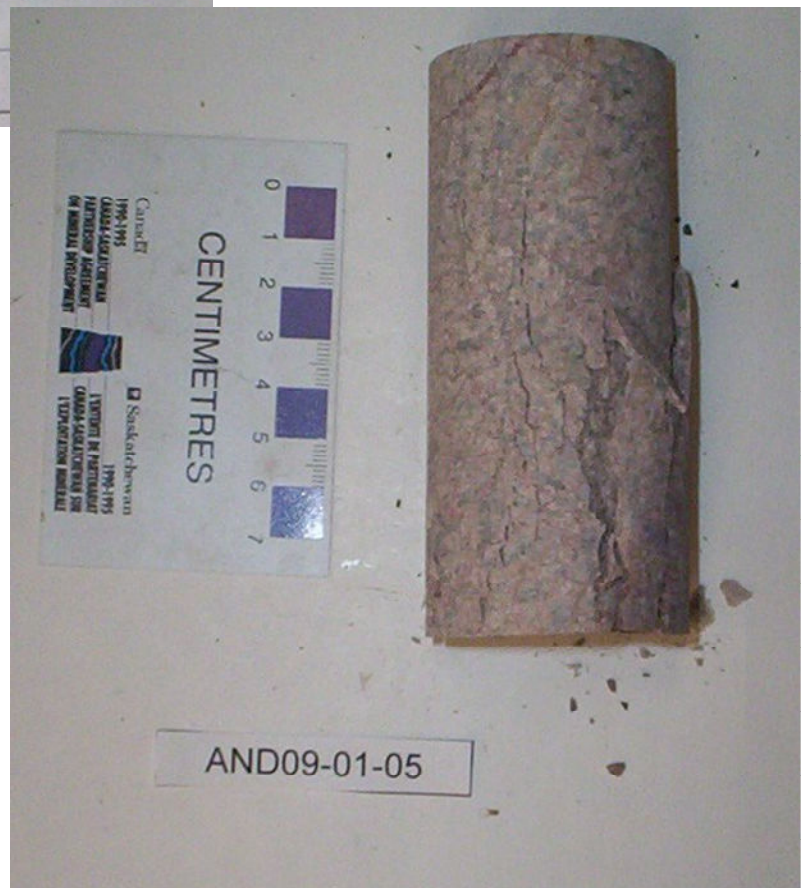
SAMPLE: AND09-01-05

Length: 108.42 mm
Diameter: 45.41 mm
Density: 2.461 g/cm³
Peak Strength: 52.0 MPa
Young's Modulus: 20.6 GPa
Poisson's Ratio: 0.16
Failure Cause: Intact Rock

AND09-01-05 Stress vs. Strain

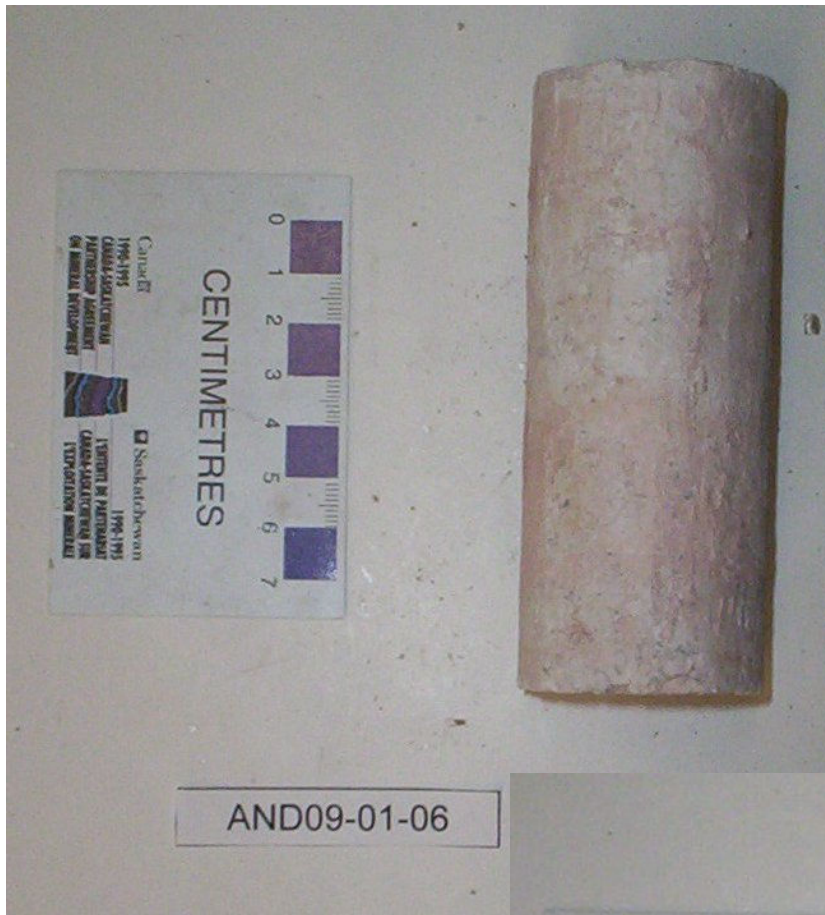
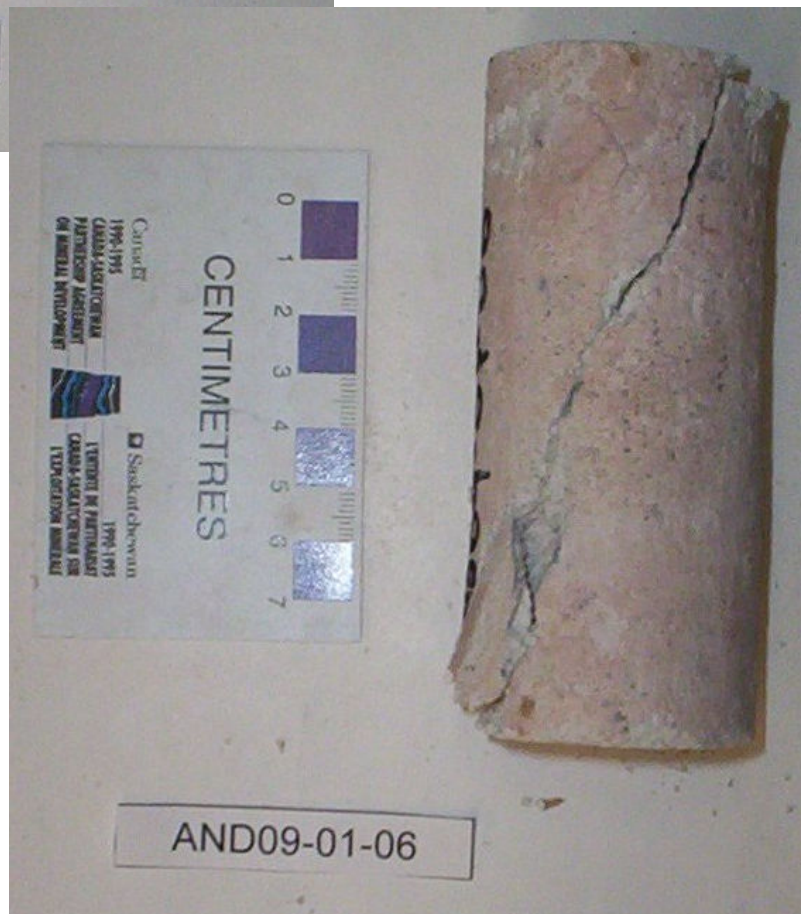
SAMPLE: AND09-01-06

Length: 112.65 mm
Diameter: 45.26 mm
Density: 1.970 g/cm³
Peak Strength: 4.9 MPa
Young's Modulus: 0.4 GPa
Poisson's Ratio: 0.06
Failure Cause: Intact Rock

Stress vs. Strain

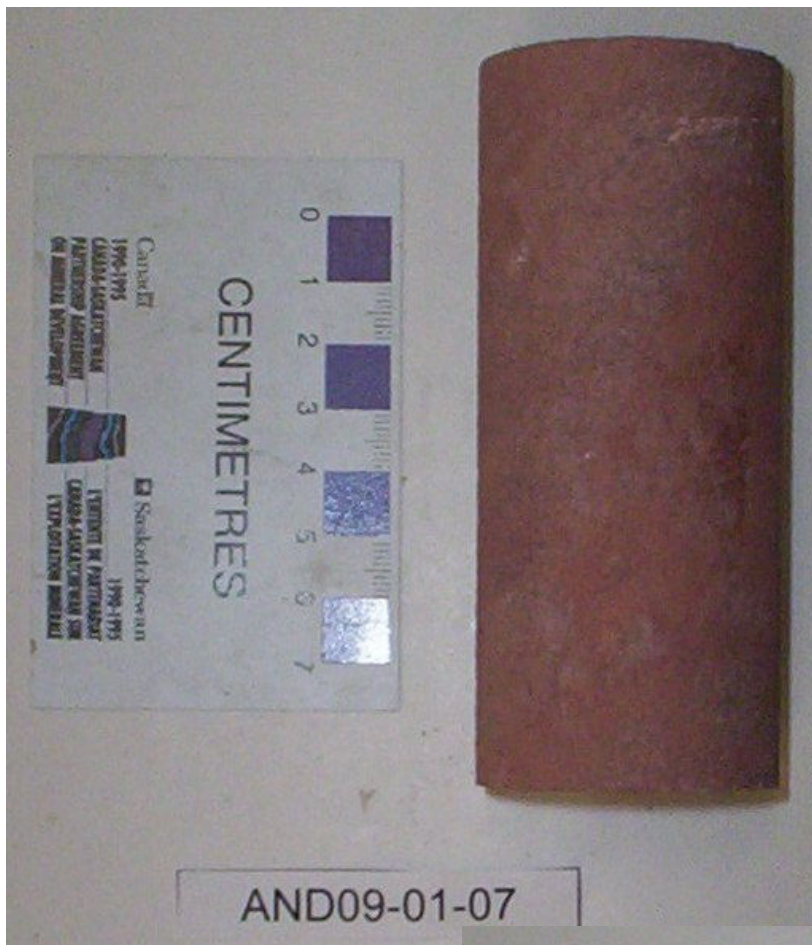
SAMPLE: AND09-01-07

Length: 106.72 mm
Diameter: 45.14 mm
Density: 2.087 g/cm³
Peak Strength: 9.8 MPa
Young's Modulus: 2.4 GPa
Poisson's Ratio: 0.04
Failure Cause: Weakness Plane

AND09-01-07 Stress vs. Strain

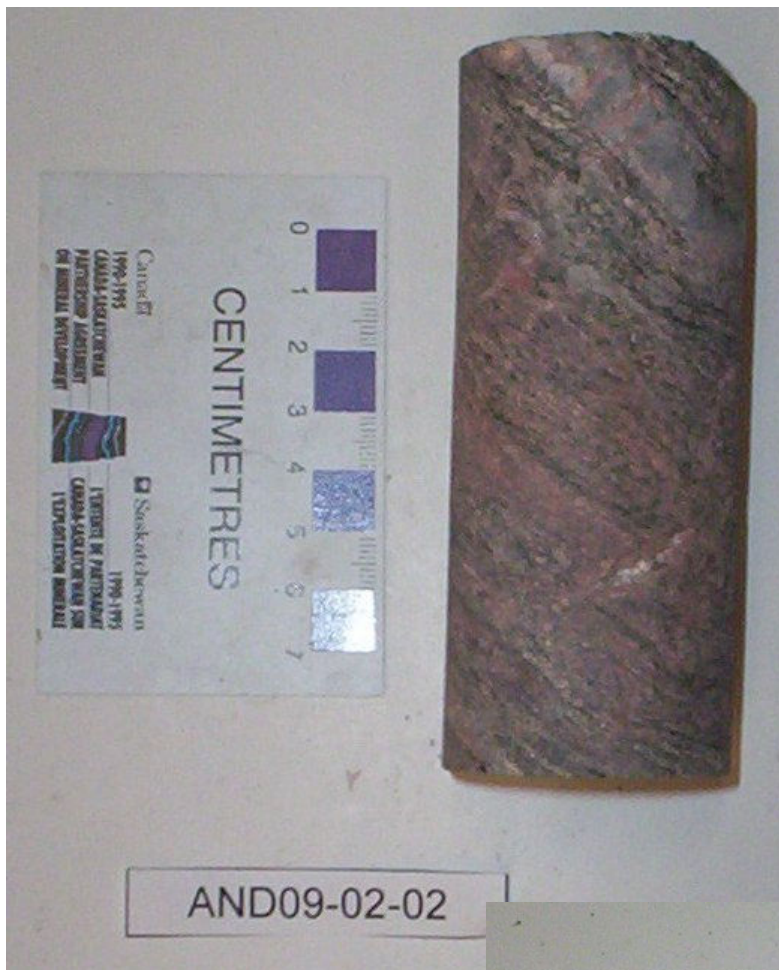
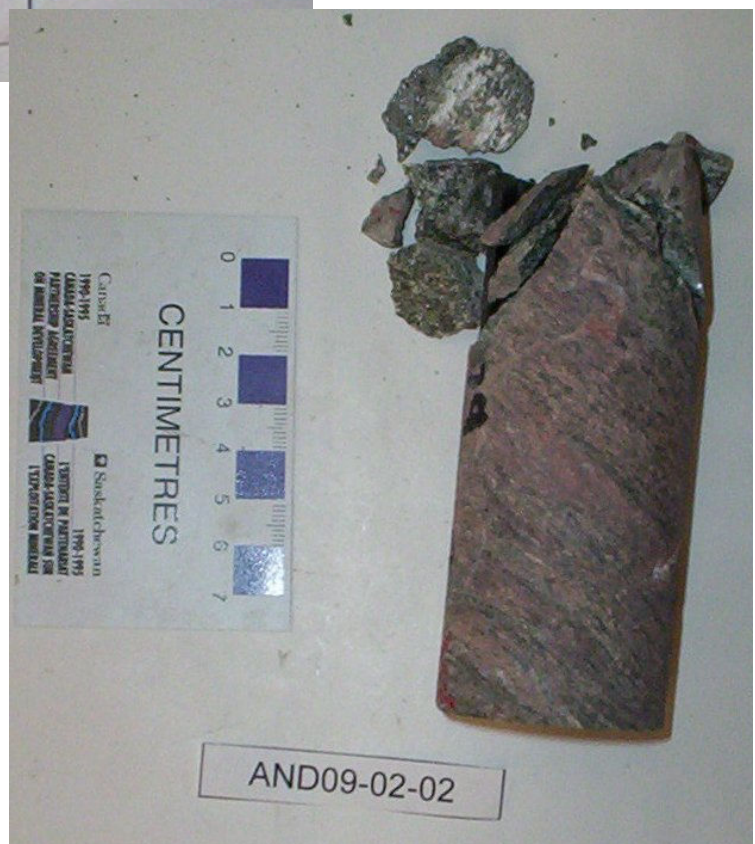
SAMPLE: AND09-02-02

Length: 111.62 mm
Diameter: 45.34 mm
Density: 2.509 g/cm³
Peak Strength: 16.1 MPa
Young's Modulus: 4.5 GPa
Poisson's Ratio: 0.03
Failure Cause: Foliation

AND09-02-02 Stress vs. Strain

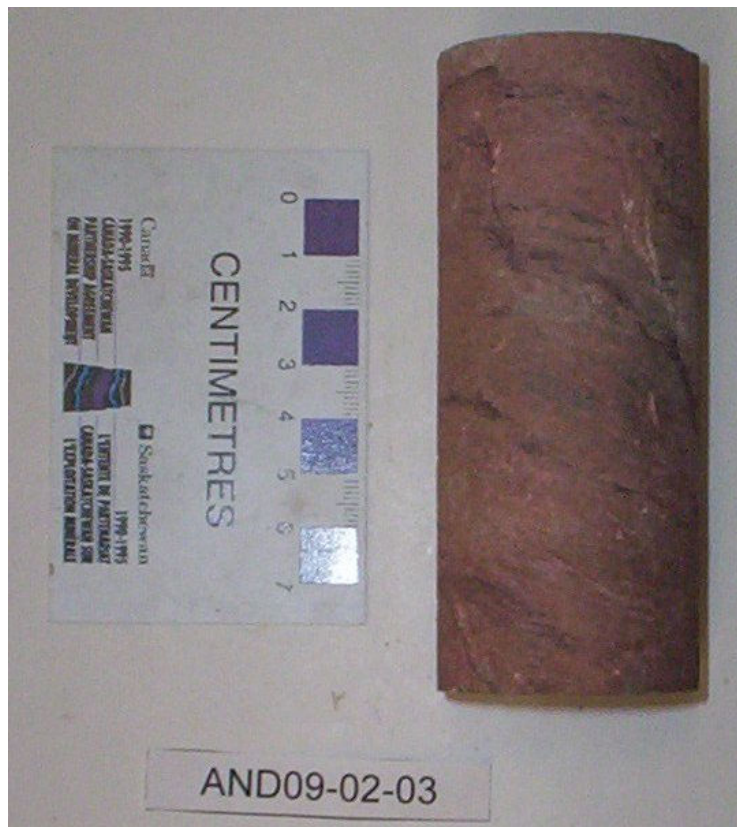
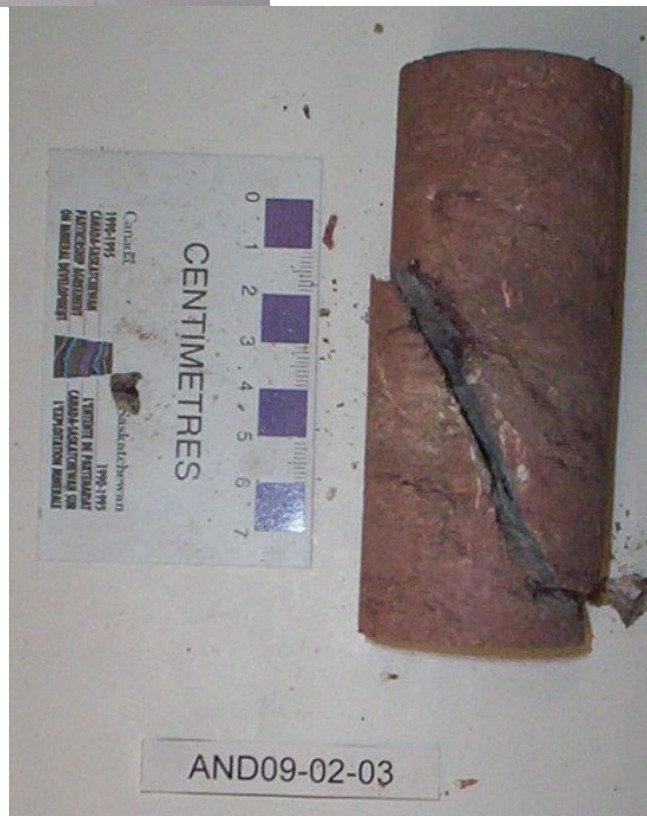
SAMPLE: AND09-02-03

Length: 109.02 mm
Diameter: 45.2 mm
Density: 2.036 g/cm³
Peak Strength: 22.4 MPa
Young's Modulus: 5.7 GPa
Poisson's Ratio: 0.16
Failure Cause: Weakness Plane

AND09-02-03 Stress vs. Strain

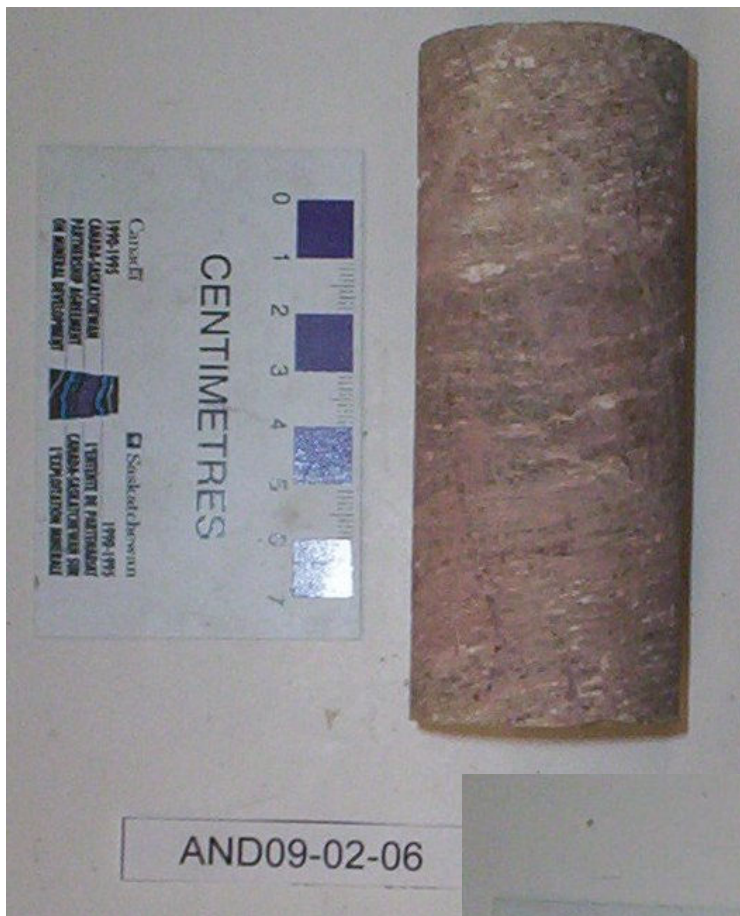
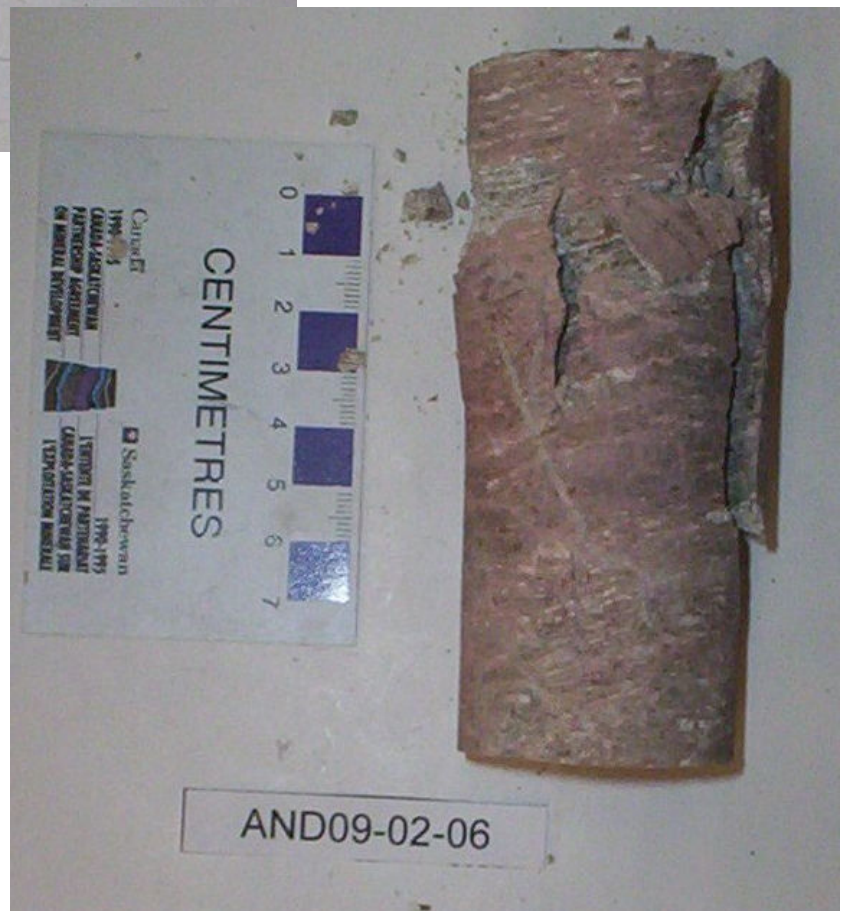
SAMPLE: AND09-02-06

Length: 111.83 mm
Diameter: 45.39 mm
Density: 2.328 g/cm³
Peak Strength: 26.6 MPa
Young's Modulus: 7.3 GPa
Poisson's Ratio: 0.08
Failure Cause: Intact Rock

AND09-02-06 Stress vs. Strain

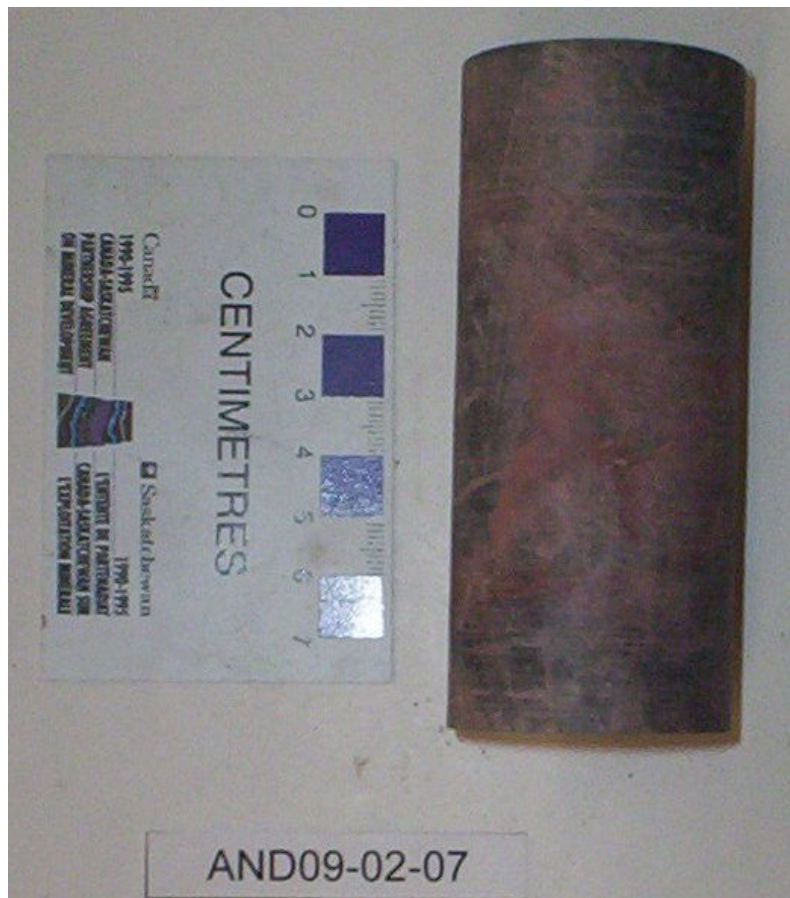
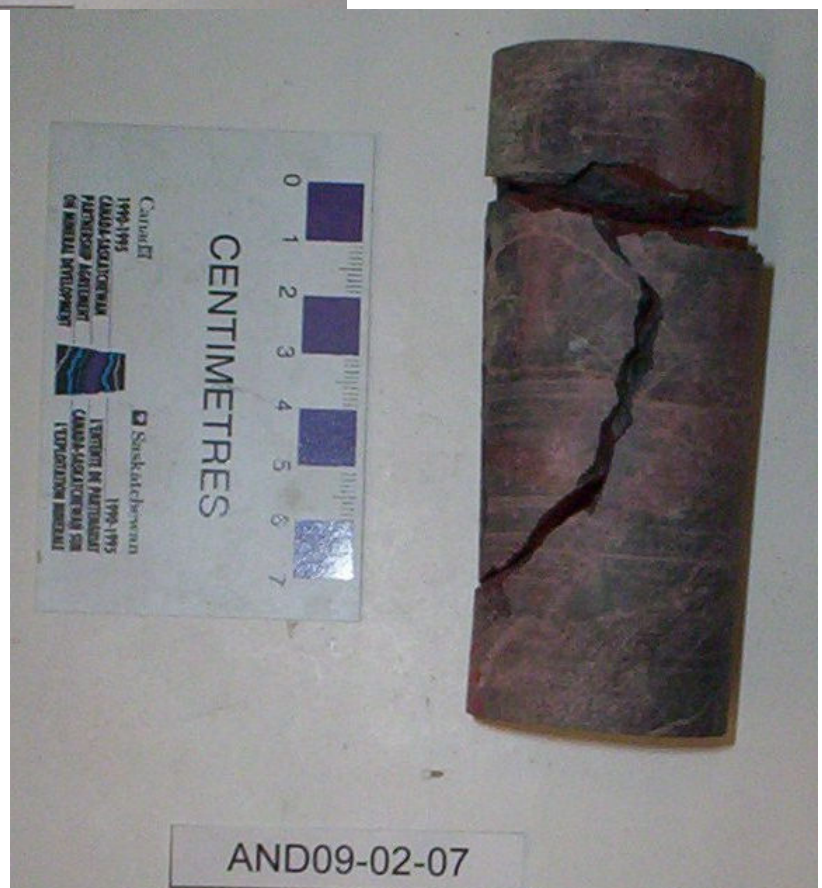
SAMPLE: AND09-02-07

Length: 103.18 mm
Diameter: 44.32 mm
Density: 2.494 g/cm³
Peak Strength: 11.8 MPa
Young's Modulus: 5.1 GPa
Poisson's Ratio: 0.04
Failure Cause: Microfracture?

AND09-02-07 Stress vs. Strain

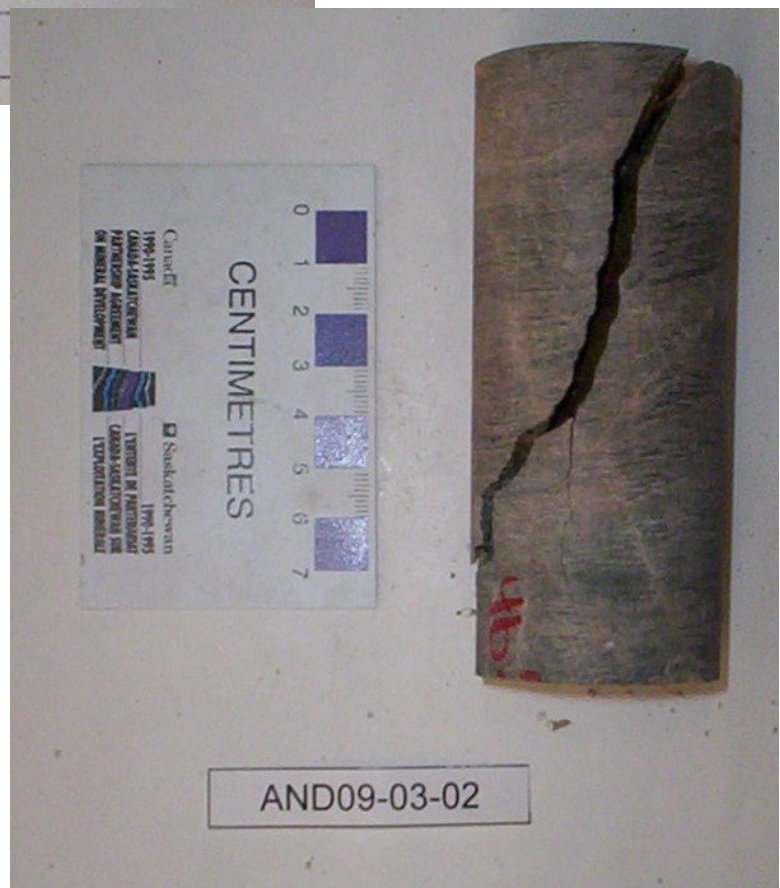
SAMPLE: AND09-03-02

Length: 112.13 mm
Diameter: 45.16 mm
Density: 2.614 g/cm³
Peak Strength: 24.3 MPa
Young's Modulus: 12.9 GPa
Poisson's Ratio: 0.12
Failure Cause: Weakness Plane?

AND09-03-02 Stress vs. Strain
