Kiggavik Project

Final Environmental Impact Statement

Tier 3 Volume 2V: Mine Geotechnical
Reports

Geotechnical Recommendations for the Proposed Andrew Lake Open Pit - Support Document For Permit Application

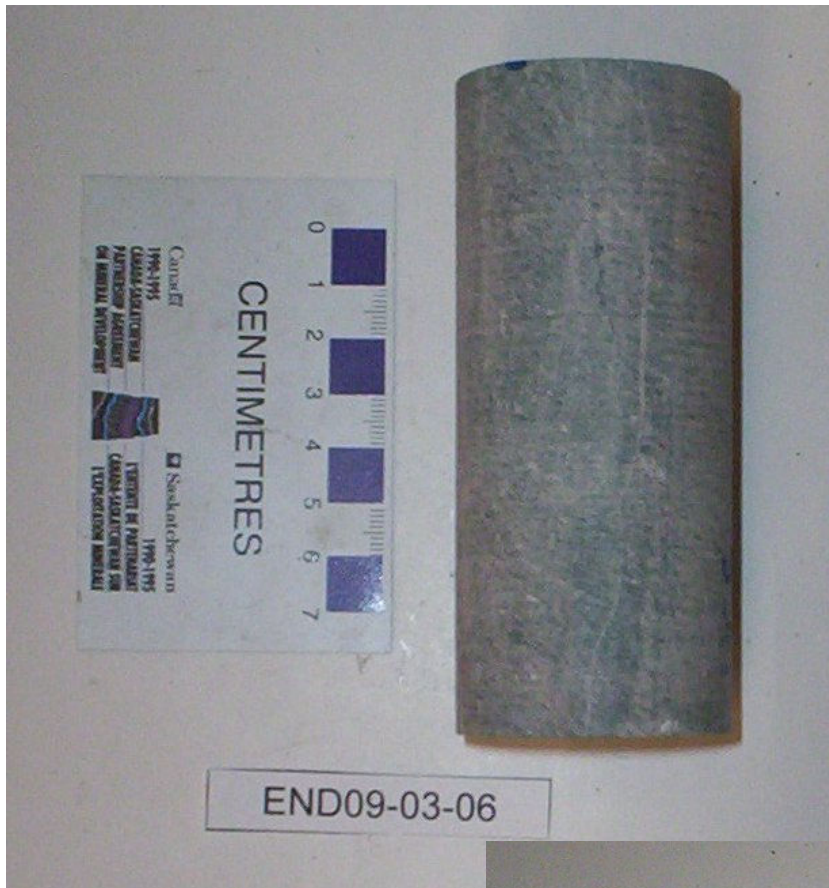
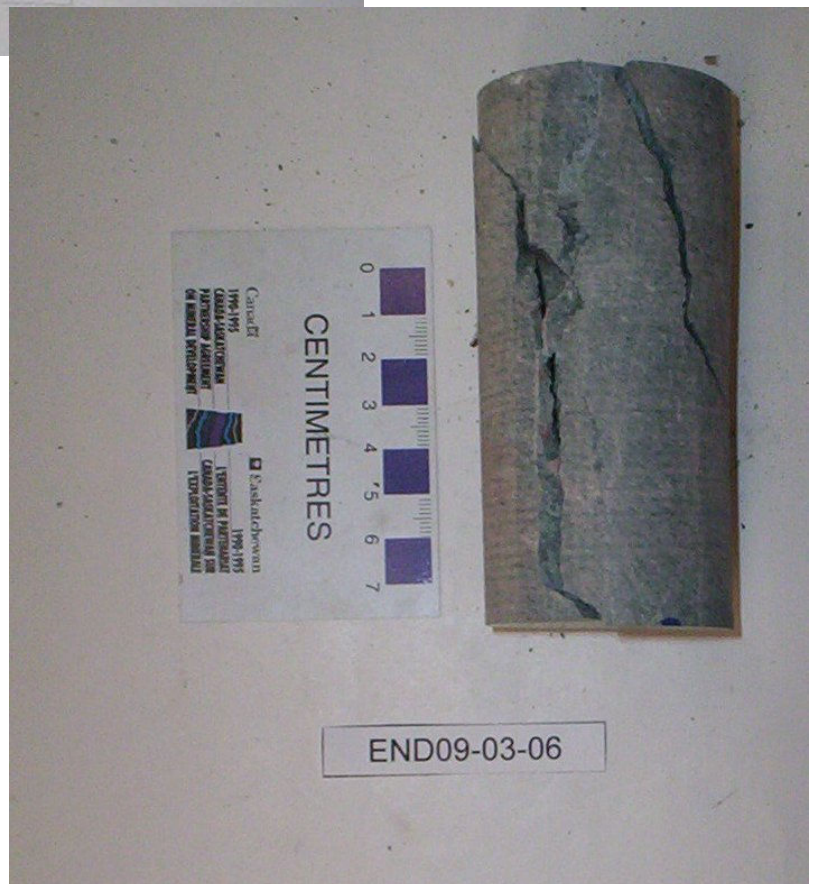
SAMPLE: END09-03-06

Length: 111.12 mm
Diameter: 47.77mm
Density: 2.415 g/cm³
Peak Strength: 36.8 MPa
Young's Modulus: 9.5 GPa
Poisson's Ratio: 0.09
Failure Cause: Weakness Plane

END09-03-06 Stress vs. Strain

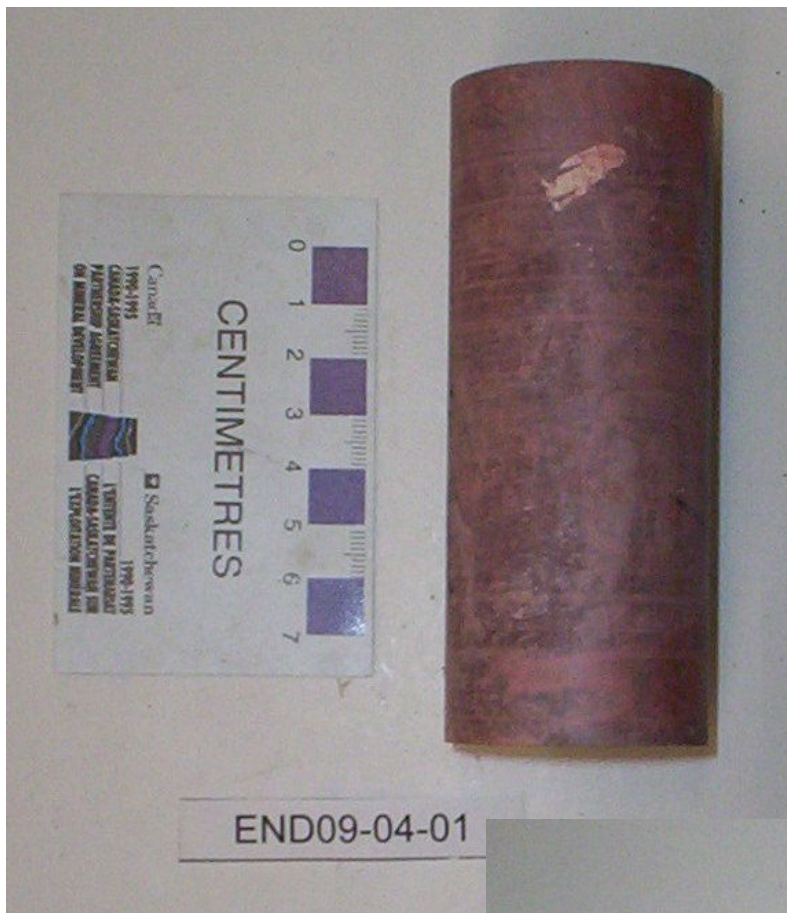
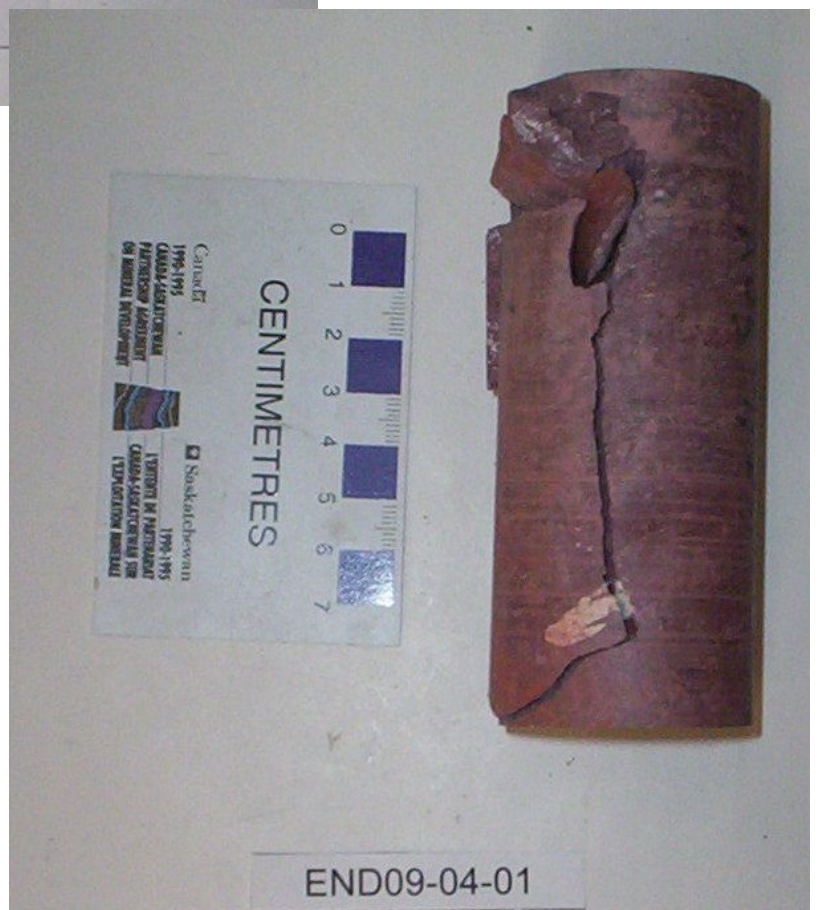
SAMPLE: END09-04-01

Length: 111.75mm
Diameter: 45.25mm
Density: 2.112g/cm³
Peak Strength: 32.1 MPa
Young's Modulus: 3.3 GPa
Poisson's Ratio: 0.09
Failure Cause: Intact Rock

END09-04-01 Stress vs. Strain

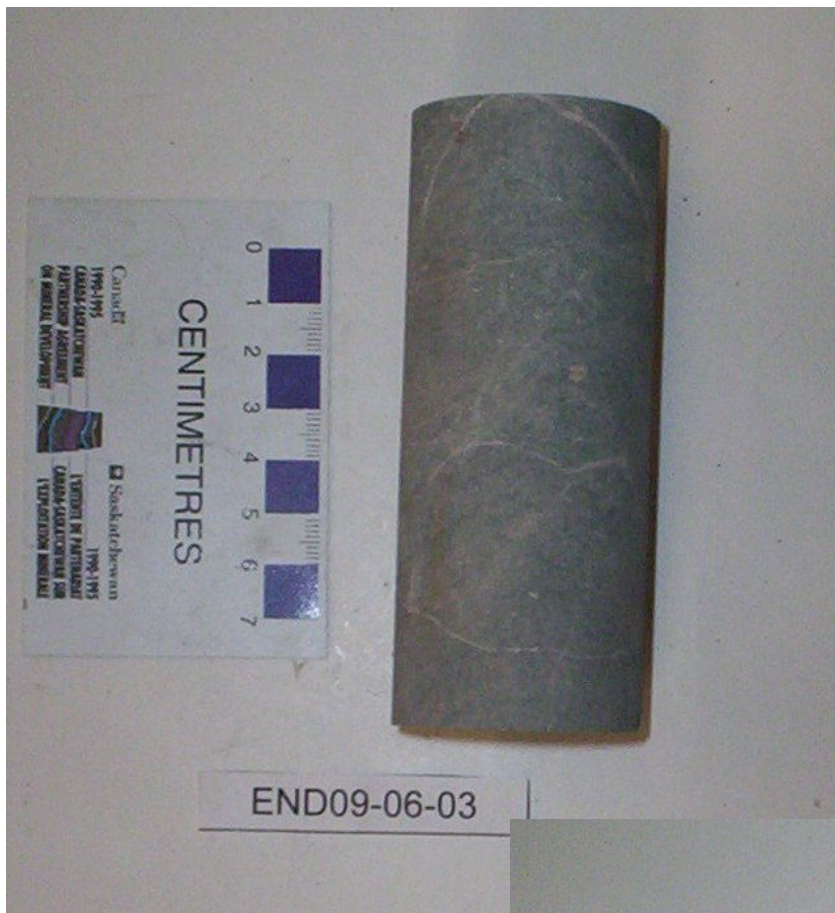
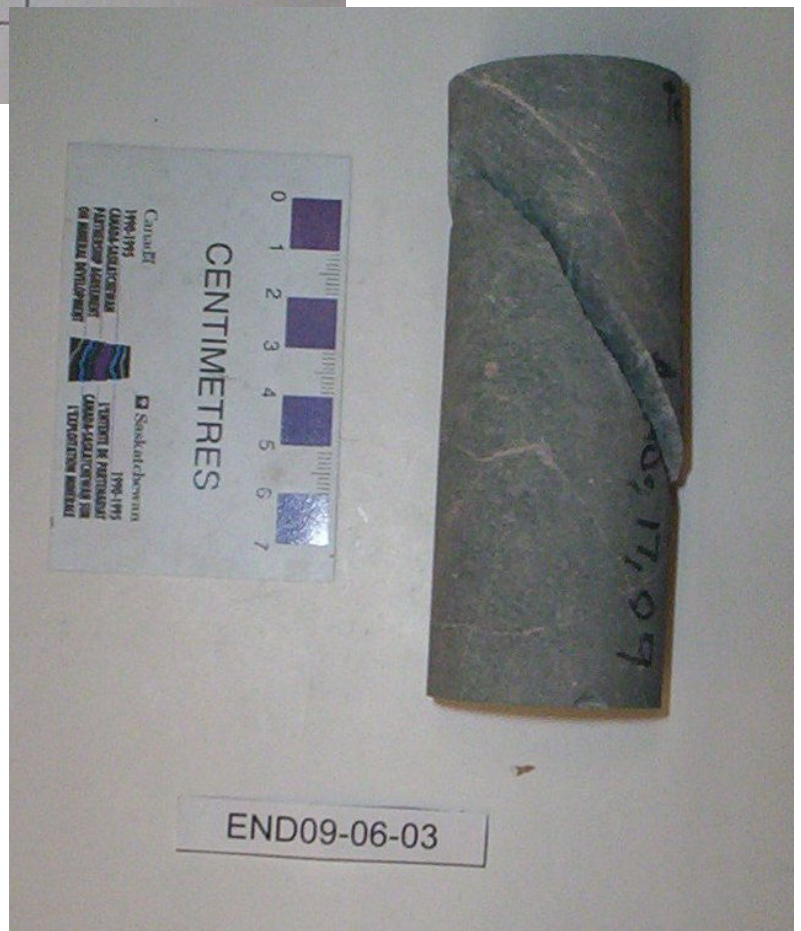
SAMPLE: END09-06-03

Length: 109.25mm
Diameter: 45.12 mm
Density: 2.444 g/cm³
Peak Strength: 16.2 MPa
Young's Modulus: 9.1 GPa
Poisson's Ratio: 0.06
Failure Cause: Weakness Plane

END09-06-03 Stress vs. Strain

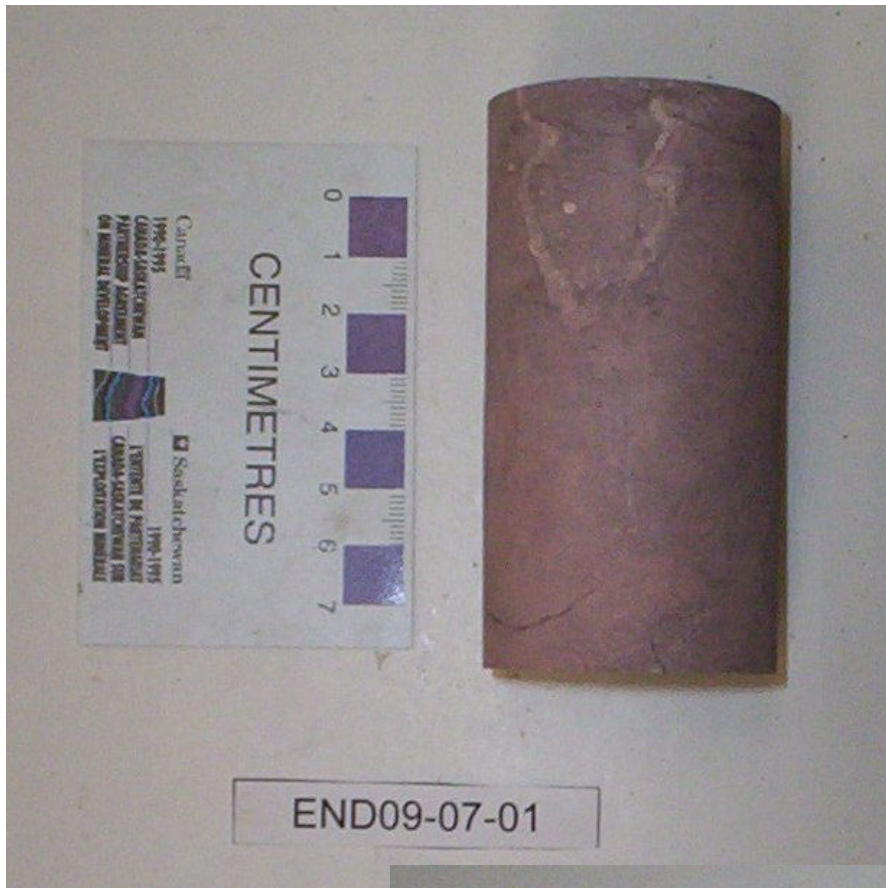
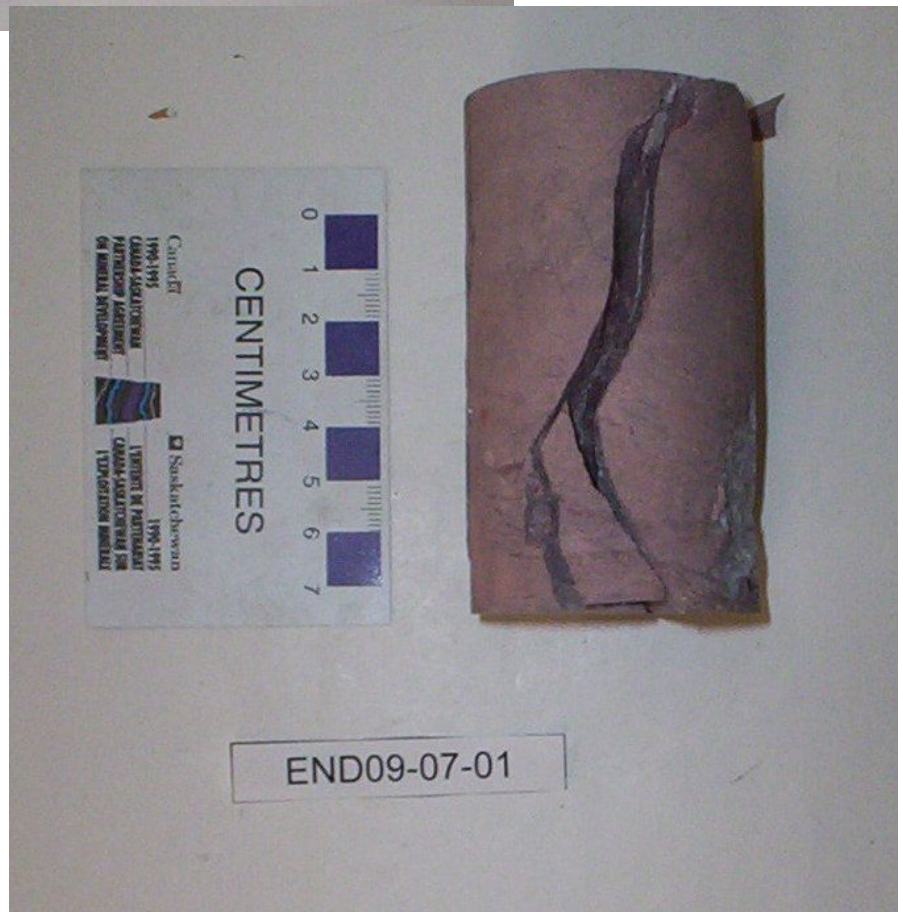
SAMPLE: END09-07-01

Length: 91.01 mm
Diameter: 47.60 mm
Density: 2.168 g/cm³
Peak Strength: 26.7 MPa
Young's Modulus: 6.6 GPa
Poisson's Ratio: 0.30
Failure Cause: Intact Rock

END09-07-01 Stress vs. Strain
