MANDALAY RESOURCES CORPORATION

LUPIN MINE CLOSURE – HUMAN HEALTH AND ECOLOGICAL RISK ASSESSMENT

MINE AND MILL SITE AREA – WATERSHEDS

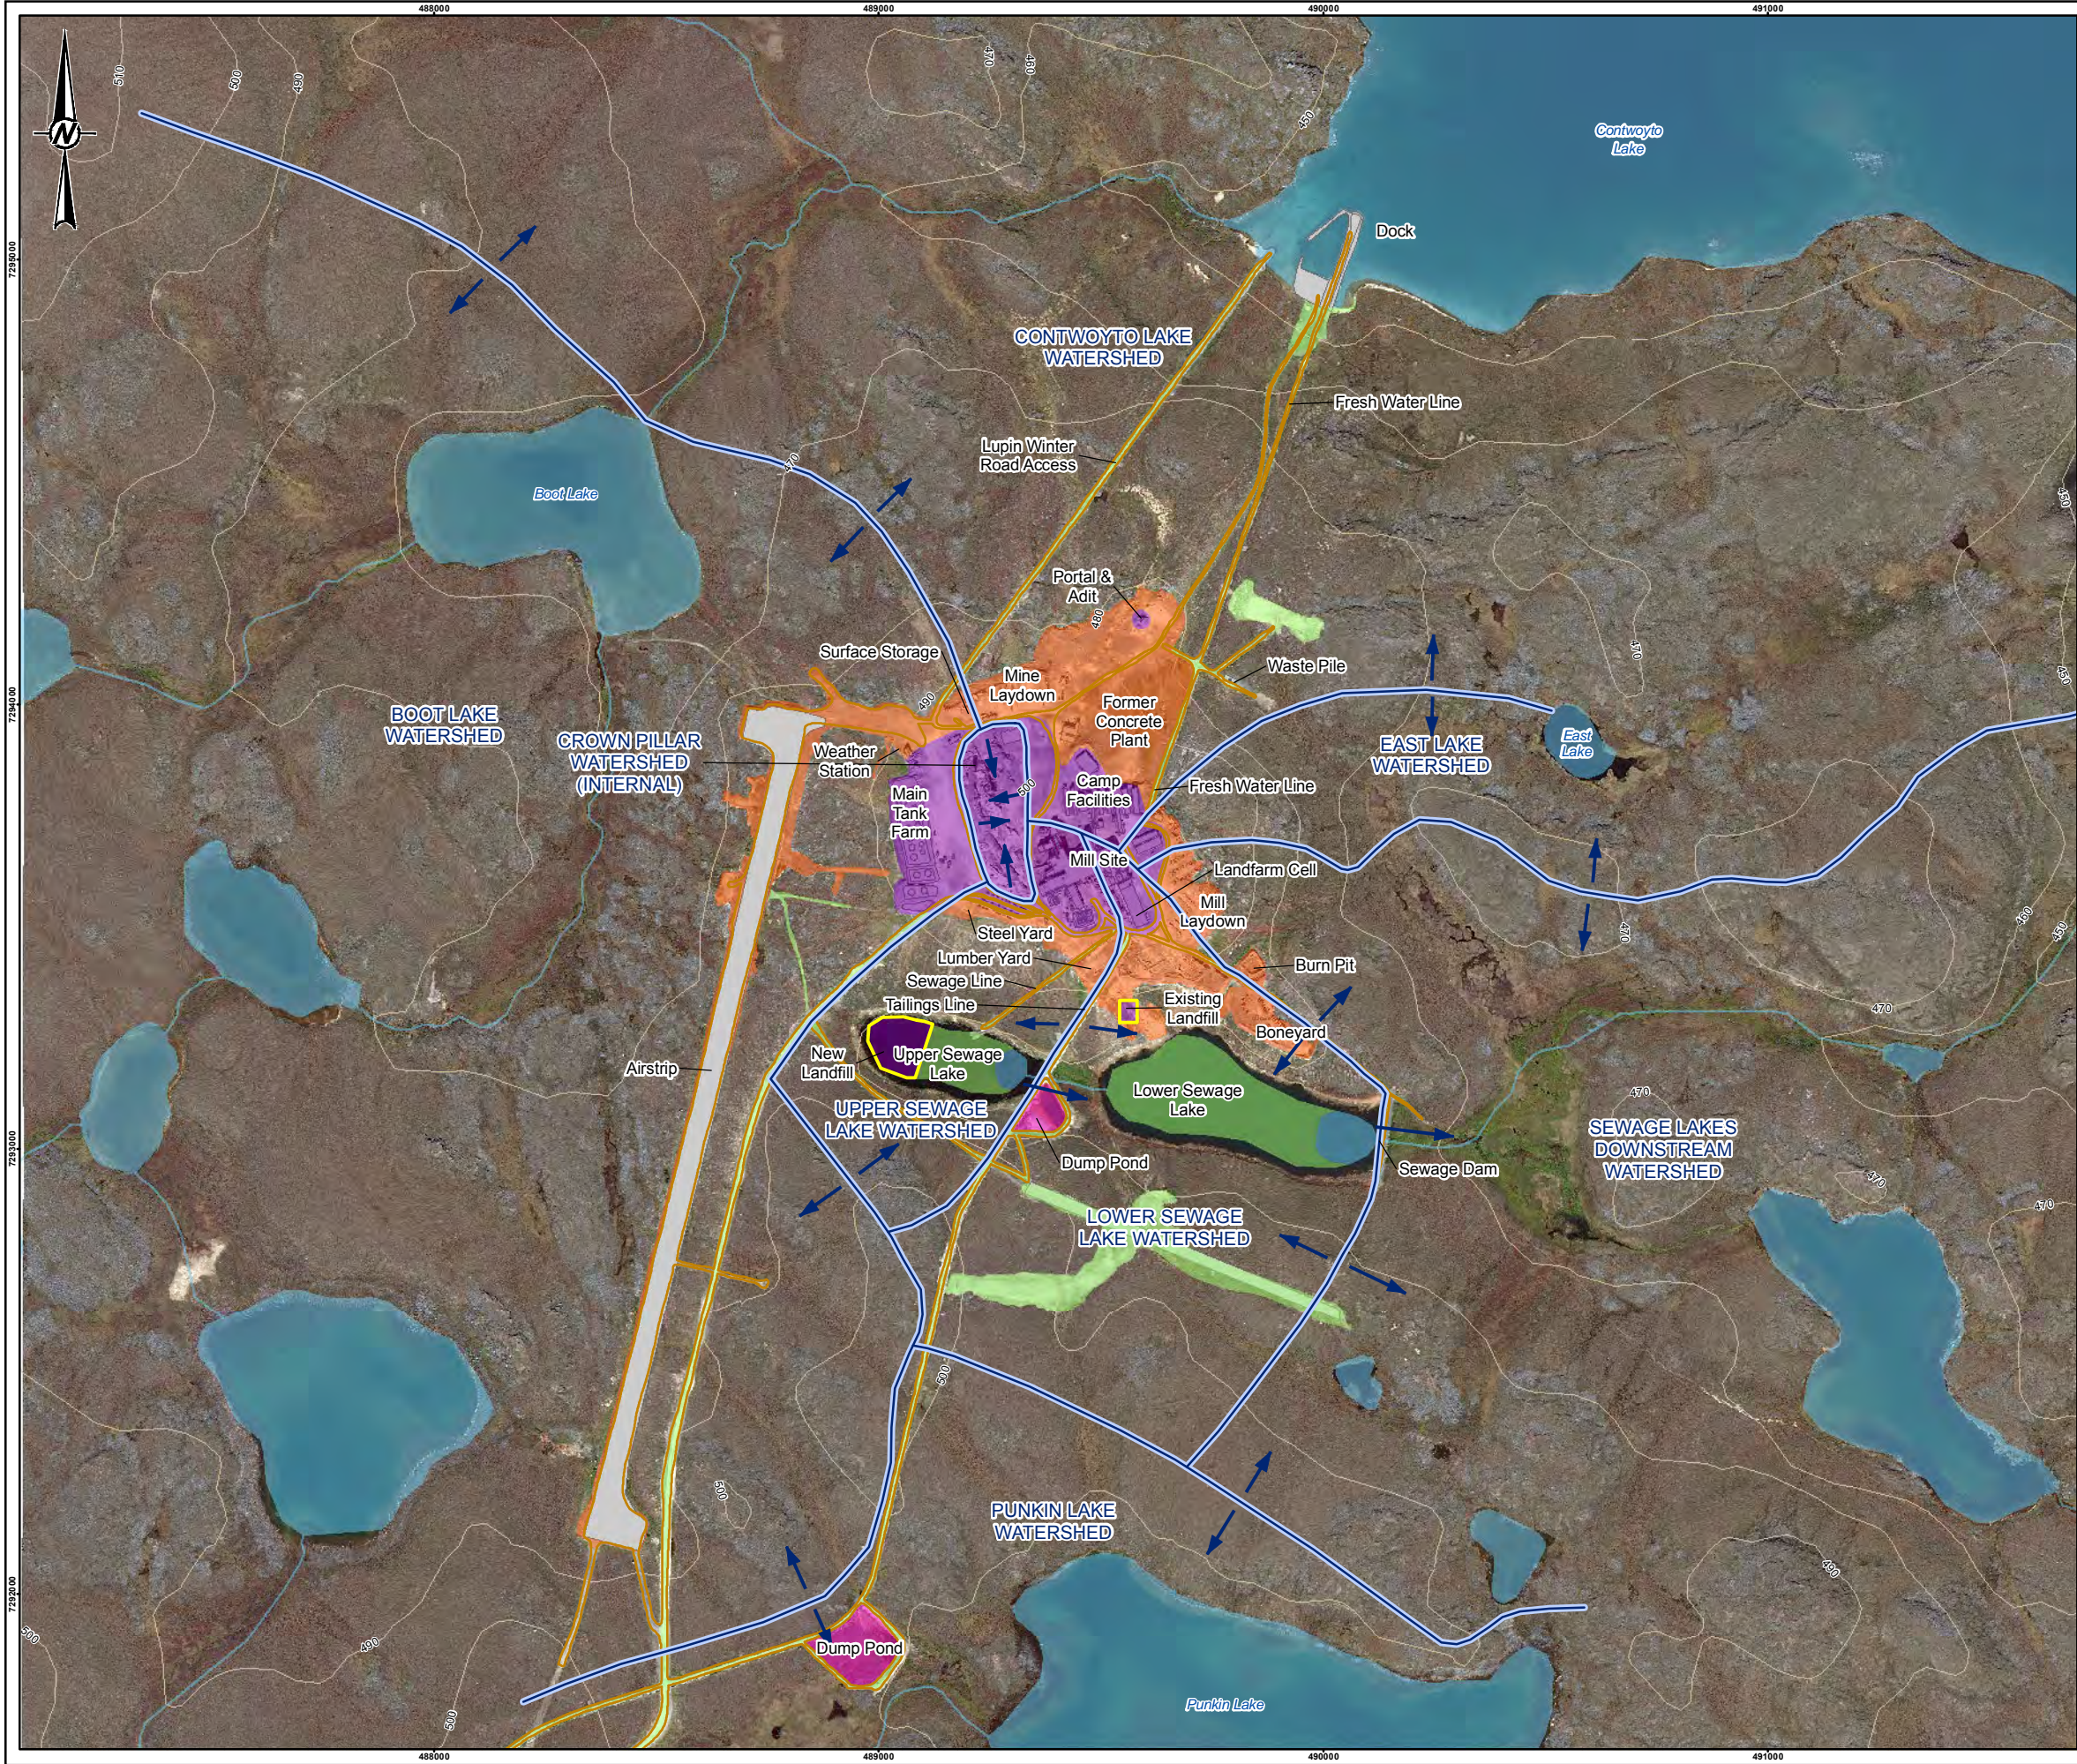
PROJECT NO.	CONTROL	REV.	FIGURE
19120487	5000	0	5

1. AFTER BLASTING, THE CROWN PILLAR WATERSHED WILL DRAIN INTERNALLY INTO THE UNDERGROUND MINE WORKING.

2. SPILLWAYS WILL BE EXCAVATED THROUGH THE SEWAGE LAKE DAMS AT CLOSURE LEAVING THEM FREE DRAINING.

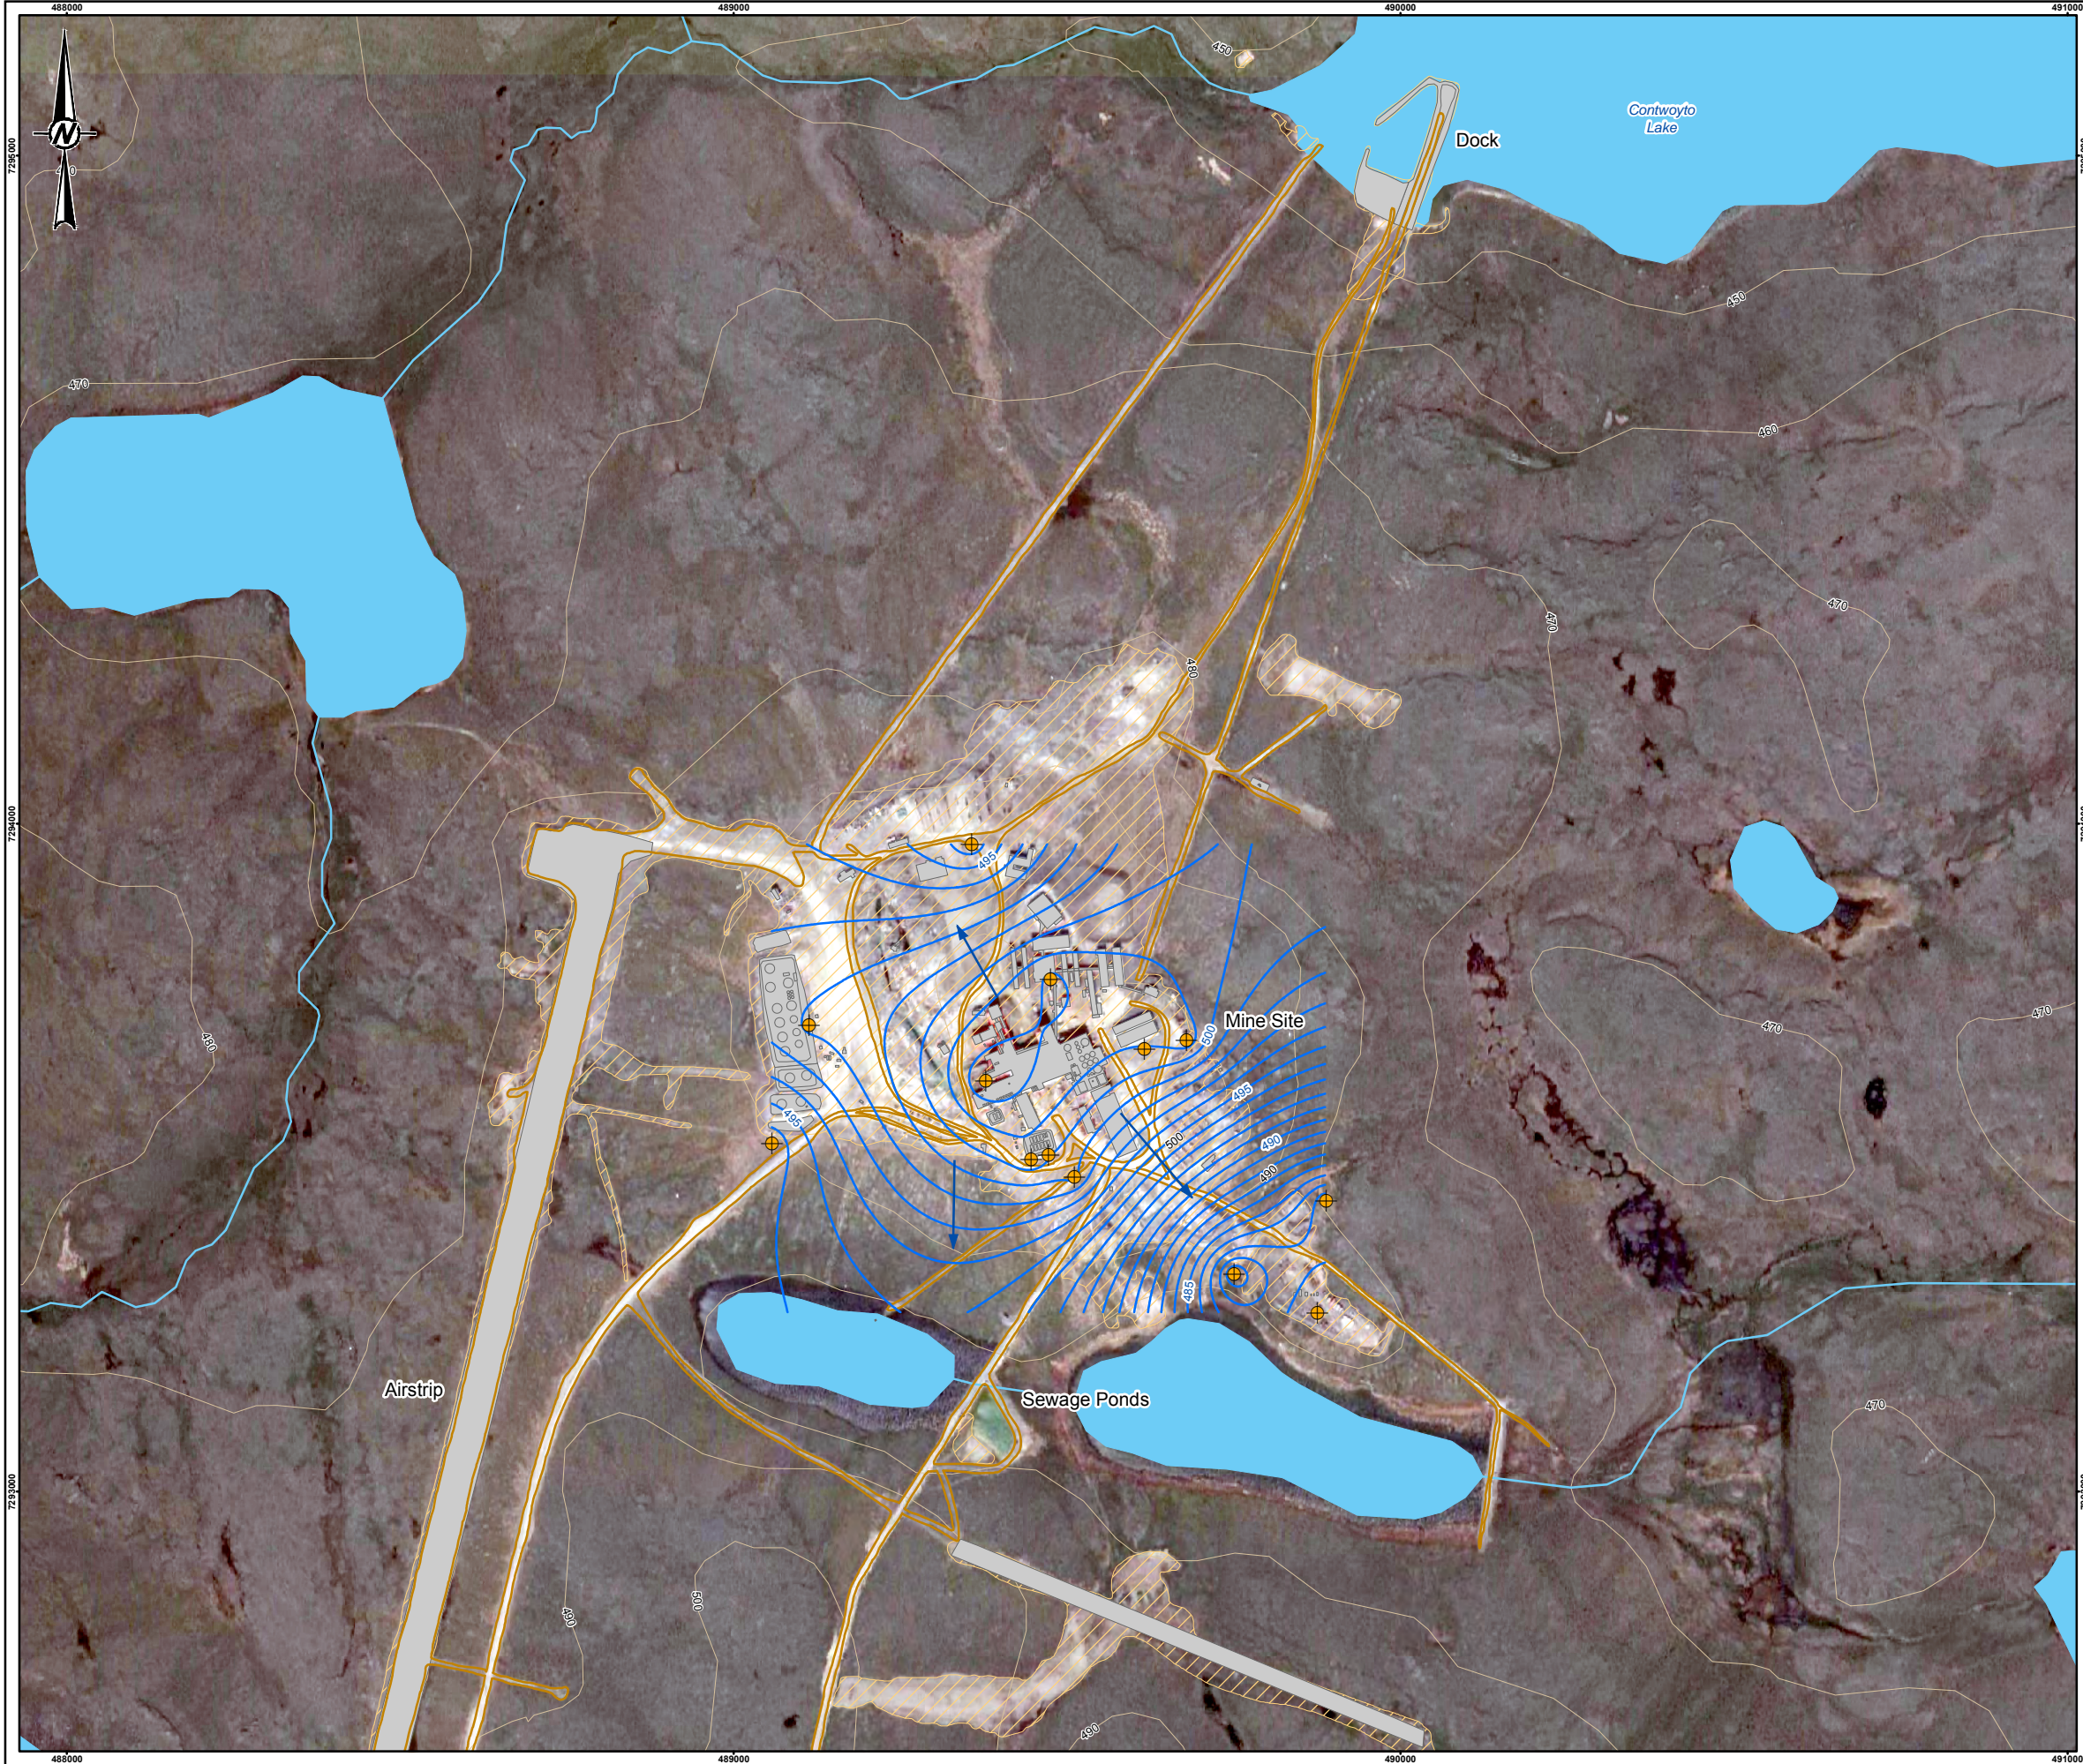
PROJECT NO.	CONTROL	REV.	FIGURE
19120487	5000	0	6

TITLE
GROUNDWATER FLOW DIRECTION

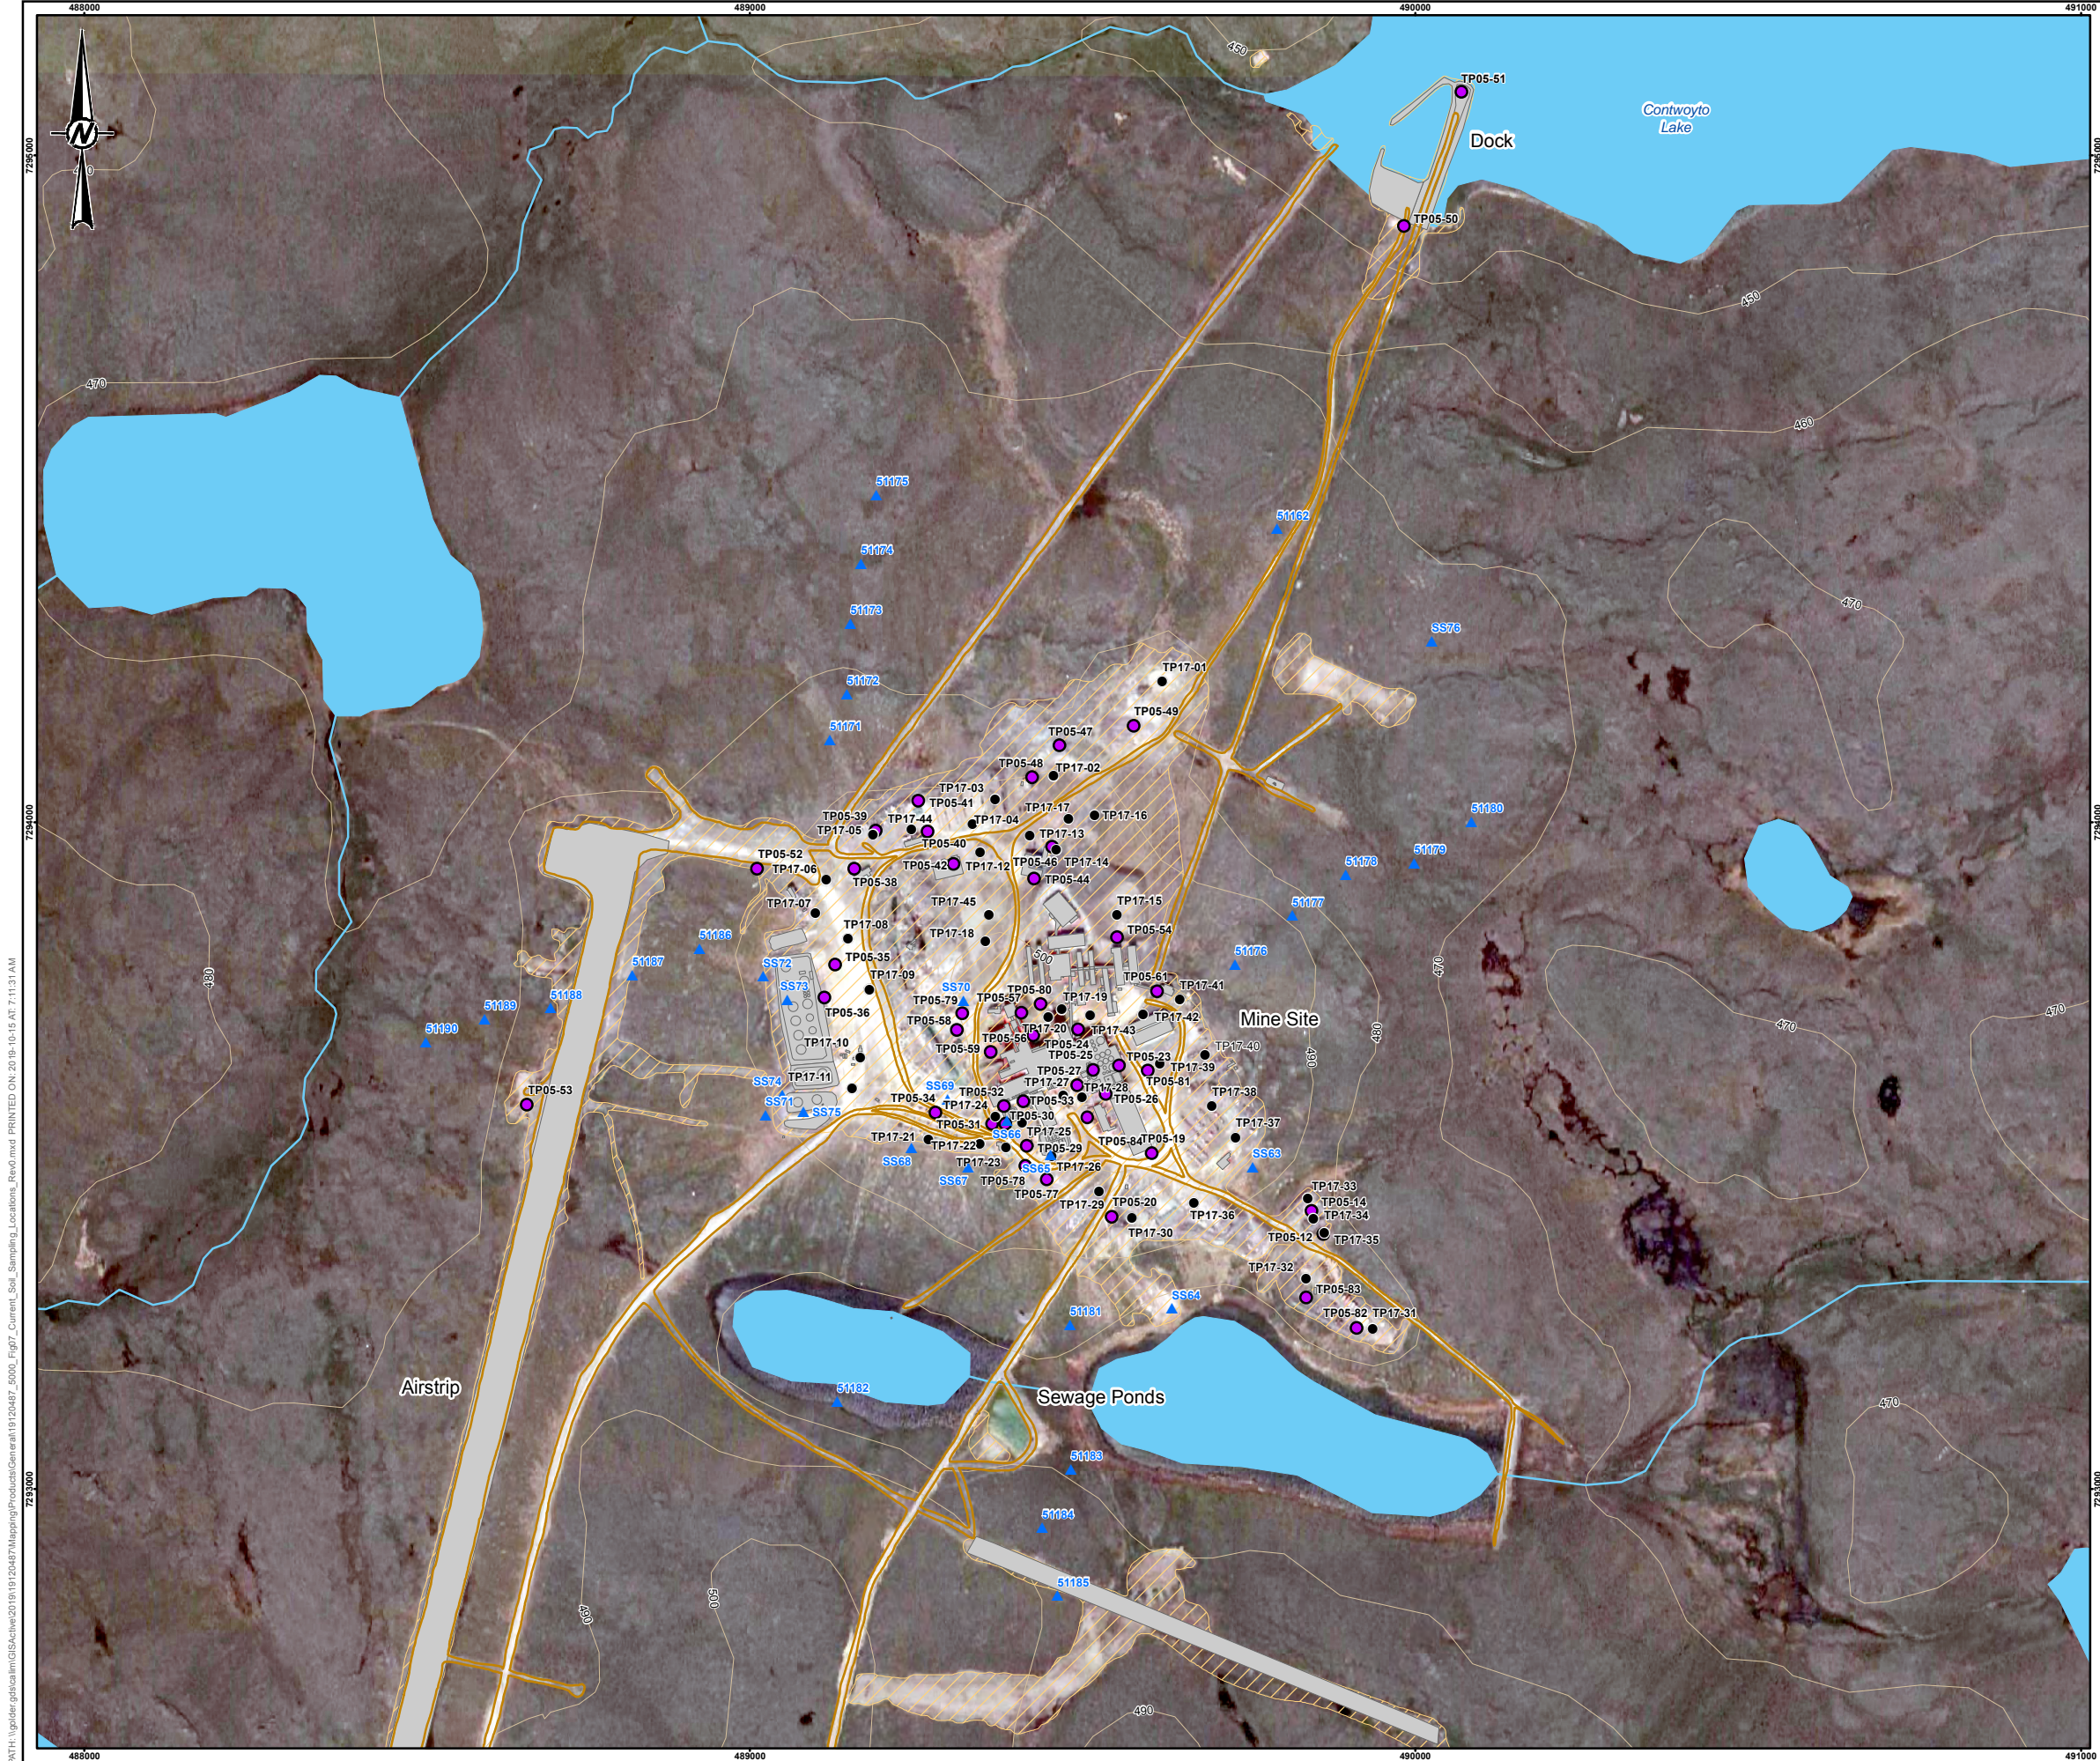
PROJECT NO.	CONTROL	REV.	FIGURE
19120487	5000	0	7

CURRENT AND HISTORICAL SOIL SAMPLE LOCATIONS

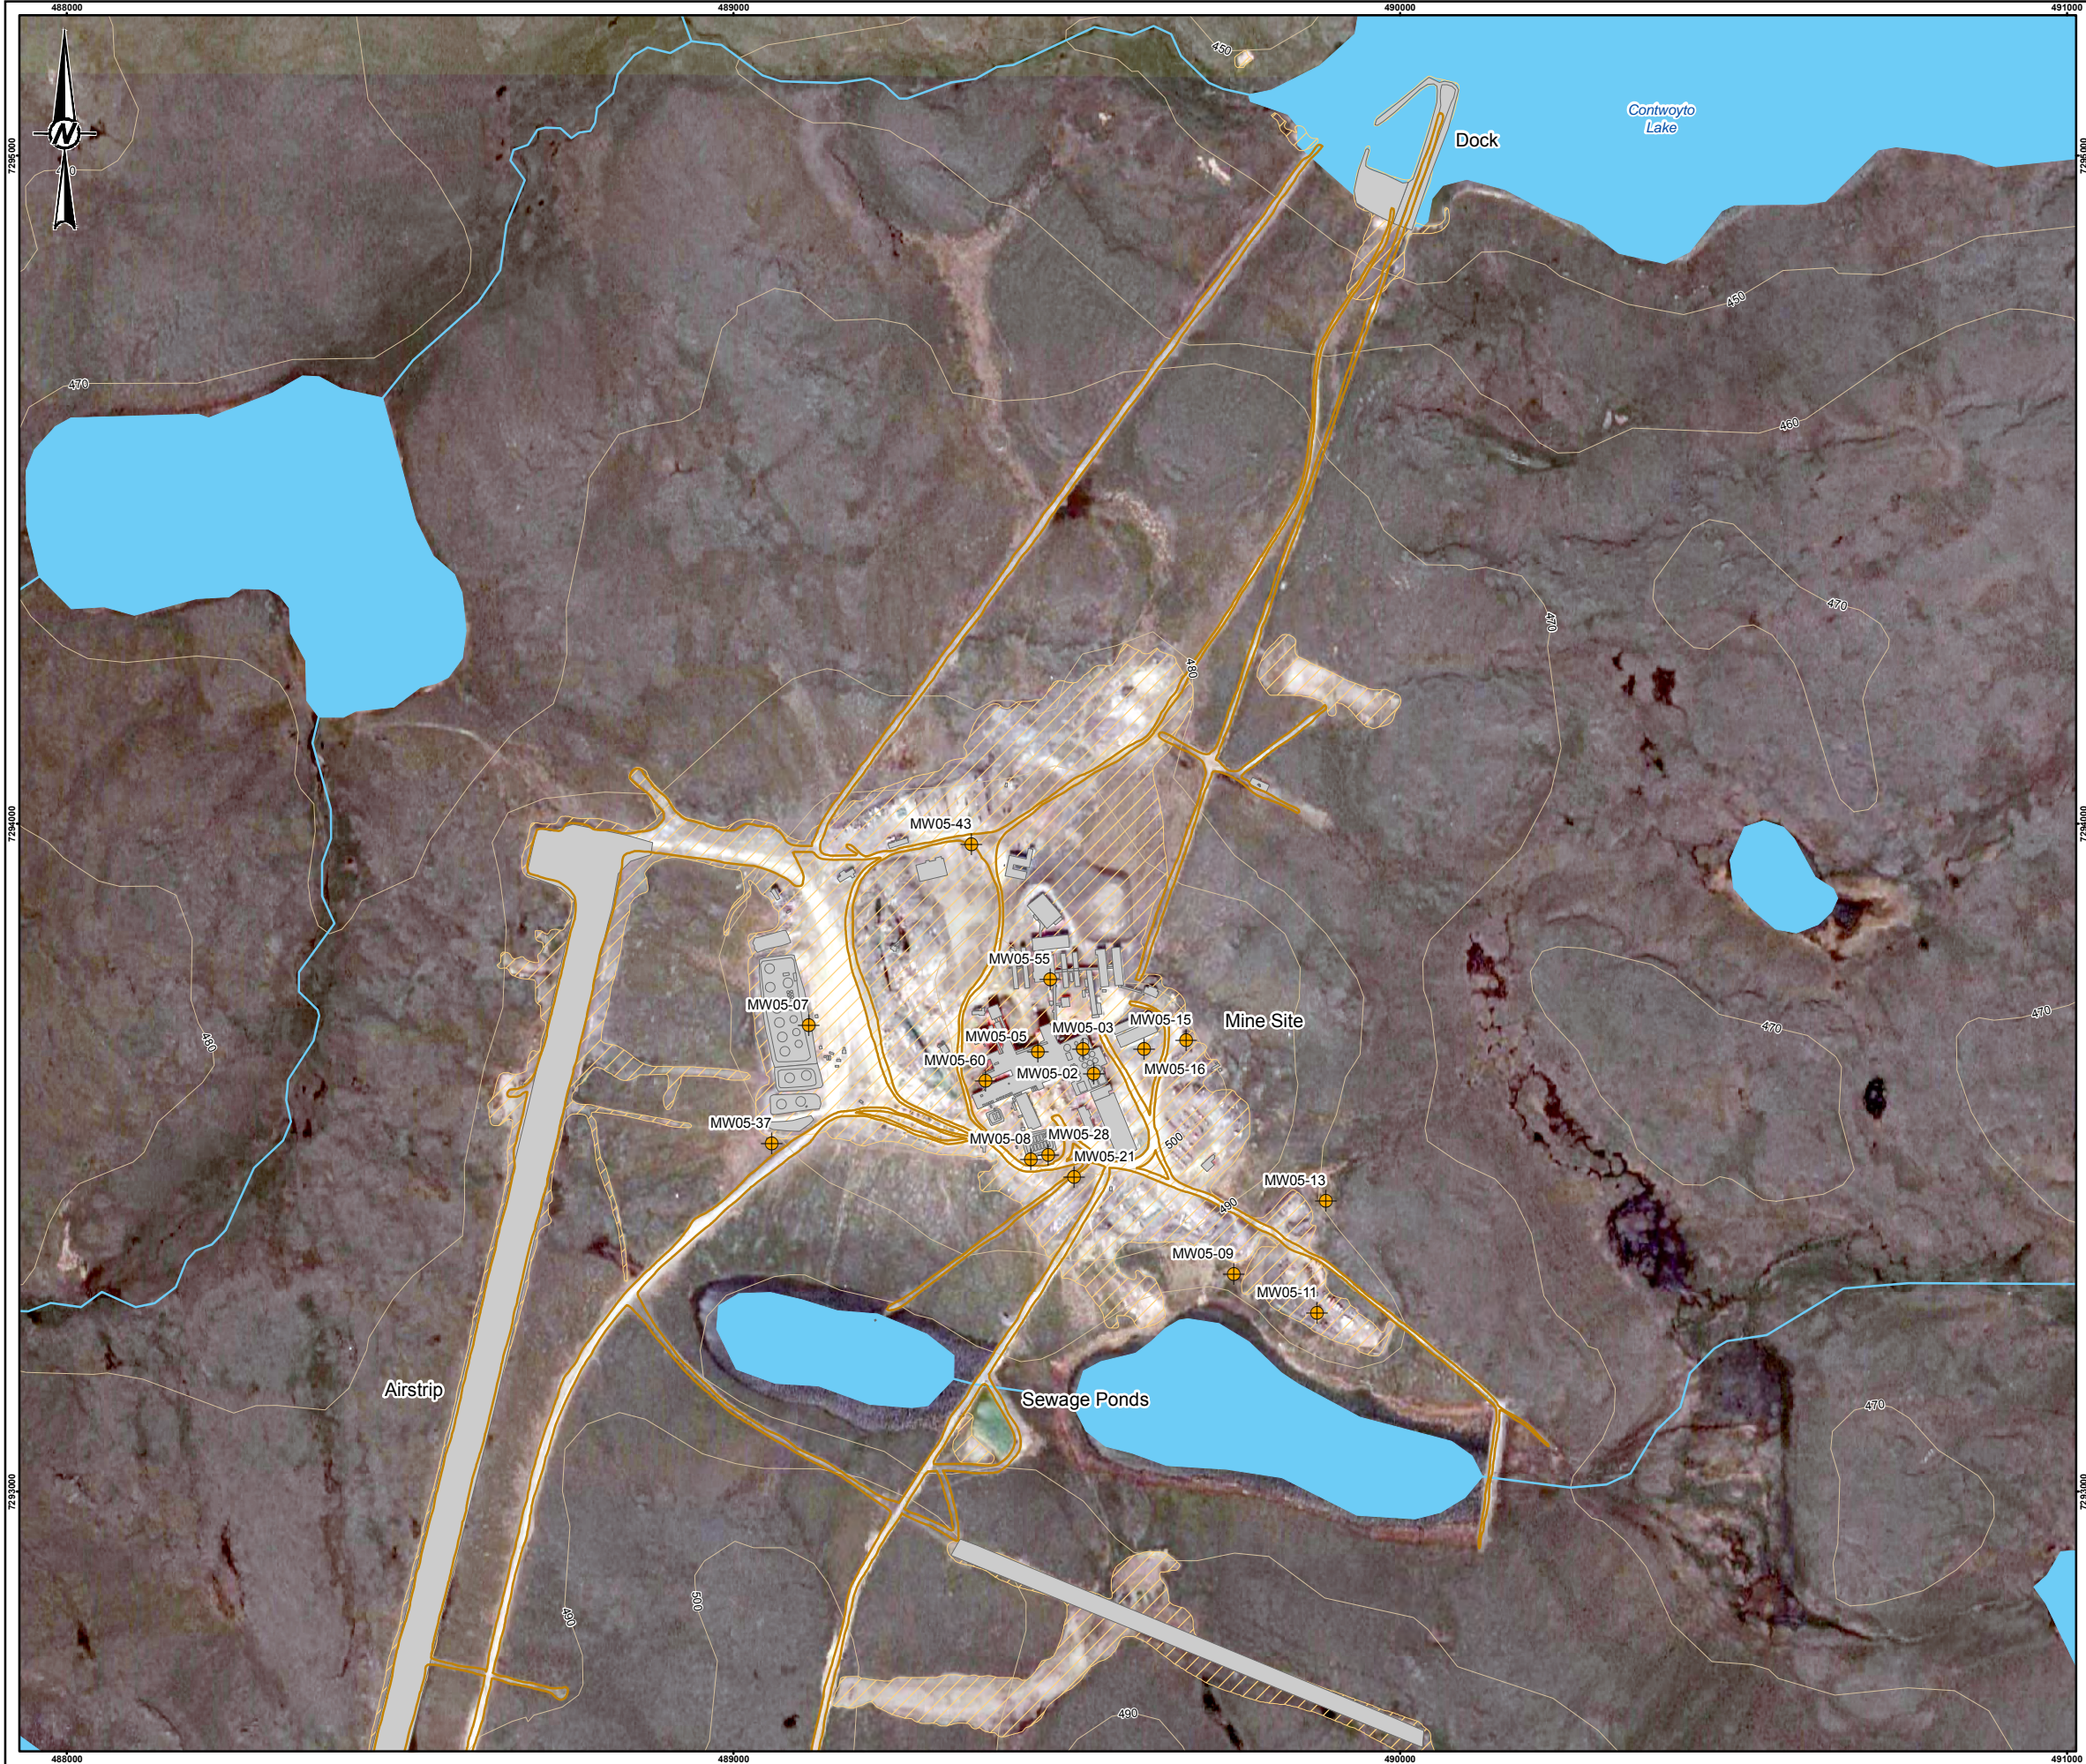
FIGURE
8

TITLE
GROUNDWATER MONITORING WELL LOCATIONS

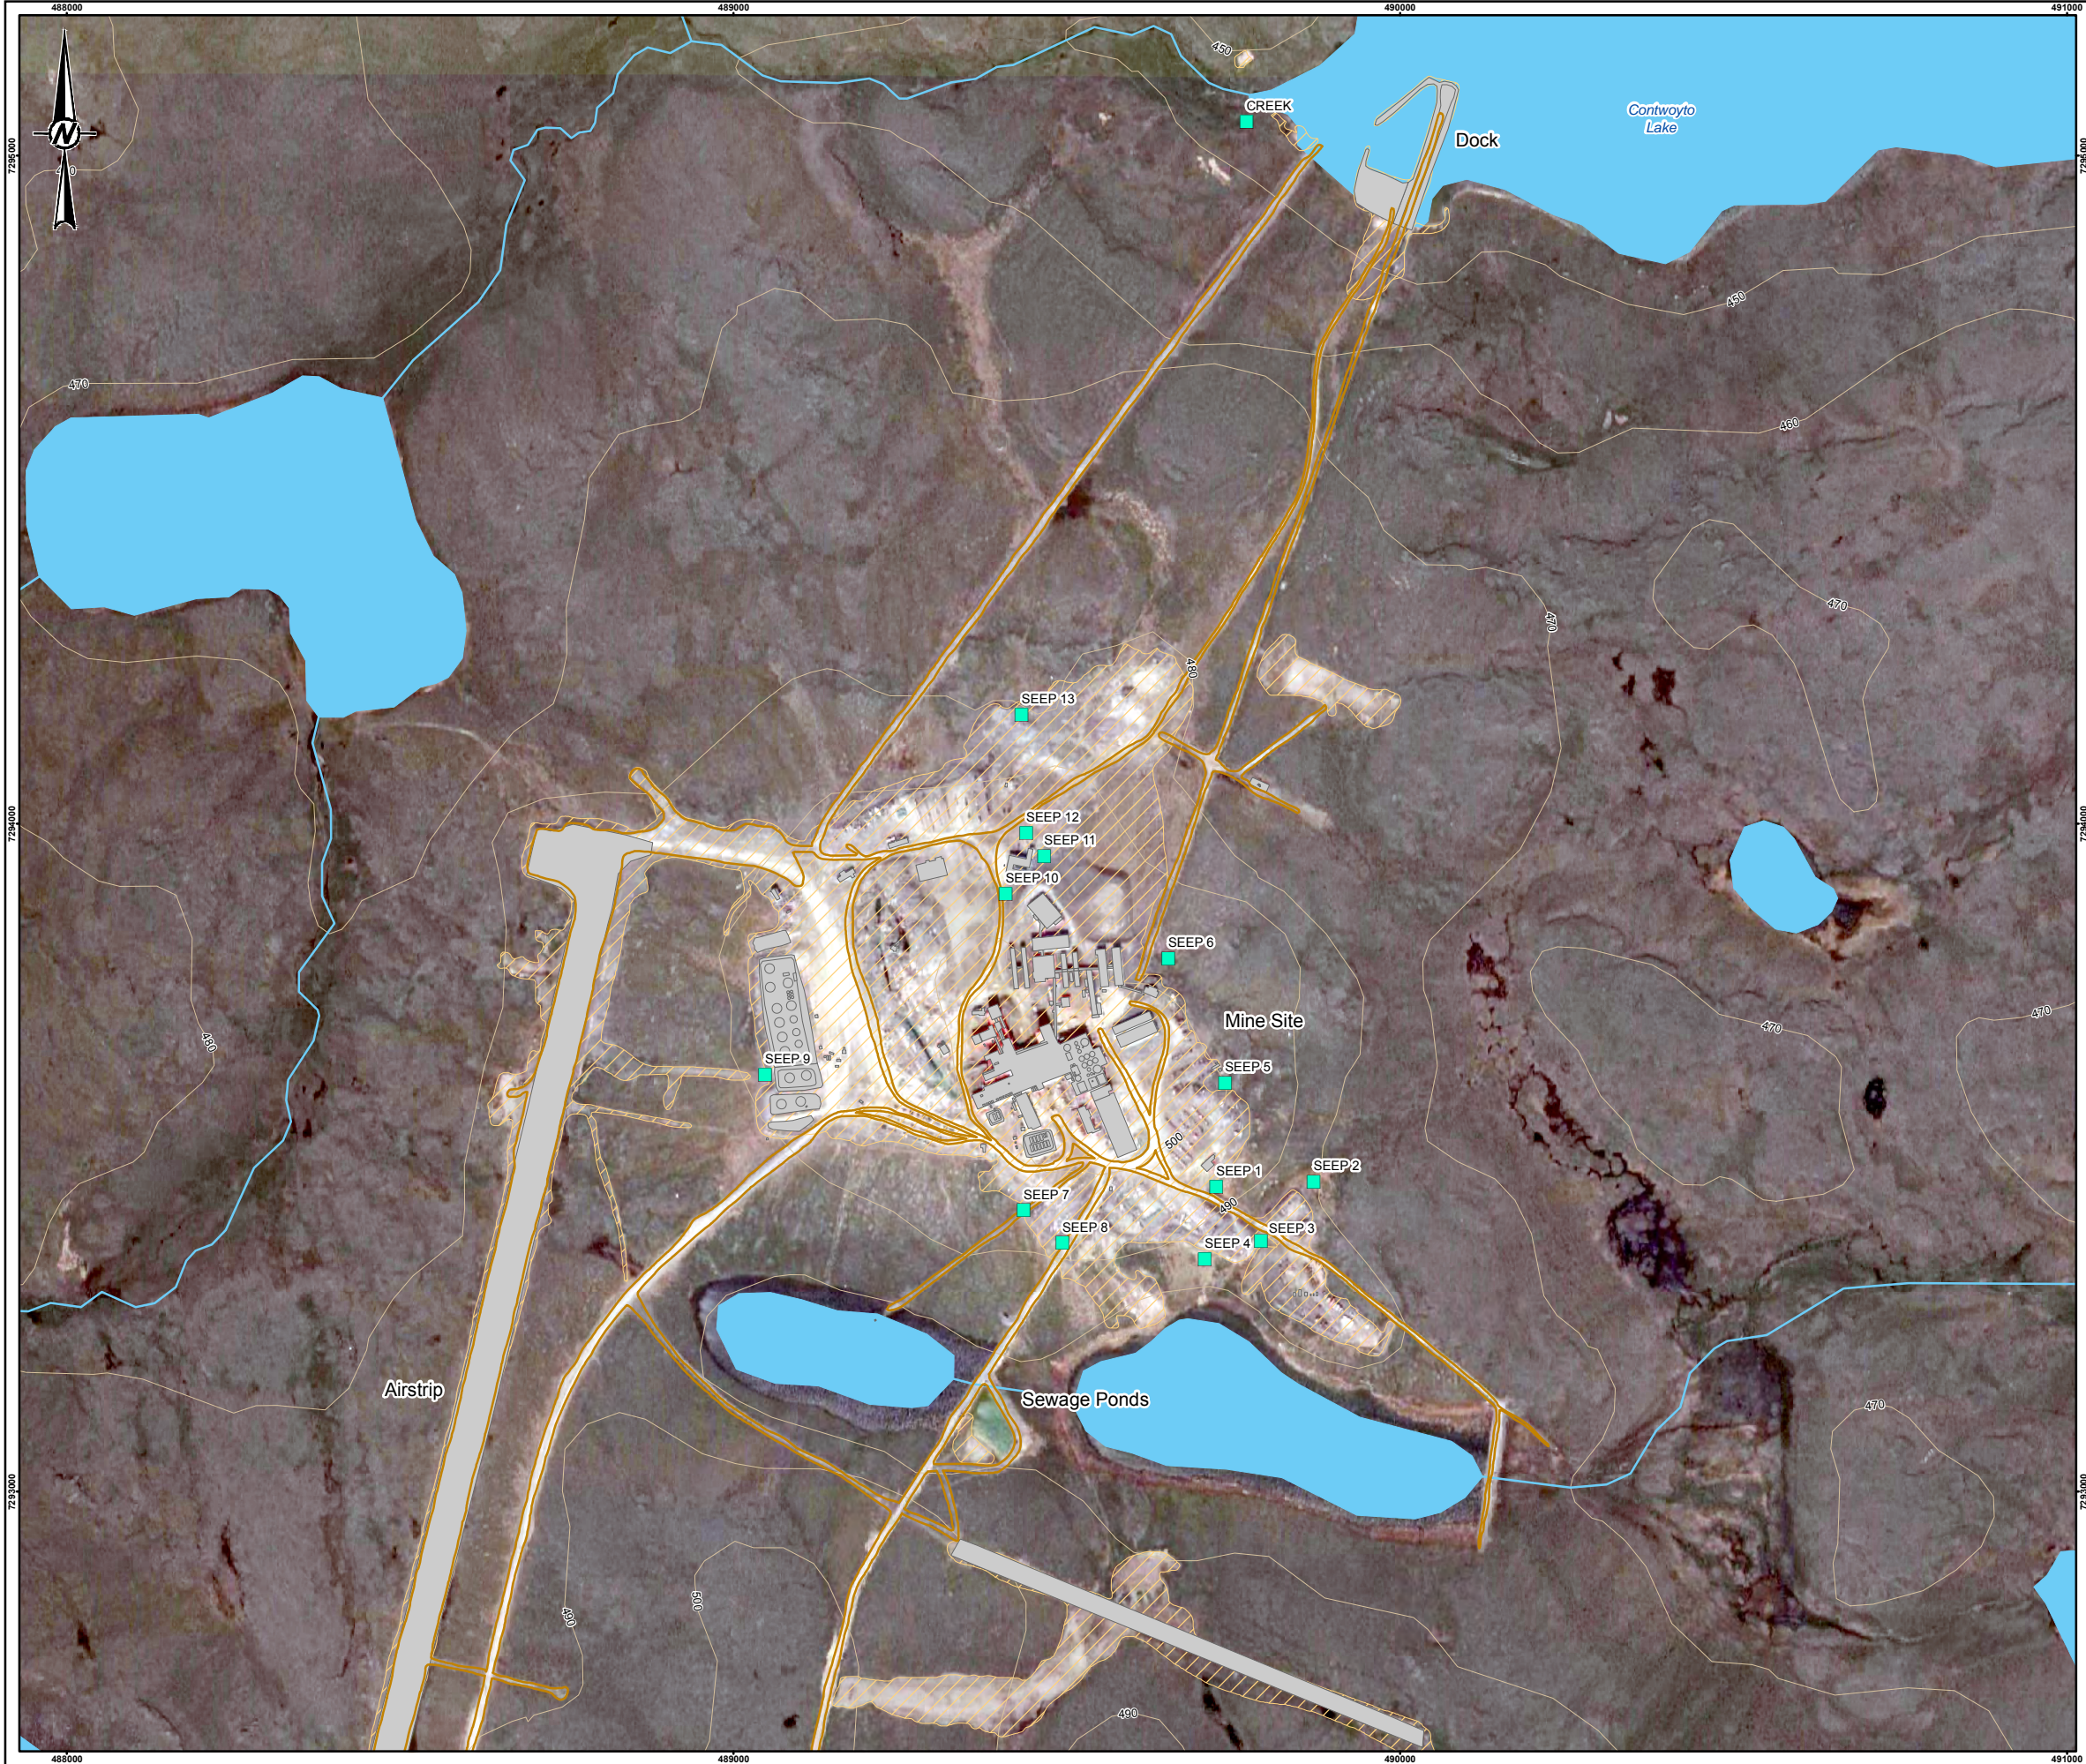
PROJECT NO.	CONTROL	REV.	FIGURE
19120487	5000	0	9

TITLE
SEEPAGE SURFACE WATER SAMPLE LOCATIONS

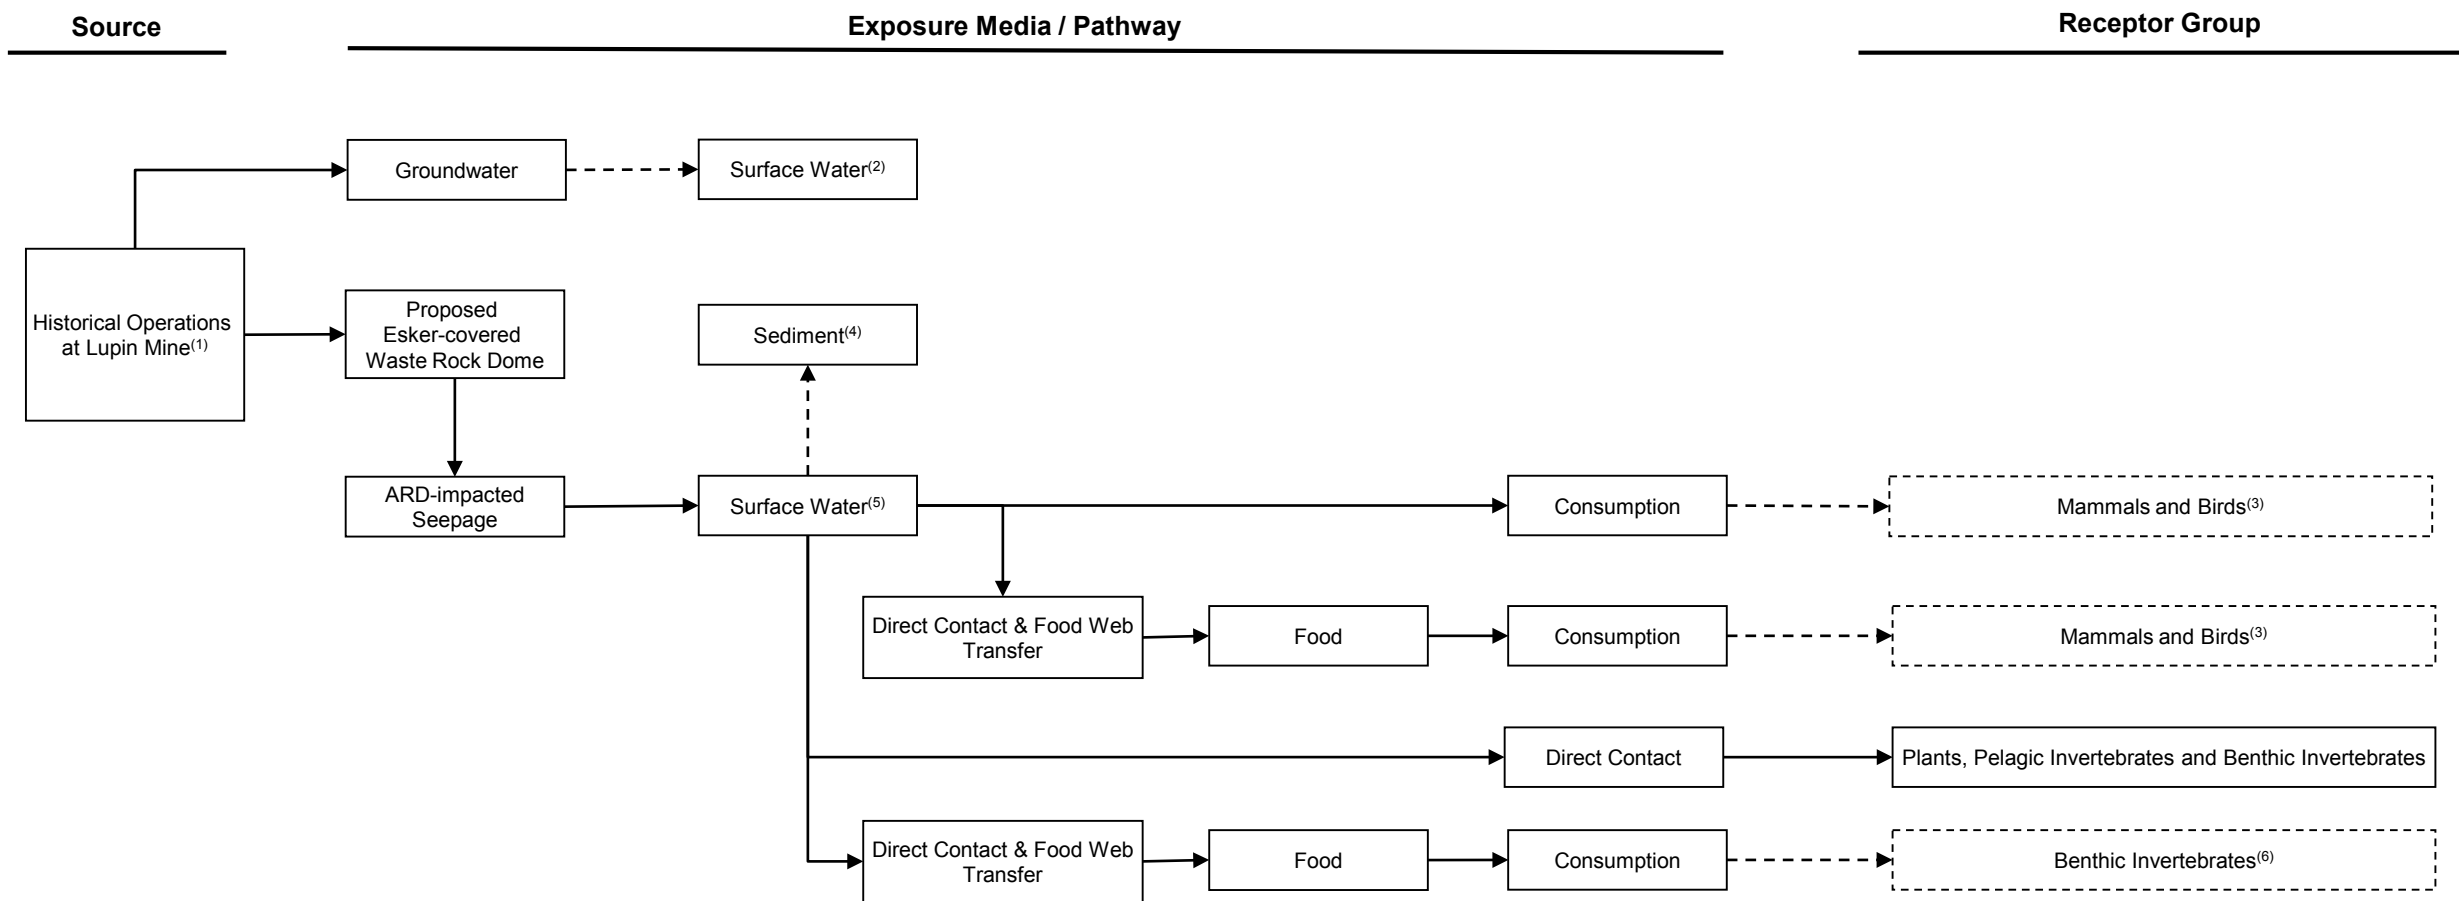
Solid lines indicate pathways that are likely to be complete or operative.

Dotted lines indicate pathways that are likely to be incomplete or inoperative.

⁽⁴⁾ The focus of the assessment was on ARD-impacted seepage and potential long-term impacts to surface water quality in the receiving water bodies. Potential impacts to sediment and all associated exposure pathways and receptor groups were not considered further.

⁽⁵⁾ Boot Lake, East Lake and Lower Sewage Lake. Impacts to surface water quality in Contwoyto Lake are expected to be negligible.

⁽⁶⁾ Uptake from the water is expected to be the dominant uptake route for most of the parameters predicted in surface water. For those parameters for which uptake from the diet may be important (e.g., selenium), predicted concentrations in the lakes were not much above reference conditions and/or guidelines protective of this pathway and are not expected to drive uptake by aquatic life.
