MANDALAY RESOURCES CORPORATION

LUPIN MINE CLOSURE – HUMAN HEALTH AND ECOLOGICAL RISK ASSESSMENT

MINE AND MILL SITE AREA – WATERSHEDS

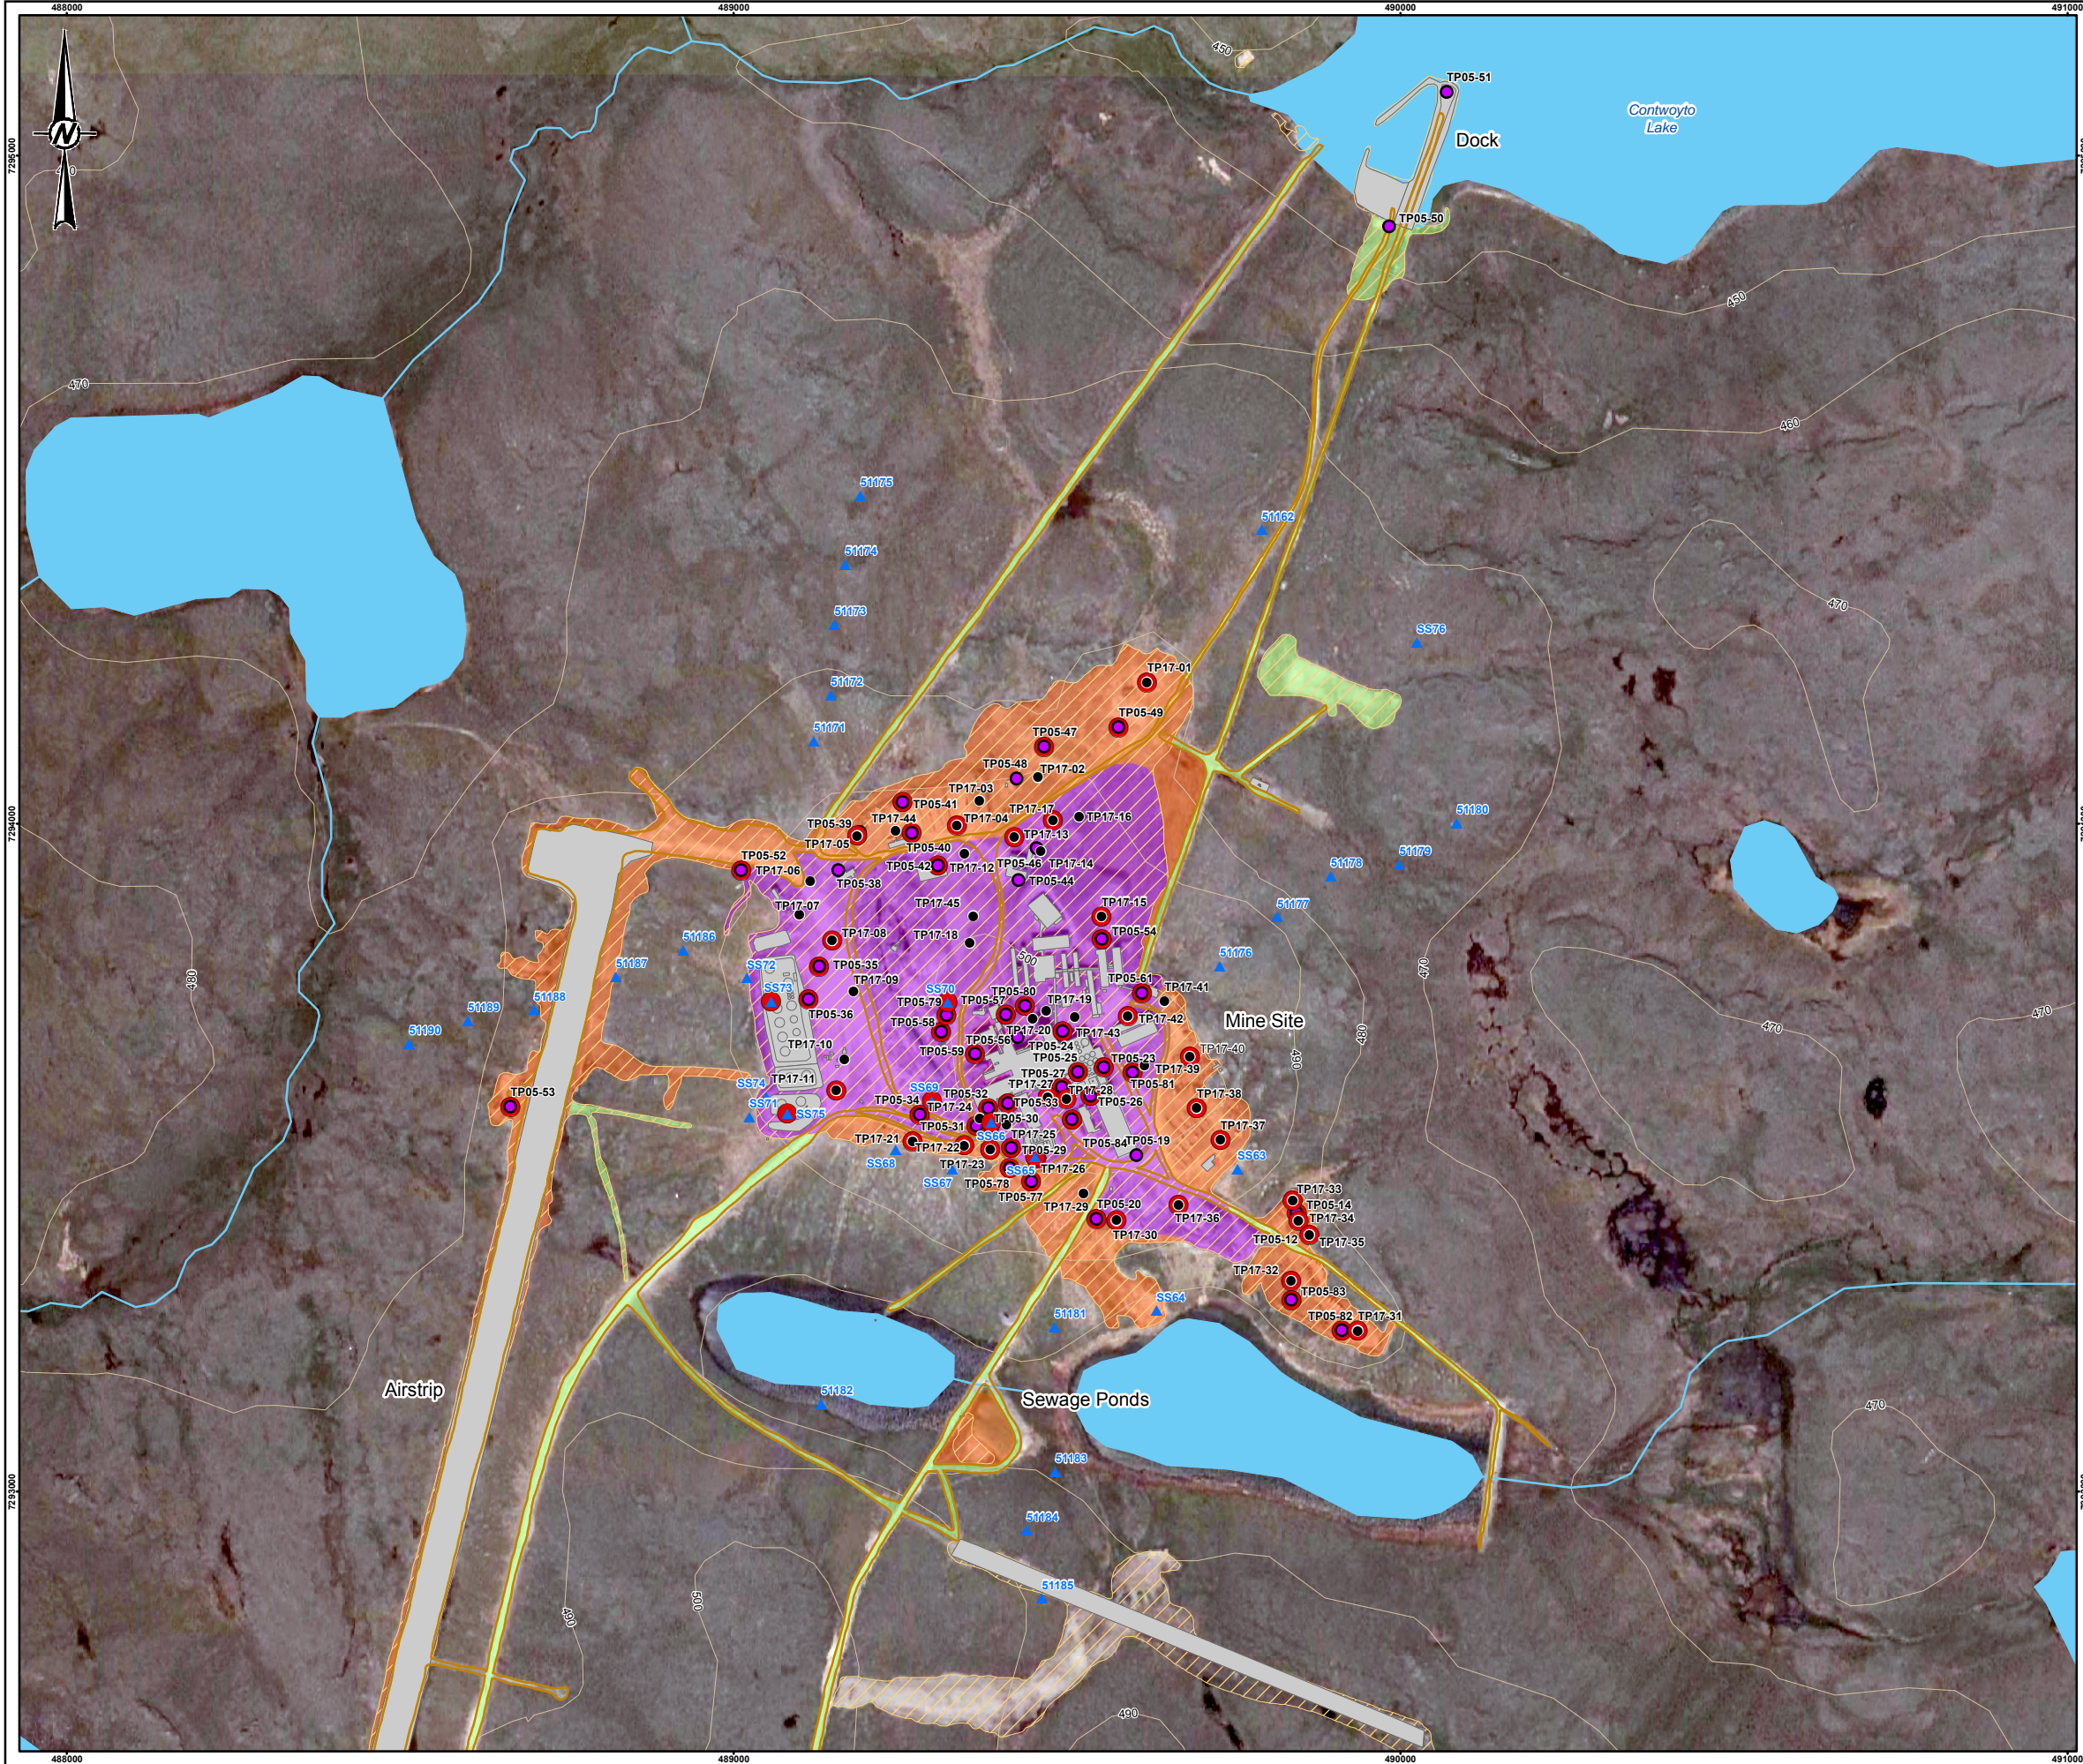
PROJECT NO.	CONTROL	REV.	FIGURE
19120487	5000	0	13

COC	SSTL (mg/kg)
PHC F1	210
PHC F2	150
PHC F3	300
Cyanide	0.9
Arsenic	79
Lead	95
Naphthalene	0.6
pH	4.13 to 9.0

EXCEEDANCES OF SITE SPECIFIC TARGET LEVELS FOR SOIL
