TECHNICAL MEMORANDUM

Reference No. 19120487/7000

CONCEPTUAL DESIGN FOR THE WASTE ROCK “DOME” AT LUPIN MINE

LUPIN MINE CLOSURE

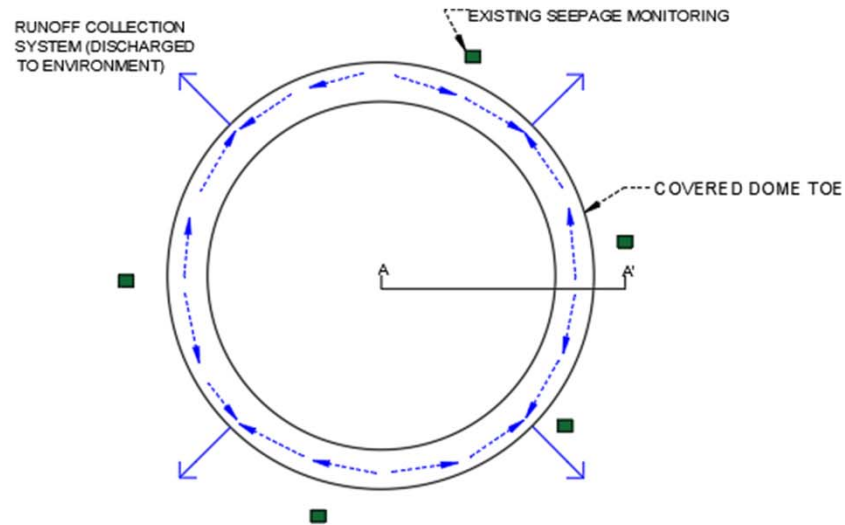
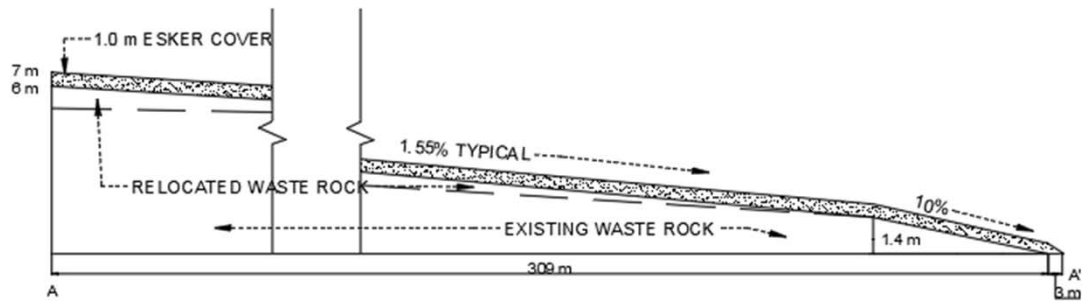
Covered Waste Rock Dome Concept

The dome (and the three small ancillary areas) will then be capped with an infiltration reduction cover comprising a 1.0 m thick layer of esker sand and gravel (Golder, 2018). The objectives of the cover are:

After closure, the waste rock dome is expected to be roughly circular and to cover an area of about 23.2 ha. It will contain or overlie about 820,000 m³ of waste rock. To prevent surface ponding, to reduce infiltration through the cover and to encourage surface runoff over the cover, the dome will have a surface slope of about 1.6%. Figure 2 provides a schematic cross-section of the planned waste rock dome.

- 1) to reduce the surface area of the waste rock, and
- 2) to reduce the amount of infiltration into waste rock in order to control the volume of acid rock drainage (ARD) impacted seepage out of the toe of the dome.

The reduction in surface infiltration will rely in part on the cover being frozen during winter and early spring to promote surface runoff rather than infiltration during the freshet period.

The model predicts that, for 2019 climatic conditions, and after the dome is formed and covered with 1.0 m of esker material, about 58% of the annual precipitation will runoff over the surface of the dome, while 15.8% will infiltrate into the underlying waste rock from whence it will eventually report as a toe seep. The model also predicts that, for 2100 climatic conditions, 43% of the annual precipitation will runoff, while 25% will infiltrate into the underlying waste rock and report as toe seeps.
