**August 11, 2001 Water Licence Inspection - Report**

## INDUSTRIAL WATER USE INSPECTION REPORT

Date: 2001/08/11      Company Rep. (Name/Title): Barry Lowe / Lands Administration  
Licensee: Echo Bay Mines Ltd., Lupin Operations      Licence No.: N7L2-0925 (expired)

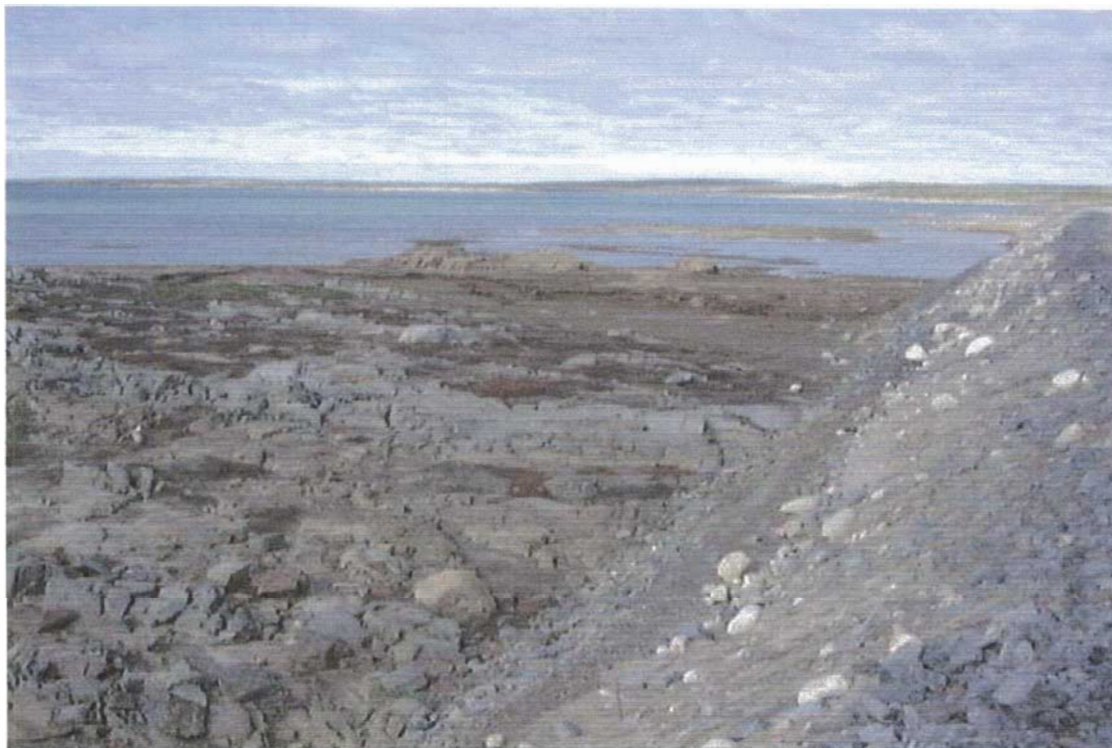
- **Tailings disposal:** Since the previous inspection, the Licensee has assessed that the recently noted seepage along M Dam was restricted to a zone of slightly fractured bedrock (figure 1). Therefore, as earlier planned, preparation work leading to the sealing of the upstream toe of M Dam with geotextile liner and/or tailings deposition had been undertaken (figure 2). In parallel, pooled water was observed between Coffey Dam and Dam 4 (figure 3). As the purpose of Coffey Dam is to act as a barrier keeping the toe of Dam 4 dry in order to minimize seepage potential, the Licensee was in the process of pumping the pooled water into Cell 4 (figure 4). Thus, the attached analytical results relating to a sample collected from the pond formed between Dam 4 and Coffey Dam reveal that while metal concentrations meet licenced thresholds, levels of arsenic (188 µg/L vs 5 µg/L), cadmium (0.3 µg/L vs 0.017 µg/L), copper (26 µg/L vs 4 µg/L), iron (1.5 mg/L vs 0.3 mg/L), lead (13 µg/L vs 7 µg/L), and zinc (119 µg/L vs 30 µg/L) exceed the *Canadian Water Quality Guidelines for the Protection of Freshwater Aquatic Life*. However, the Microtox sample, which constitutes a reliable toxicity indicator (IC<sub>50</sub>), did not attribute toxicity to the pooled water. Nevertheless, given the fact that the field pH value of 3.7 breached the licenced standard of 6.0, a surface grab sample of Laurie Lake along the downstream side Coffey Dam was also taken in order to appraise possible seepage concerns. Although the sampling results appear inconclusive, the Inspector commends the Licensee for taking a diligent approach by pumping the pooled water into Cell 4 and ensuring that the toe of Dam 4 remains in the future as dry as possible.

**figure 1.** Seepage zone along M Dam, with Pond 2 in background; 2001/08/11.

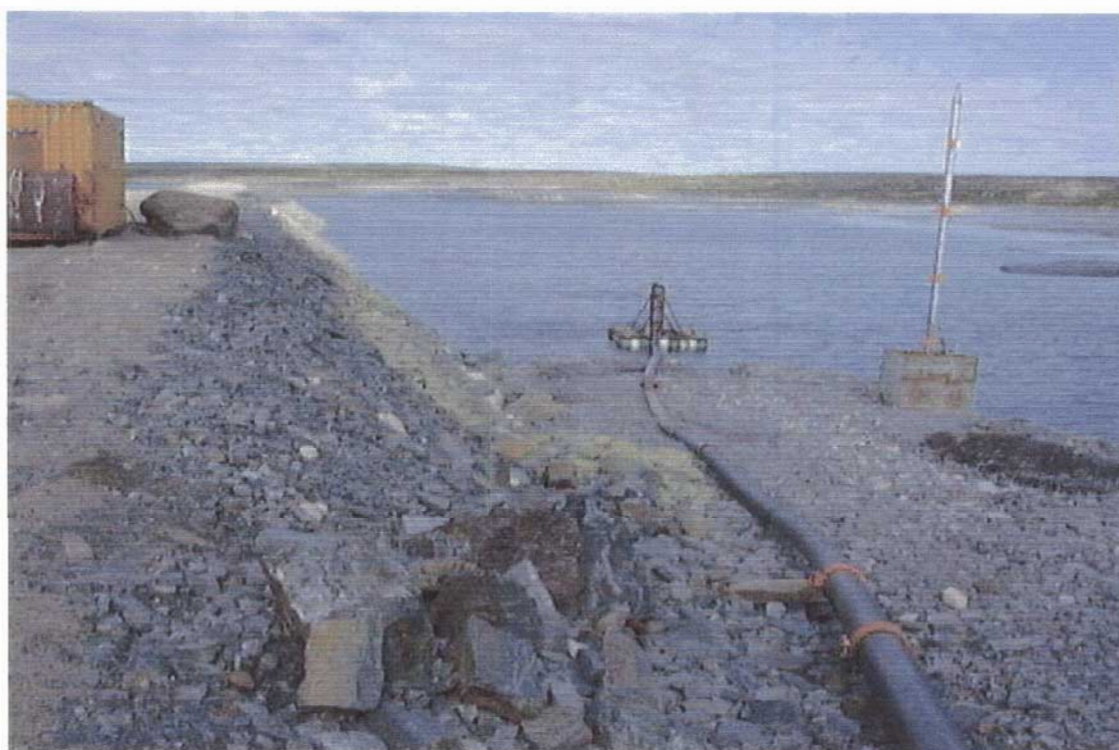
**figure 2.** Isolation work on the upstream face of M Dam, facing Cell 5; 2001/08/11.

Comments: Discharge from the Tailings Containment Area (TCA) not planned for this year; no noticeable flow from the Pond 2 discharge at Dam 1A, SNP station 925-10. Cell 5 has been partly drawn down, enabling the upcoming deposit of tailings along the upstream toe of M Dam; dam sealing work to be undertaken prior to freeze up. Pooled water between Coffe Dam and Cell 4 being pumped into Cell 4; likely surface runoff, but possible seepage. Preparing to siphon the contents of Pond 1 into Pond 2, prior to the transfer of Cell 4 into Pond 1. Level of the Lower Sewage Lake significantly lowered since the previous inspection; repair/replacement work to be undertaken once decant is terminated, prior to freeze up. Flow noted from both the siphon line and the discharge culvert. No concerns noted at the solid waste disposal facility.

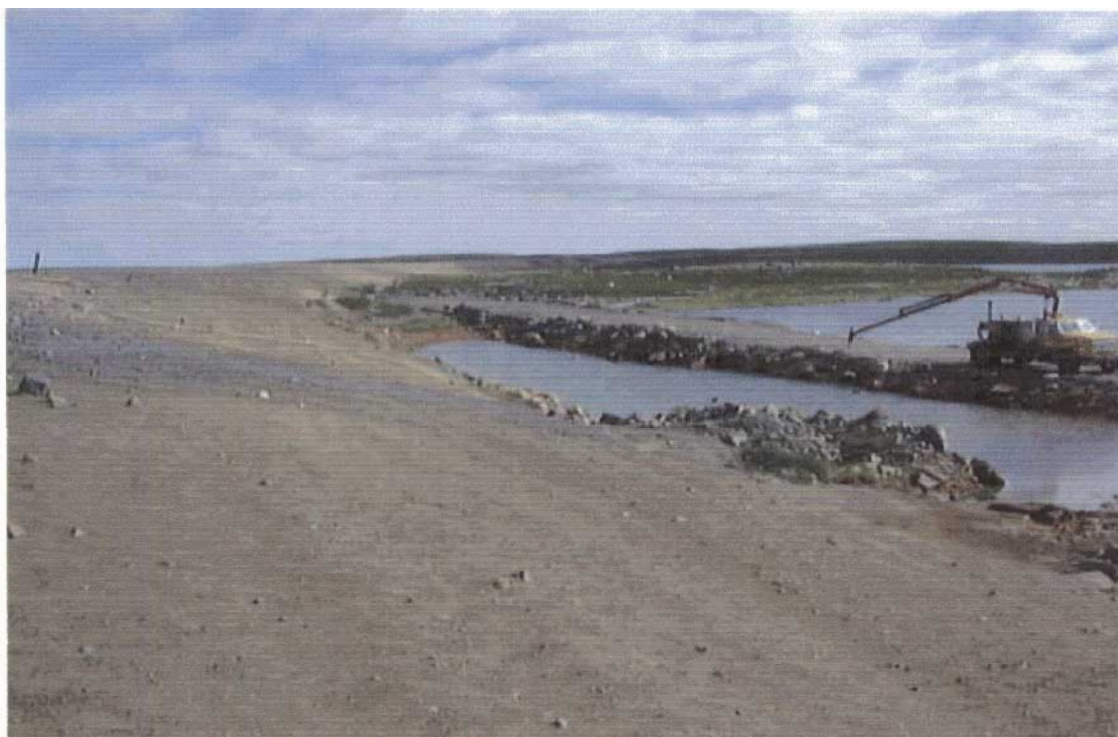
**figure 3.** Cofferdam beyond Cell 4, with Laurie Lake in background; 2001/08/11.

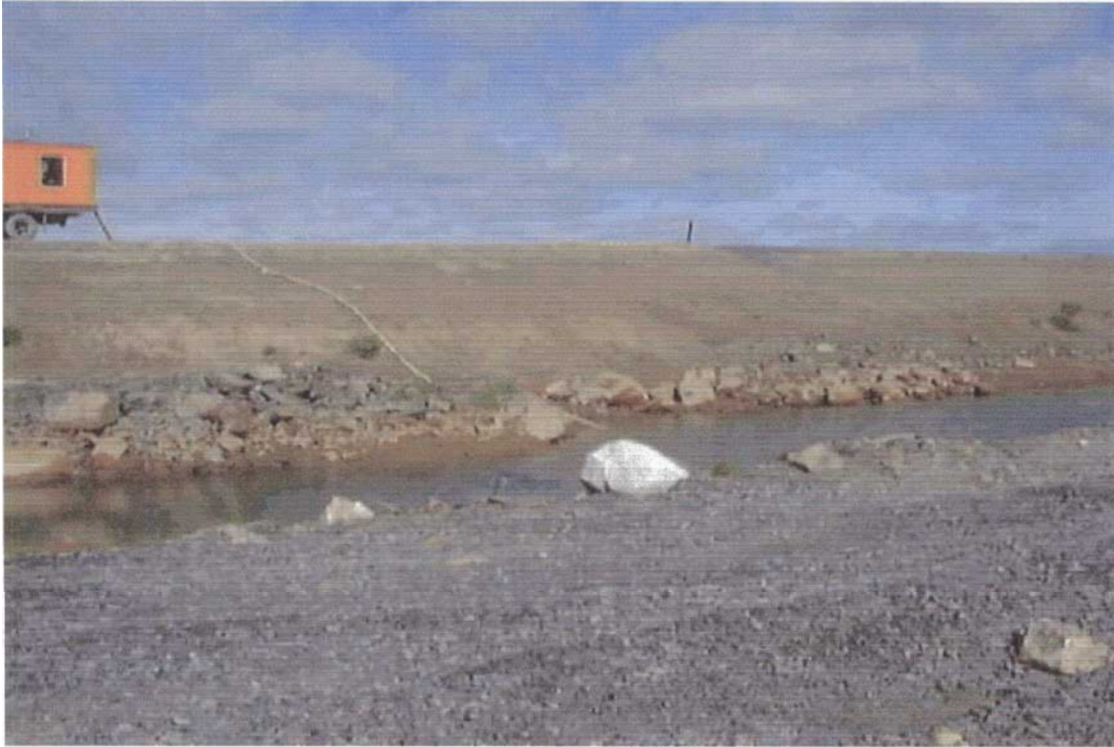
Violations of Act or Licence: Possible acid seepage through Dam 4, pooled within Coffe Dam, prudently pumped into Cell 4. Decant structure of the Sewage Lakes Disposal System to be repaired/replaced shortly.

**figure 4.** Pumping, into Cell 4, of water pooled by Cofferd Dam; 2001/08/11.

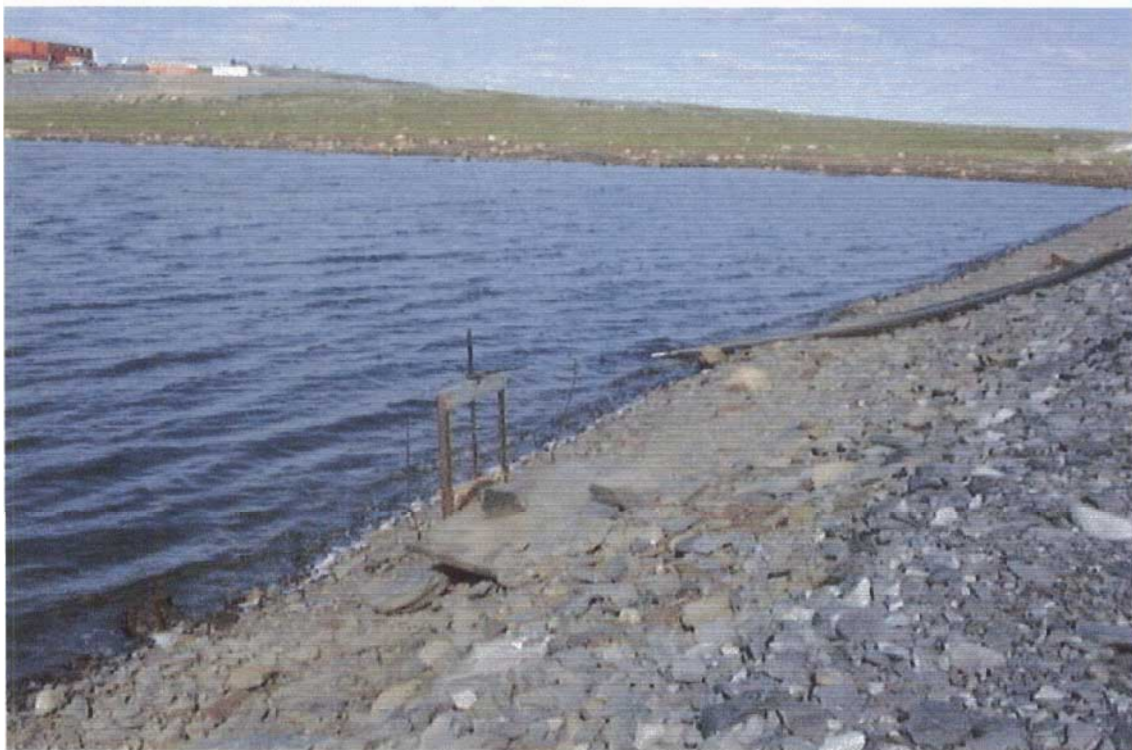
• **Sewage disposal:** At the time of the inspection, the annual decant of the Sewage Lakes Disposal System was well under way. In fact, the level of the Lower Sewage Lake (figure 5) was significantly drawn down in relation to observations made during the previous inspection. However, as sewage effluent discharge was still occurring, repair/replacement work on the decant structure at Surveillance Network Program (SNP) station 925-14 had not yet been initiated. This being said, the attached analytical results relating to a sample collected from SNP station 925-14 (figure 6) indicate that while all licenced metal thresholds were met, the field pH breaches the licenced benchmarks (5.3 vs 6.0-9.5). In addition, concentrations of ammonia (5.24 mg/L vs 2.2 mg/L), arsenic (10 µg/L vs 5 µg/L), copper (7 µg/L vs 4 µg/L), and zinc (58 µg/L vs 30 µg/L) slightly exceed the *Canadian Water Quality Guidelines for the Protection of Freshwater Aquatic Life*. However, the Microtox sample, which constitutes a reliable toxicity indicator (IC<sub>50</sub>), did not attribute toxicity to the effluent discharged from the Sewage Lakes Disposal System.

**figure 5.** Final retention dam of the Sewage Lakes Disposal System; 2001/08/11.

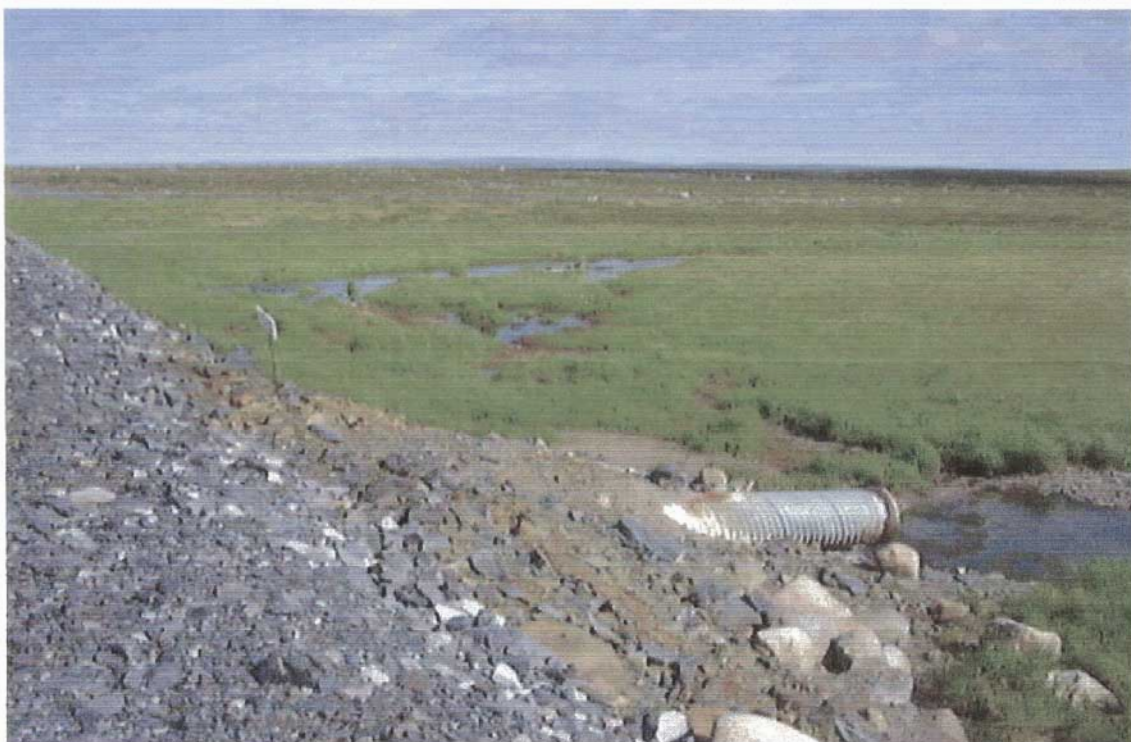
**figure 6.** Discharge from the Sewage Lakes Disposal System, SNP 925-14; 2001/08/11.
