RE: August 19, 2002 Water Licence Inspection - Report

INDUSTRIAL WATER USE INSPECTION REPORT

Licensee: Echo Bay Mines Ltd., Lupin Operations Licence No.: NWB1LUP0008

Lupin Mine Inspection Pictures 2002

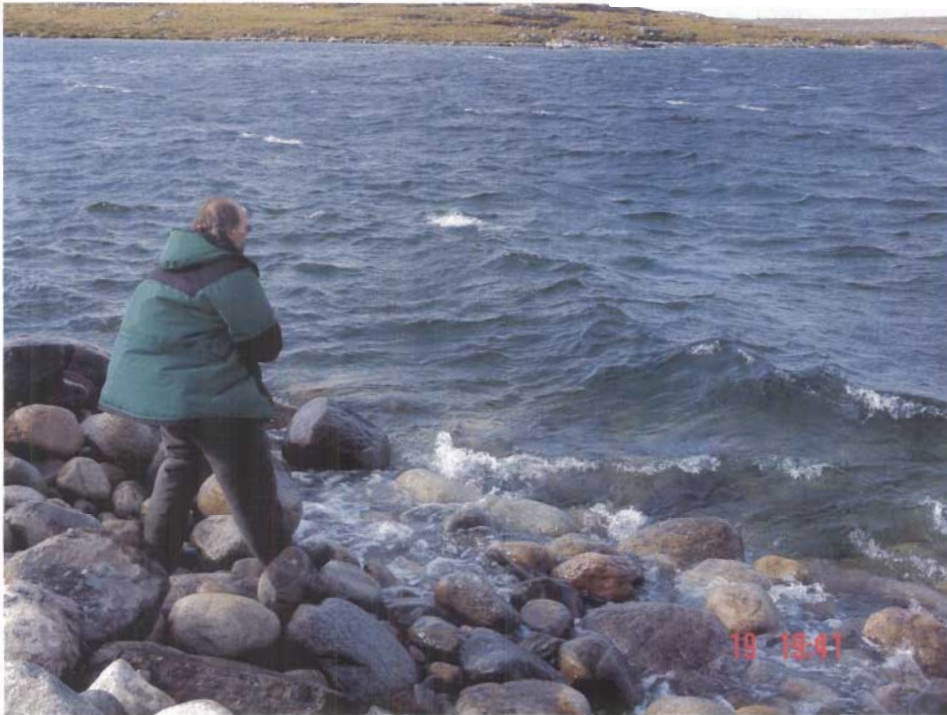
Photo # 1. Potable water supply for Lupin Mine, Contwoyto Lake.

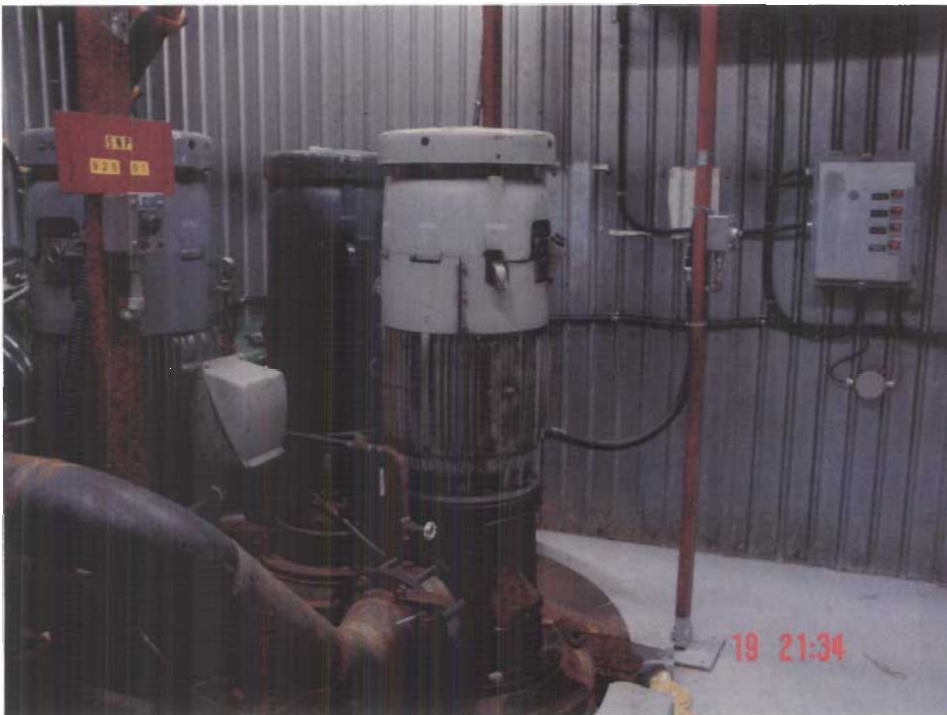
Comments: Inspected Water Intake Facility on Contwoyto Lake. The facility was well kept with the exception of pump # 3 leak requiring maintenance. The disinfection of drinking water is achieved by treating water with Ultra Violet light. Of some concern is the location of the UV sterilization system in a relatively dusty location, this could be of particular concern when maintenance is required on the UV unit. Some form of dust protection may be provided for the unit and pipes located above. The drinking water treatment system was well maintained and operational at the time of inspection.

Photo # 2. Some leakage from water supply pump in foreground at Water Intake Facility, SNP station -01.

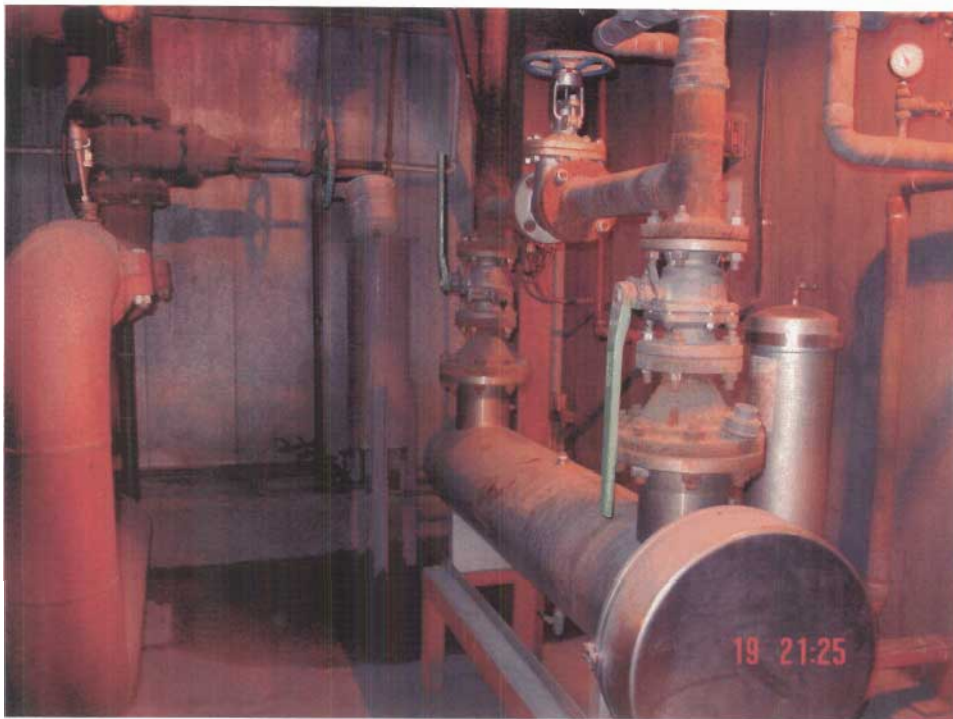
Photo # 3. Ultra Violet Disinfection System for potable water in milling complex.

- ☐ **Water Supply:** The water intake is located 70 meters from the Water Intake Facility on Contwoyto Lake at a depth of 10 meters. The mine operates a small marina within 30 meters of the Water Intake Facility. No spill equipment was noted in the vicinity of the boat dock area. It is recommended that spill equipment be placed in the marina area to contain any spills that may occur in relation to the refueling and operation of boats and planes in this area. The Water Intake Facility was a very clean and in good operational condition with the exception of a leak at Pump # 3 (Photo 2). Enclosed analysis of potable water taken on Contwoyto Lake (Photo 1) at (SNP 925-01) indicates that Arsenic (0.0014 mg/L vs 0.025 mg/L), Cadmium (<0.0003 mg/L vs 0.005 mg/L), Chromium (<0.003 mg/L vs 0.05 mg/L), Copper (0.003 mg/L vs 0.01 mg/L), Lead (<0.001 mg/L vs 0.01 mg/L) and Zinc (<0.01 mg/L vs 5.0 mg/L) concentrations are found to be within the *Guidelines for Canadian Drinking Water Quality*. However pH (6.48 vs 6.5-8.5) is slightly in excess of the *Guidelines of Canadian Drinking Water Quality Maximum Acceptable Concentrations*. The Ultra Violet water disinfection system was operational during the inspection (Photo 3). The Ultra Violet disinfection system is located in an area with excessive milling dust. To reduce the potential of contamination while servicing the UV system some form of cover should be installed to reduce dust accumulation on the UV system and pipes located directly above the system.

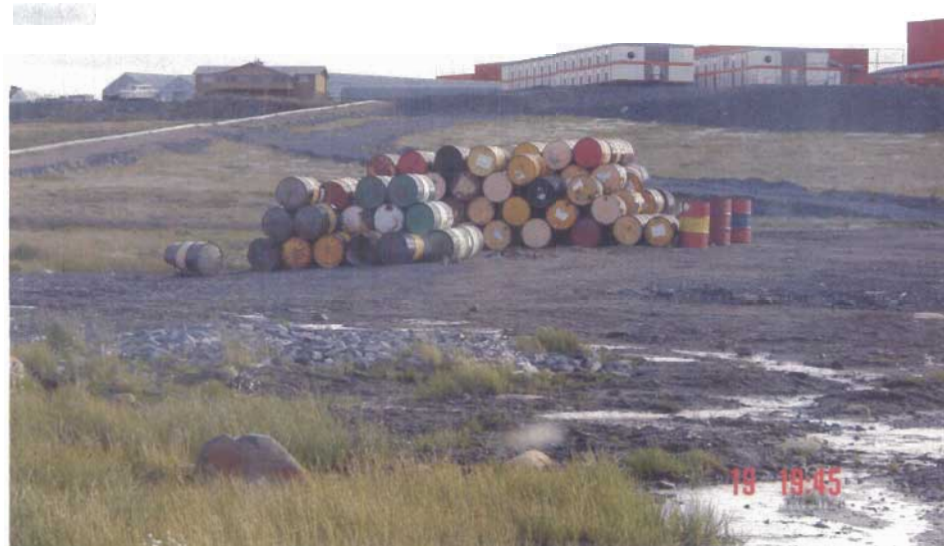
Photo # 4. Empty drum storage area located by Contwoyto Lake Water Intake Facility.

- ☐ **Fuel and Chemical Storage:** The Inspection of the Tank Farm and associated drummed fuel storage area revealed a well managed and orderly facility with appropriate signs (Photo 5). There were no visible breaches of the storage area berm or synthetic liner. There was a small area where the berm liner was visible, by the fuel drum storage area (Photo 6). The visible portion of the liner should be covered with aggregate material. The Tank Farm and fuel drum storage were dry with no visible staining from fuel or oil. A storage area for empty drums was located within 100 meters of the potable Water Intake Facility. Given the natural slope of the land toward Contwoyto Lake the drums should be relocated or alternatively a retention berm should be installed in this drum storage area.

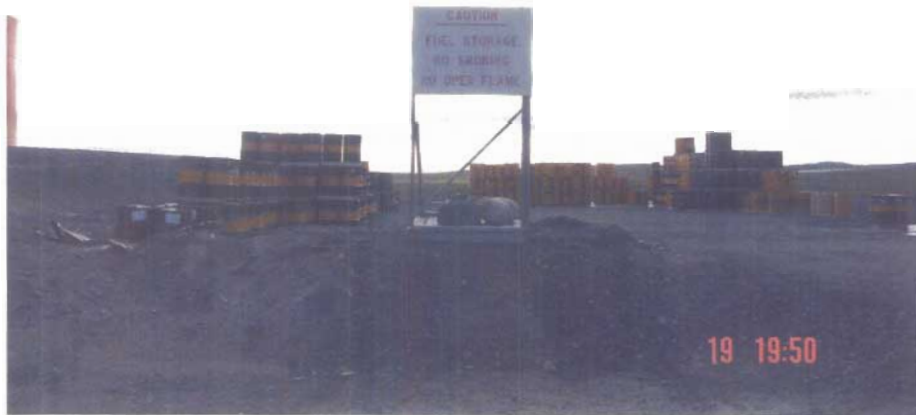
Photo # 5. Chemical and fuel storage area with posted sign.

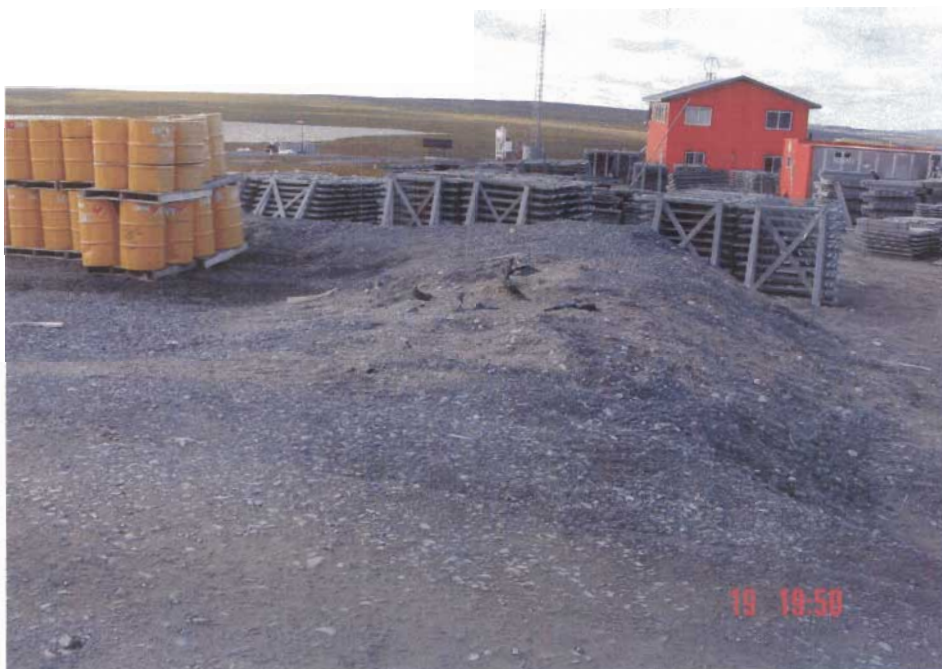
Comments: The Tank Farm is totally enclosed in a retention berm. There was no noticeable fuel or water within the berm noted during the inspection.

Photo # 6. Tank Farm and drummed fuel storage. The area is bermed and lined with synthetic impermeable liner.

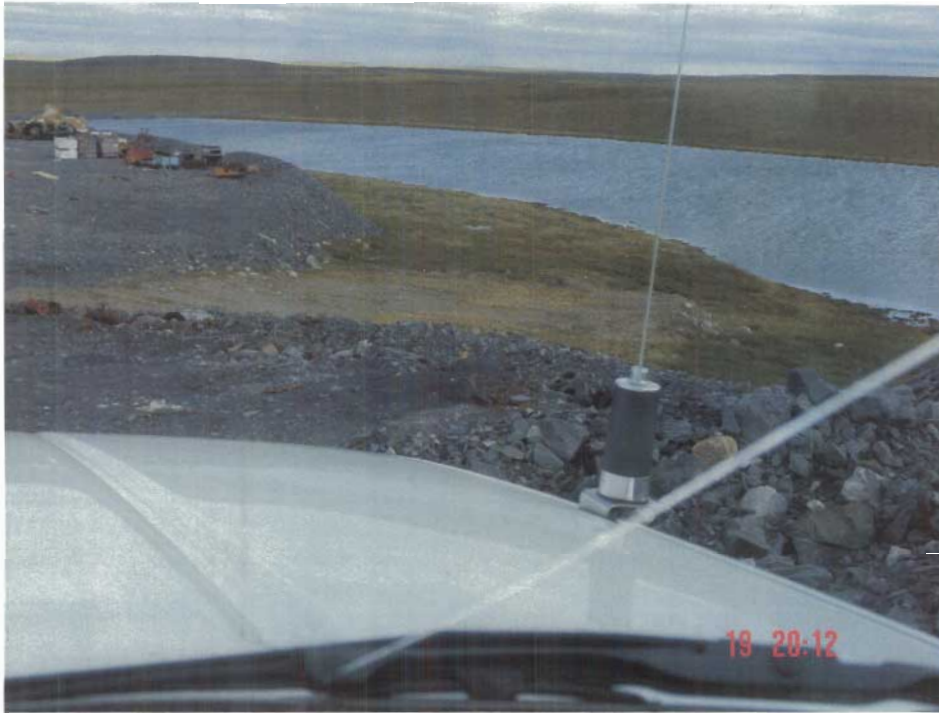
Photo # 7. Sewage Lake # 2 of Treatment Lake System.

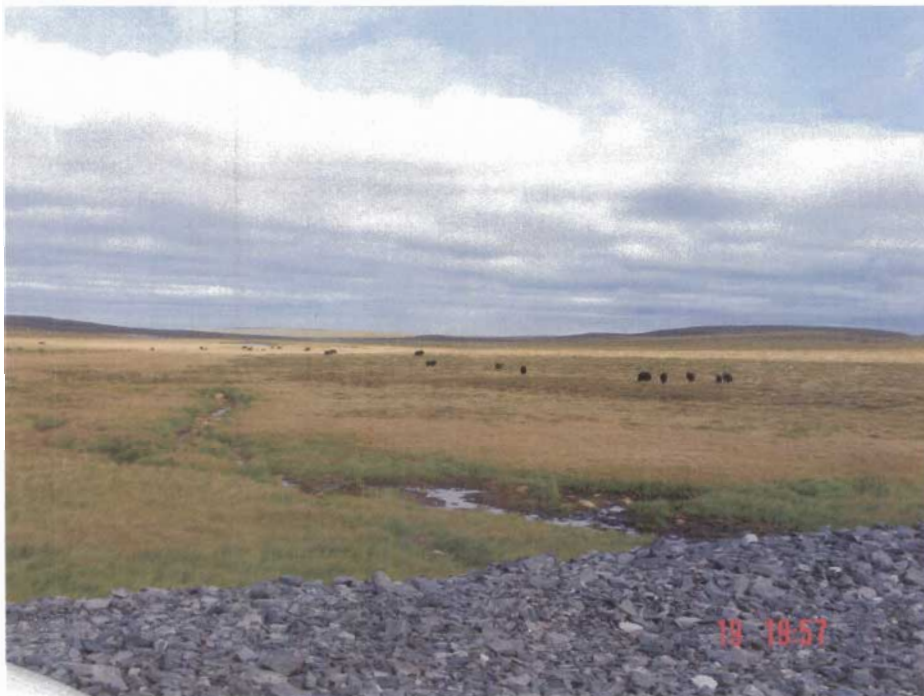
Comments: Flow from the culvert at Sewage Pond #2 (SNP 925-14) was sampled. Burning of garbage was observed at burn pit during the inspection. The decanting of Tailings Pond # 2 at decanting structure Dam 1A was in progress during sampling (SNP 925-10).

Violations of Act or Licence: Follow up report has not been submitted for all the last spill (02-591) 200 to 300 gallons of mine water on December 23, 2002. Analysis of discharge from sewage Pond # 2 SNP 925-14 indicates that pH measurements do not meet Licence discharge criteria.

Photo # 8. Location of sewage sample at discharge end of culvert centre of photo. Sewage Lake discharge, considerable vegetation prior to effluent entering Contwoyto Lake.

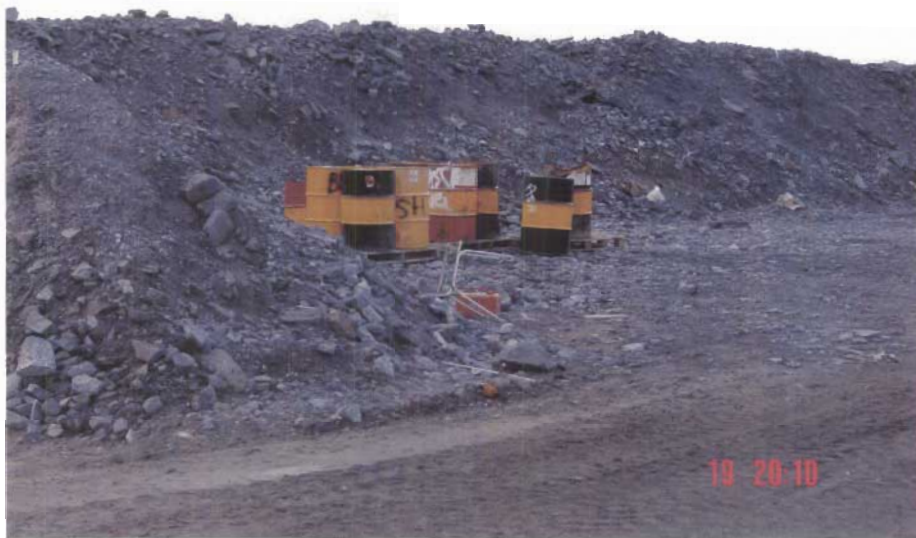
- ☐ **Waste Disposal:** The Solid Waste Disposal Facility consists of Landfill, Burn Pit and Incinerator areas. Combustible waste is burned at the Solid Waste Burn Pit (Photo 11), or in the Incinerator (Photo 12). Waste oil is used to assist in burning waste at the Burn Pit (Photo 9). Non Combustible waste is buried at the Solid Waste Disposal area (Photo 10). The Sewage Disposal Lakes System consists of 2 lakes with decanting of Lake 2 (Photo 7) into a wetland of considerable vegetation (Photo 8) prior to entering Contwoyto Lake. Analysis enclosed of samples taken at Sewage Lakes Disposal System (SNP 925-14) decant structure indicates that pH (5.09 vs 6-9.5) exceed Water Licence Maximum Average Concentration.

Photo # 9. Burn Pit, waste oil in drums used to operate Burn Pit.

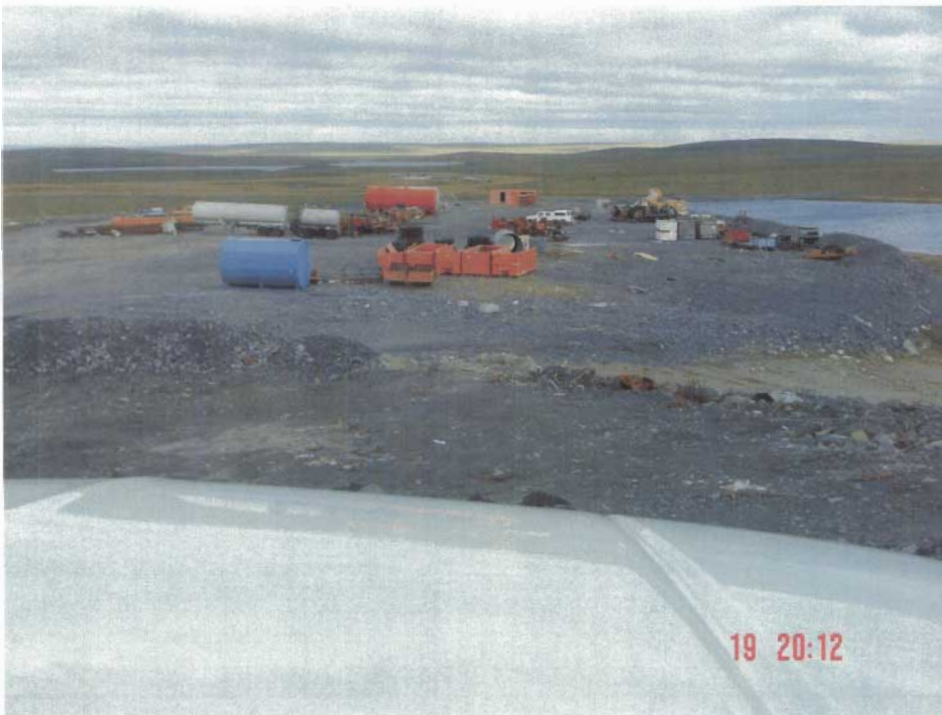
Photo # 10. Top of Solid Waste Disposal Facility Landfill area.

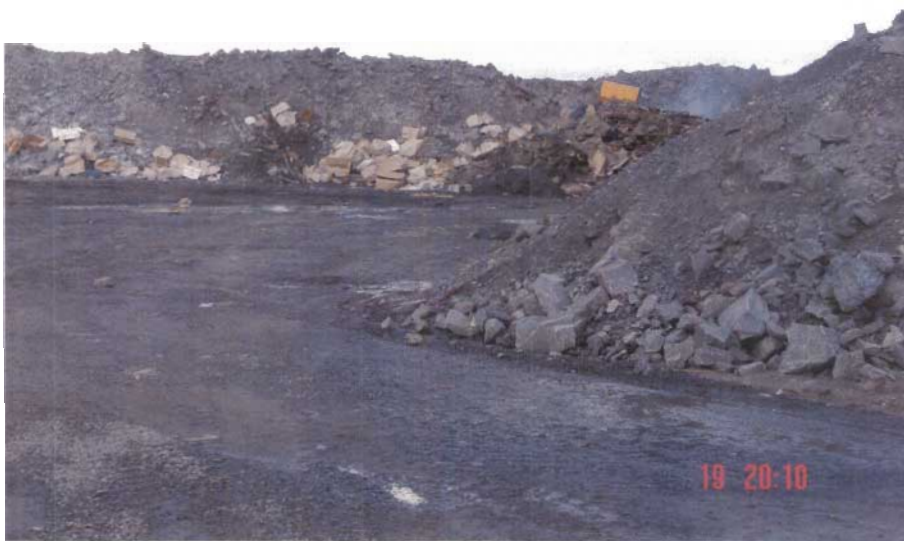
Photo # 11. Burn Pit in operation.

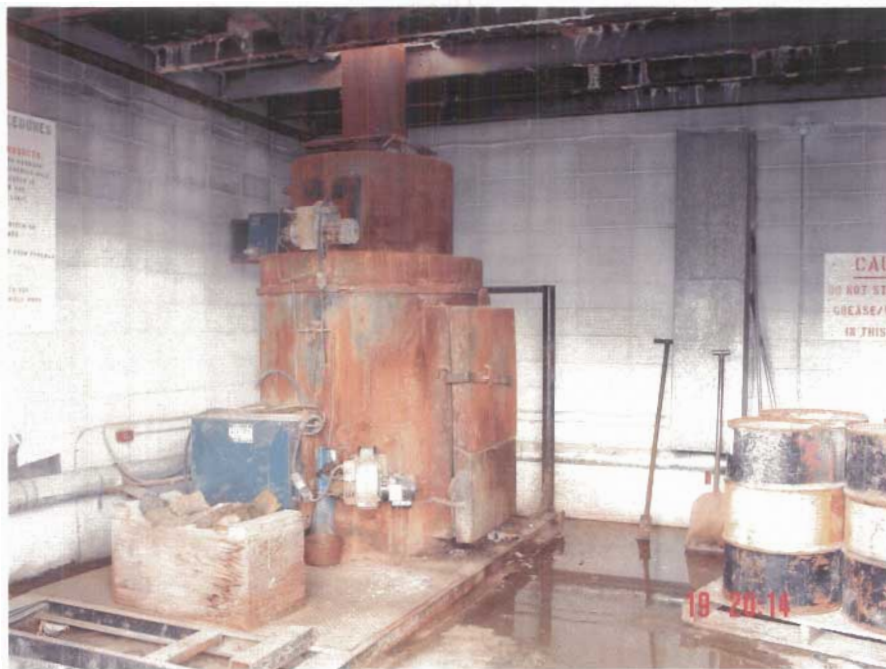
Photo # 12. Incinerator used to burn non hazardous waste.

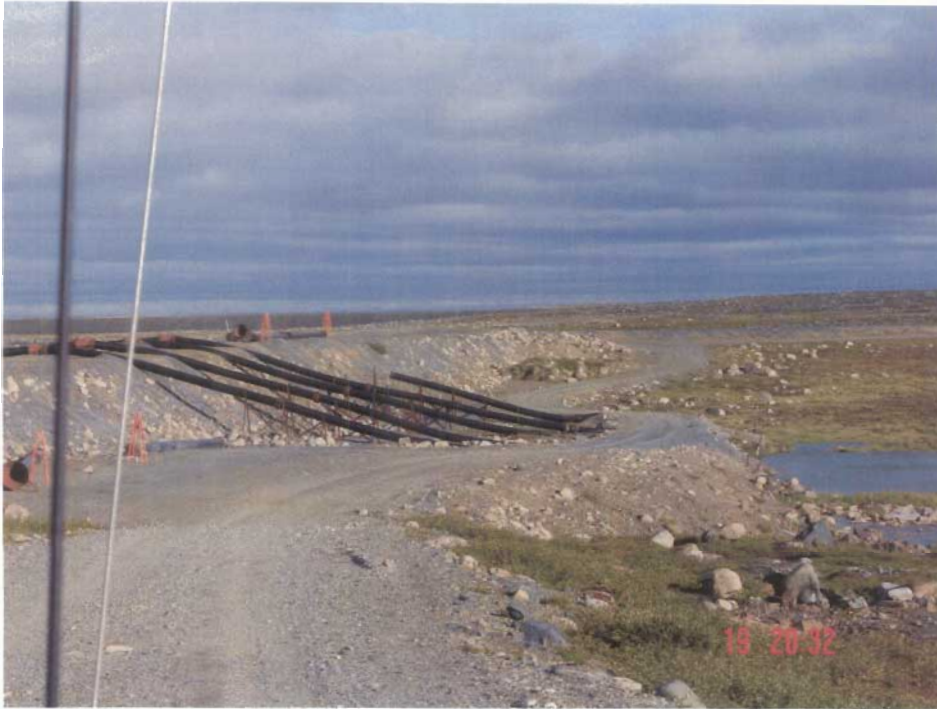
Photo # 13. Tailings Pond 2 Siphon Discharge Structure. Dam 1A location of Tailings discharge SNP-925-10 sample location.

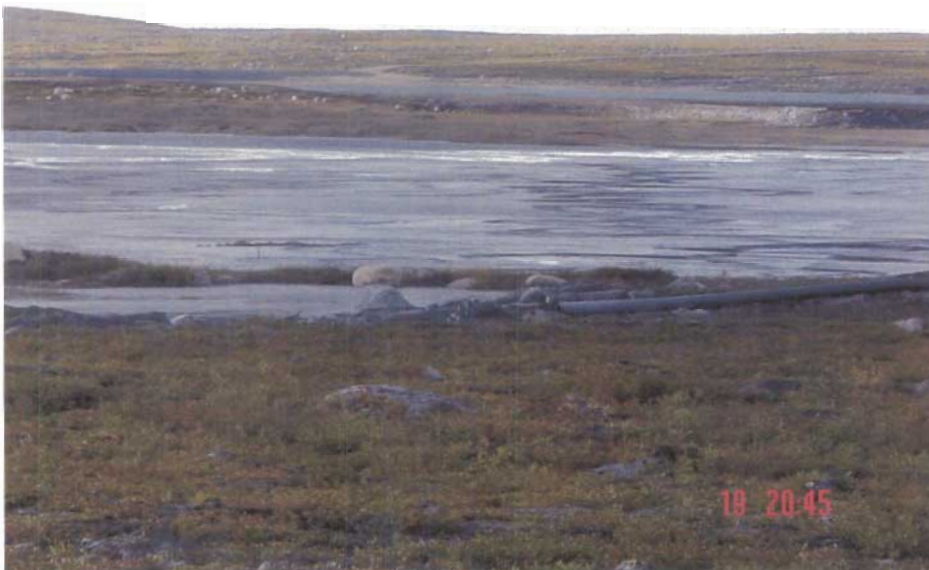
- ☐ **Tailings Disposal:** Mine tailings are pumped to the tailings ponds (Photo 14) where the wastewater is held for 3 years. Mine wastewater treatment, is achieved with a combination of chemical pH neutralization and biodegradation. Tailings Pond 2 was in the process of being decanted at the time of inspection (Photo 13). Enclosed analyses of samples taken at (SNP 925-10) Tailings Pond # 2 syphoning structure indicate that pH (6.88 vs 6.5-9.5), Arsenic (0.0195 mg/L vs 0.1 mg/L), Copper (0.01 mg/L vs 0.3 mg/L), Cyanide (0.044 mg/L vs 1.6 mg/L) and Zinc (0.159 mg/L vs 0.8 mg/L) are in compliance with Licence Discharge Criteria.

Photo # 14. Mine Tailings Line discharge .
