Re: Lupin Mine Water Licence Inspection July 7, 2004 and July 13, 2004

INDUSTRIAL WATER USE INSPECTION REPORT

Licensee: Kinross Gold (Echo Bay Mine)

Licence No.:NWB1LUP0008

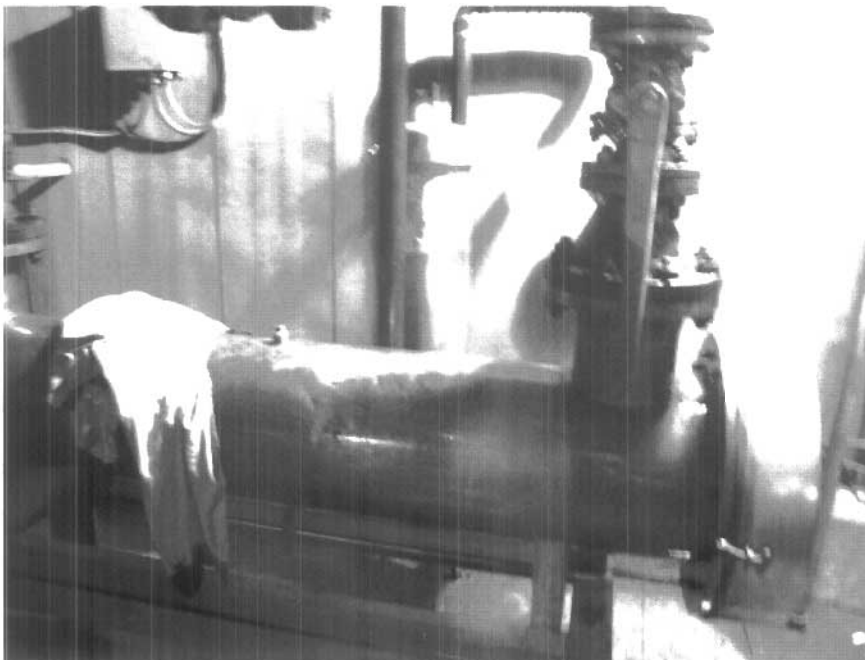
Drinking water quality is maintained using Ultra Violet radiation in combination with a 10 um filtration system. The filters are changed every two days and water use is recorded weekly and used to calculate annual water consumption. According to the pumping report provided for 2003, 681 584 cubic metres of water was pumped out of Contwoyto Lake and used either as potable or process water. The amount reported was well below the annual limit of 1 700 000 cubic metres per year set by the Nunavut Water Board. Discussion with Mike Tansey suggested that the use of End Lake as a water source for dust suppression was cleared by the NWB however, this water use should be included in the annual report. All parameters tested were within the Canadian Council of Ministers of the Environment Summary of Guidelines for Canadian Drinking Water Quality 2003.

Figure 2. Ultraviolet Radiation Unit in the Water Treatment Plant at Lupin Mine.

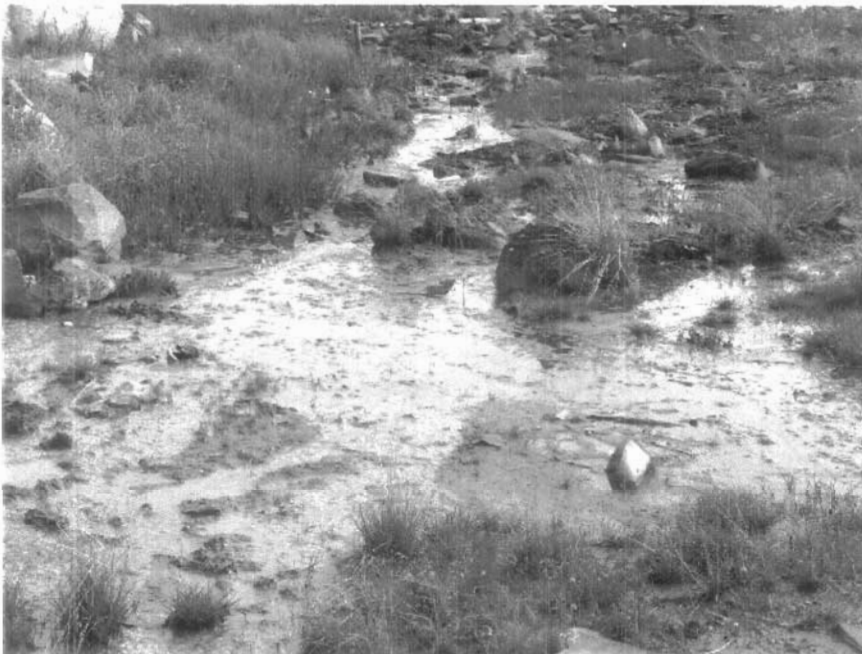
Burnable waste is open burned (figure 3) and landfilled while metal waste is compacted and landfilled. The Landfill site appears to be efficiently operated with the waste covered regularly. A seep on the south east side of the landfill had a film of oil and grease on it's surface (figure 4). The sample was taken at N 65°45'42.1" W 111°13'23.6". A number of the parameters measured exceeded the Canadian Water Quality Guidelines for the Protection of Aquatic Life 2002. Arsenic 223 ug/L >> 5.0 ug/L, Oil and Grease 26 mg/L > no visible sheen, Cadmium 0.6 ug/L > 0.017 ug/L (hardness not incorporated into Water Quality Guideline) Chromium 7.6 ug/L > 1.0 ug/L, Iron 17 300 ug/L >> 300 ug/L, Selenium 2 ug/L > 1.0 ug/L and Zinc 1360 ug/L >> 30 ug/L. Given the high levels of contaminants in this seep and it's potential toxicity, measures need to be taken to contain and treat this seepage to prevent it's entry into water which would be a violation of the Nunavut Waters and Nunavut Surface Rights Tribunal Act 2002.

Figure 4.A seep adjacent to the Lupin Landfill taken at N 65°45'42.1" W 111°13'23.6".

The Licencee is out of compliance with respect to leachate being discharged in the area of the Landfill. Water at the coffer dam at cell four of the TCA exceeds CCME Water Quality Guidelines for the Protection of Aquatic Life 2003. Accordingly, the water collected in the coffer dam at cell 4 should be pumped into the tailings pond and discharged as part of the tailings effluent. Aside from the problems noted with the sewage effluent and landfill leachate the licensee appears to be in compliance and committed to operating within the parameters of their licence.

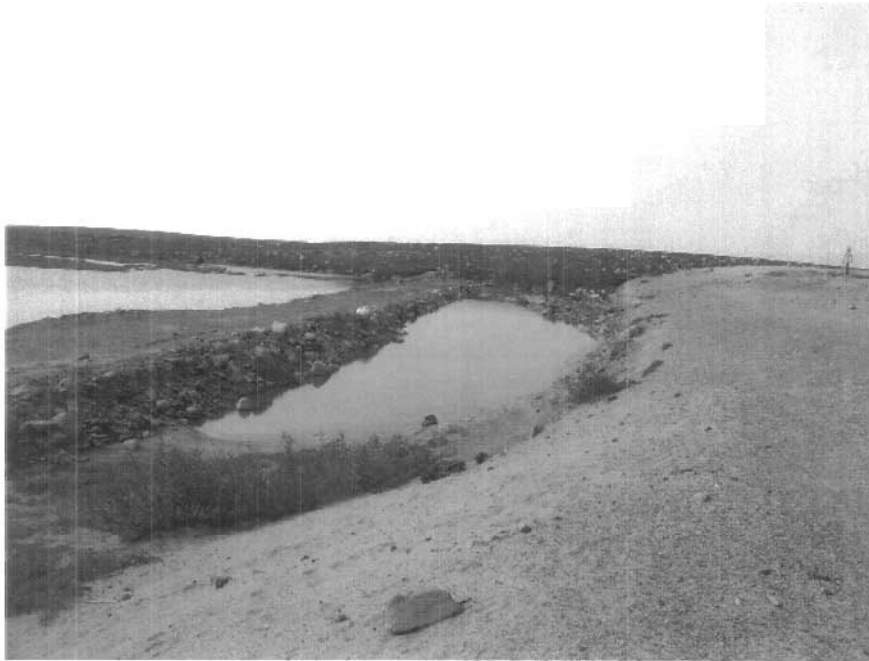
No leachate was observed at the Tailings Containment Area however; water samples taken at the Coffor Dam at Cell 4 (Figure 5) exceeded Canadian Guidelines for Aluminum (3110 ug/L > 5-100 ug/L), Arsenic (163 ug/L > 5ug/L), Copper (39.9 ug/L > 2-4 ug/L), Iron (10300 ug/L > 300 ug/L) and Zinc (155 ug/L > 30 ug/L). The parameters measured do not exceed the discharge guidelines for the tailings effluent but the high levels at the coffer dam could indicate a seep or runoff problem..

Figure 5. Sample taken at N 65° 43' 02.7" W 111° 16' 13.1" at Coffey Dam at cell four of Lupin Tailings Containment Area.

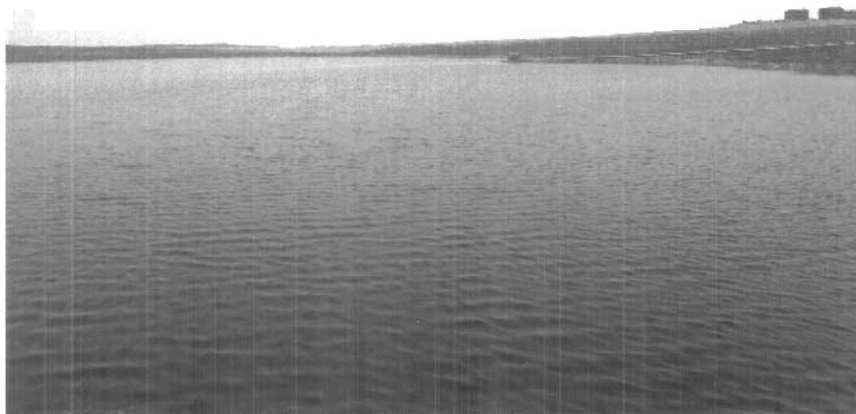
The two sewage treatment lagoons at Lupin Mine (figure 6) appear to be working effectively however, during the first site visit the pH of the sewage effluent exceeded the Licenced Guideline (9.84 > 7.0 to 9.0). As a result, sewage effluent could not be discharged from the second lagoon. Discharge was delayed until the pH was within Licenced Guidelines. Samples of the sewage effluent being discharged on July 13, 2004 revealed that the effluent exceeded the Canadian Water Quality Guidelines for the Protection of Aquatic Life 2003 for a number of parameters. These parameters include Arsenic (11 ug/L > 5.0 ug/L), Aluminum (112 ug/L > 100ug/L), Copper (8.1 ug/L > 4.0 ug/L) and Selenium (3.0 ug/L > 1.0 ug/L), however none of the parameters measured exceeded the Licenced Guidelines. The free board in the lagoon was not a concern.

Figure 6. The first lagoon of the two lagoon sewage treatment system at Lupin Mine.
