LUPIN MINES INCORPORATED – A WHOLLY OWNED INDIRECT SUBSIDARY OF ELGIN MINING INC.

Fuel Containment Management Strategy

Lupin Mine Site

February 2012

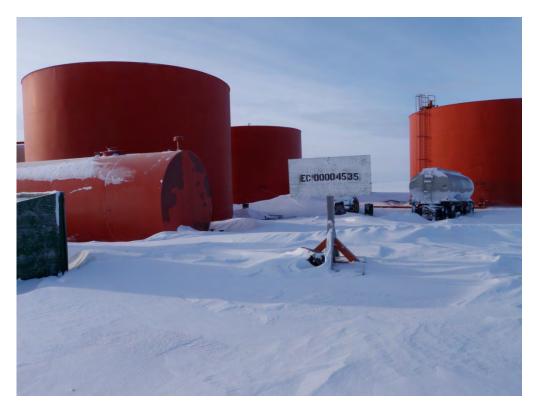
Photo 1: Main Tank Farm, Feb 2012. Tanks M-22, M-05, M-06, M-23, M-11 (left to right).

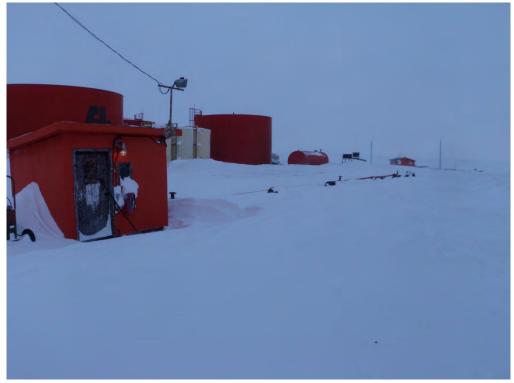
Photo 2: Main Tank Farm, Feb 2012. Pump Station 2, Tanks M-04, M-21, M-20, M-19, M-5, M-23 (left to right).

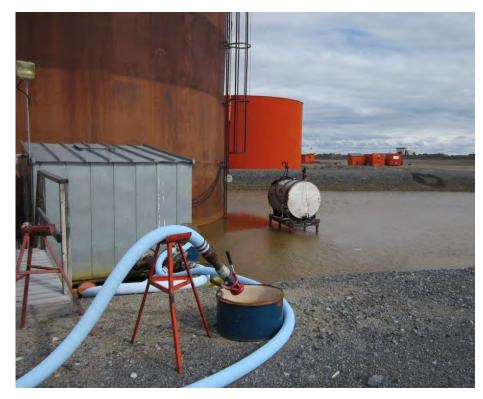
the system, including changing elements in the filter separator and the fuel monitor. A spill box is used when dispensing fuel, as shown in Photo 3.

One remaining horizontal AST, MTF-1, is approximately 2,000 L in capacity and is located adjacent to M-15 as shown in Photo 3. This tank is not registered.

Photo 3: Jet A Fuel Dispensing Facility, Aug 2011. Tanks M-15, M-13, MTF-1 (left to right).

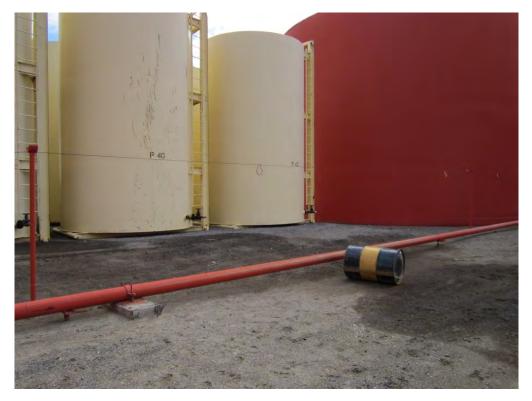
The MTF is located in a lined, bermed area providing secondary containment for all of the tanks and piping. Patches of historically contaminated soil are present within the containment (Photo 4).

Photo 4: Individual Tanks in MTF, Aug 2011. Tanks M-20, M-19, M-5 (left to right).

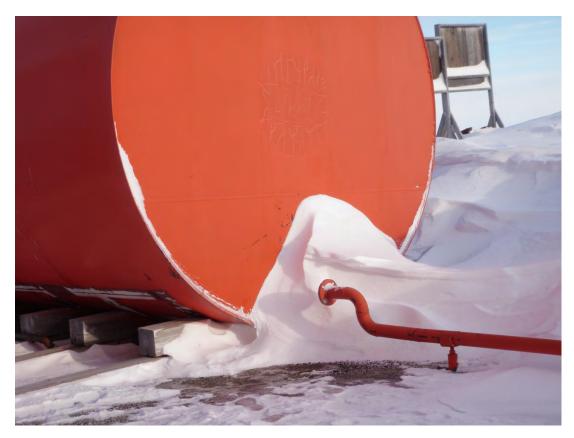
Two of the remaining tanks, M-22 and M-23, are located north of tank M-05 and are registered as EC-00018377 and EC-00018378, respectively. They are horizontal ASTs. Tank M-22 has a capacity of approximately 144,000 L and Tank M-23 has a capacity of approximately 6,000 L. Both tanks were emptied in October 2011 when the P-40 diesel was consolidated in tanks M-10 and M-13. Neither are connected to the system (Photo 5).

Photo 5: M-22 Disconnected From Piping, Feb 2012.

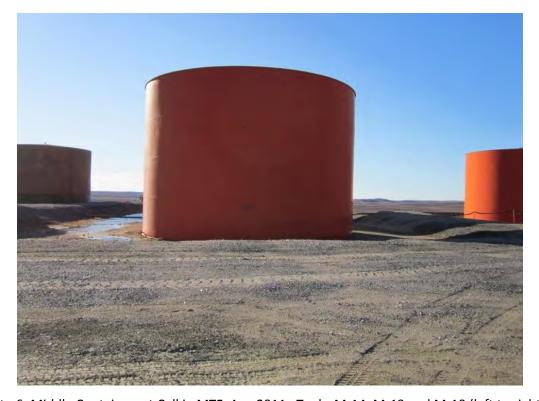
Photo 6: Middle Containment Cell in MTF, Aug 2011. Tanks M-14, M-13 and M-10 (left to right).

Expansions to the tank farm have resulted in three containment areas being present. The Main Pump House, Tanks M-01 thru M-11, and M-16 thru M-23 are located within the original secondary containment. Tanks M-12 and M-13 are located in a second containment area (Photo 6) and the Jet A pump station, Jet-A tanks M-15, M-14 and MTF-1are located in a third area.

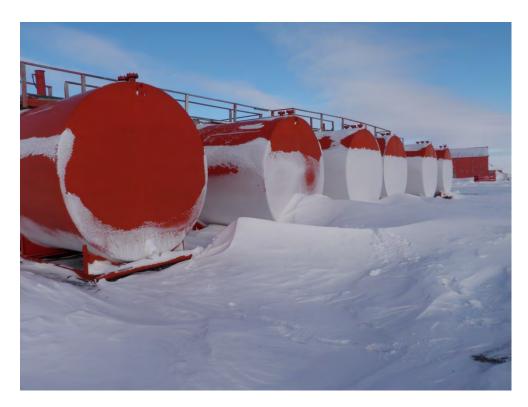
There are 10 diesel tanks (S-1 through S-10) in the STF diesel system, registered as EC-00004544 (Photo 7). They are steel, single wall, horizontal above ground storage tanks, all with an individual capacity of 92,920 L (individual specs listed in Appendix 1). Tanks S1 to S4 (closest to the shop) were originally set up to contain P-50 fuel. These tanks fed the radiant heaters in the surface shop and the vehicle fuel pumps. Tanks S-5 to S-10 (closest to road) were originally set up to contain P-40 fuel. These tanks fed the powerhouse.

Photo 7: STF, Feb 2012. Tanks S-05 thru S-10 (left to right).

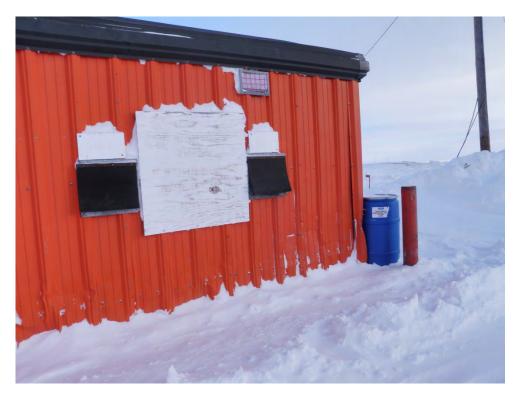
The diesel pump station is located outside of the secondary containment area in the same building as the gasoline pump (see Photo 8). It was not in service when Elgin Mining purchased the property. It has subsequently been reactivated and is currently used to provide product to the mobile site delivery tank for refueling of the active day tanks listed in Section 2.5 of this document.

Photo 8: Diesel and Gas Pump Station, STF, Feb 2012.

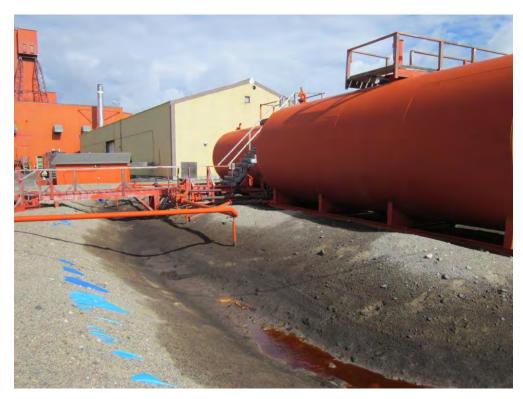
The STF is located in a lined, bermed area providing secondary containment for all of the tanks and a portion of the piping. Contaminated soil lining the containment area has been observed; it is suspected that a historical spill occurred causing the contamination, as all tanks have been deemed leak-free (Photo 9).

Photo 9: Evidence of Historical Spill in STF, Aug 2011. Tank S-05 in the Foreground

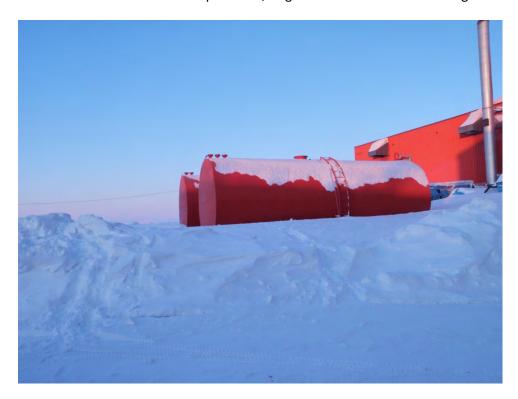
The waste oil tank farm (WOTF) is located south of the power house (Photo 10). Used oil from the surface and underground shops was placed in the two used oil above ground storage tanks. During operations the tanks were emptied into a tanker truck for off-site transport via the winter ice road and disposal as required. The tanks are located within secondary containment and contain two (2) tanks and partially buried piping connecting it to the power house (Photo 11).

Photo 10: WOTF, Feb 2012. Tank WO-2 in the Foreground.

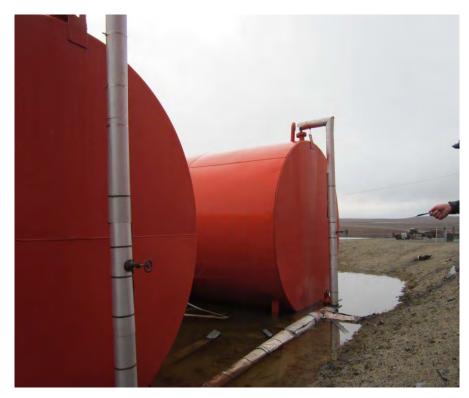
The waste oil was transferred from the powerhouse to the tanks via an underground wrapped pipeline as shown in Photo 11.

Photo 11: WOTF, Sept. 2011. Tanks WO-2 and WO-1 (left to right).

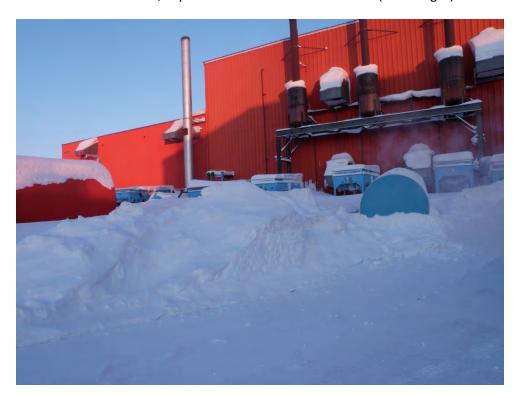
The power house glycol tanks, GLY-1 and GLY-2, and several radiators are located outside of the power plant (Photo 12). The glycol tanks have a capacity of approximately 9,000 L each. There is no secondary containment in this area. Historical spill reports show that the north radiator released an undetermined amount of glycols in the past.

Photo 12: Blue Glycol Tank (GLY-2 in foreground) and Radiators, Feb 2012.

• Inspect and document condition of glycol tanks and radiators. Maintain tanks and radiators in empty state pending the decision to reopen the Lupin Mine.

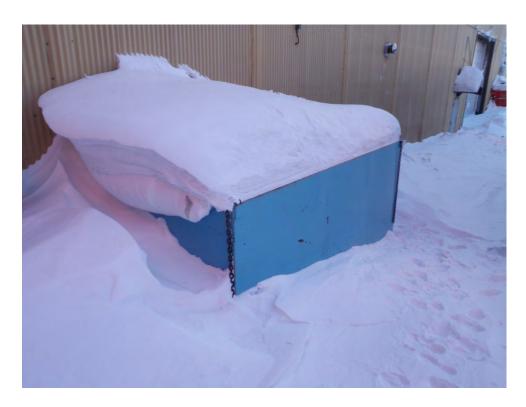
Tank GLY-4 is located adjacent to the machine shop (Photo 13) and has a capacity of approximately 22,000 L. This tank is in its original location.

Photo 13: GLY-4, Feb 2012.

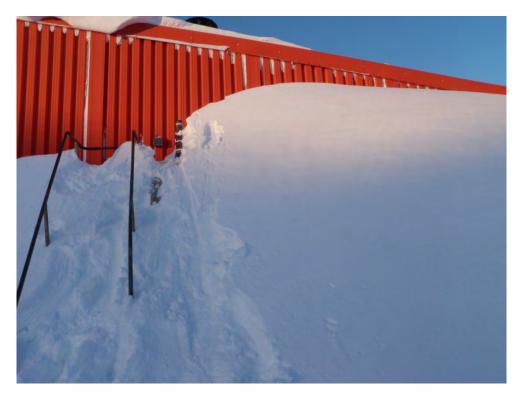
Tank GLY-5 is located adjacent to the office complex (Photo 14) and has a capacity of approximately 2,000 L. Based on historical information, this tank is believed to be in its original location, connected to a boiler system inside the plant. Full assessment of the tank was not possible during a recent visit due to snow cover.

Photo 14: GLY-5, Feb 2012.

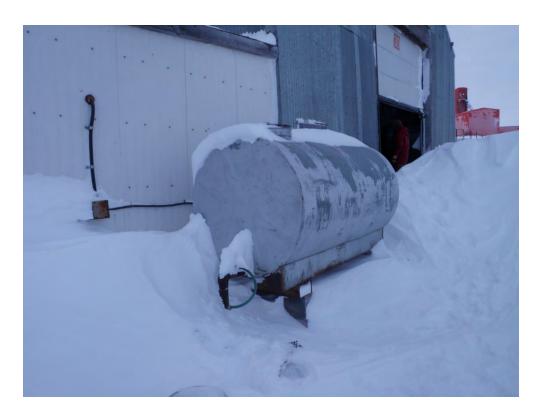
There is an approximately 2,000 L tank located outside the RTL shop, tank IND-1 (Photo 15). This tank is currently not in use, and is believed to have contained diesel. The tank is not registered.

Photo 15: Tank IND-1 at RTL Shop, Feb 2012.

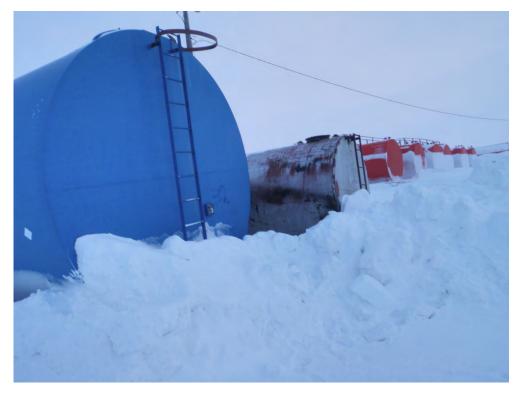
Tank IND-4 is a 60,000L horizontal AST located adjacent to the STF (Photo 16). This tank was removed from service prior to 2008 is currently being used to contain hydrocarbon contaminated water, until the water can be tested and treated prior to disposal or discharge.

Tanks IND-5 and IND-6 are currently not in use, and are spare tanks. Tank IND-5 has a capacity of approximately 22,000 L and is located adjacent to the STF (Photo 16). Tank IND-6 is a new tank that has not been installed. It has a capacity of 2,290 L and is a double wall tank.

Photo 16: Tanks IND-4, IND-5, S-05 thru S-10 (left to right).

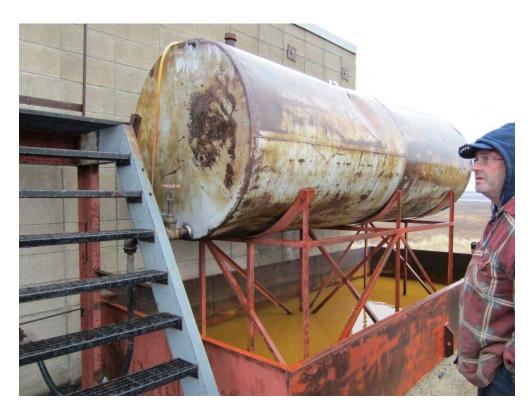
When in use, the incinerator is fueled by a single wall, horizontal AST, with 7,000 L of capacity, IND-8 (Photo 17). The incinerator and tank are currently not in use.

Photo 17: Incinerator Tank, IND-8.

- Replace tank in generator station and install second tank system as back-up in accordance with Sections 14, 33, 34 and 44 of the Regulations.
- Replace incinerator tank in accordance with Sections 14, 33, 34 and 44 of the Regulations.
- Install tanks to provide heat for the machine shop to replace supply from the STS (exempt under Section 2.(2)(c) of the Regulation).
- Replace hosing on shop generator tank in order to meet current standards.
- Replace emergency generator tank (exempt under section 2.(2)(c) of the Regulation).
- Replace 205 L drums being used to heat the hot water and sewage building (exempt under section 2.(2)(c) of the Regulation).

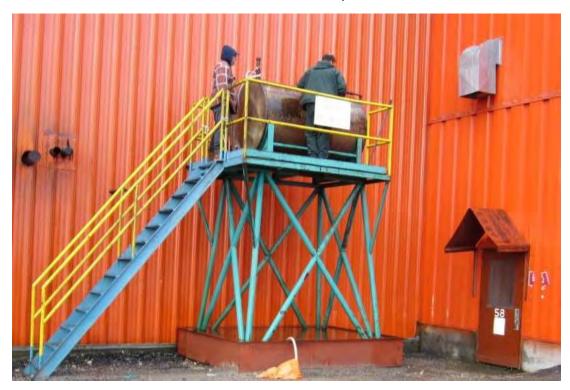
One tank remains connected to the mill, but is not in use, IND-10. This tank has a capacity of approximately 2,000 L and is in secondary containment (Photo 18).

Photo 18: Mill Tank, IND-10.

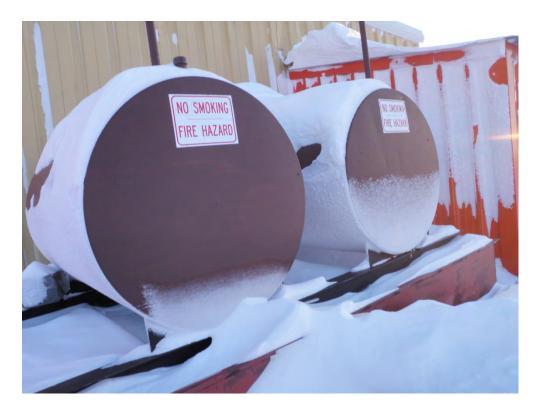
Two tanks supply the former emergency power house, EG-1 and EG-2 (Photo 19). Each tank is approximately 2,000 L in capacity. They are located in secondary containment.

Photo 19: Tanks for former emergency powerhouse, Feb 2012. EG-1 and EG-2.

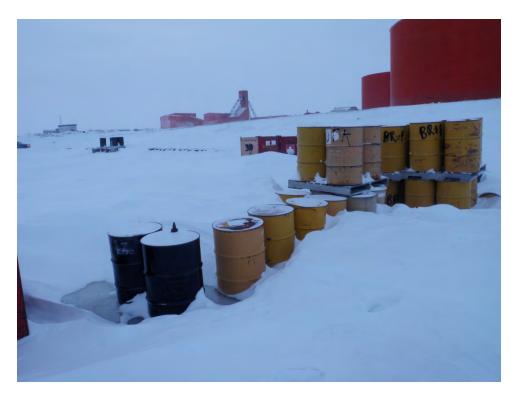
Photo 20: Third Party Storage Area, Feb 2012.

Third party fuel is stored on site in a bermed storage area north of the MTF (Photo 20). It is assumed that this area is lined. Various containers of fuel and lube oil are stored here.

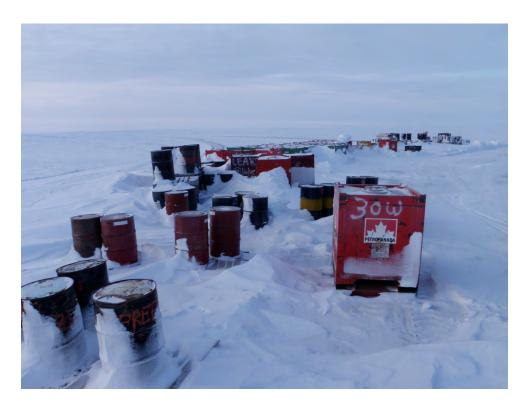
Photo 21: Lube Oil Storage Area, Feb 2012

Miscellaneous lube oils are stored in a bermed, lined area north of the MTF (Photo 21).

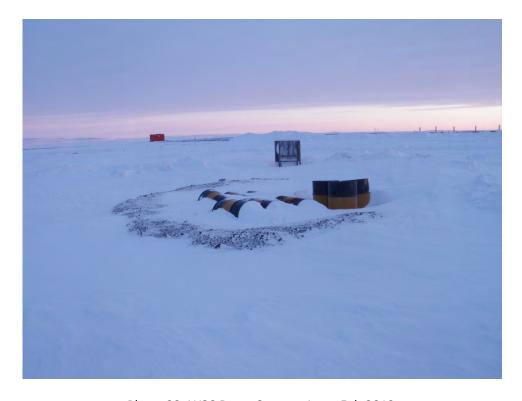
Photo 22: WSC Drum Storage Area, Feb 2012

Water Survey Canada had some fuel drums stored on site near the freshwater intake on Contwoyto Lake. In summer 2011, these barrels were relocated to a bermed, upland storage area beyond 31 m from the high water mark (Photo 22).

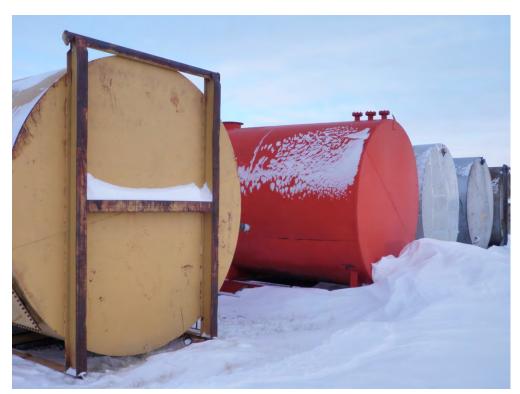
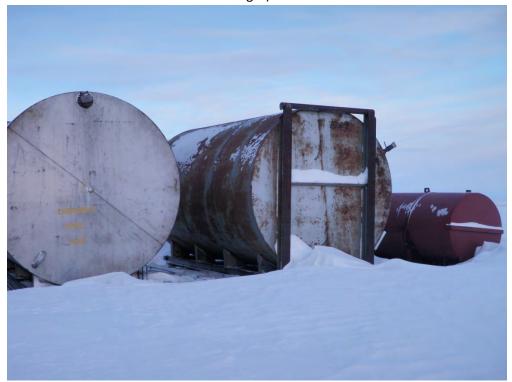
Six (6) horizontal ASTs are located in the site bone yard, ranging in volume from 14,000 L to 105,000 L (Photos 23, 24); two (2) tanks are listed in FIRSTS as EC-00018404 and EC-00018409, and were permanently withdrawn from service and discarded prior of the regulations coming into force in June 2008. It is unclear which of the six tanks are EC-00018404 and EC-00018409.

Photo 23: Tanks Withdrawn From Service in the Bone Yard, Feb 2012. Tanks BY-1 thru BY-5 (left to right).

Photo 24: Tanks Withdrawn From Service in the Bone Yard, Feb 2012. Tanks BY-4 thru BY-6 (left to right).

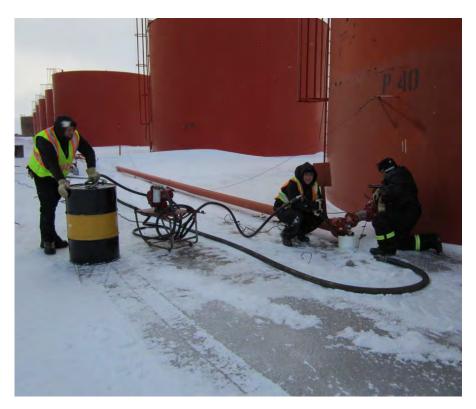
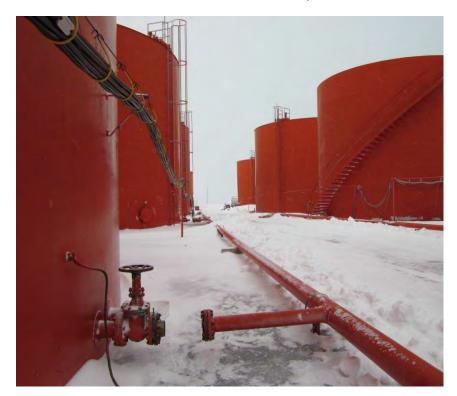
Photo 25: Remedial Works in MTF, Oct 2011.

Photo 26: Remedial Works in Oct 2011. Disconnected Header in MTF.

All inactive tanks were disconnected from the common header and blinded (Photos 25 and 26). The pipeline header was pressure-tested and determined to be leak free. It has been drained and capped.
