Lupin Mines Incorporated

Lupin Mine Site

Interim Closure and Restoration Plan

October 2017

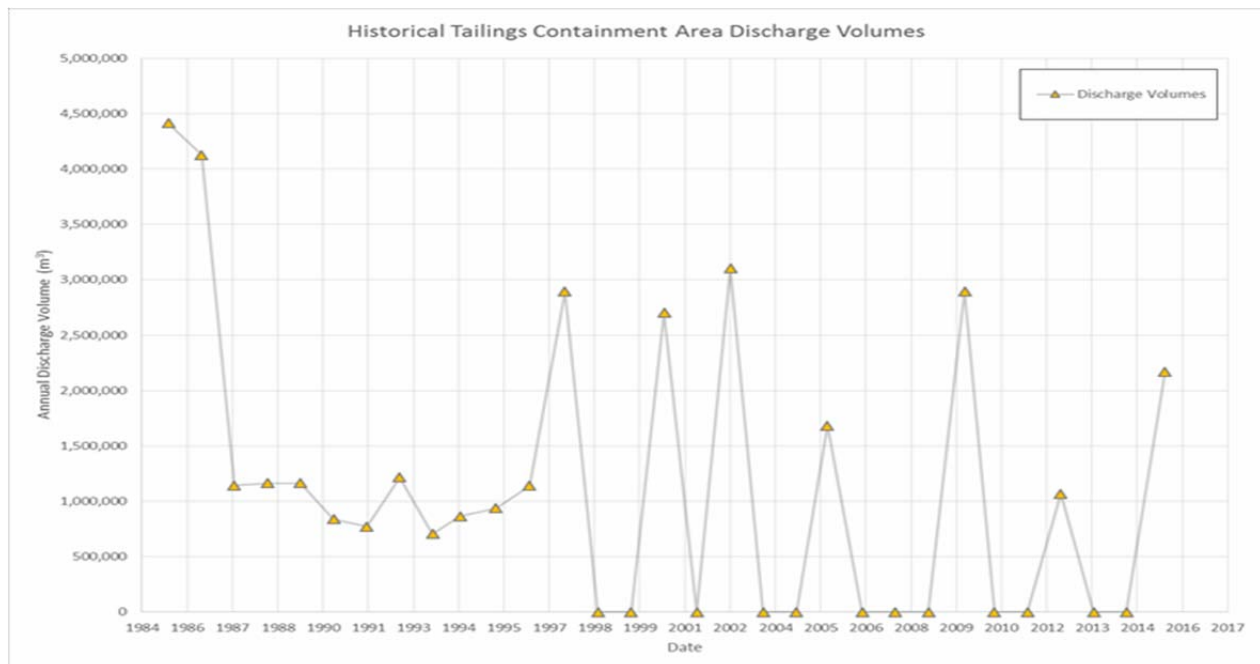
Figure A: Historical Tailings Containment Area Discharge Volumes

The frequency of water discharge from TCA into the receiving environment has been variable over the life of the mine. Discharge occurred annually between 1985 and 1997, and then every two to four years until 2015. Since the Site entered care and maintenance in 2005, there have been four water treatment campaigns to reduce the volume of water within the facility. These campaigns have occurred in 2005, 2009, 2012, and 2015. Figure A illustrates the annual volume of water discharged to the environment.
