Lupin Mine Reclamation

2021 Construction Summary Report –
Cell 3 – Rev.2

Mandalay Resources Ltd.

Stantec Consulting Ltd.

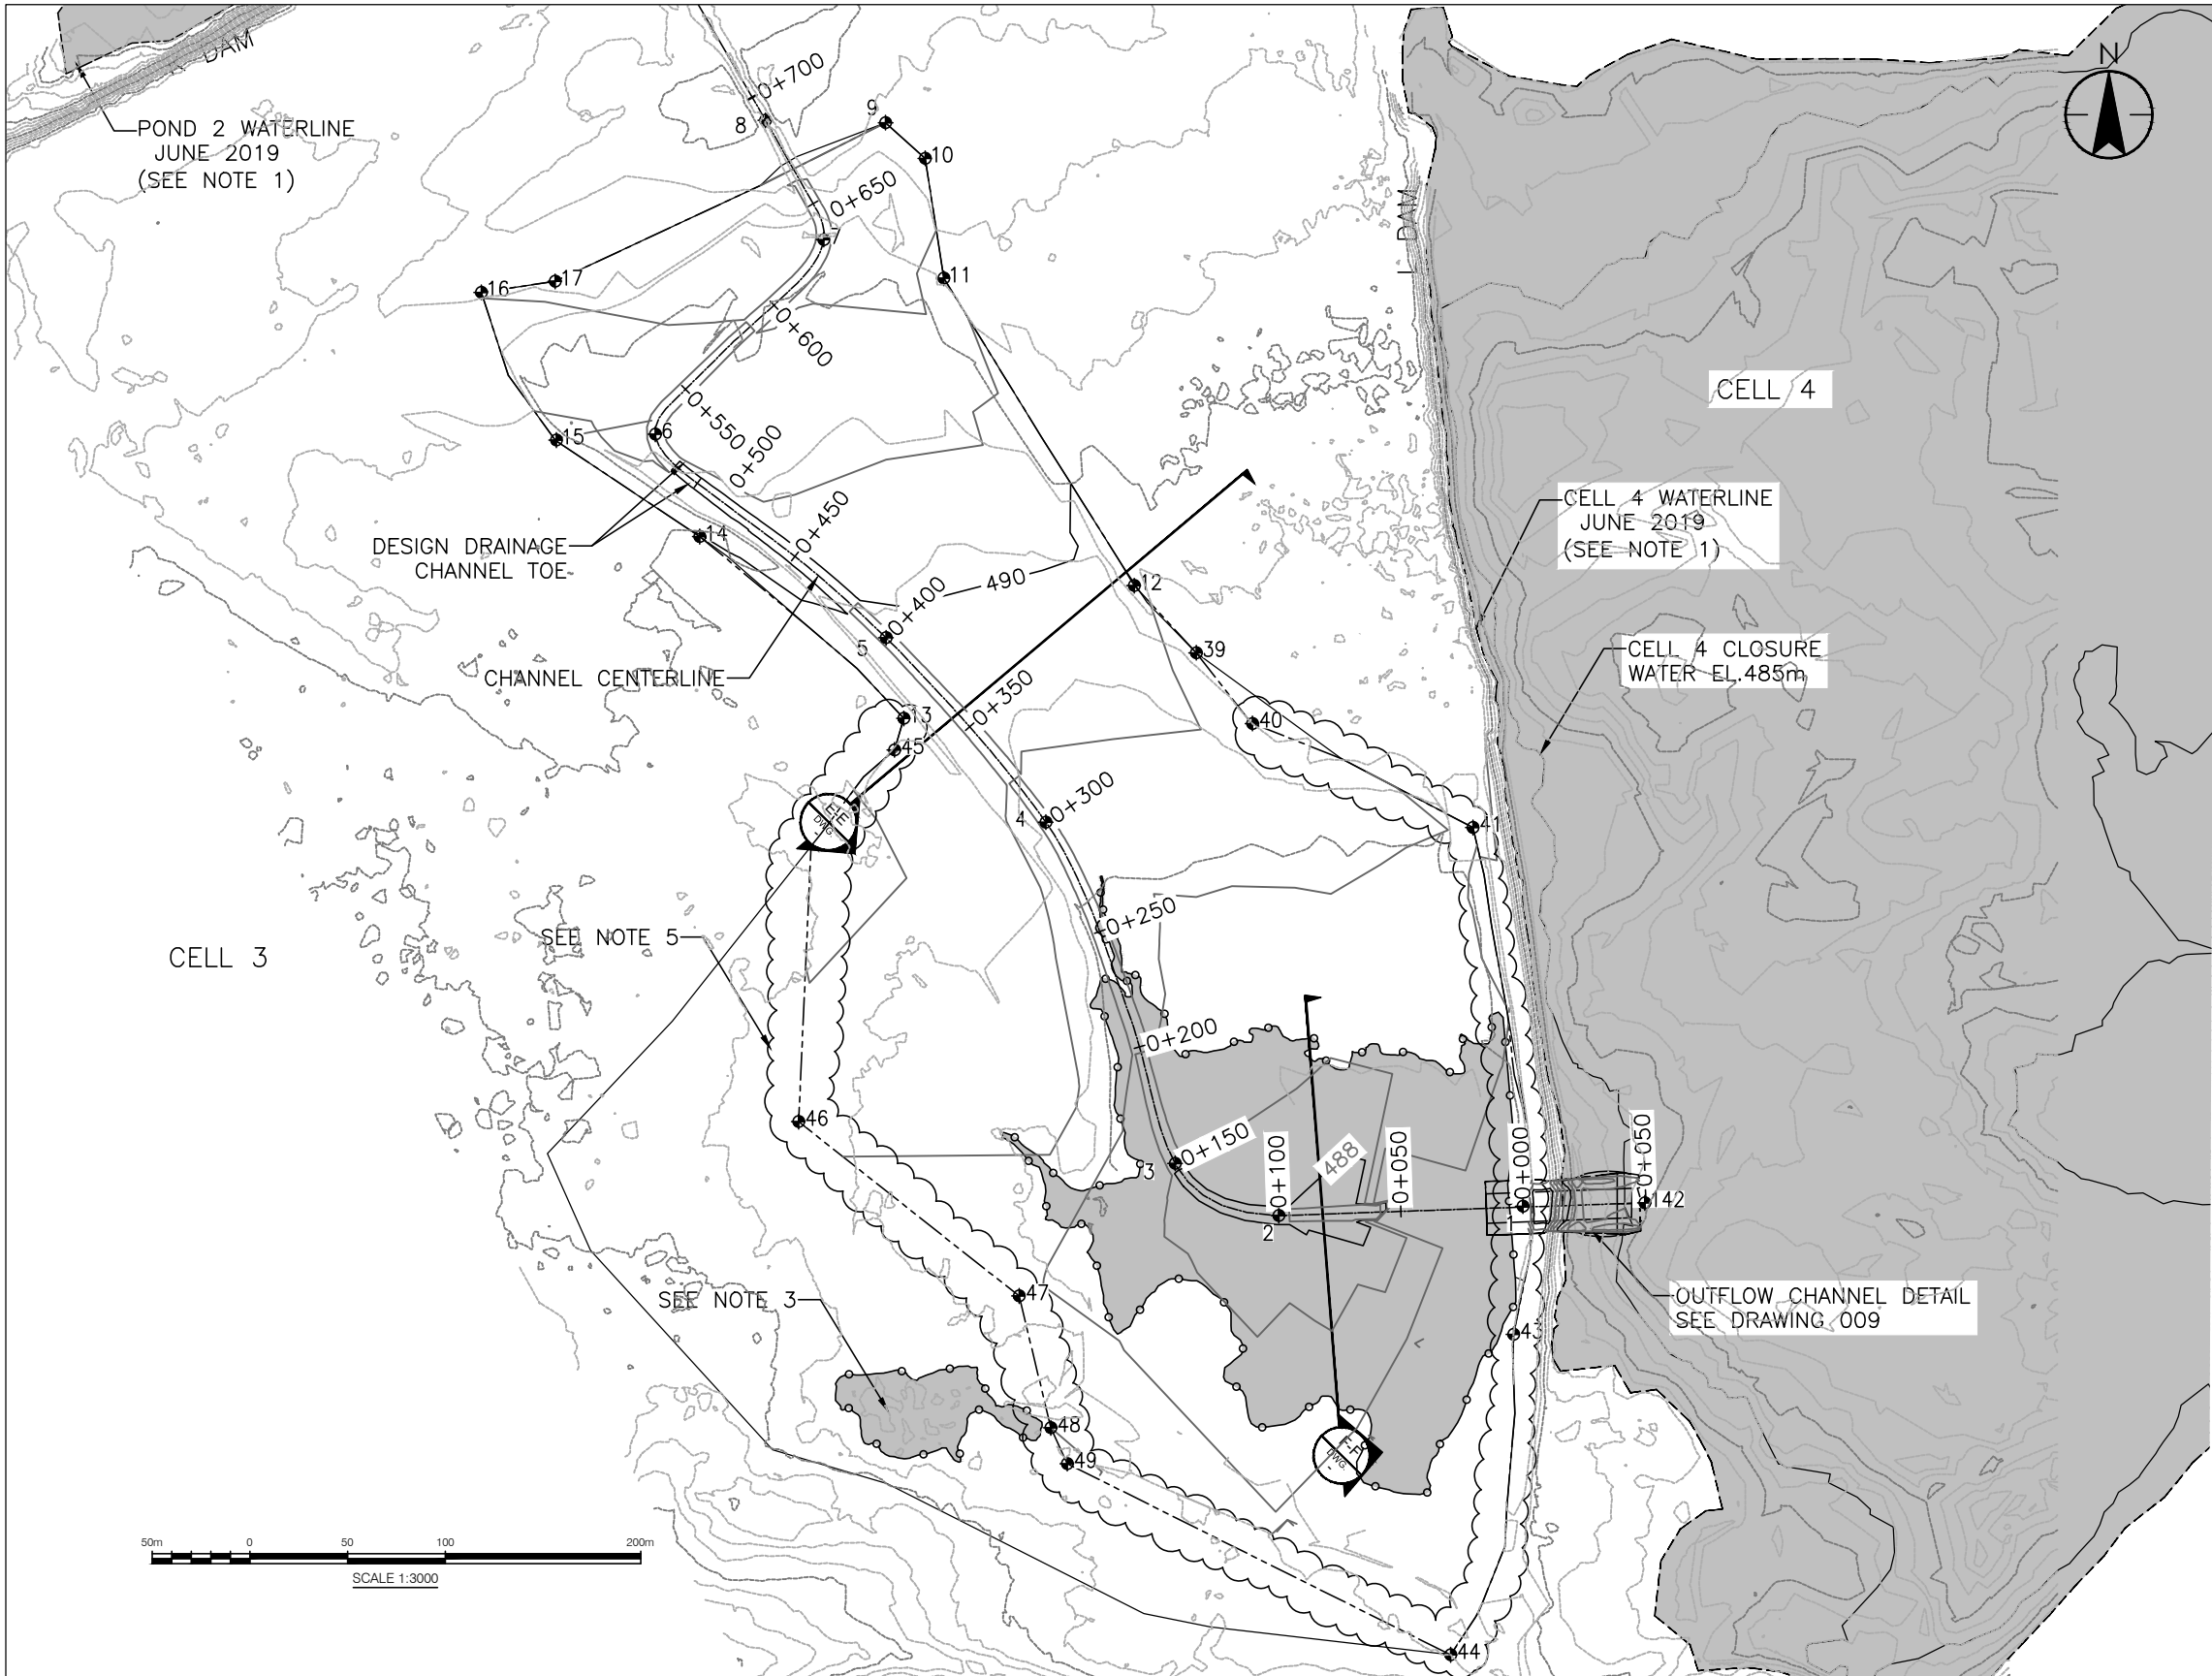
Title
CELL 3 CLOSURE
PLAN VIEW

Cell 3 was designed to be fully covered by 1 m of esker material with a surface channel draining into Cell 4. Cover tie-in to the existing ground and structures were planned to be field-fitted by the resident geotechnical engineer with the assistance of a surveyor. The outflow channel was designed through a section near the south abutment of Dam L to be primarily composed of coarse sand and gravel with cobble material overlaying a geotextile cover placed on original ground and esker material. Surface water management design criteria can be found in Table 2. The associated design flow for the 1:100-year event is 1.56 m³/s. Detailed Cell 3 design criteria can be found in Table 3 and Drawings 006 to 009 in Appendix A.

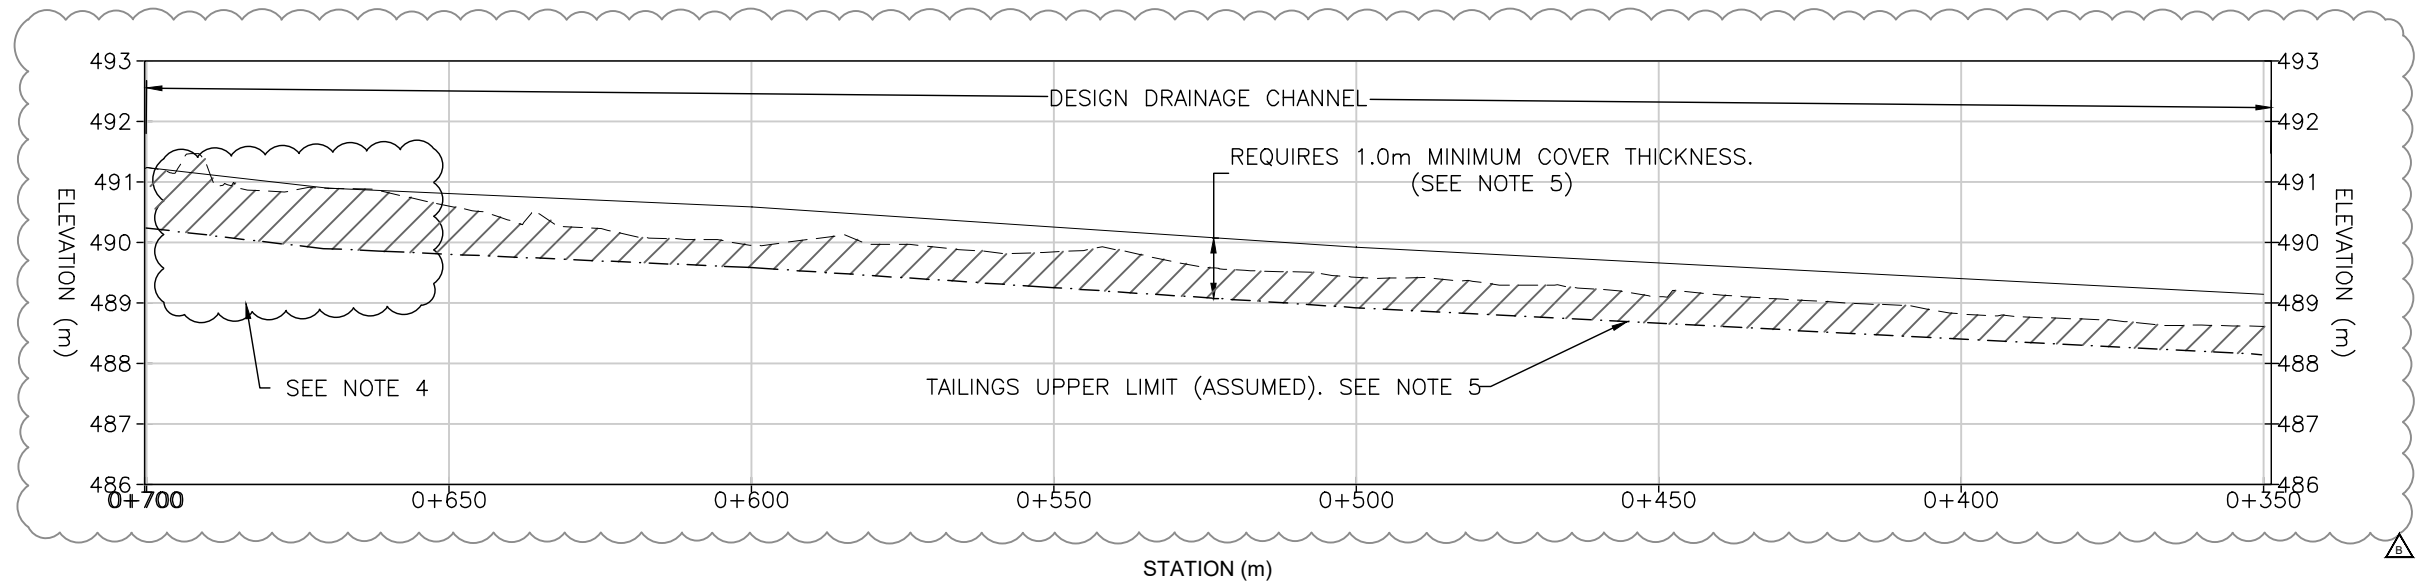
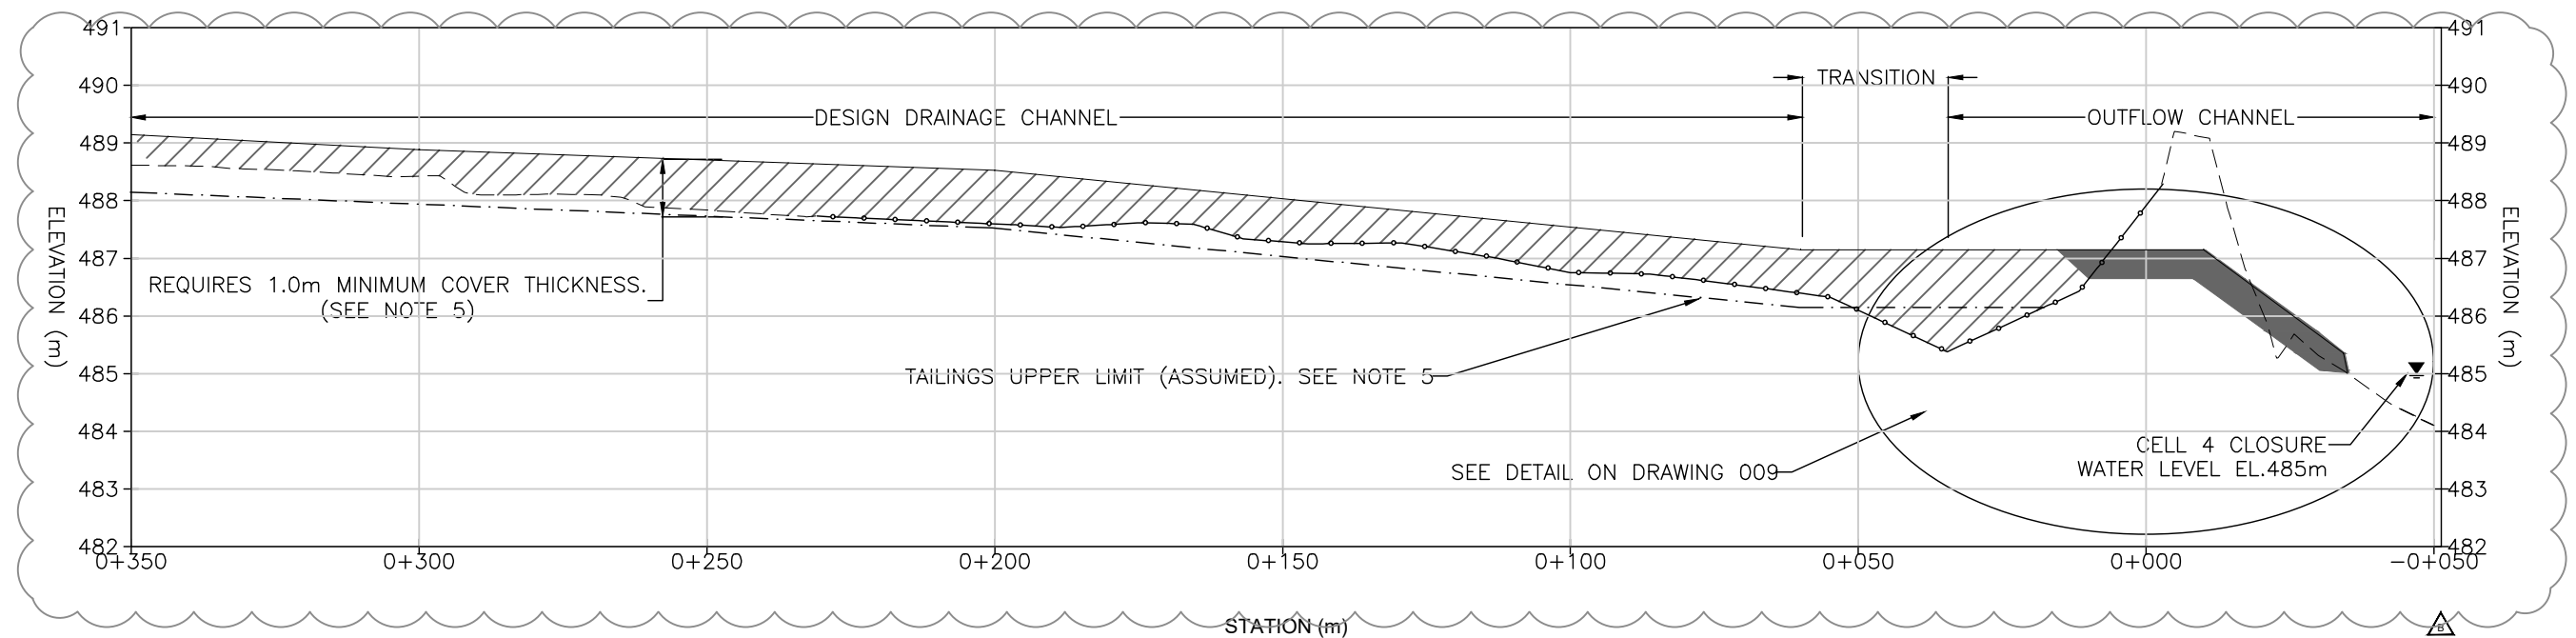
CELL 3 CLOSURE
PROFILE ALONG CHANNEL CENTERLINE

CHANNEL CENTERLINE PROFILE (STA 0+350 TO STA 0+760)
VERTICAL EXAGGERATION: 10X

CHANNEL CENTERLINE PROFILE (STA 0+00 TO STA 0+350)
VERTICAL EXAGGERATION: 10X

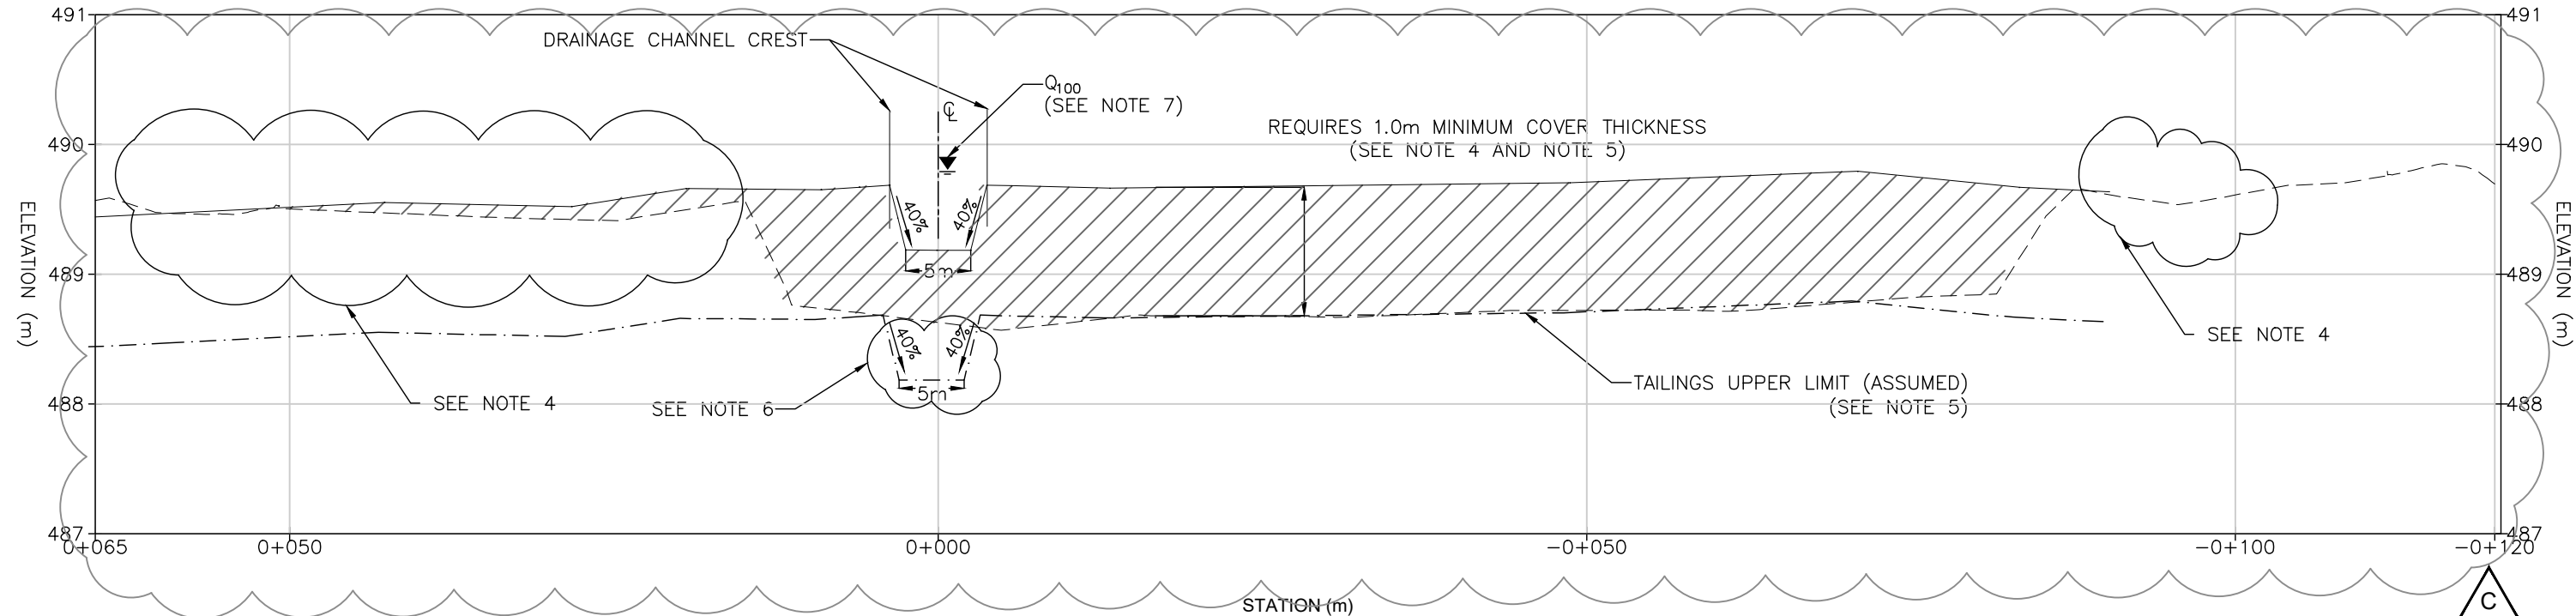
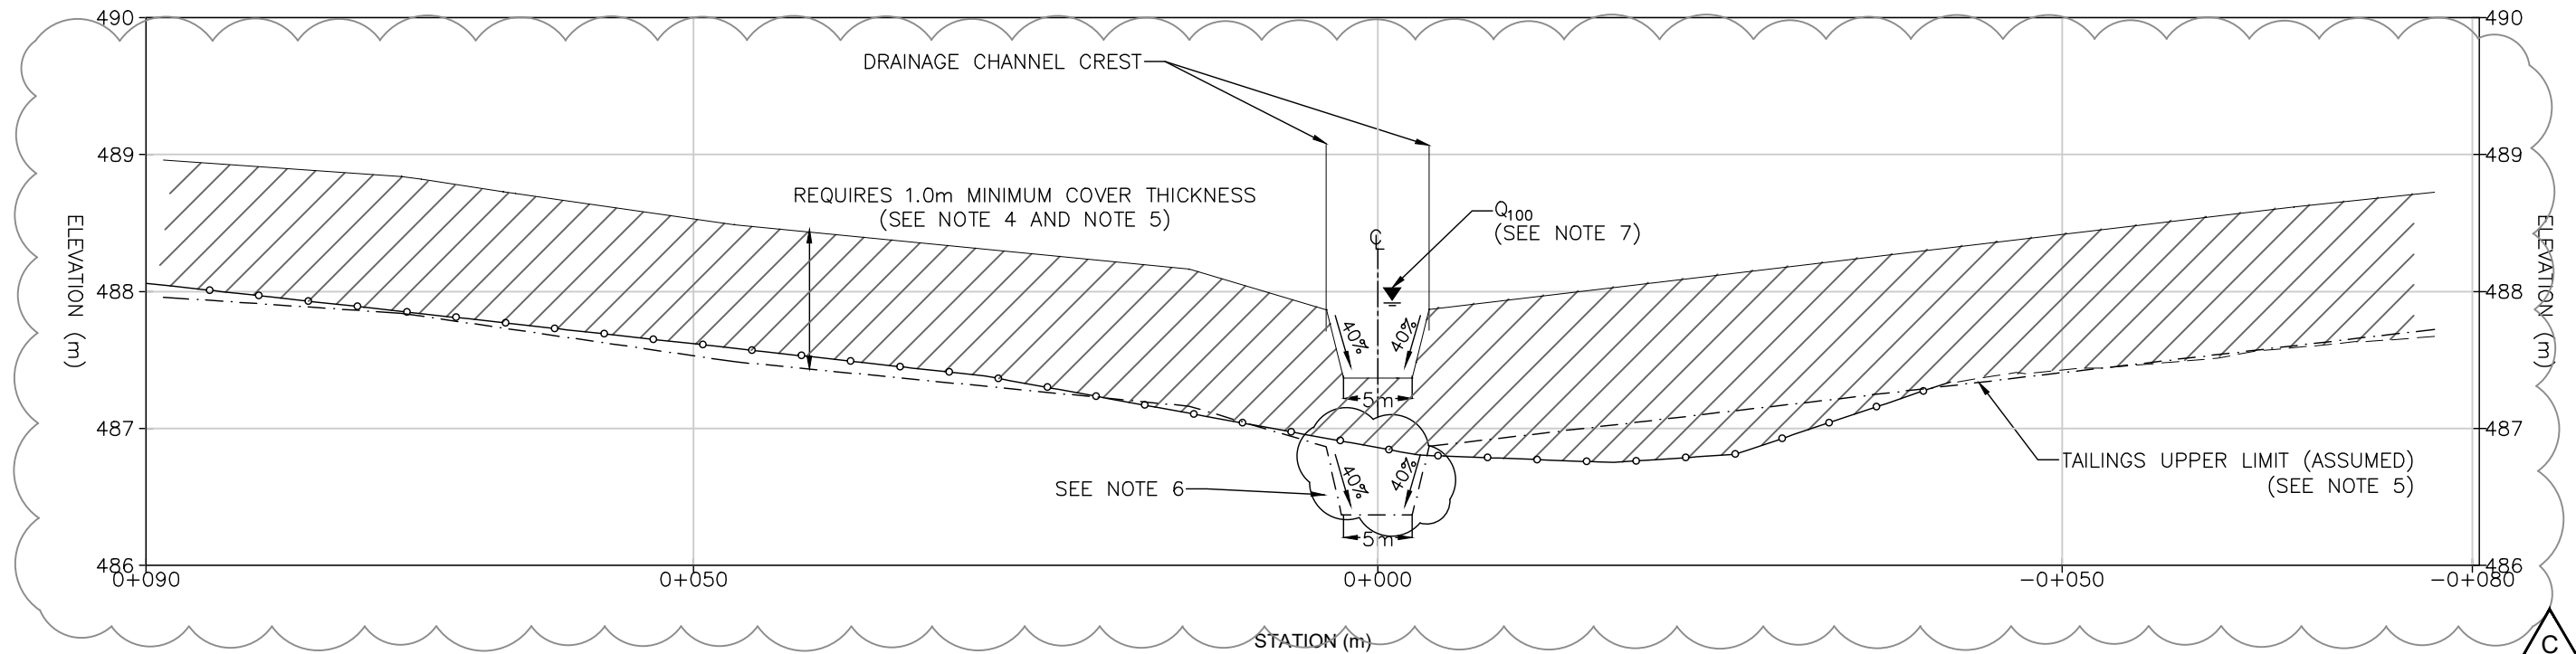
Title
**CELL 3 CLOSURE
CROSS-SECTIONS**

- ILLUSTRATES APPROXIMATE FLOW DEPTH FOR 1-IN-100-YEAR, 24-HOUR STORM EVENT.

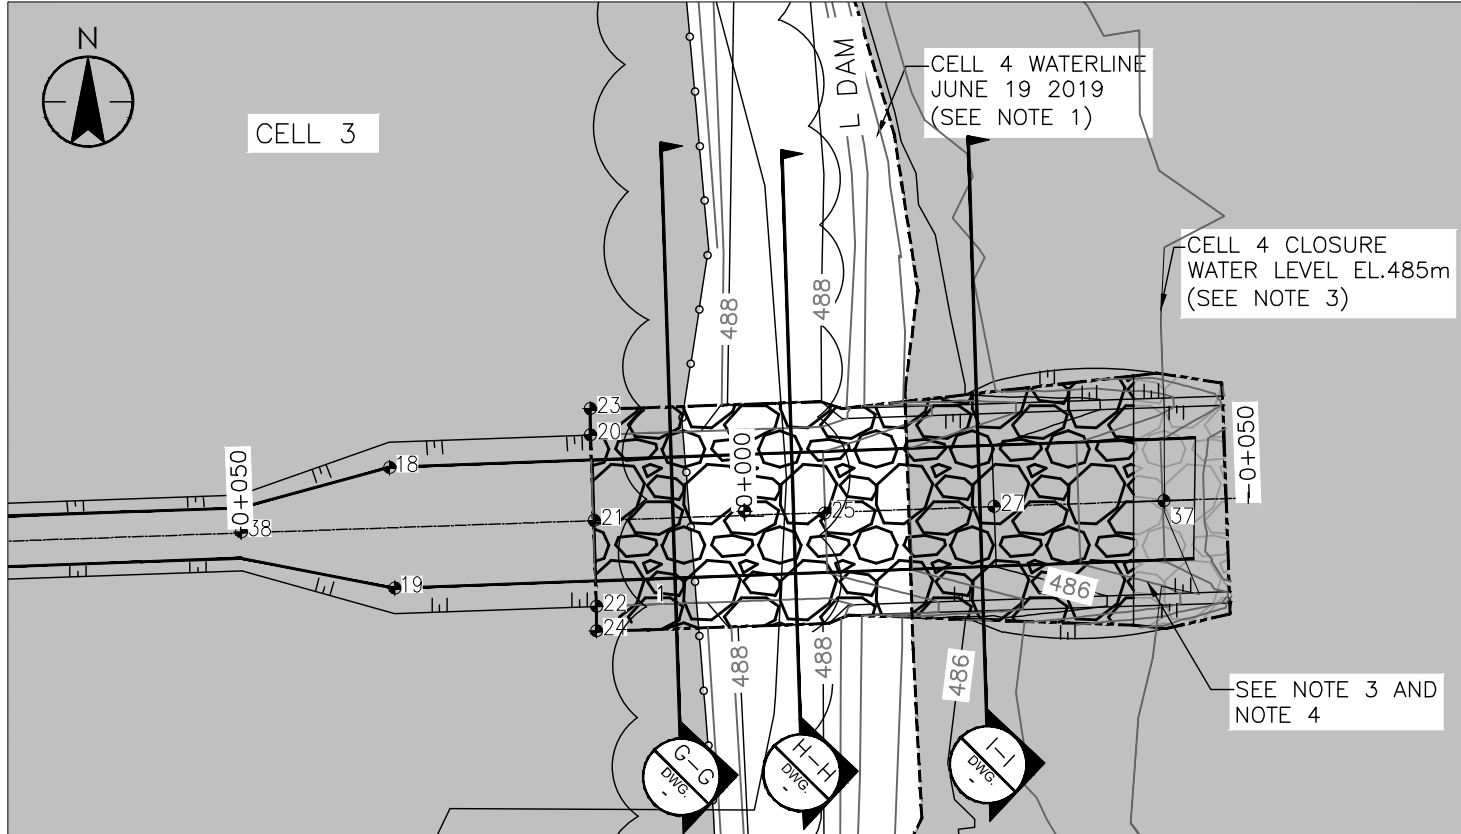
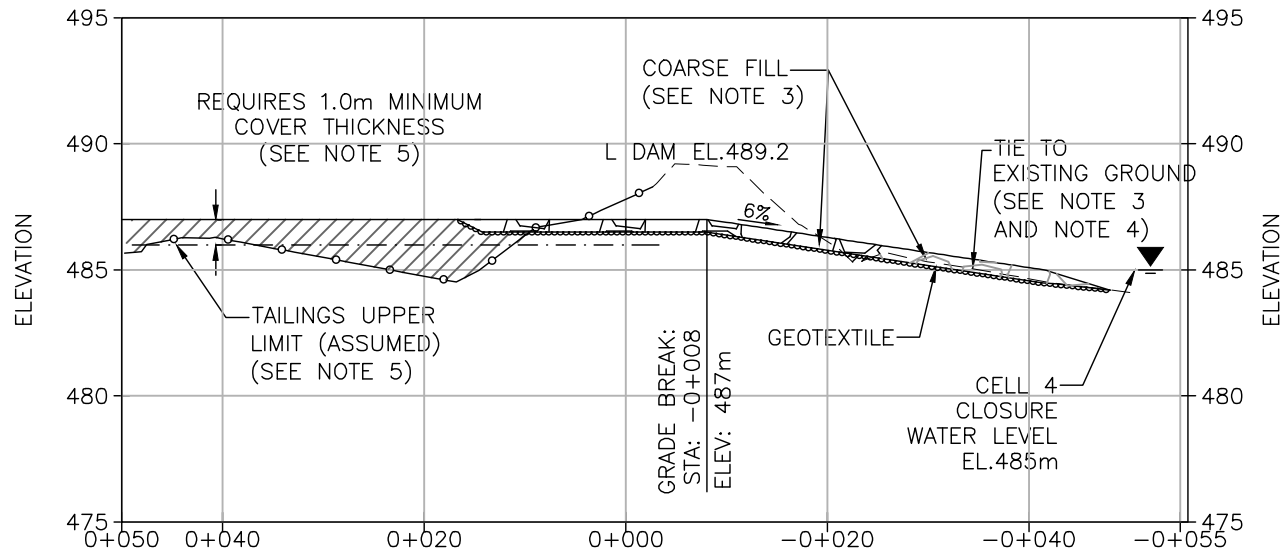
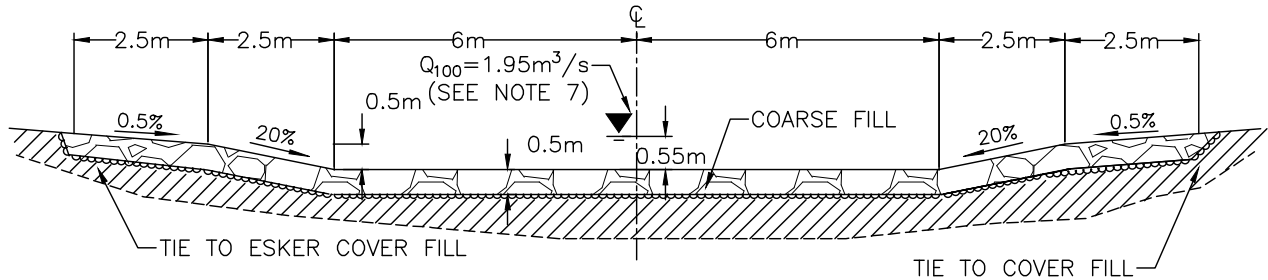
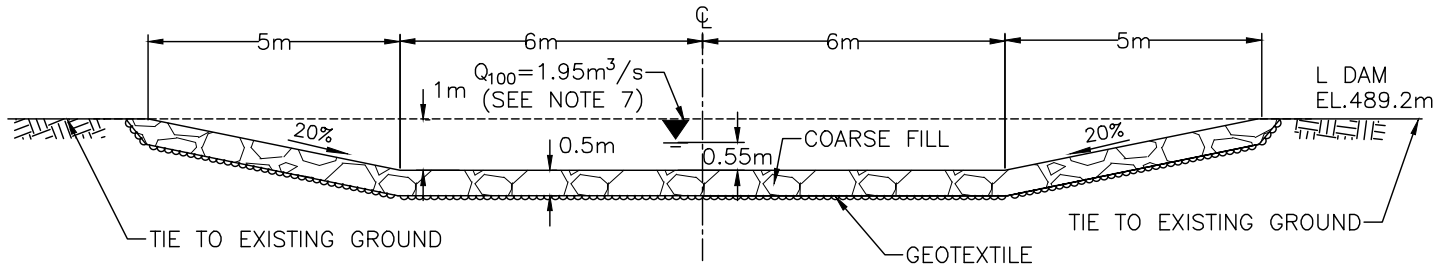
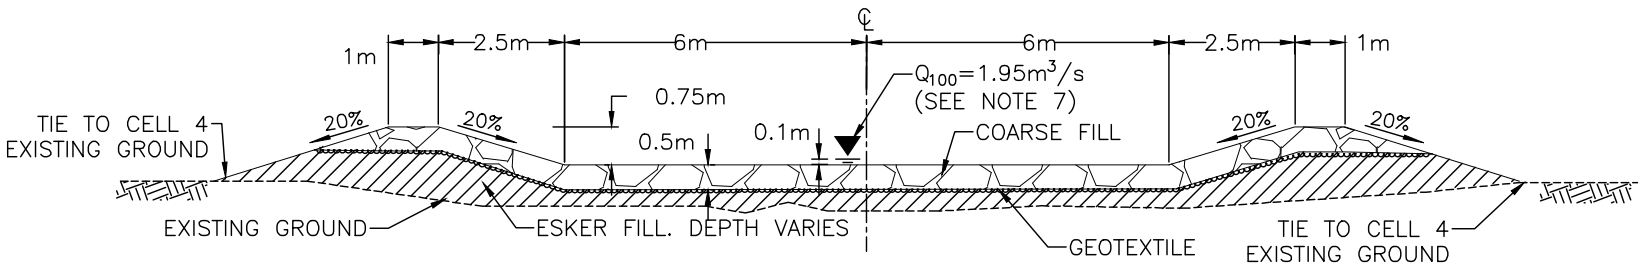
CELL 3 CLOSURE
OUTFLOW CHANNEL

PLAN VIEW – OUTFLOW CHANNEL
SCALE 1:750

PROFILE – OUTFLOW CHANNEL
VERTICAL EXAGGERATION: 2.5X

- COARSE FILL FOR OUTFLOW CHANNEL THROUGH L-DAM SHALL BE PRIMARILY MADE UP OF GRAVEL, COBBLE AND STONE MATERIAL RANGING FROM 25MM TO 400MM WITH D_{50} AT LEAST 300MM. MINOR AMOUNTS OF SAND AND/OR LARGER STONE MAY BE PERMITTED IN WELL-GRADED MIXTURES, DEPENDING ON LOCALLY AVAILABLE MATERIALS. MATERIAL USED SHALL BE FIELD-VERIFIED FOR GRAIN SIZE DISTRIBUTION AND APPROVED BY THE RESIDENT ENGINEER. REFER TO CONSTRUCTION SPECIFICATIONS DRAWING 001 TABLE 2.

- COARSE FILL SHALL BE PLACED IN A MINIMUM OF TWO PACKED LIFTS AS DIRECTED BY THE RESIDENT ENGINEER, ENSURING MATERIAL PLACEMENT IS STABLE, WELL GRADED AND PLACED IN A UNIFORM MANNER WHICH MINIMIZES LARGE VOIDS. ILLUSTRATES APPROXIMATE FLOW DEPTH AND FLOW RATE (Q) FOR 1-IN-100-YEAR, 24-HOUR STORM EVENT.

Cell 3 was designed to be fully covered by 1 m of esker material, with a surface channel draining into Cell 4. The outflow channel was designed through a small section of L Dam to be primarily composed of coarse sand and gravel with cobble material overlaying a geotextile cover placed on esker material and original ground.

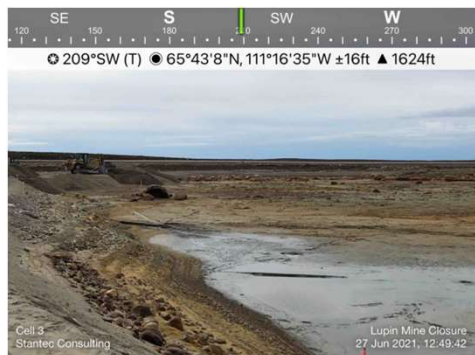
Photo 1: Esker cover placement in Cell 3. The cell has been dewatered prior to cover placement.

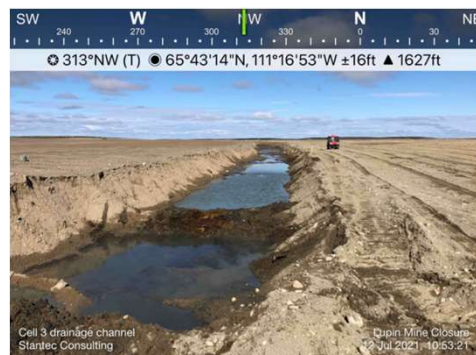
Photo 2: Cell 3 outflow channel during construction.

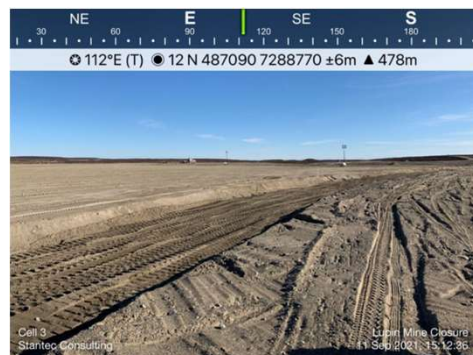
Photo 3: Completed Cell 3 esker cover. The cover surface was graded to be smooth and free draining.

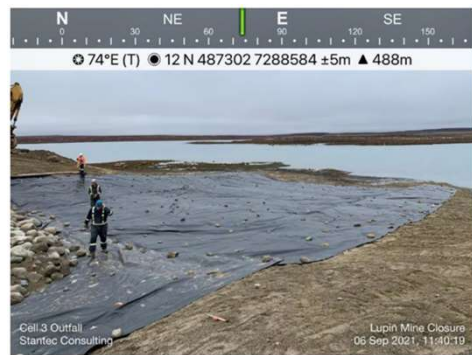
Photo 4: Geotextile fabric in Cell 3 outflow channel.

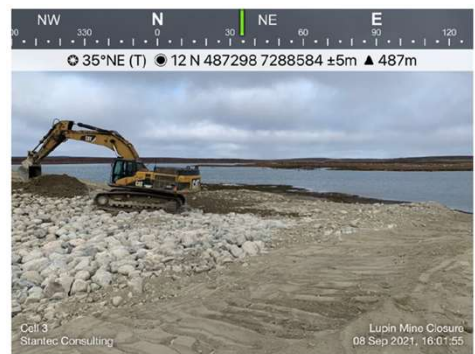
Photo 5: Excavator works to lay coarse material onto geotextile fabric in Cell 3 outflow channel.

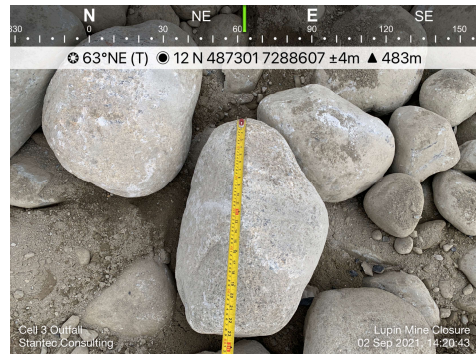
Photo 6: Typical particle size of the coarse gravel and sand.

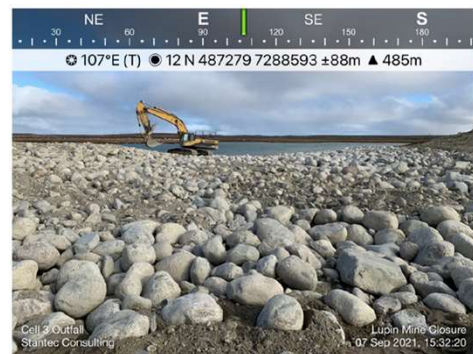
Photo 7: Completed Cell 3 outflow channel.

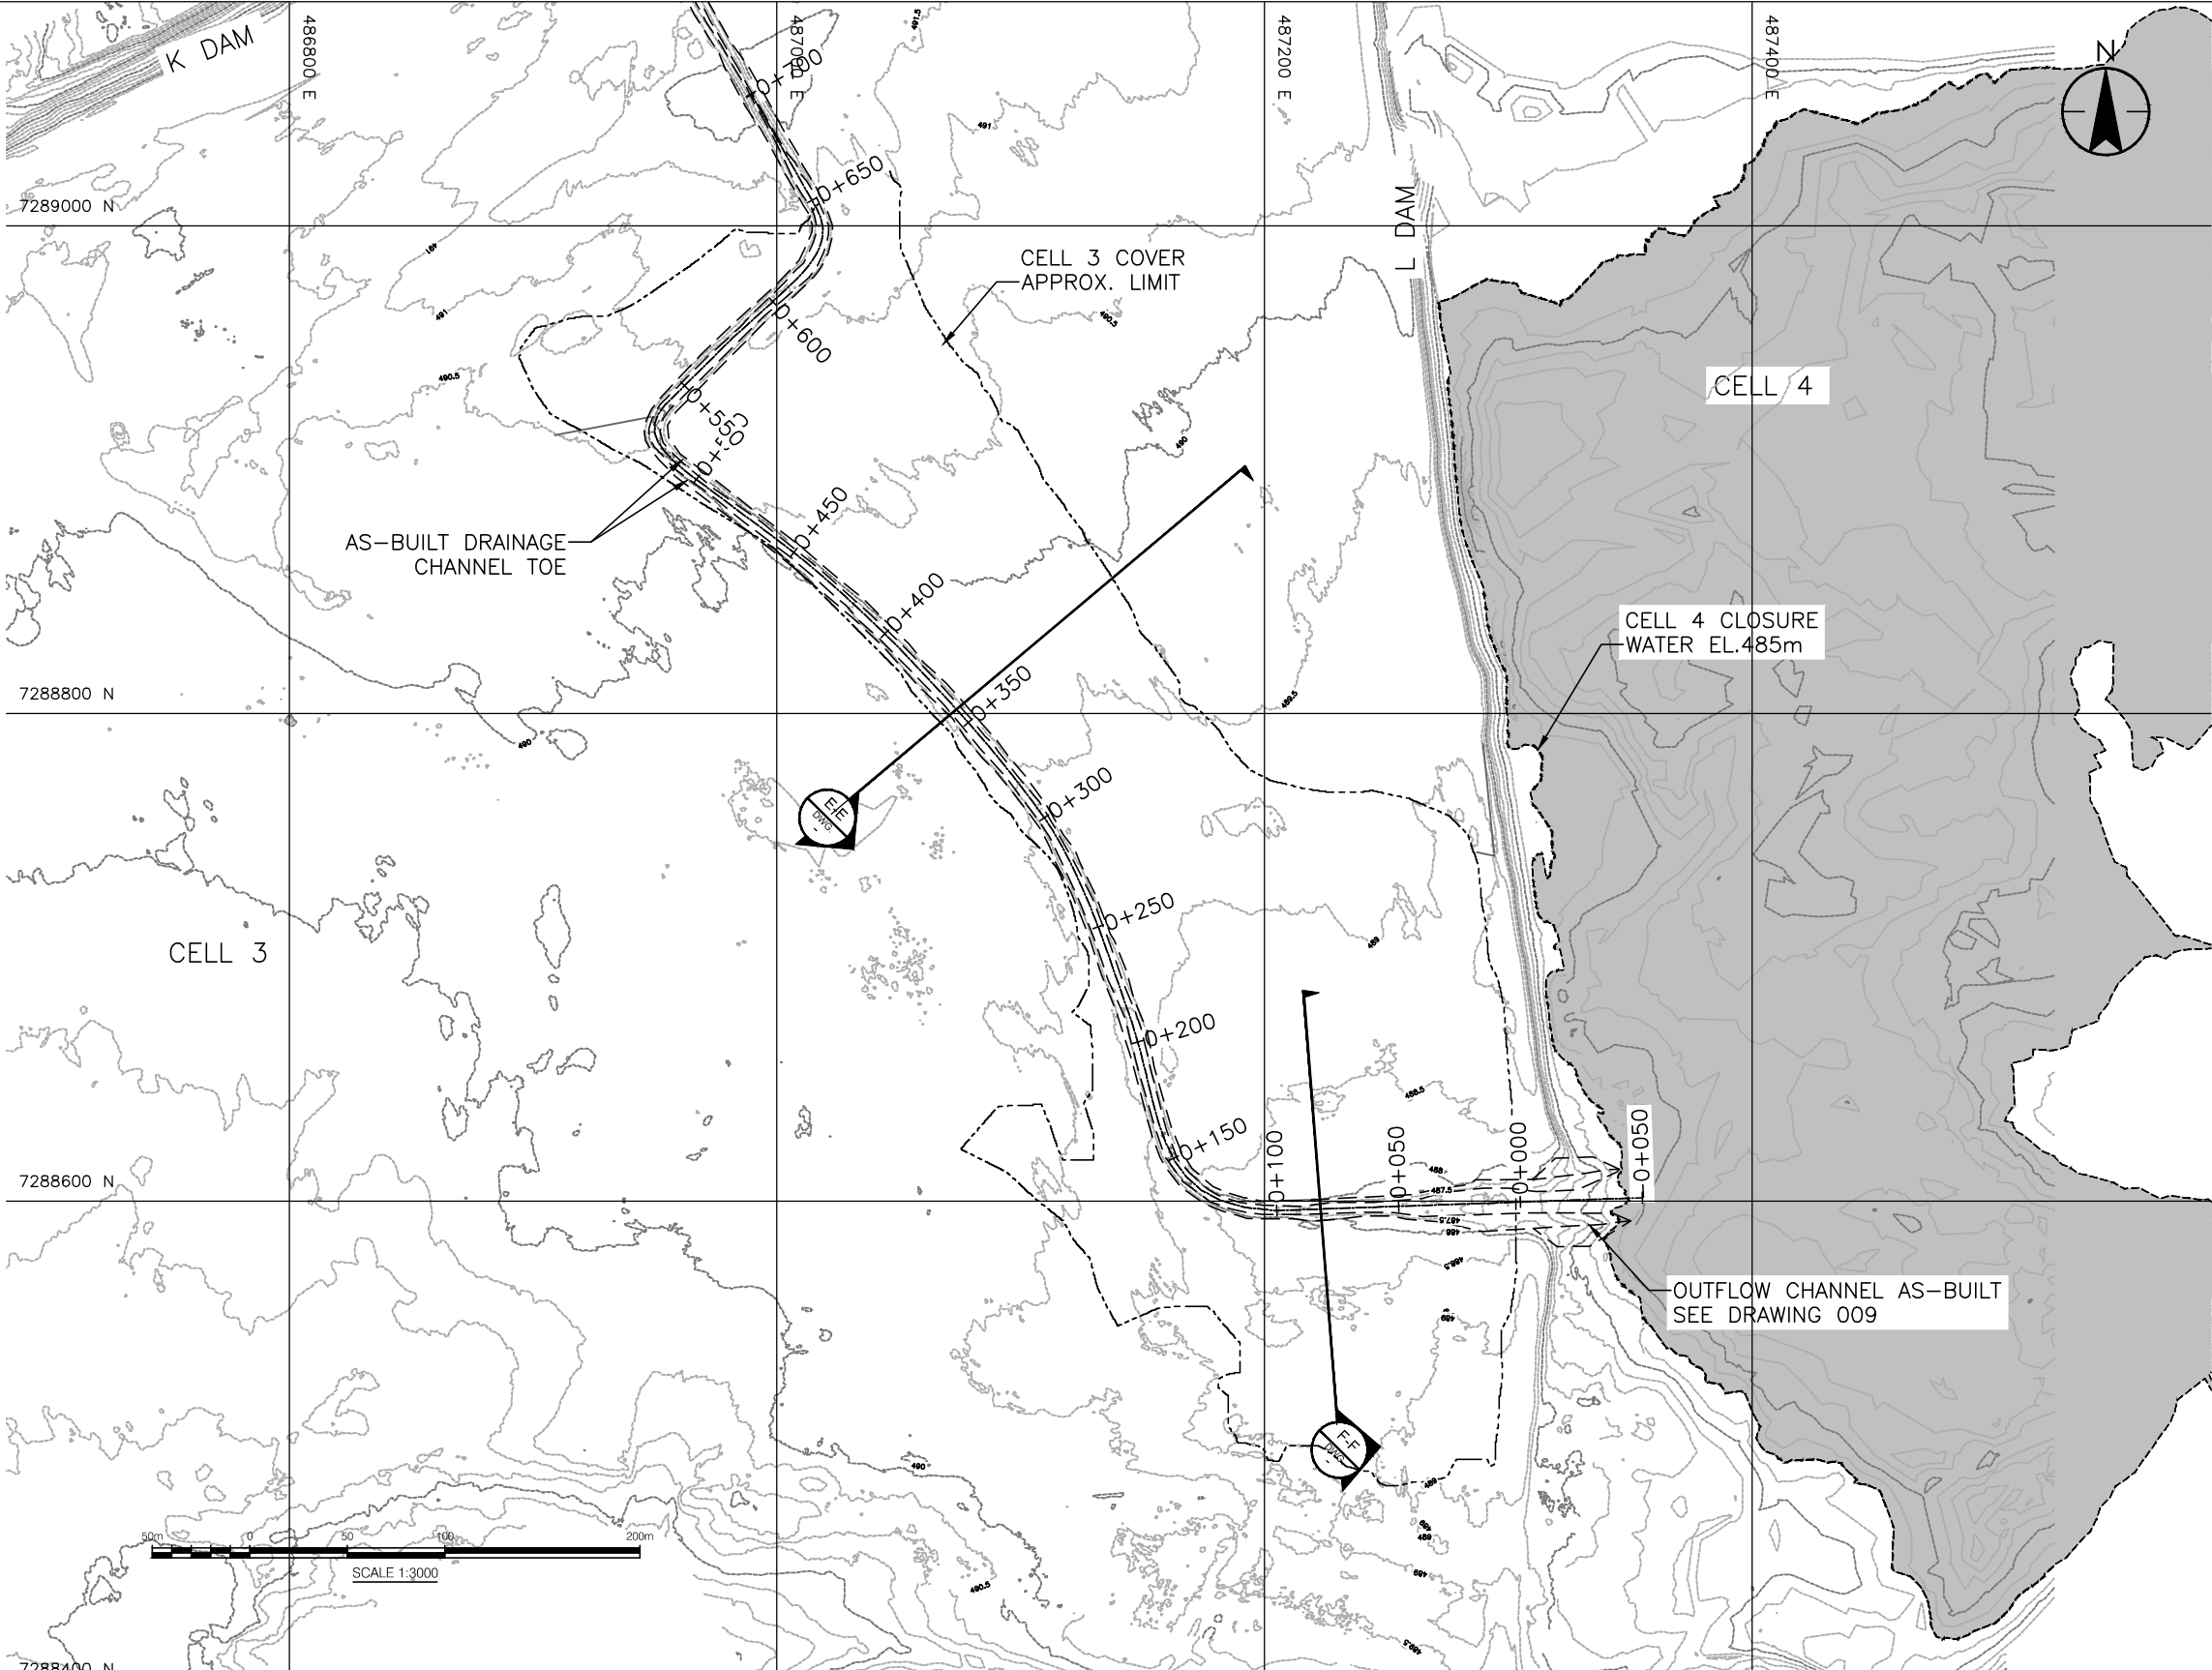
Title
CELL 3 CLOSURE
AS-BUILT PLAN VIEW

- EXISTING TOPOGRAPHIC CONTOURS AND WATER COVERED AREAS DELINEATED FROM AERIAL SURVEY ON OCTOBER 4th, 2021.
- COORDINATES ARE PRESENTED IN NAD83 UTM, ZONE 8N.
- OUTLINE OF AS-BUILT COVER LIMIT SHOWN IS APPROXIMATE TO REPRESENT BOUNDARY OF SIGNIFICANT FILL. THIN LIFTS AND GRADING WERE DONE ON A LARGER AREA TO FACILITATE DRAINAGE.

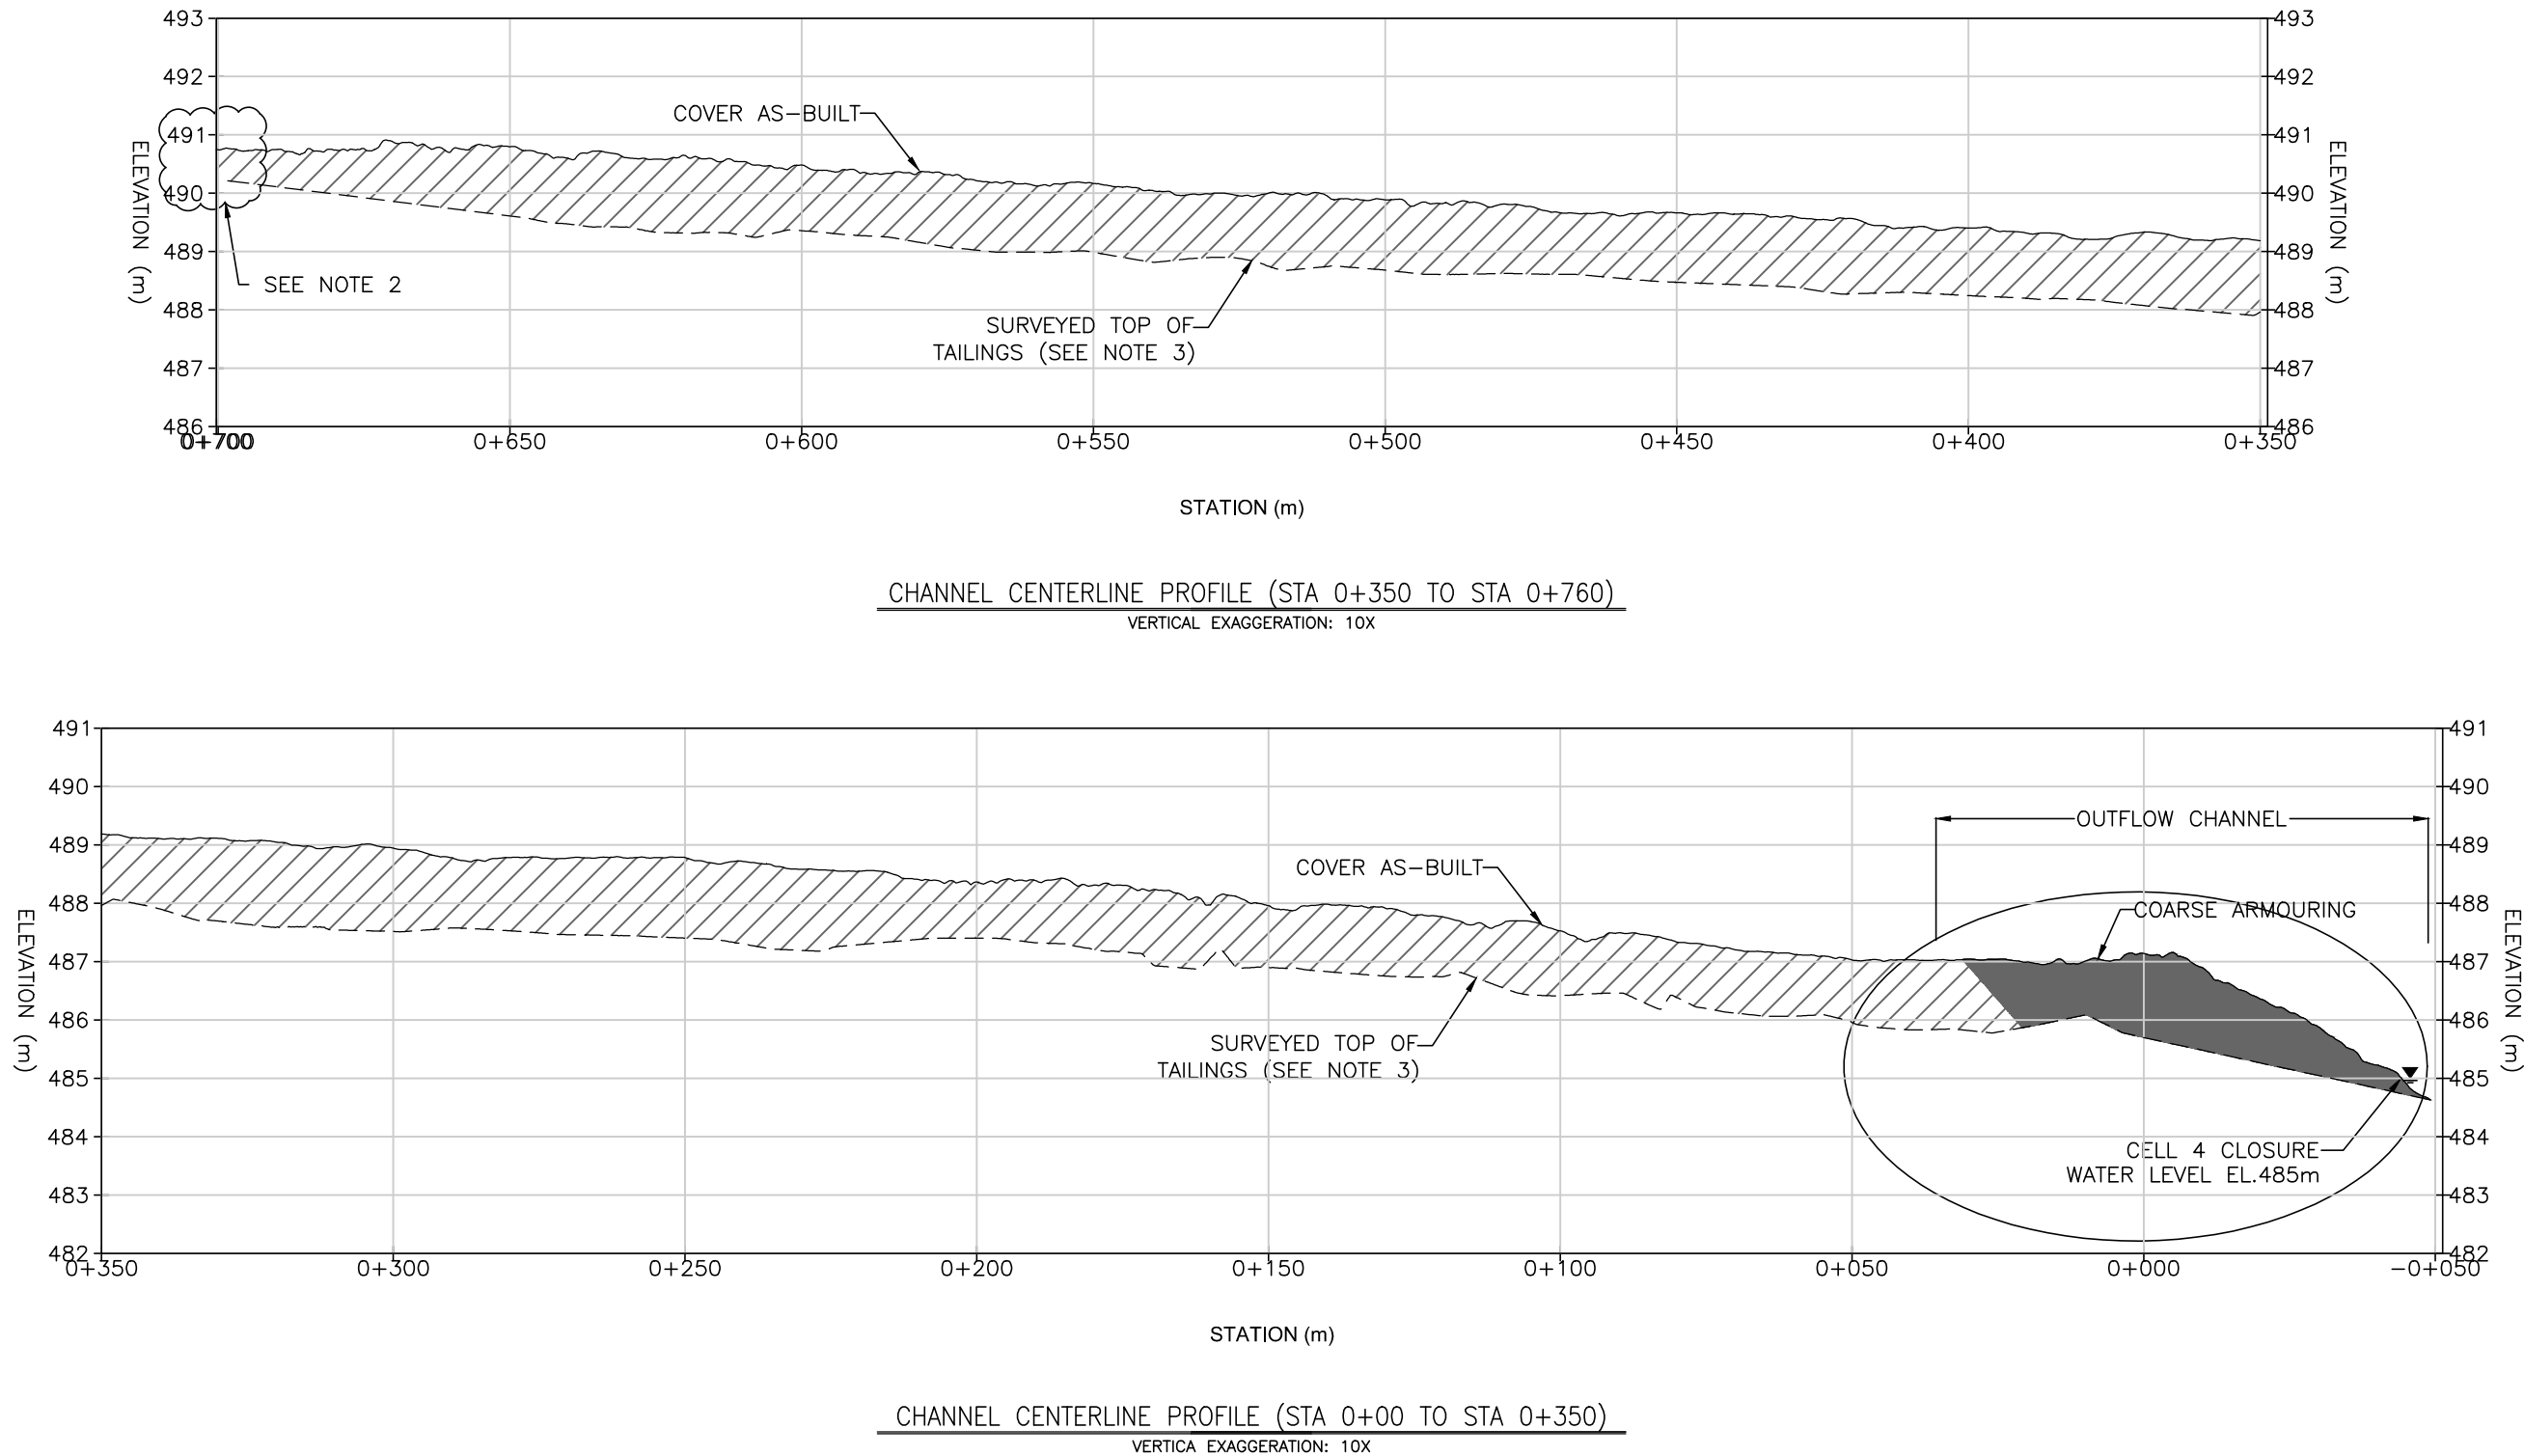
AS-BUILT PROFILE ALONG
CHANNEL CENTERLINE

- EXISTING TOPOGRAPHIC CONTOURS AND WATER COVERED AREAS DELINEATED FROM AERIAL SURVEY ON OCTOBER 4th, 2021.
- A SMALL AREA OF COVER IS LESS THAN THE DESIGN MINIMUM OF 1m. THE COVER HERE WAS CONSTRUCTED AS SHOWN TO FACILITATE DRAINAGE.
- SURVEYED TAILINGS SURFACE IS COMPILATED FROM GROUND AND AERIAL SURVEYS ON EXPOSED TAILINGS, AND TESTPIT RESULTS IN HISTORICAL COVER AROUND THE 2020/2021 CONSTRUCTION LIMITS.

During QA checks of the Cell 3 cover, it was discovered there is a small area with <1 m cover at the tie-in of the Cell 3 outflow channel near chainage 0+700 and the Dam K cutoff ditch. A transition is required to allow passive drainage from the cutoff ditch to flow into the design channel. In order to maintain the required gradient, the transition reduced the cover thickness to overall 0.6 to 0.7m over an approximate 50 m² area. Increasing the cover thickness over this transition would impact surface water management and would cause significant erosion elsewhere along Dam K. As this transition area does not meet the minimum 1 m esker cover design, it will be instrumented with a volumetric water content sensor (VWC) to monitor the depth of saturated conditions that are maintained in the cover.
