Lupin Mine Reclamation

2021 Construction Summary Report –
Cell 3 – Rev.2

Mandalay Resources Ltd.

Stantec Consulting Ltd.

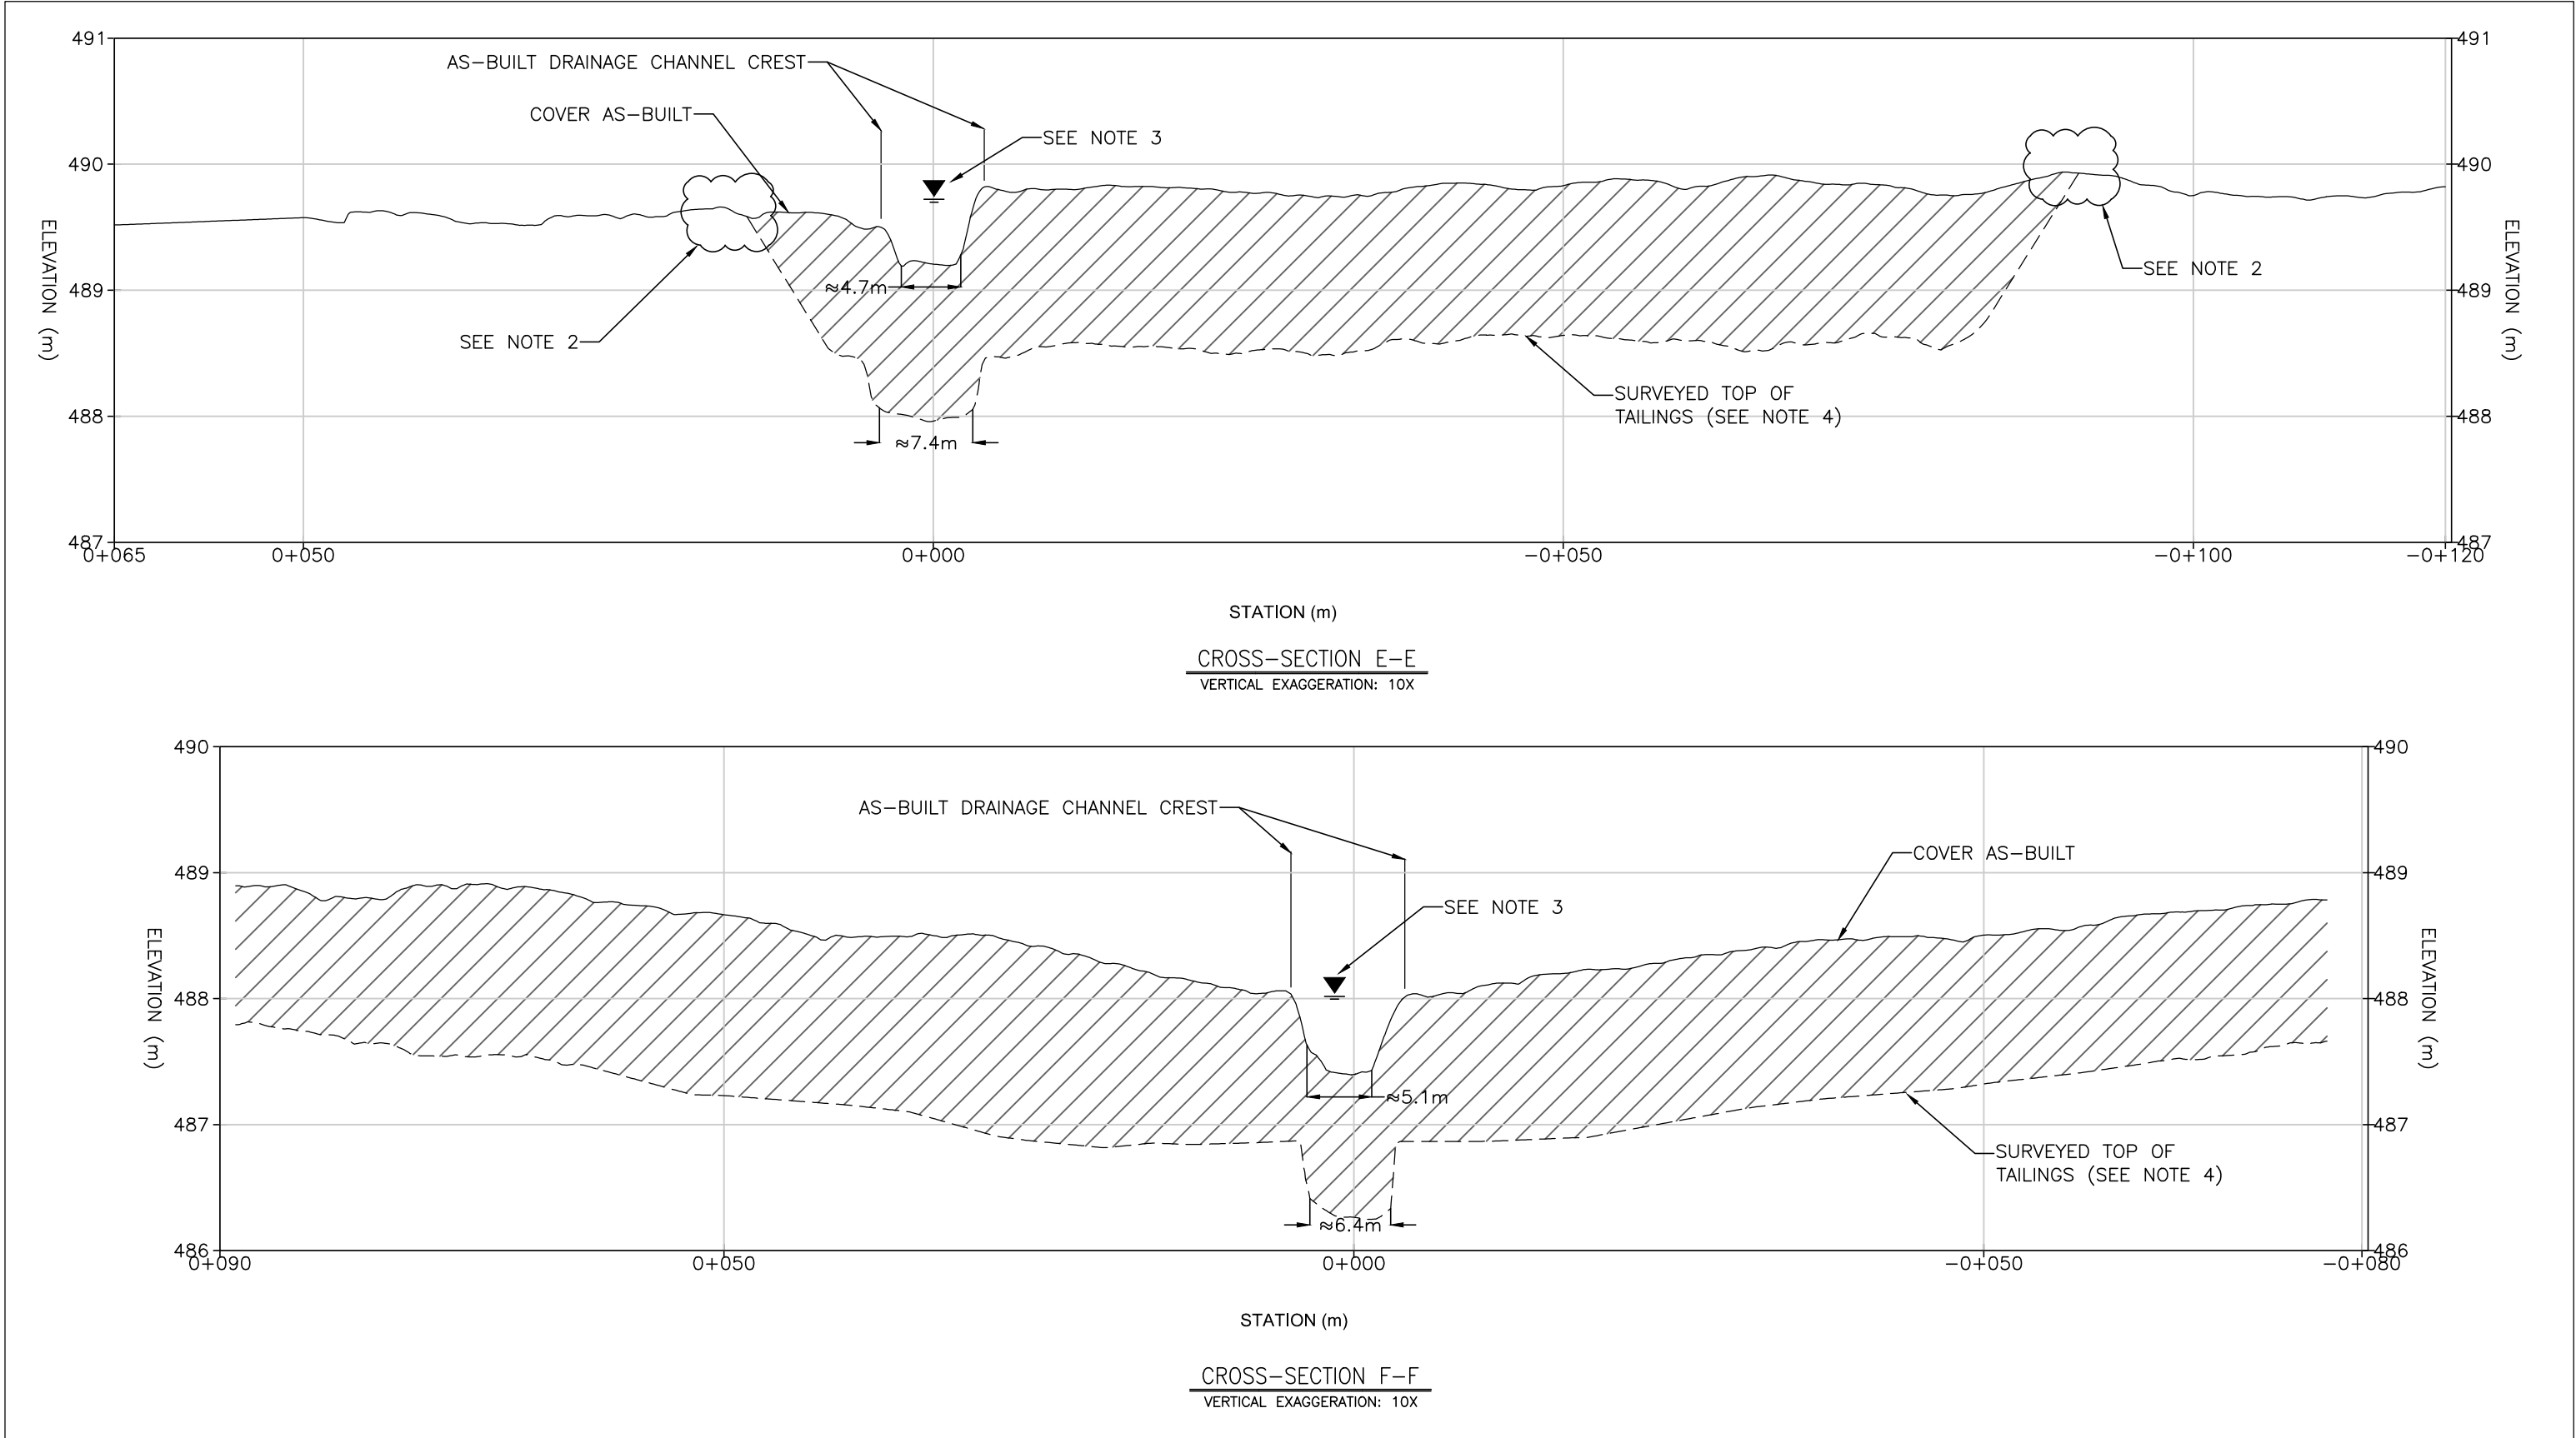
Title
CELL 3 CLOSURE
AS-BUILT CROSS-SECTIONS

- EXISTING TOPOGRAPHIC CONTOURS AND WATER COVERED AREAS DELINEATED FROM AERIAL SURVEY ON OCTOBER 4th, 2021.
- OUTLINE OF AS-BUILT COVER LIMIT SHOWN IS APPROXIMATE TO REPRESENT BOUNDARY OF SIGNIFICANT FILL. THIN LIFTS AND GRADING WERE DONE ON A LARGER AREA TO FACILITATE DRAINAGE.
- ILLUSTRATES APPROXIMATE FLOW DEPTH FOR 1-IN-100-YEAR, 24-HOUR STORM EVENT.
- SURVEYED TAILINGS SURFACE IS COMPILATED FROM GROUND AND AERIAL SURVEYS ON EXPOSED TAILINGS, AND TESTPIT RESULTS IN HISTORICAL COVER AROUND THE 2020/2021 CONSTRUCTION LIMITS.
