**LUPIN MINES INCORPORATED**  
(A wholly owned indirect subsidiary of  
Mandalay Resources Corporation)

## **LUPIN MINE SITE**

# **Final Closure and Reclamation Plan**

**Report Number: 1789942\_003\_Rpt\_Rev0**

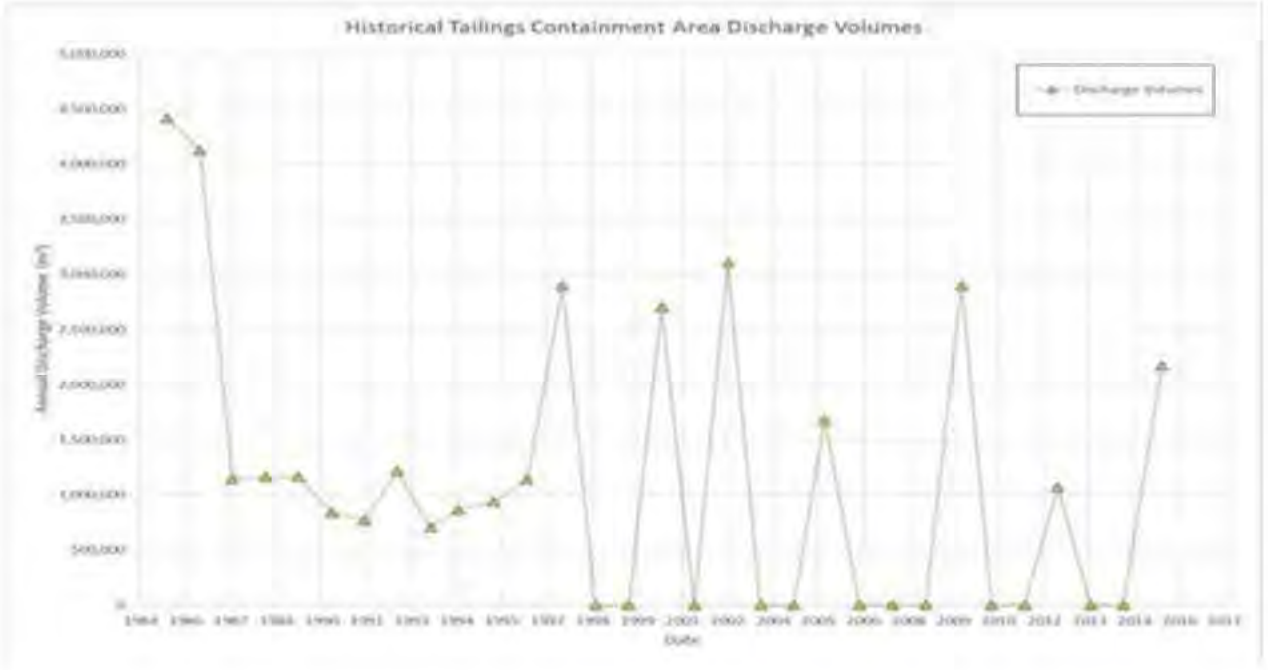
PROJECT NO. 1789942	CONTROL 3000	REV. 0	FIGURE 9
------------------------	-----------------	-----------	-------------

TITLE  
HISTORICAL TCA WATER DISCHARGE TO THE ENVIRONMENT

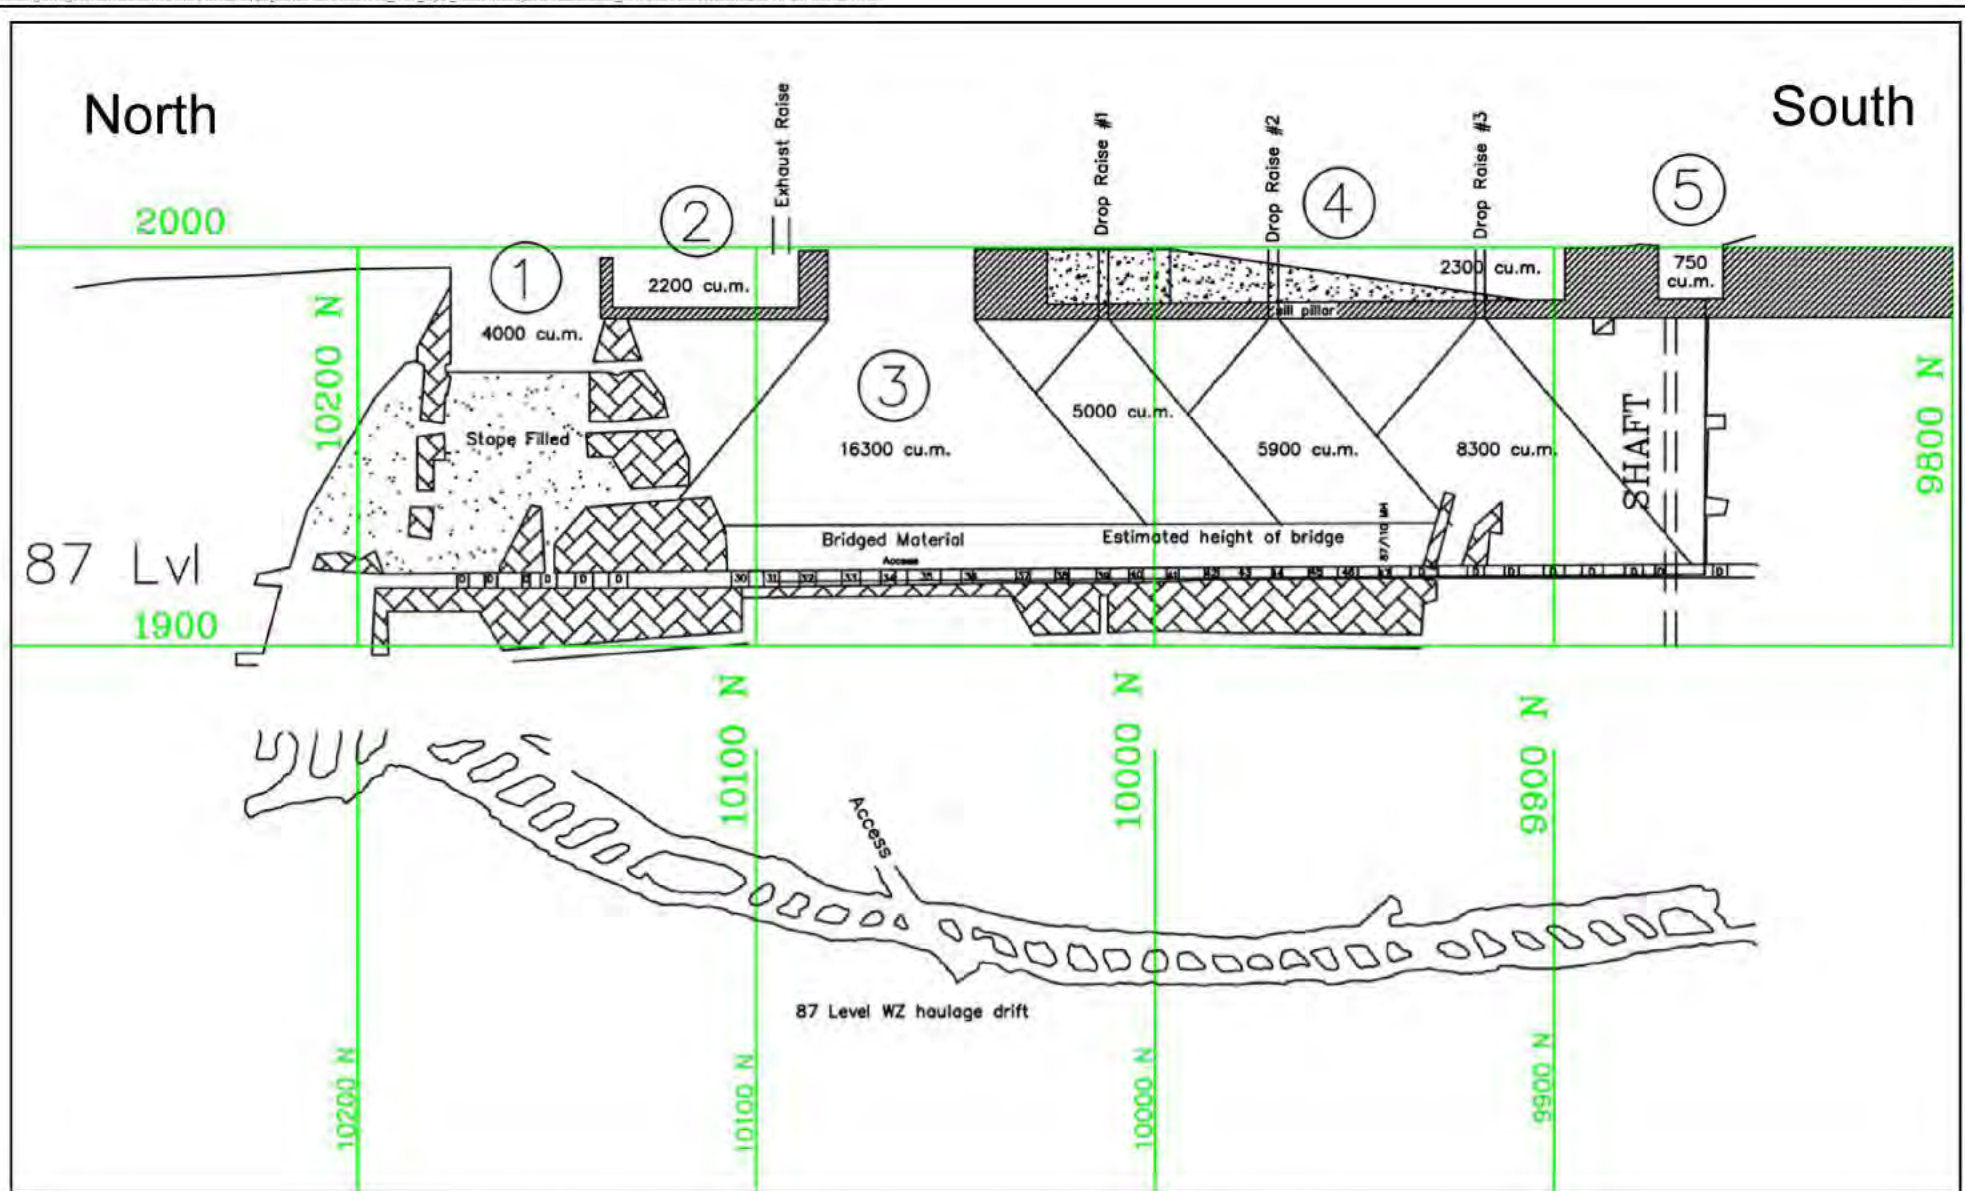
PROJECT NO: 1789942 CONTROL: 3000 REV: 0 FIGURE: 13

TITLE:  
KINROSS 2006 WEST ZONE CROWN PILLAR STOPES  
UNDERGROUND DISPOSAL PLAN

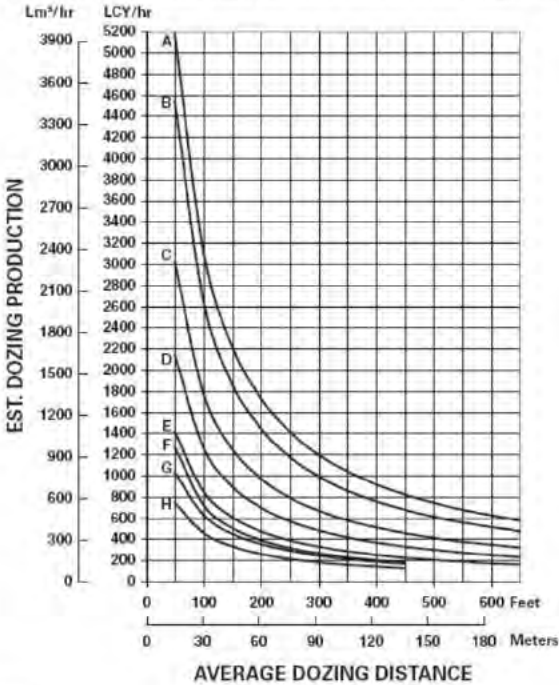
ESTIMATED DOZING PRODUCTION • Universal Blades • D7G through D11T CD

KEY  
A – D11T CD  
B – D11T  
C – D10T  
D – D9T  
E – D8T  
F – D7E  
G – D7R Series 2  
H – D7G

NOTE: This chart is based on numerous field studies made under varying job conditions. Refer to correction factors following these charts.

SPREADING/DOZING			
Productivity			
Machine Cat D8			
Estimate production using example curves provided or equivalent from other supplier	600	m3/hr	
Correction factors (see table provided)			
operator skill	0.75		
material type, see table	0.80		
slot dozing	1.00		
side by side dozing	1.00		
visibility	1.00		
job efficiency	0.83		
altitude adjustment	1.00		
slope adjustment	1.00		
Hourly productivity	298.8	m3/hr	
Operating Costs			
- Contractor			
Hourly rate - contractor supplied	\$260.00	\$/hr	
Dozing - contractor rate	0.87	\$/m3	
- Owner			
ownership, daily		\$/day	
maintenance		\$/hr	
fuel		\$/hr	
consumables (cutters, tires)		\$/hr	
operator		\$/hr	
Owner hourly rate	\$0.00		
Spreading/Dozing Cost - owner rate	\$0.00	\$/hr	
Spreading/Dozing Cost - select contractor or owner rate (N22 or N31)		\$/m3

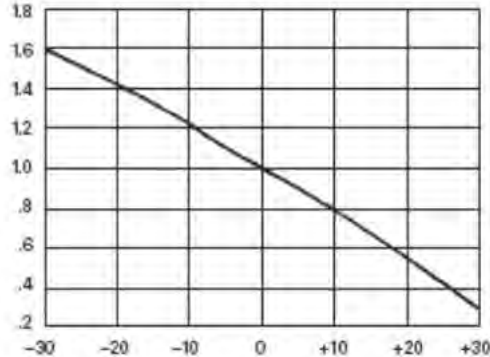
% Grade vs. Dozing Factor

(-) Downhill  
(+) Uphill
