LUPIN MINES INCORPORATED

Final Closure and Reclamation Plan

Rev1 (August 2020)

LUPIN MINE - FINAL CLOSURE AND RECLAMATION PLAN

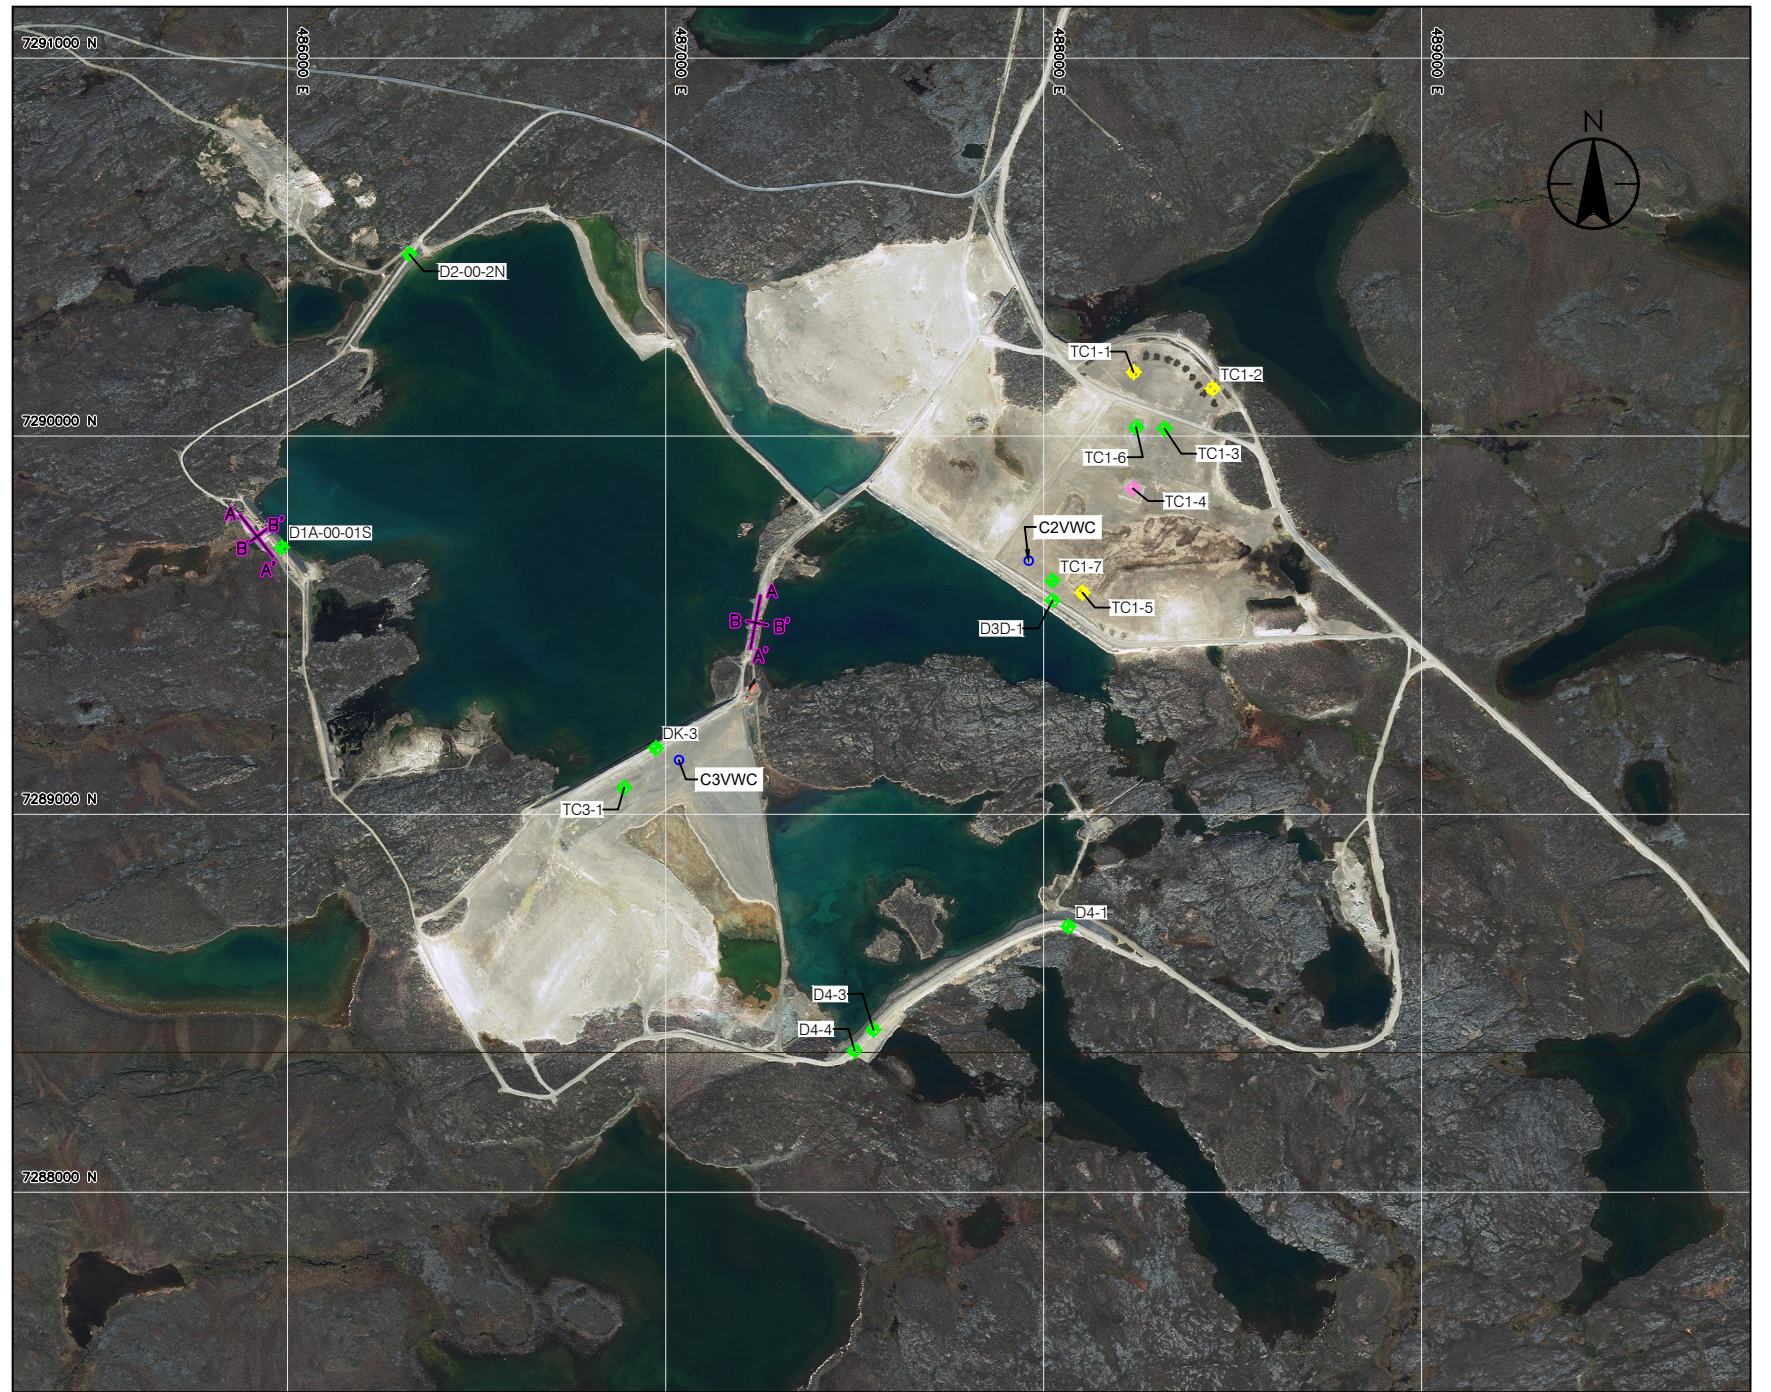
PLAN VIEW
SCALE 1:20,000

- ACTIVELY MONITORED
- MONITORED DURING DSR-NO CALIBRATION DATA
- UNLOCATED-LOCATION ESTIMATED FROM HISTORICAL MAP
- VOLUMETRIC WATER CONTENT SENSOR STRINGS
