LUPIN MINE CLOSURE

GENERAL ARRANGEMENT PLAN - CURRENT CONDITIONS

FINAL CLOSURE AND RECLAMATION PLAN

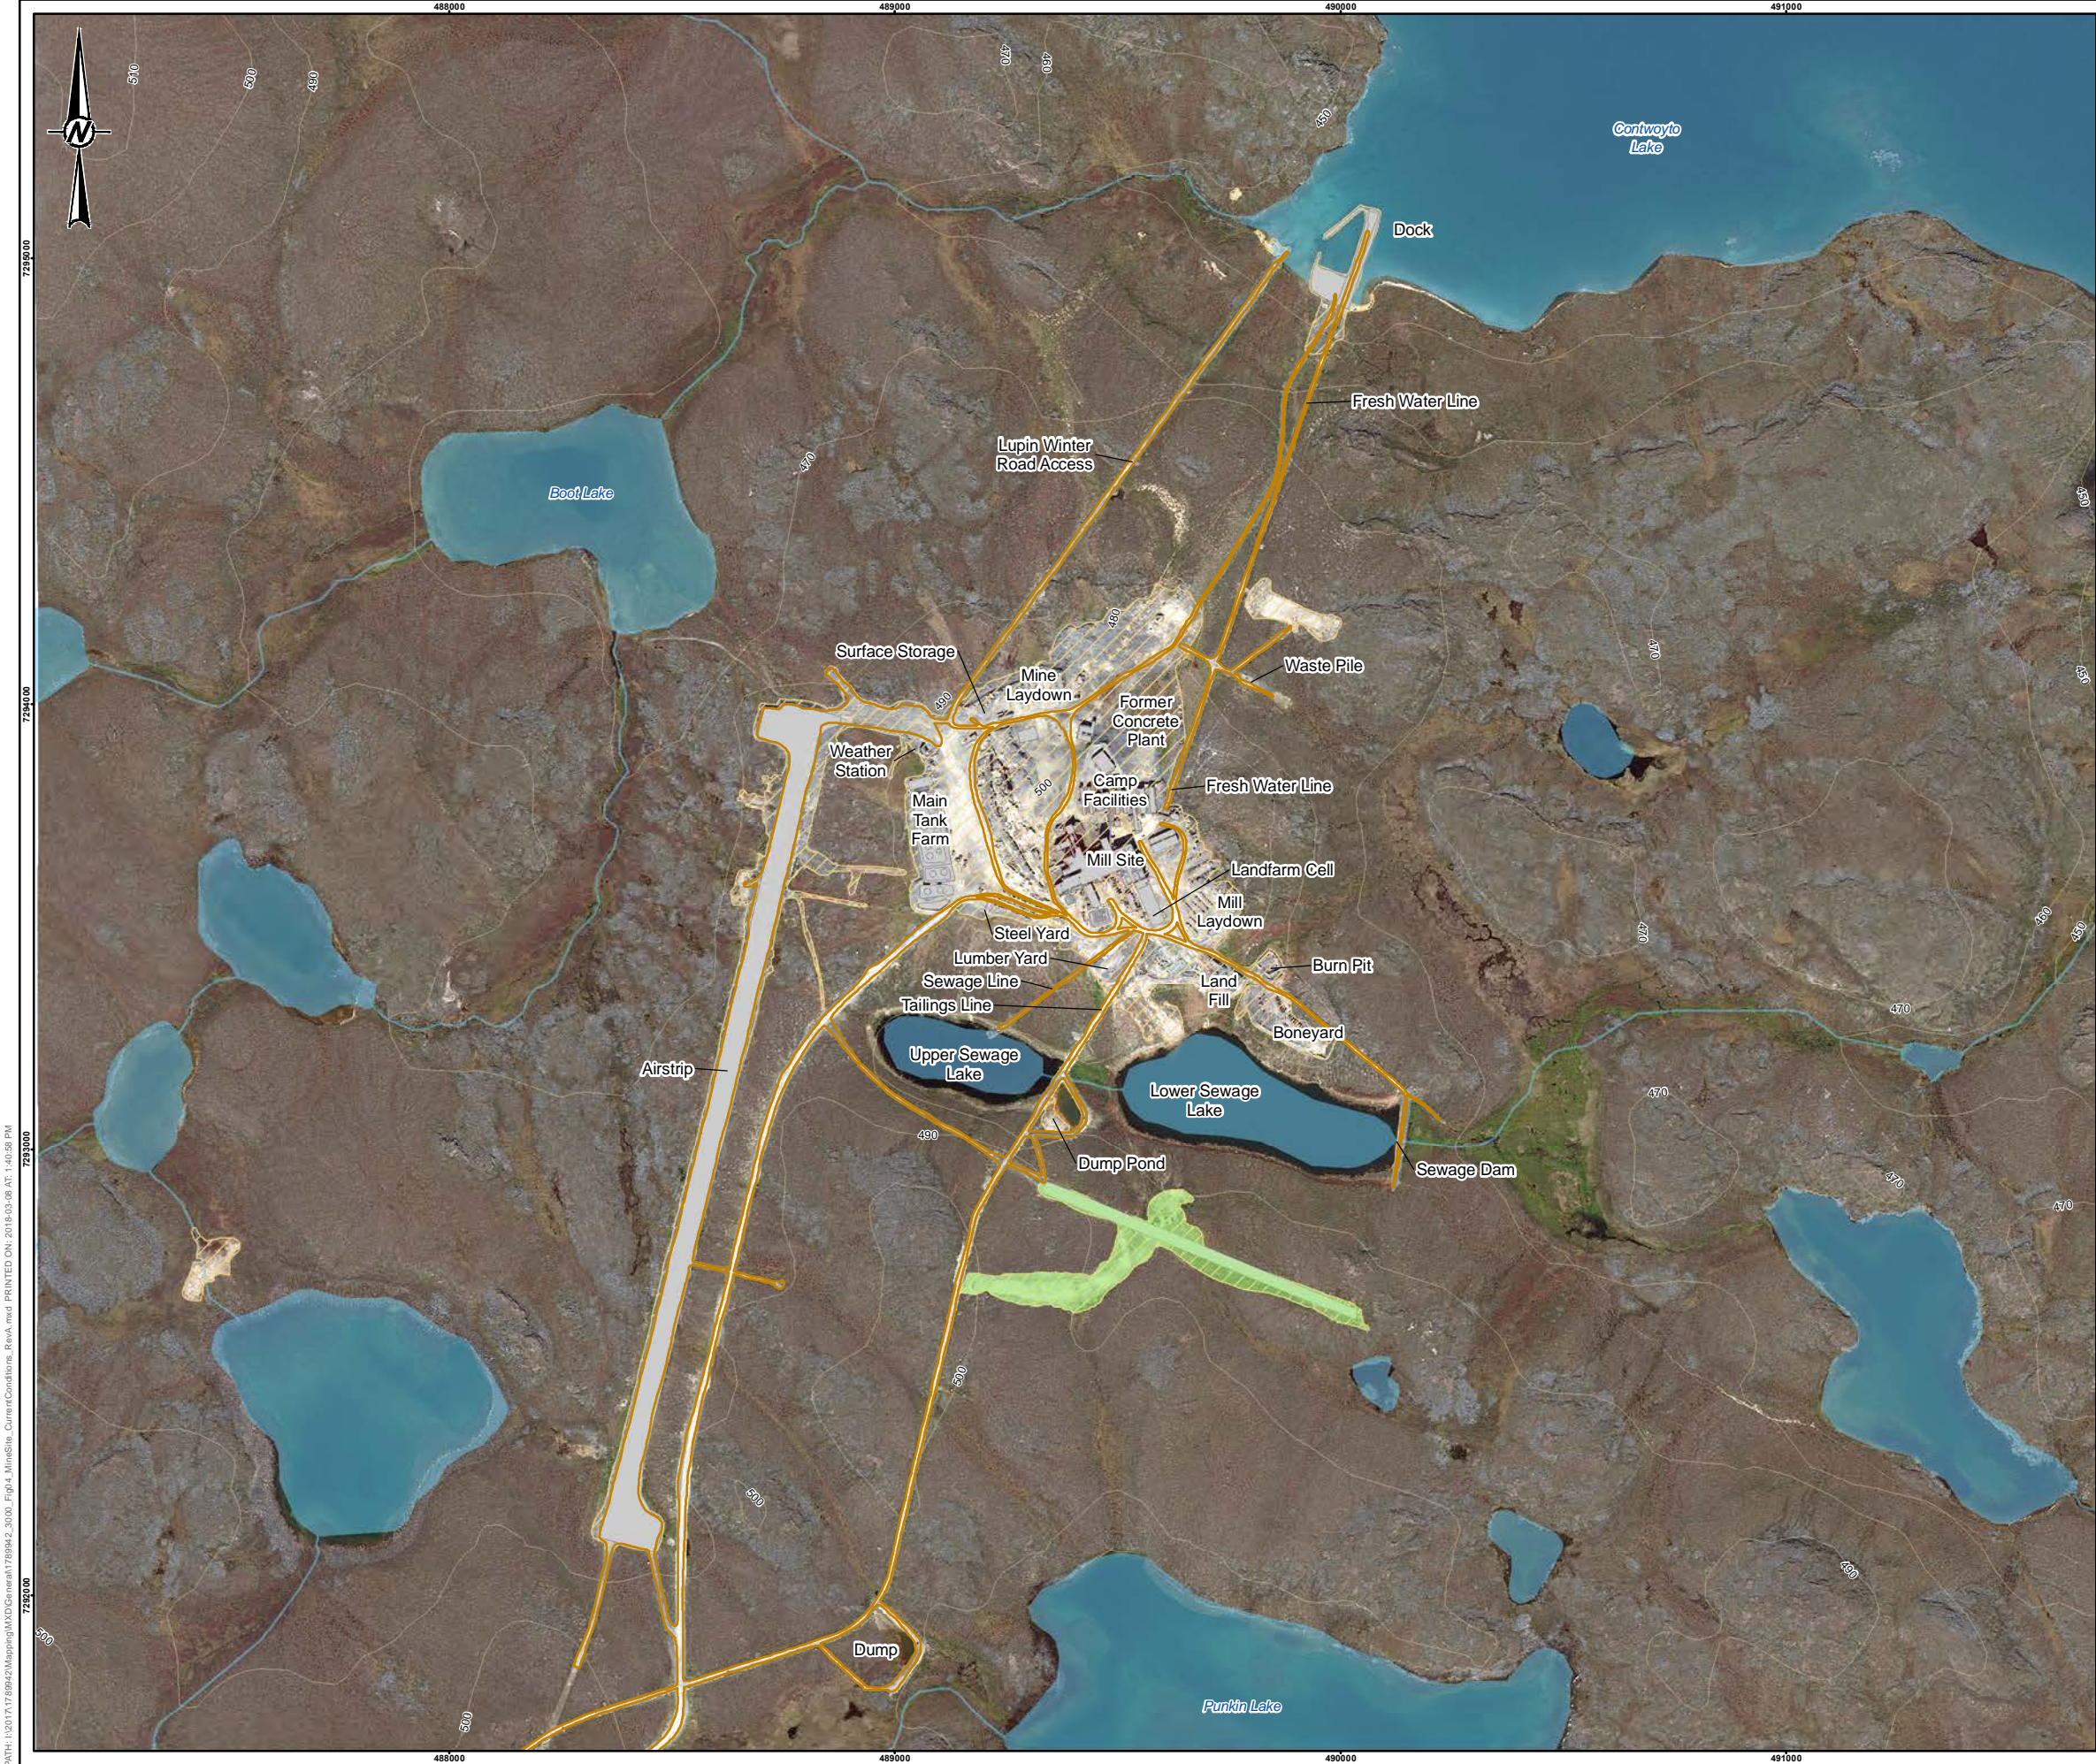
| 1789942 | 3000 | A | 4 |

TITLE  
**MINE AND MILL SITE AREA – CURRENT CONDITIONS**

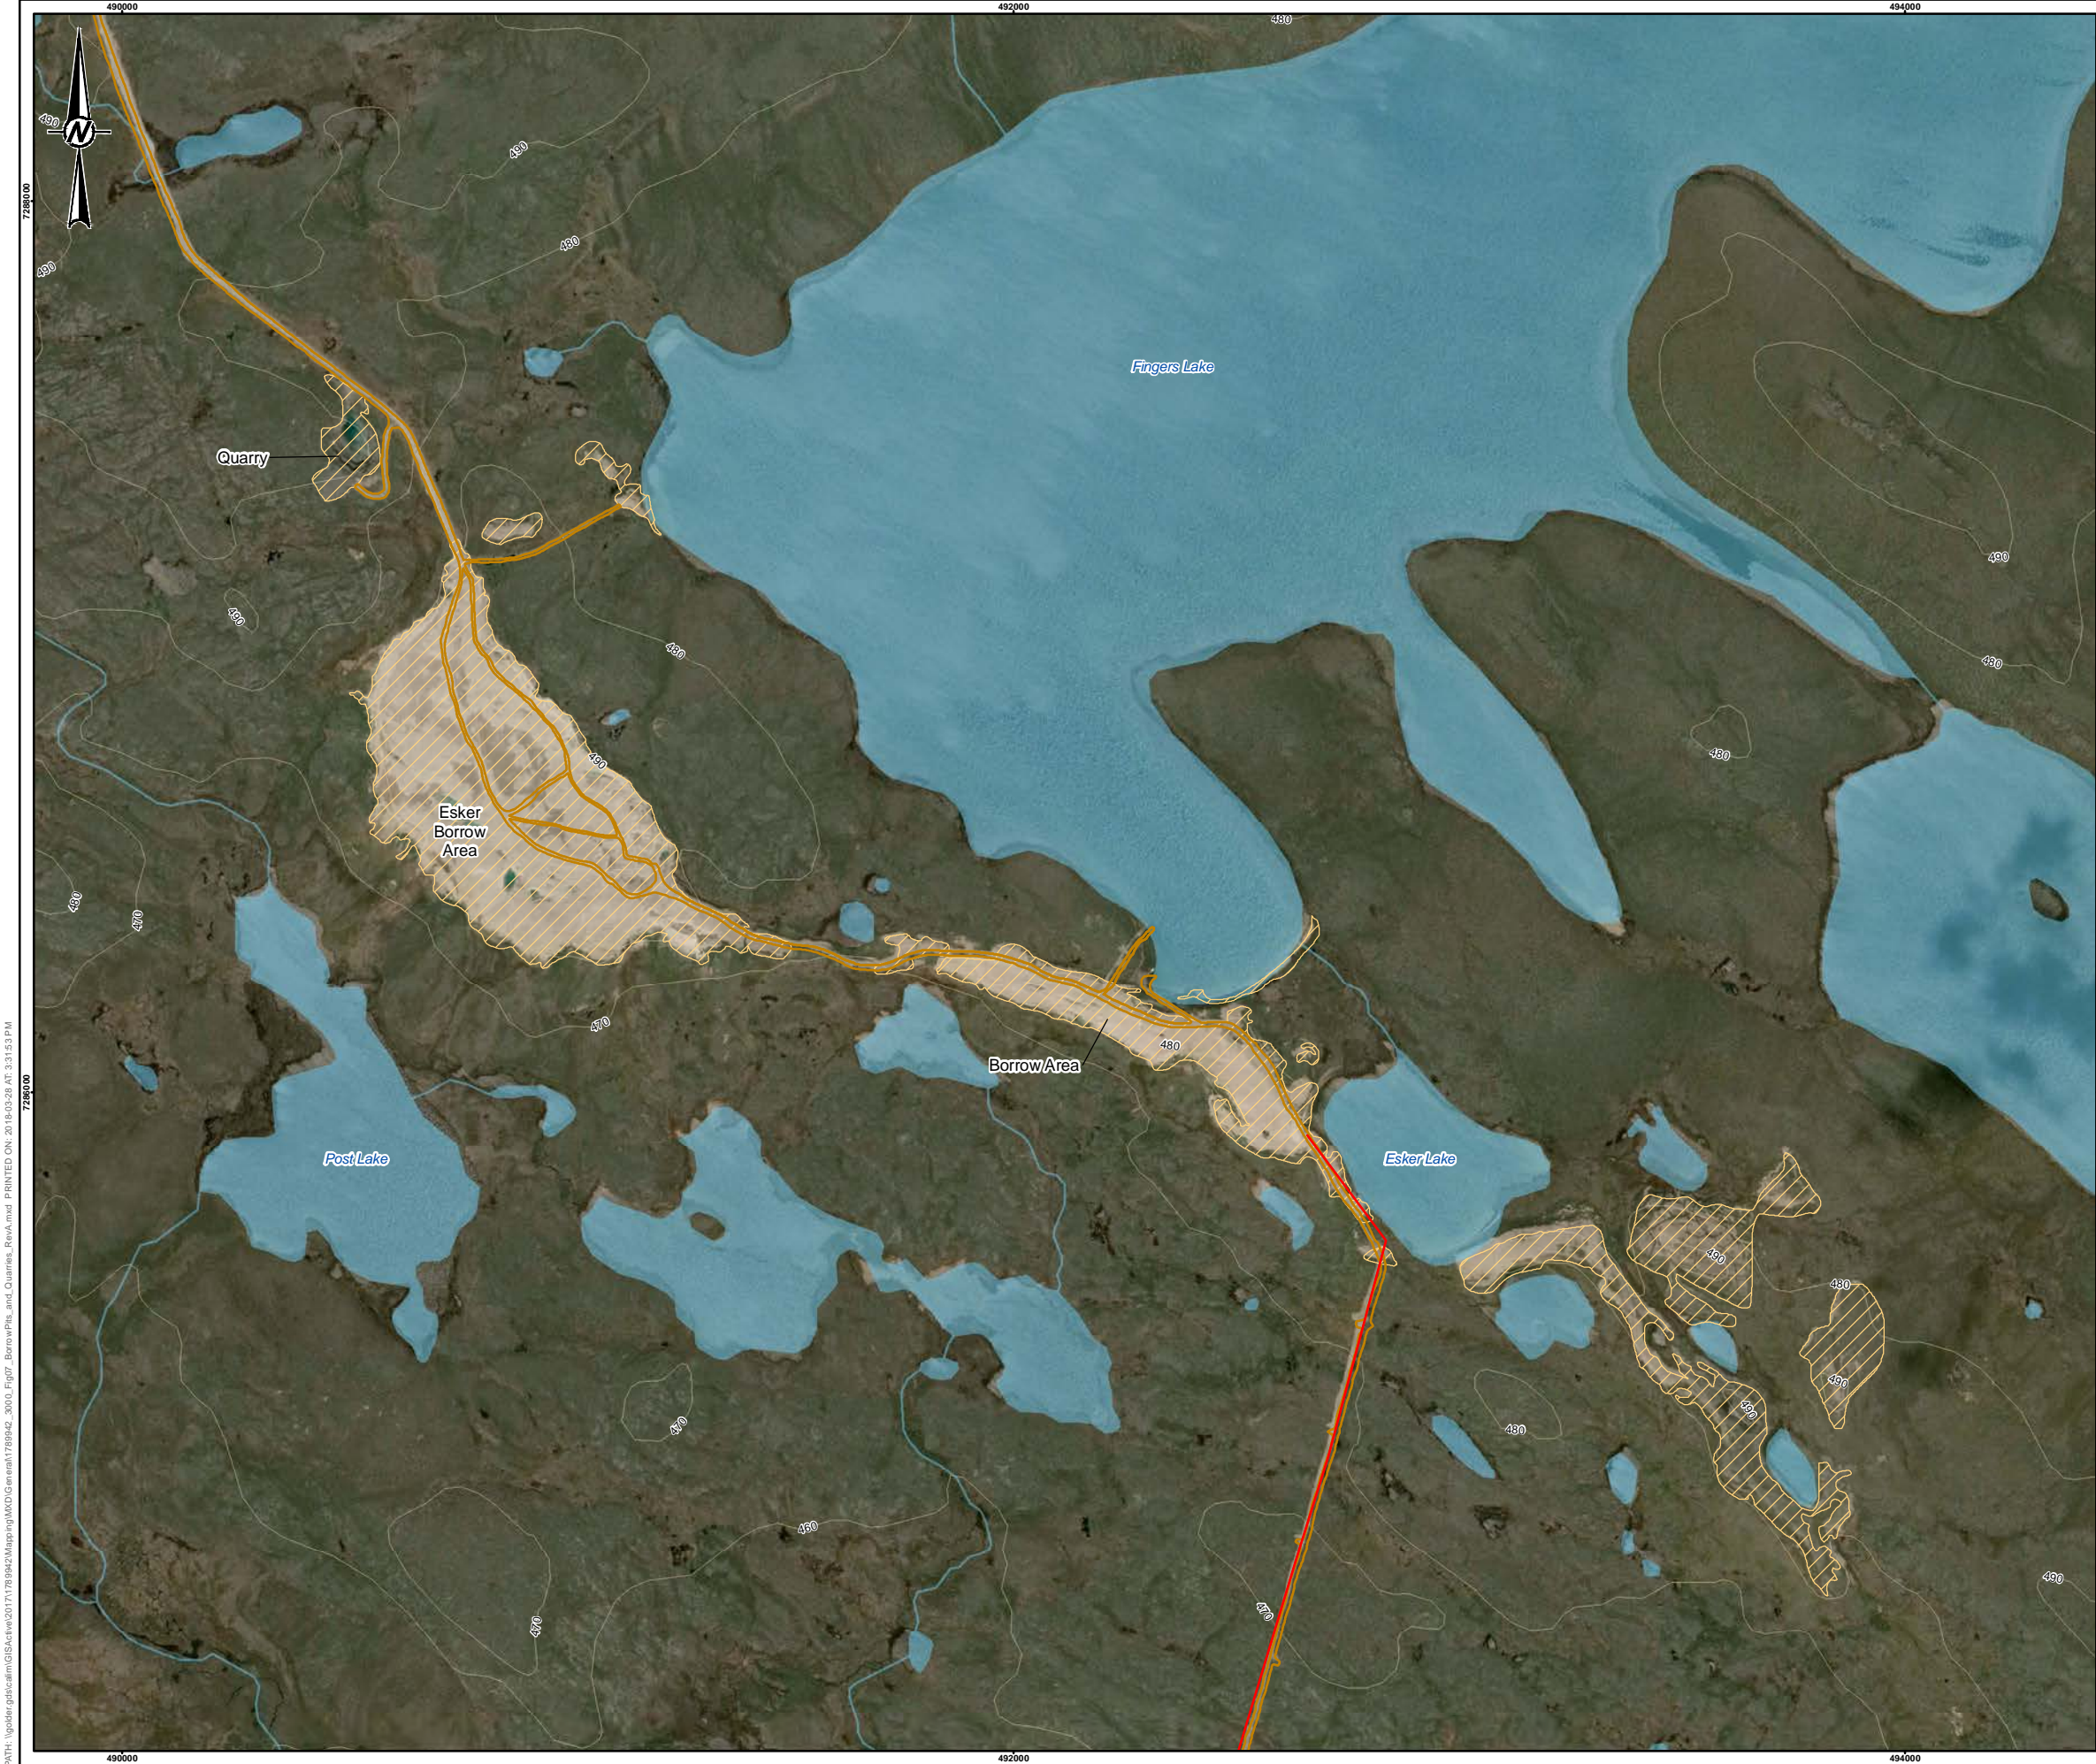
| 1789942 | 3000 | A | 7 |

**TITLE**  
LOCATION OF BORROW PITS AND QUARRIES

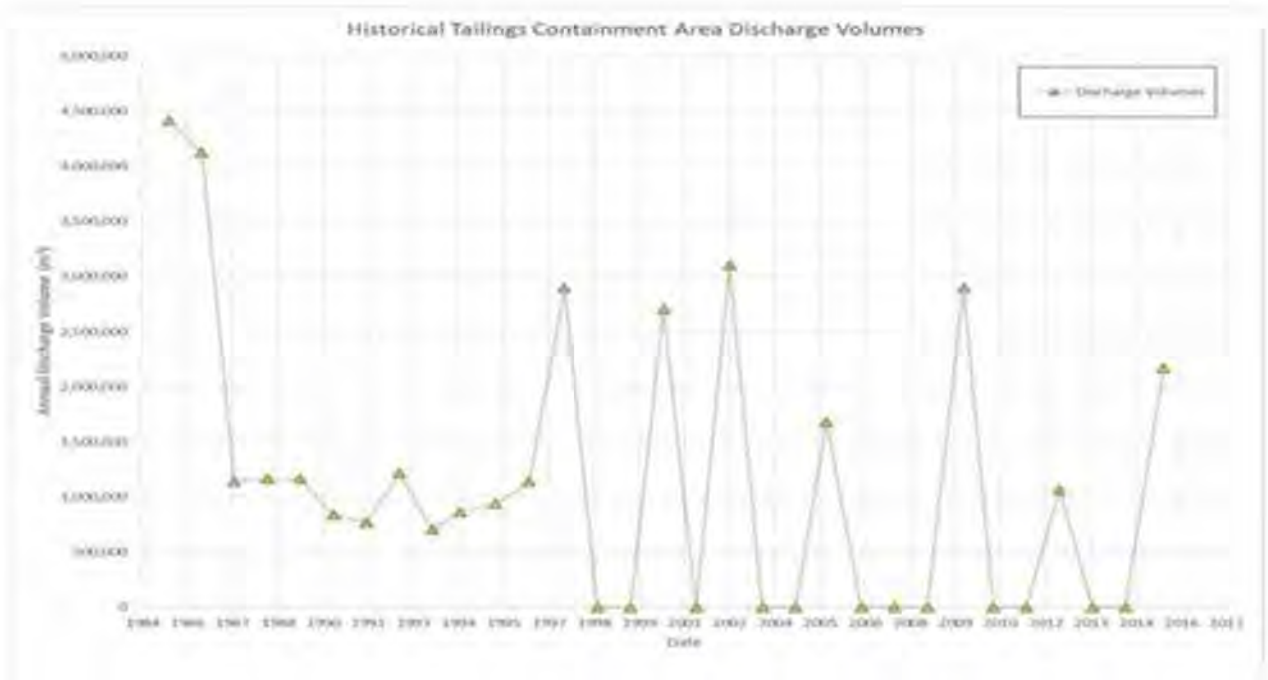
FIGURE  
9

TITLE  
**HISTORICAL TCA WATER DISCHARGE TO THE ENVIRONMENT**

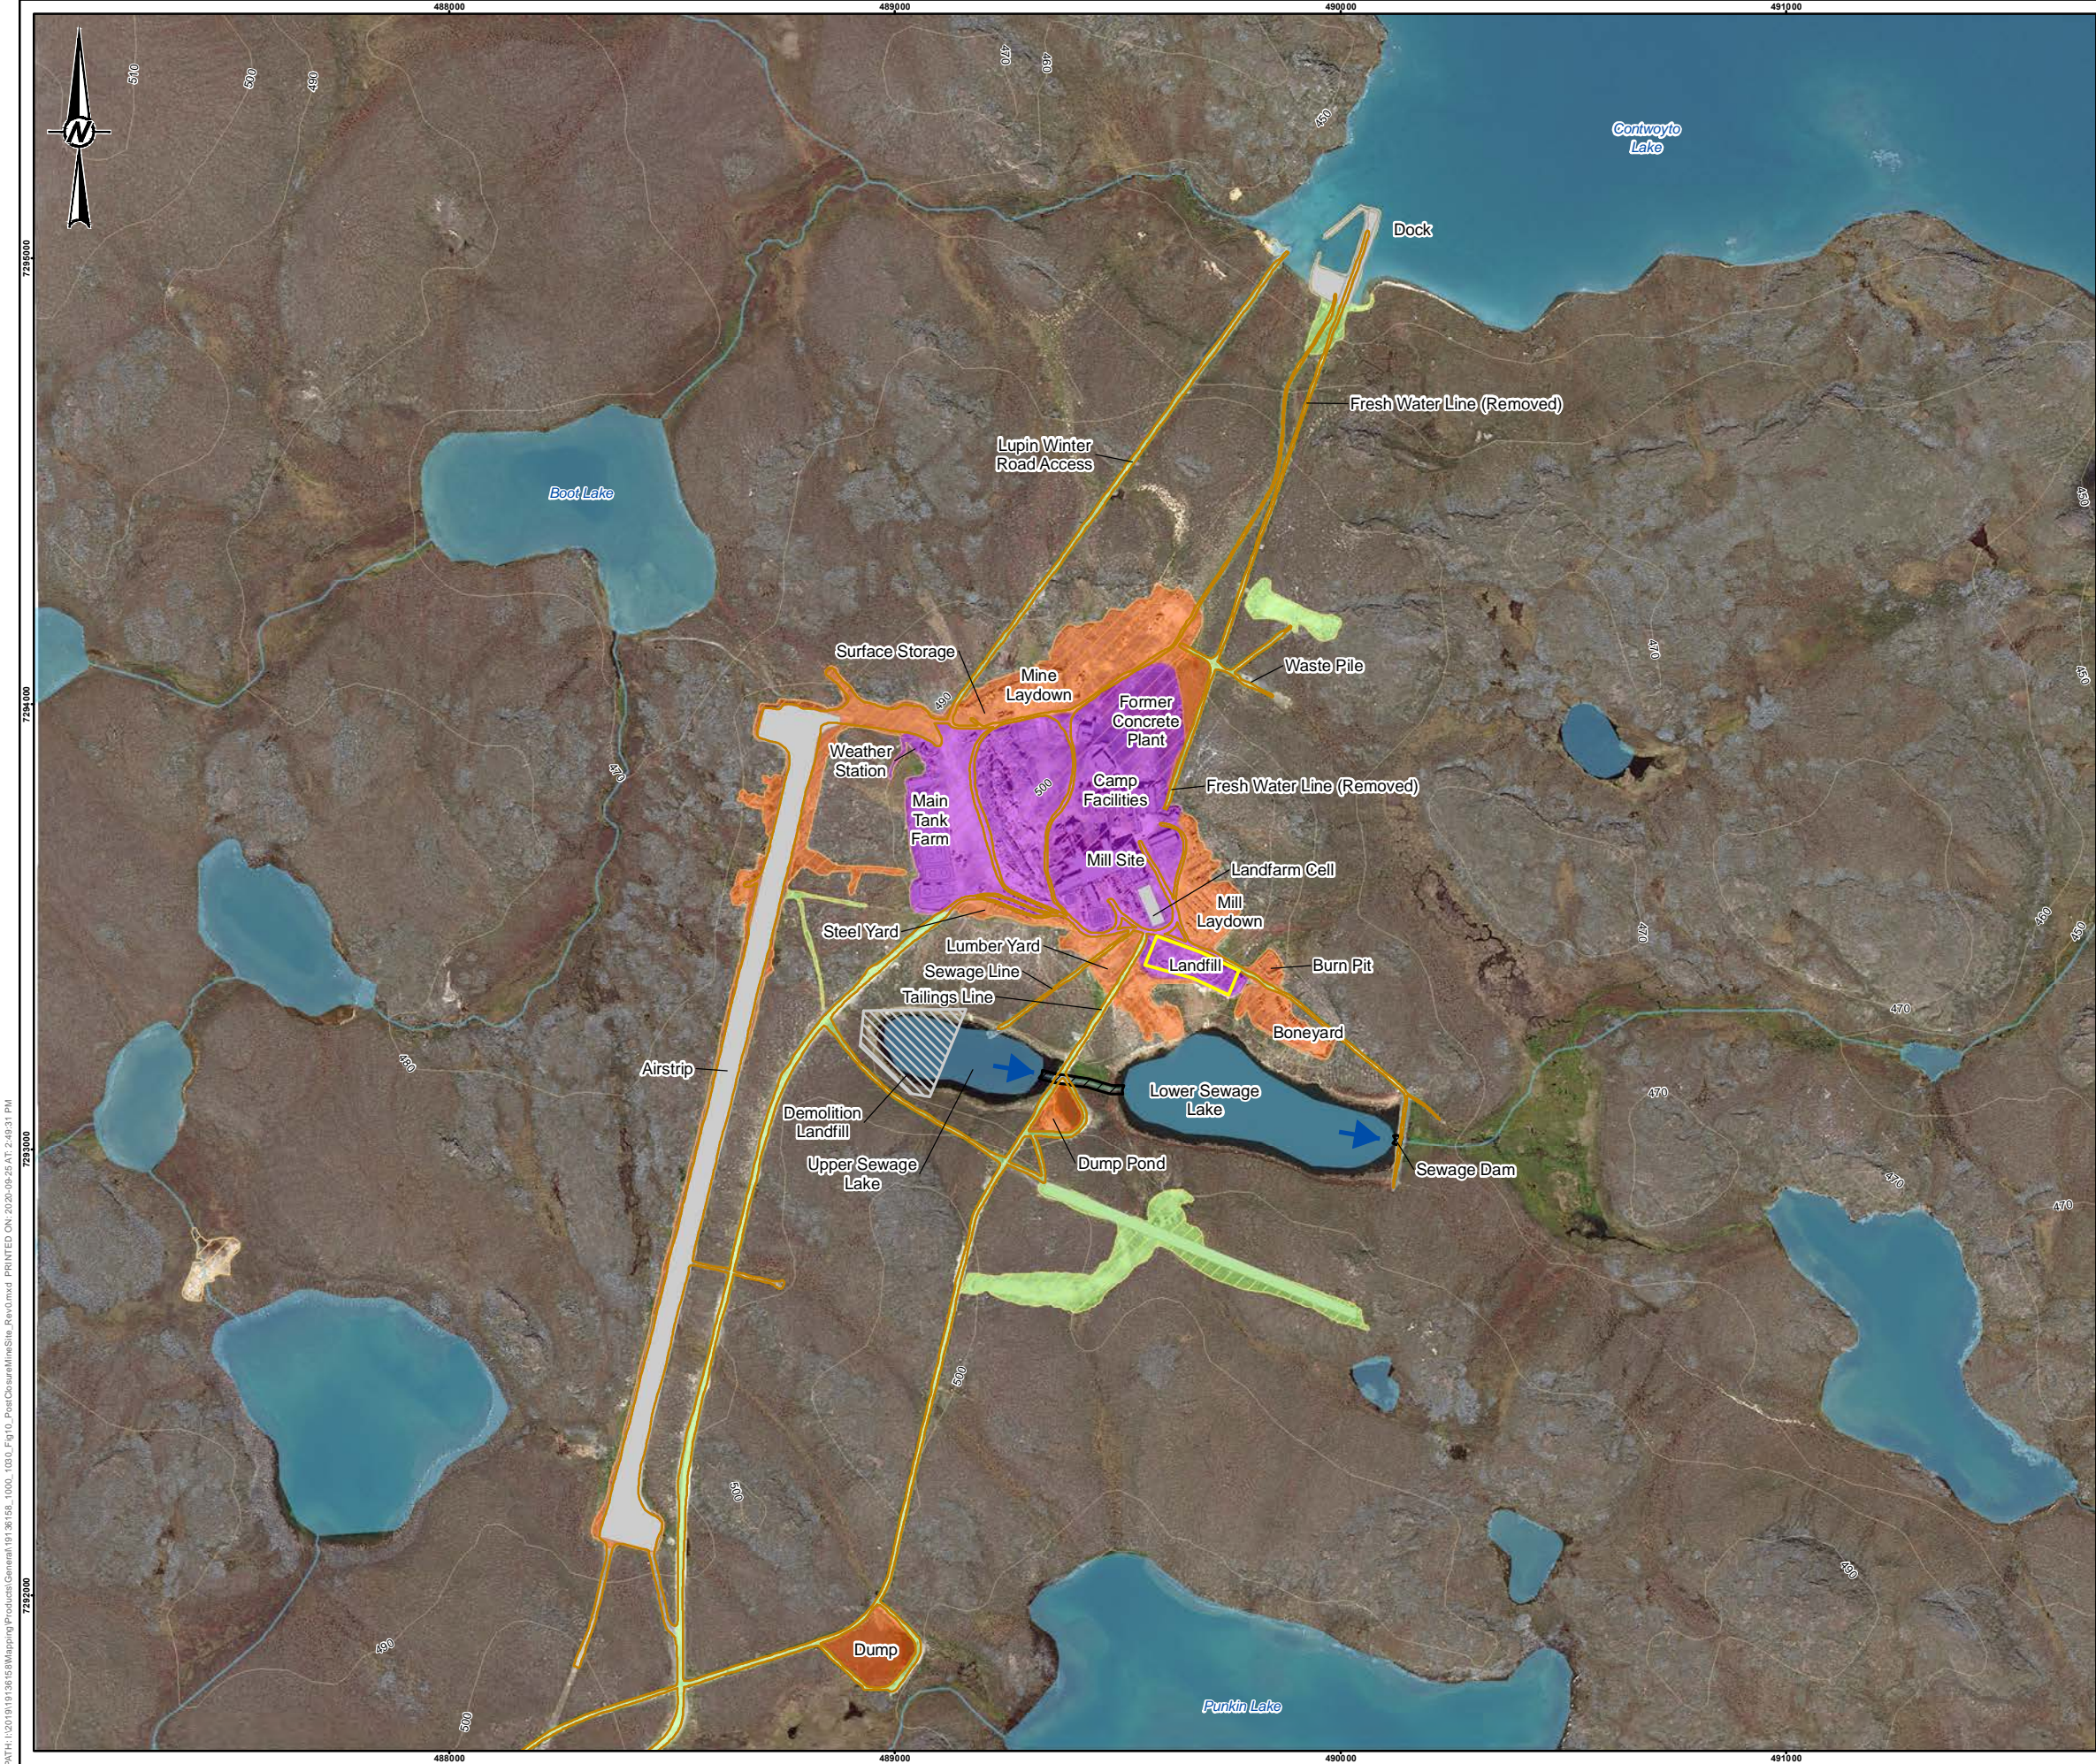
| 19136158 | 1000-1030 | 0 | 10 |

TITLE  
**MINE AND MILL SITE AREA – POST-CLOSURE**

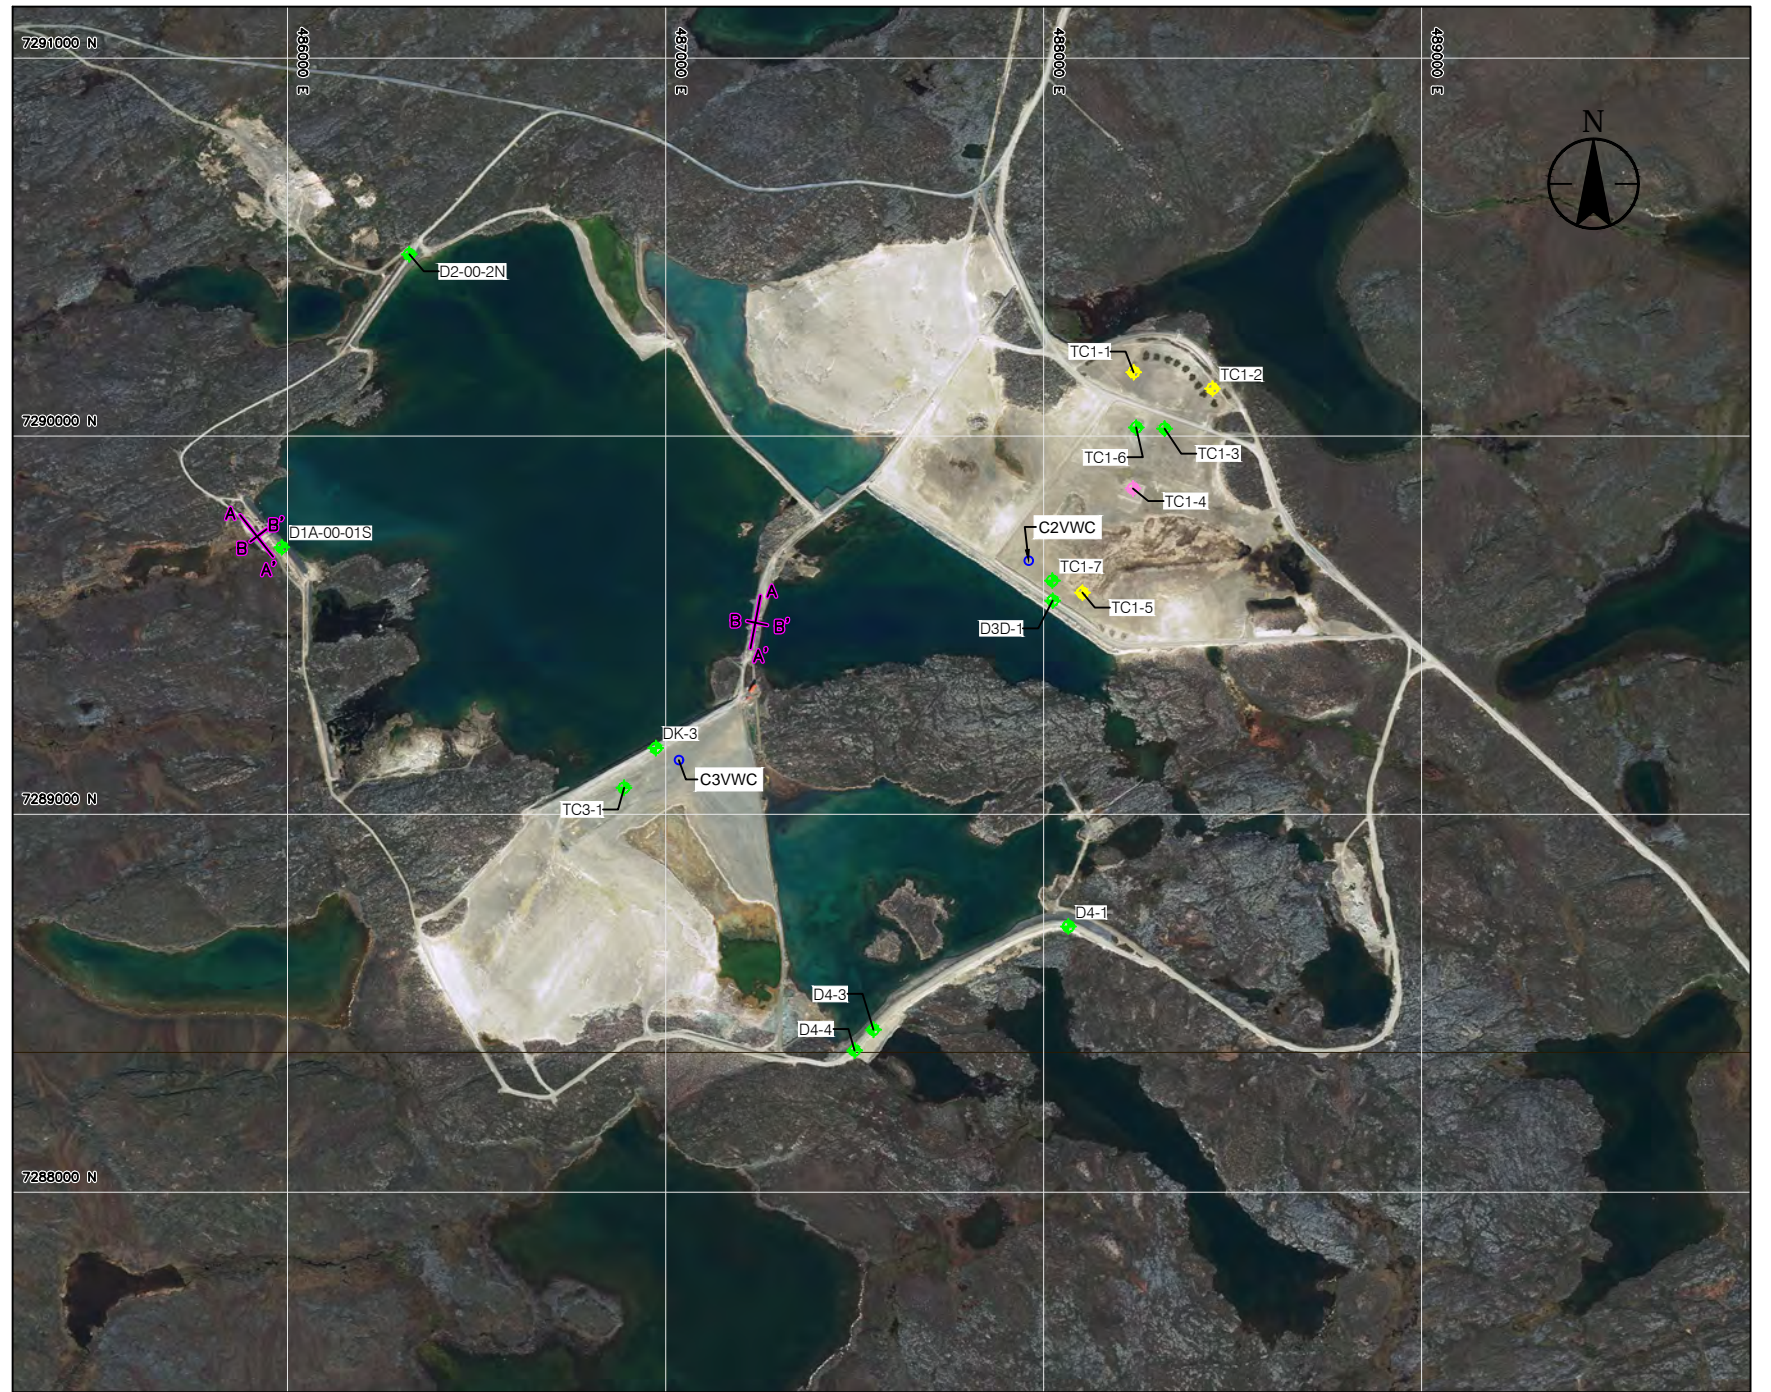
FIG. NO.:  
15

SECTION A-A'  
SCALE 1:200

SECTION B-B'  
SCALE 1:200

- COARSE ROCK ABOVE THE FLOOD LEVEL ON THE UPSTREAM AND DOWNSTREAM OF THE DAM WILL BE SALVAGE TO BE USED AS RIPRAP FOR SPILLWAY CONSTRUCTION. THE EXCAVATION WILL BE CONTOURED TO ENSURE STABILITY.

TAILINGS CONTAINMENT AREA CLOSURE  
SPILLWAYS CONCEPTUAL PLAN AND  
CROSS-SECTIONS
