Reference: 2AM-LUP1520 Technical Meeting Commitment Number 11 Response – Geophysical Survey Lupin Mine Tailings Containment Area Dams

Re: Lupin Tailings Dams Geophysics Survey 2019

Reference: 2 AM-LUP Technical Meeting Commitment Number 12 Response – Risk Assessment on Two Dams in the Lupin Tailings Containment Area

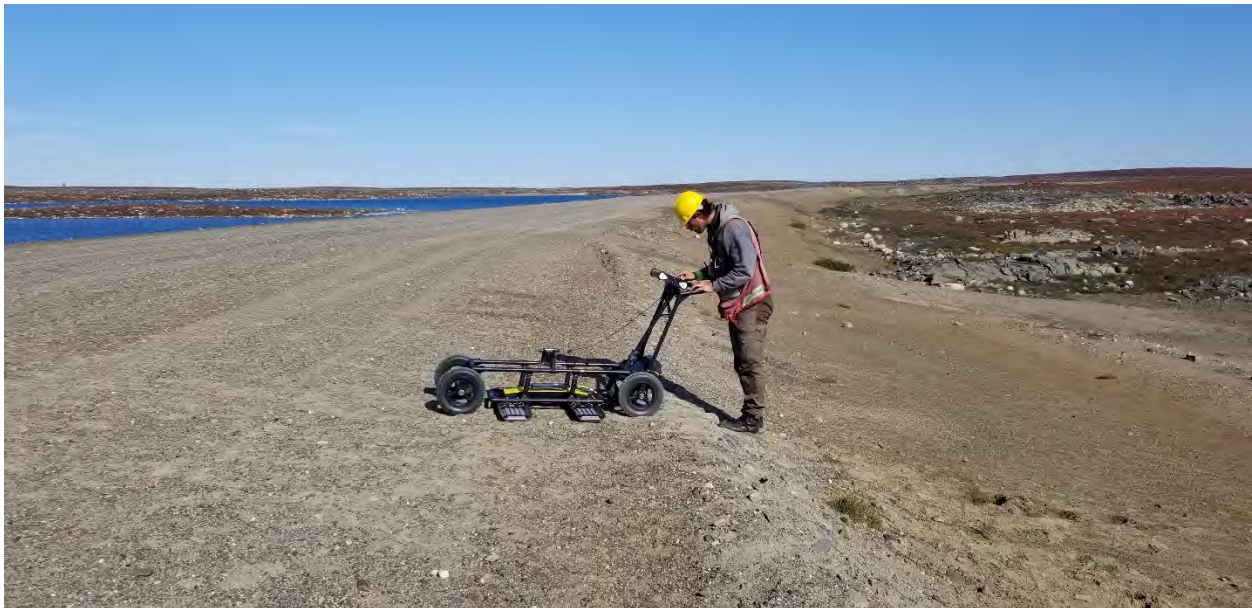
Figure 1. Operator performing the Ground Penetration Radar (GPR) cross profile on dam 4.

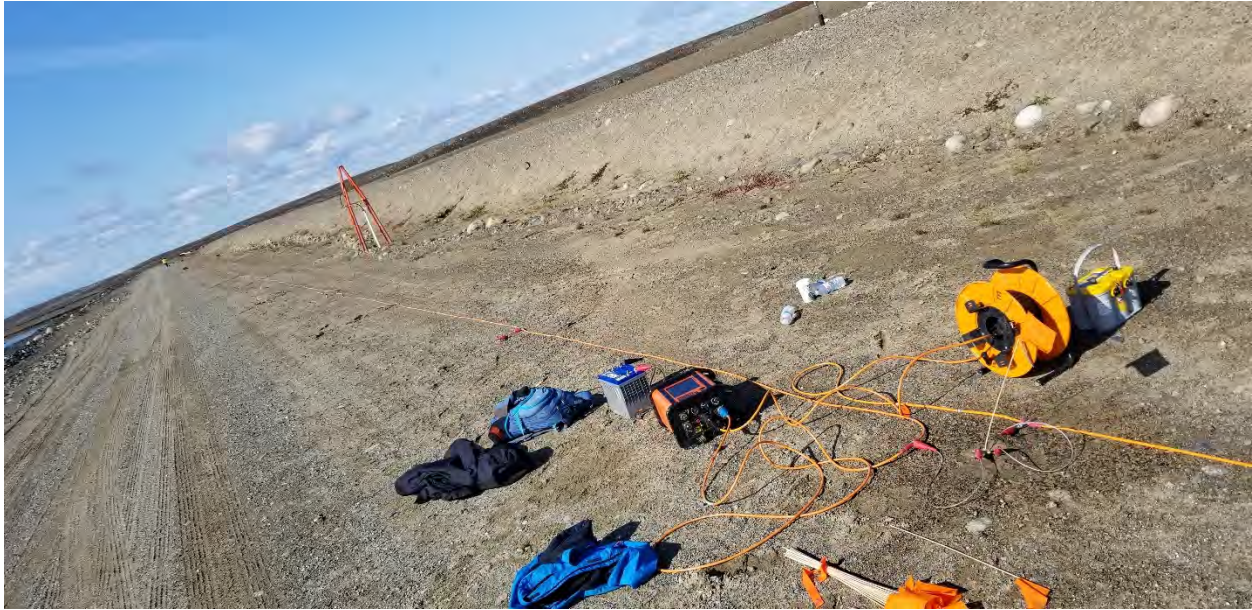
Figure 2. Electrical Resistivity Tomography setup on dam 3D.

Prior to setting up the ERT system, GPS coordinates were obtained from sections along the dam so as to plan the survey profile according to specifications given by the client. In Dam 4, the profile was conducted along the center line of the dam while at Dam 3D, it was offset upstream along the dyke (Figure 2). Where electrical contact problems occurred due to a relatively resistive ground, fresh water mixed with salt (sodium or calcium chloride) was added to the electrode location. Failing this, the electrode would be disabled from the array and located at a suitable location. This survey was conducted using both dipole-dipole and gradient-plus configurations.

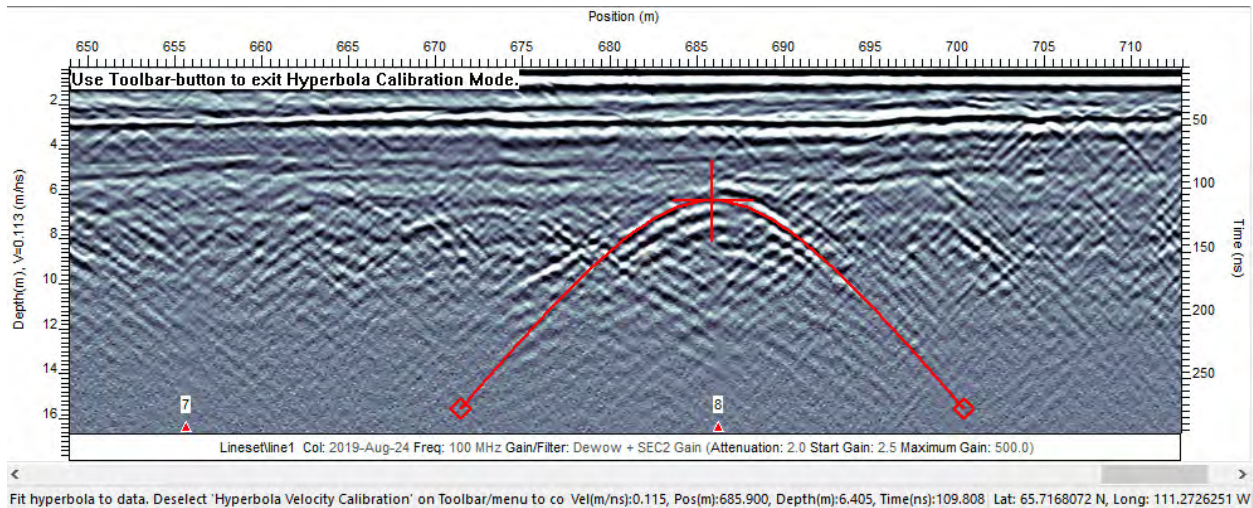
this curve fitting process is shown in Figure 3, where the GPR section crossed buried thermistor D4-4 on Dam 4.

Figure 3: Hyperbola velocity calibration at thermistor D4-4 on Dam 4.

Velocity calibration: GPR data is recorded as a series of reflected radio waves. The time it takes for these reflections to arrive is noted in the raw GPR data. However, in order to convert these times into depth below the ground surface, an estimate for the radar velocity below the surface must be obtained. The simplest way to obtain this estimate is to look for hyperbolic reflectors. The best hyperbolic reflectors are single points that pass directly below the radar instrument. By fitting a theoretical hyperbola to these observed hyperbola, an estimate can be produced. Several hyperbola were fit at various spots in the data arriving at an estimate of 0.115 metres per nanosecond, plus or minus 0.005. An example of

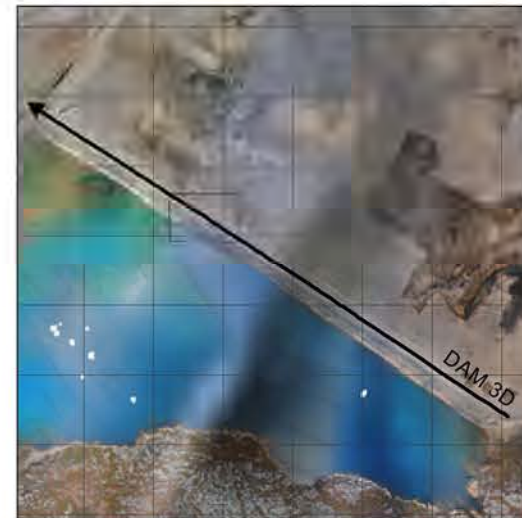
Section 1: Dam 3D Interpreted Electrical Resistivity and GPR Reflectors

All three GPR reflectors are continuous, indicating no break or absence in the ice core of the dam.

The ERT data indicates a slightly conductive surface layer (yellows), beneath which lies more resistive material (blues, greens, whites) which is consistent with the ice core of the dam and underlying bedrock. Beyond 10 m depth, the model becomes conductive again, which is interpreted as conductive features adjacent to the dam.

A single anomalous area is interpreted in the data, both in the GPR data and the ERT data. This area stretches 120 m in length and is characterized by: the interpreted top of the ice core being deeper, several strong GPR reflectors which produced strong hyperbola (circled on Section 1), and conductivity anomalies associated with those strong GPR reflectors (reddish colour within circles on Section 1). While this area is considered anomalous, it does not indicate a failure of the ice core. Rather, it is likely that the top of the ice core is depressed at this location. It is possible that the circled spots indicate wet spots that have higher total dissolved salts, fractures, or buried metal objects (i.e.: old culverts, drill casing, rebar reinforced concrete, instrumentation, etc.).

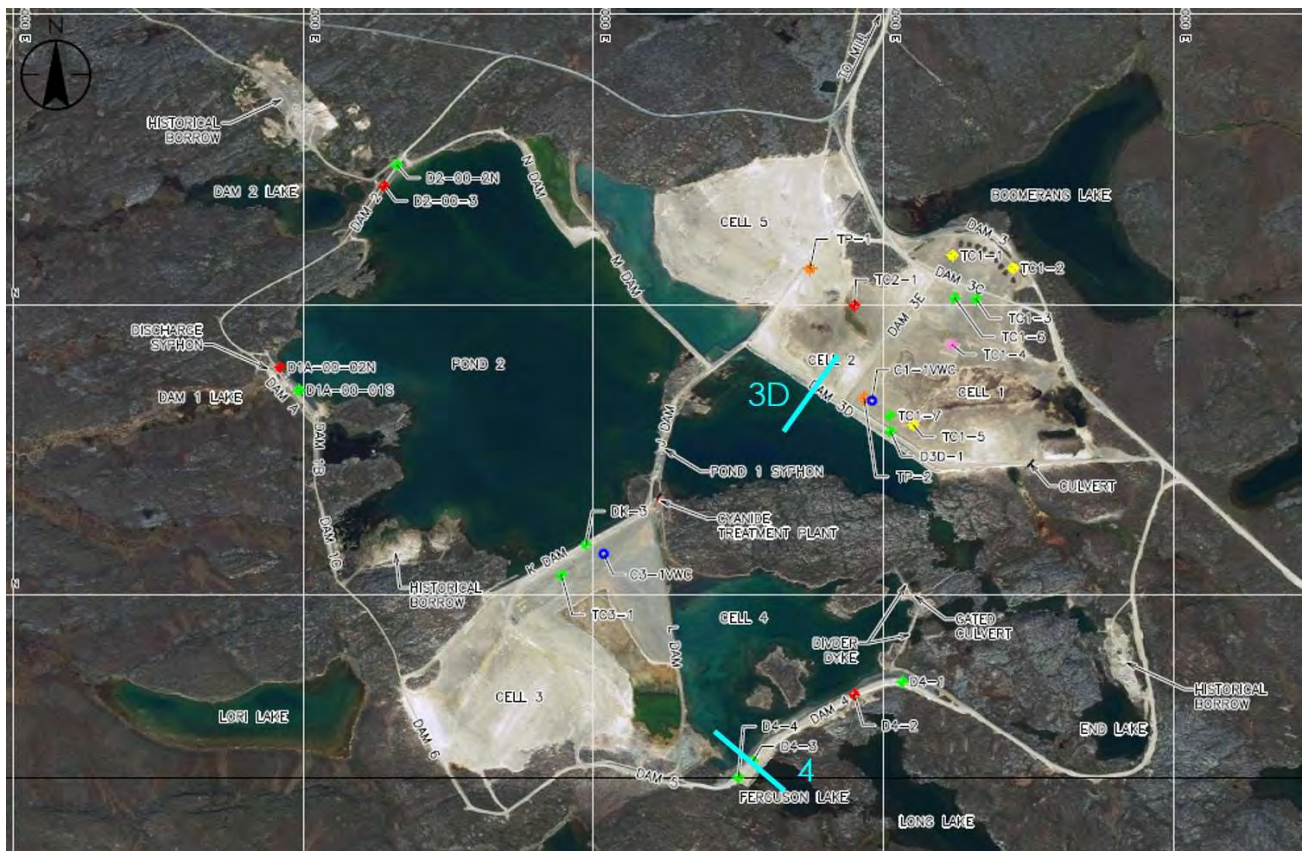
Figure 2: Tailings Containment Area Stability Section Locations

Table 2 shows the material properties used in the analyses and the Figure 1 shows the locations of the stability sections.
