**PHASE 1 AND 2
ENVIRONMENTAL SITE ASSESSMENT**

**Lupin Mine Site
Nunavut Territory**

**A053017
January 11, 2006**

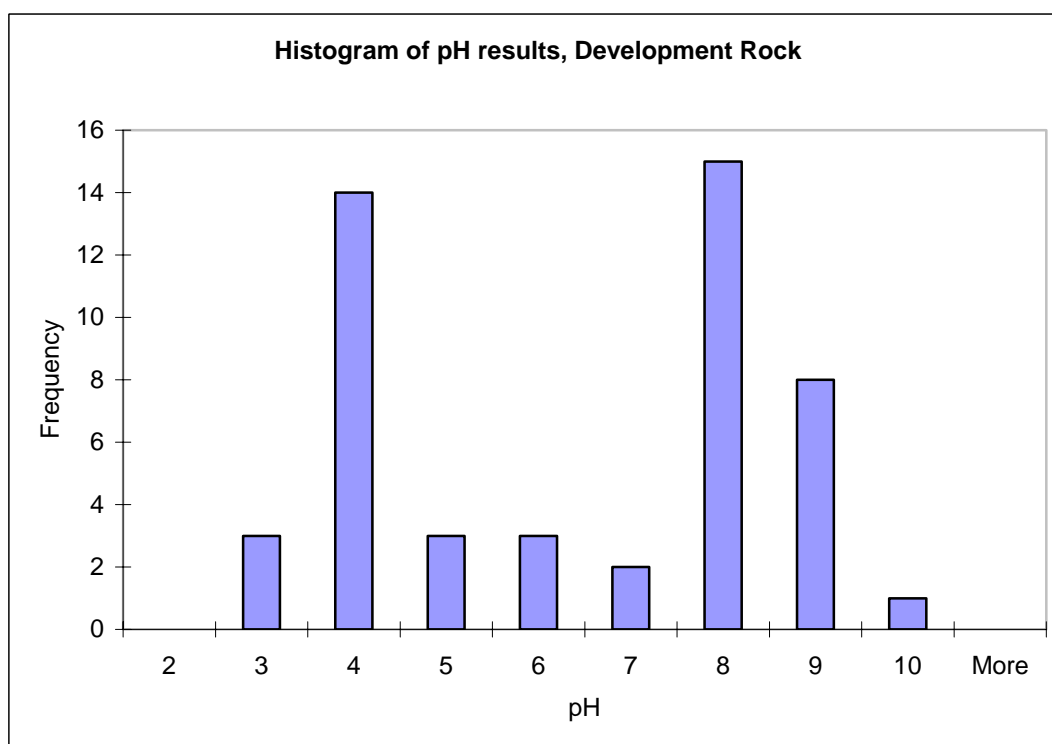
Figure 1: Histogram of pH Results, Development Rock

Since the pH of the development/waste rock has an influence on the likelihood of leachate generation, the pH of was examined for distribution patterns. A histogram of pH results in the development rock presented in Figure 1. The histogram suggests there are two populations for pH in development rock – the measured pHs were either relatively alkaline (i.e., 8 to 10), or relatively acidic, (i.e., 4 to 6). The significance of this observation in comparison to the other analytical results is discussed in Section 10. It is noted that these results differ from previous ABA sampling which suggested that most of the waste rock was alkaline.

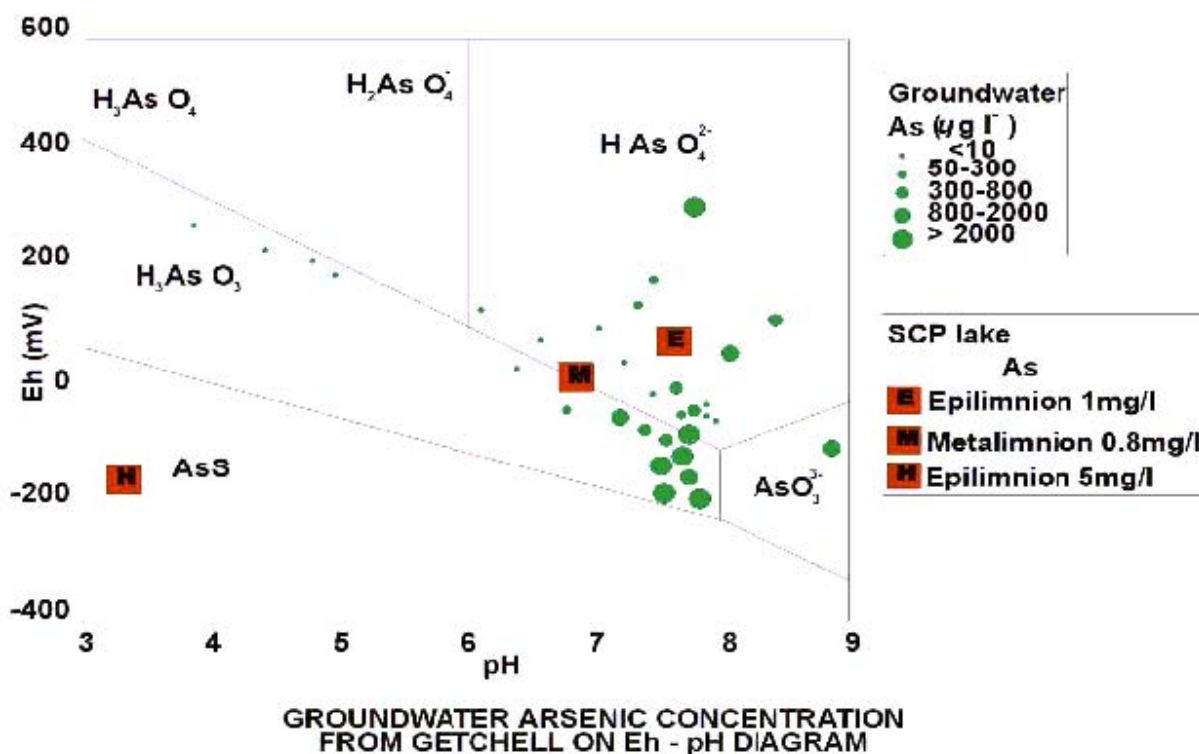
Figure 4: Eh-pH diagram for Arsenic⁸

The elevated arsenic concentrations appear to be associated with water with more alkaline pH (i.e., 7 to 9 pH units) which is consistent with the Eh-pH diagram for arsenic shown in Figure 4, and literature (e.g., MEM guidelines) which indicate that arsenic can be more soluble under slightly alkaline or weakly acidic conditions. If ARD was extensive at the site, arsenic concentrations would be reduced in relation to metals that are mobile under acidic conditions. This result supports the conclusion that enlarging the direct measurement data set (i.e., seep sampling) is the best method for evaluating ARD/ML.

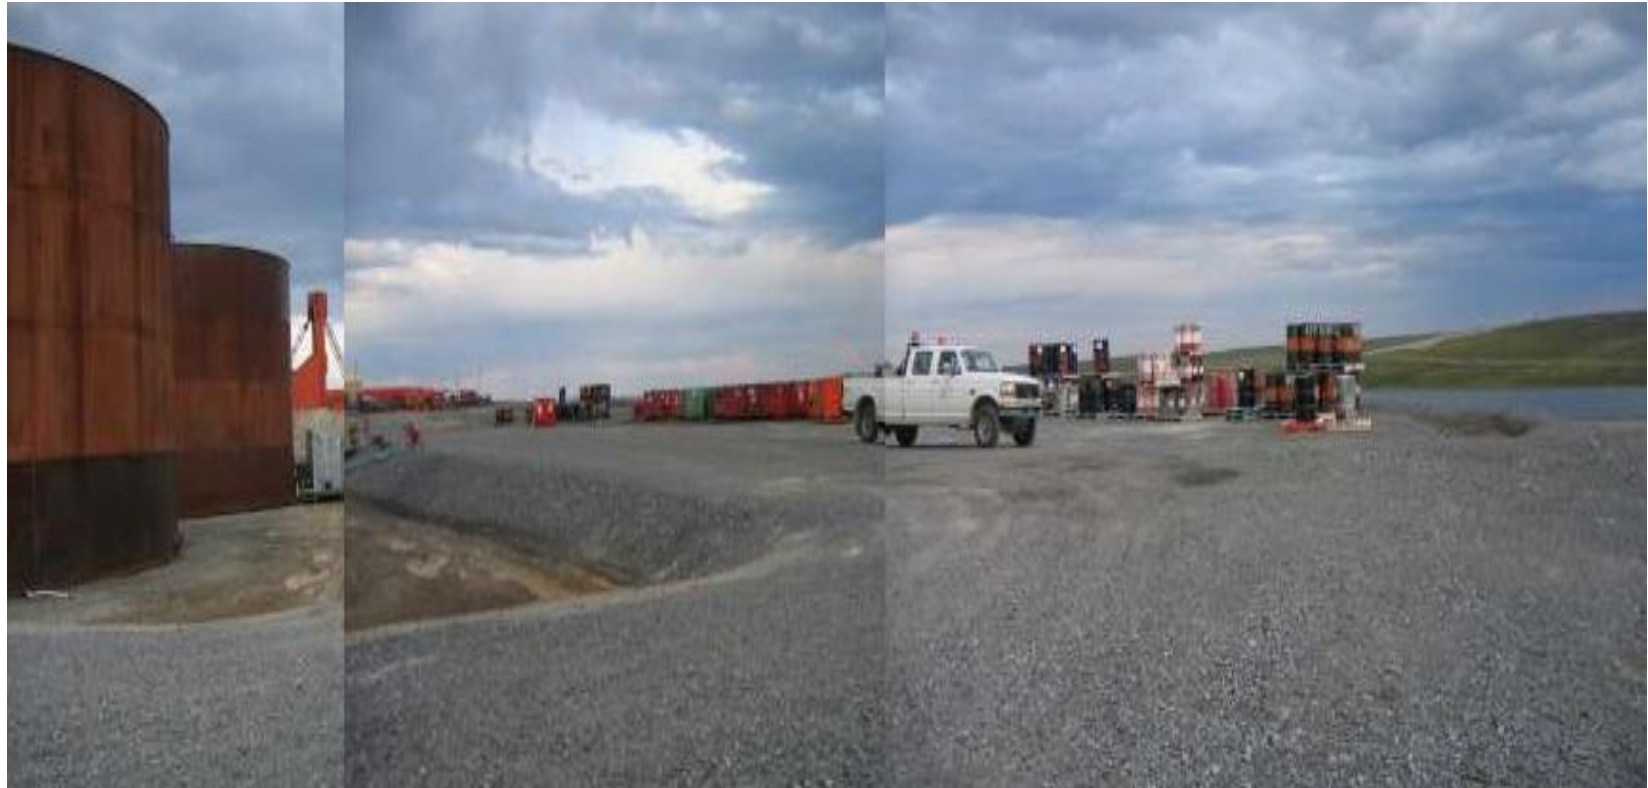
Photograph 4: Panoramic view to east of Main Tank Farm Area, July 2005.

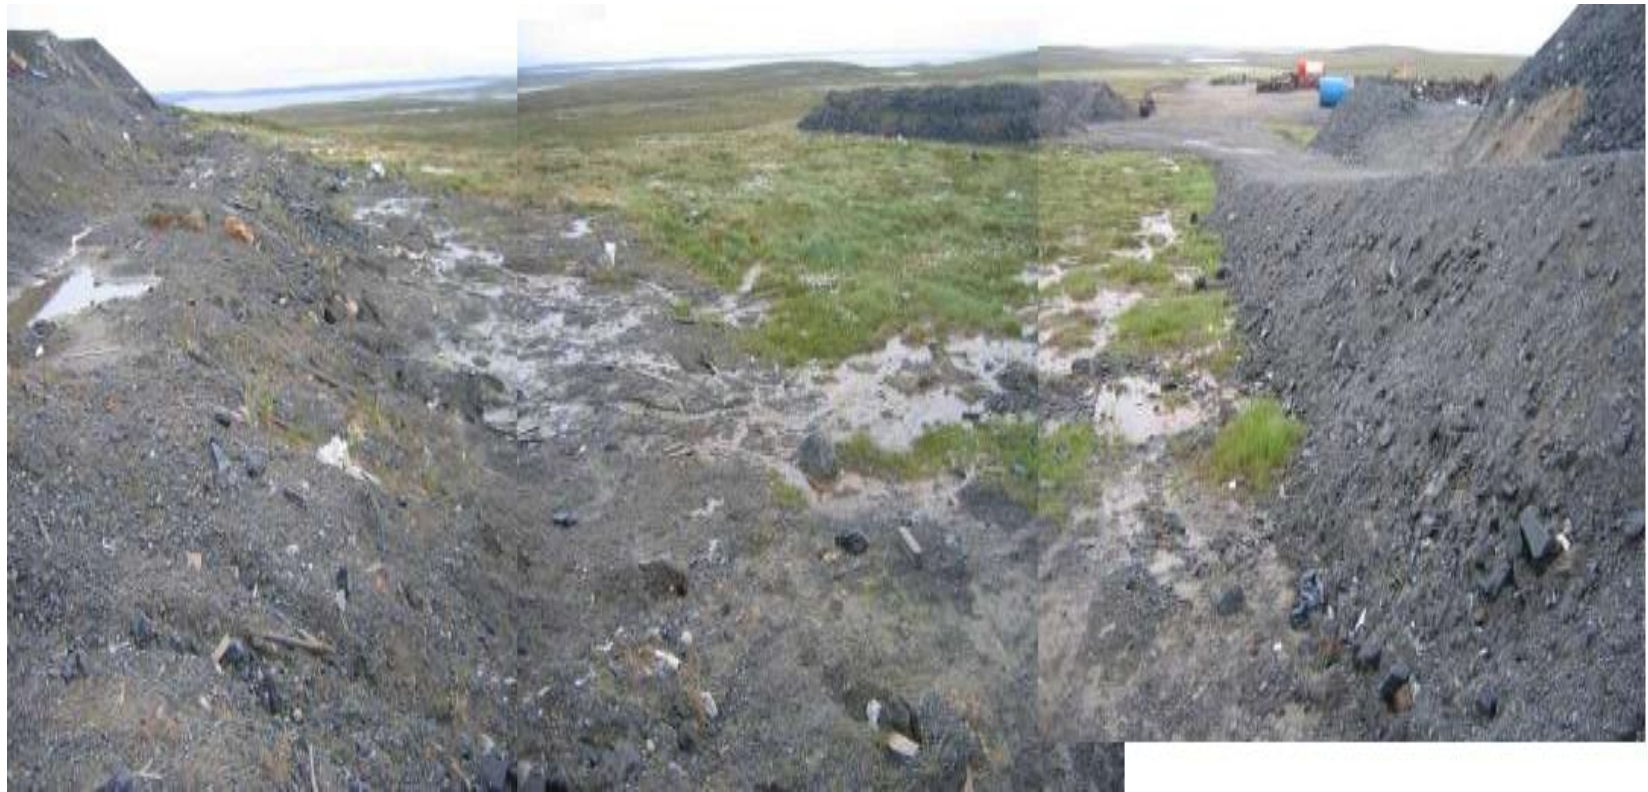
Photograph 6: Panoramic view to south of south burn pit and landfill area, July 2005.

A diesel fired incinerator was used to burn scrap food and the residual ash was placed into the landfill. Other burnable solid waste was collected into two burn pits – one near the north portal for underground solid wastes (Photograph 39) and one at the south side of the site for surface wastes (Photograph 6). The solid waste was burned in the burn pits (used oil or diesel used as a starter), and then the residual solids were placed in a landfill at the south side of the site (Photograph 6). The land filled materials were covered with lifts of soil or waste rock.

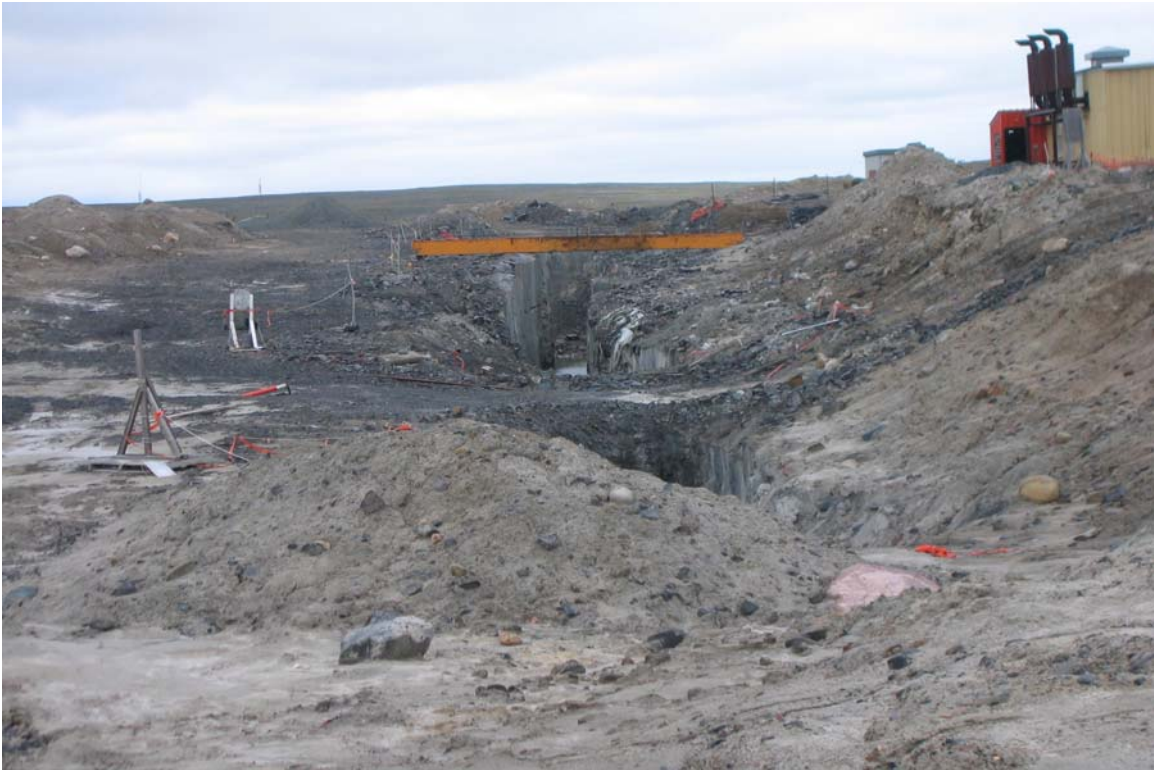
Photograph 7: View to north of Open Stopes, July 2005.

During the last few years of mining, the crown pillars of the Lupin orebody were recovered. The crown pillars were the portions of the East, Centre, and West zones between surface and 27 m level that were left behind when the initial mining was carried out. The East Zone crown pillar was recovered in 1997 and was completely backfilled with waste rock and non-hazardous waste material in 1998. Mining of most of the Centre Zone crown was completed in 2003 and it was backfilled with pastefill that same year. A small portion of the Centre Zone crown pillar was mined during 2004 and remains open for the deposition of non-hazardous waste material. The West Zone crown pillar was mined between 1996 and 2004, and has been left open for the future disposal of hydrocarbon and metals impacted soils. It is estimated that 36,000 m³ to 65,000 m³ volume¹ is available for disposal in these open stopes. A photograph of the open stopes is provided as Photograph 7, Appendix II.

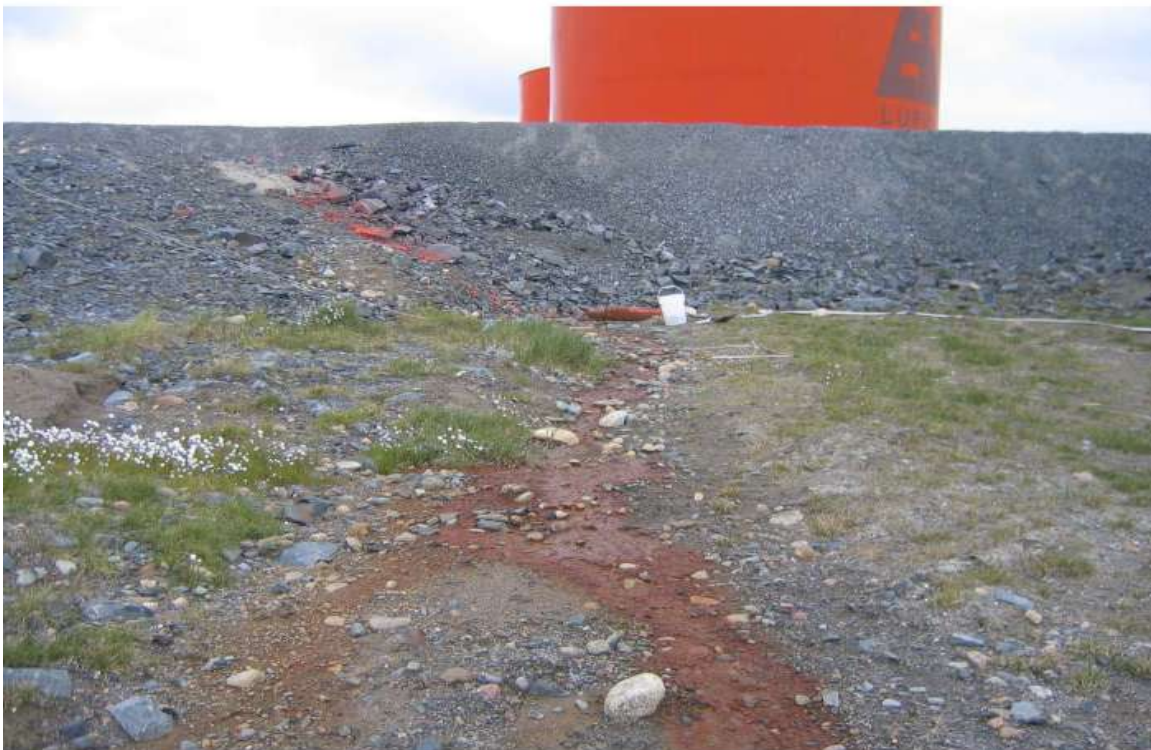
Photograph 12: View of Seep 9 on west side of Main Tank Farm, July 2005 (APEC 2a).

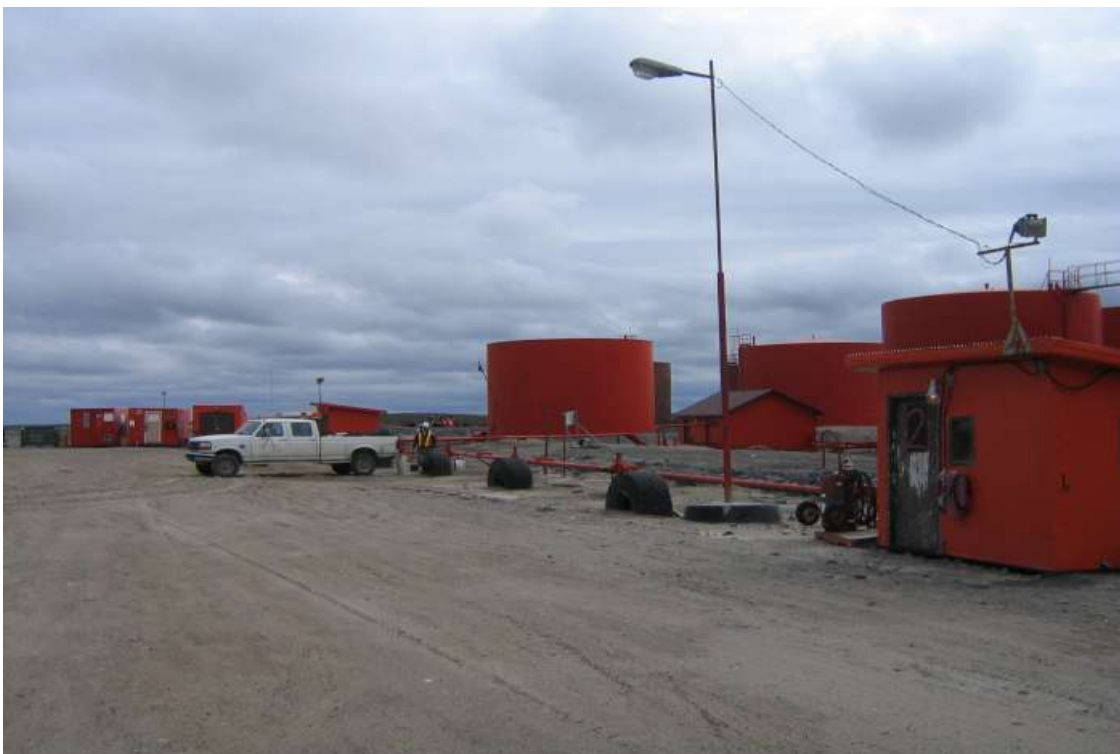
Photograph 14: View to south while sampling monitoring well 05-37 by Main Tank Farm loaders, July 2005 (APEC 2b).

2b	Main Tank Farm Loaders	Diesel fuel	Tank farm loaders are uncontained and hydrocarbon staining observed on ground surface.	14	Test pit/monitoring well 05-07 and test pit 05-36.	per 2a	F2 Insufficient water available to complete other analyses.	per 2a

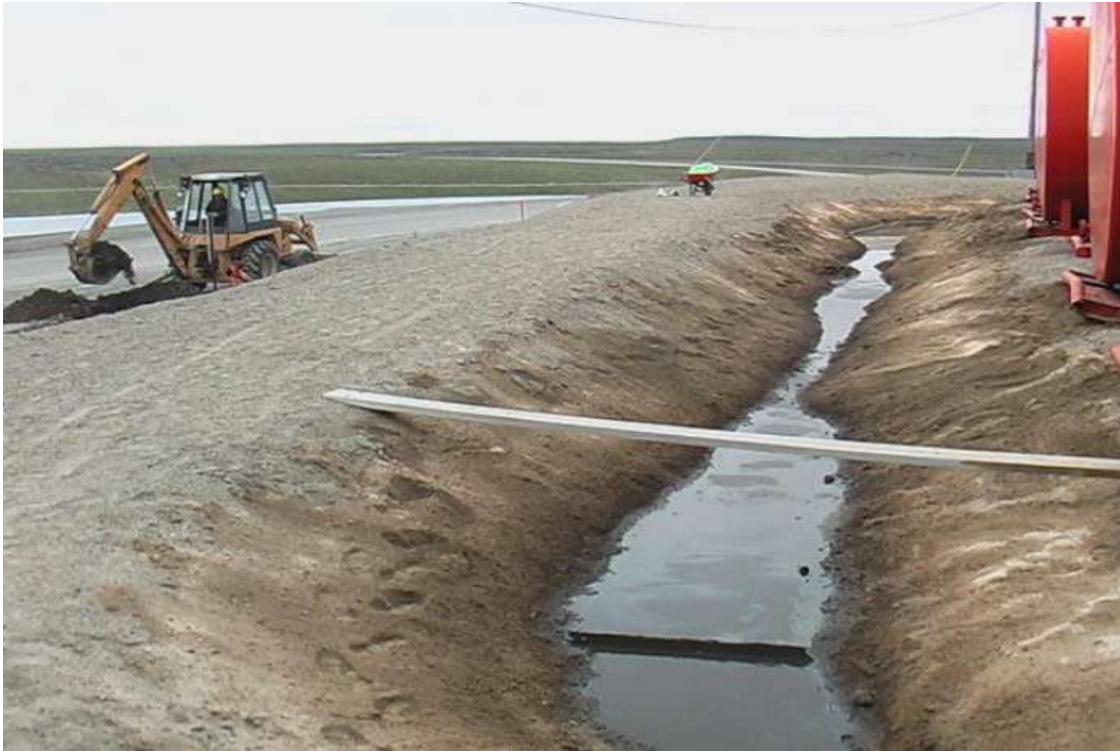
Photograph 17: View to west berm and test pit 05-28 located adjacent to Satellite Tank Farm, July 2005 (APEC 3a).

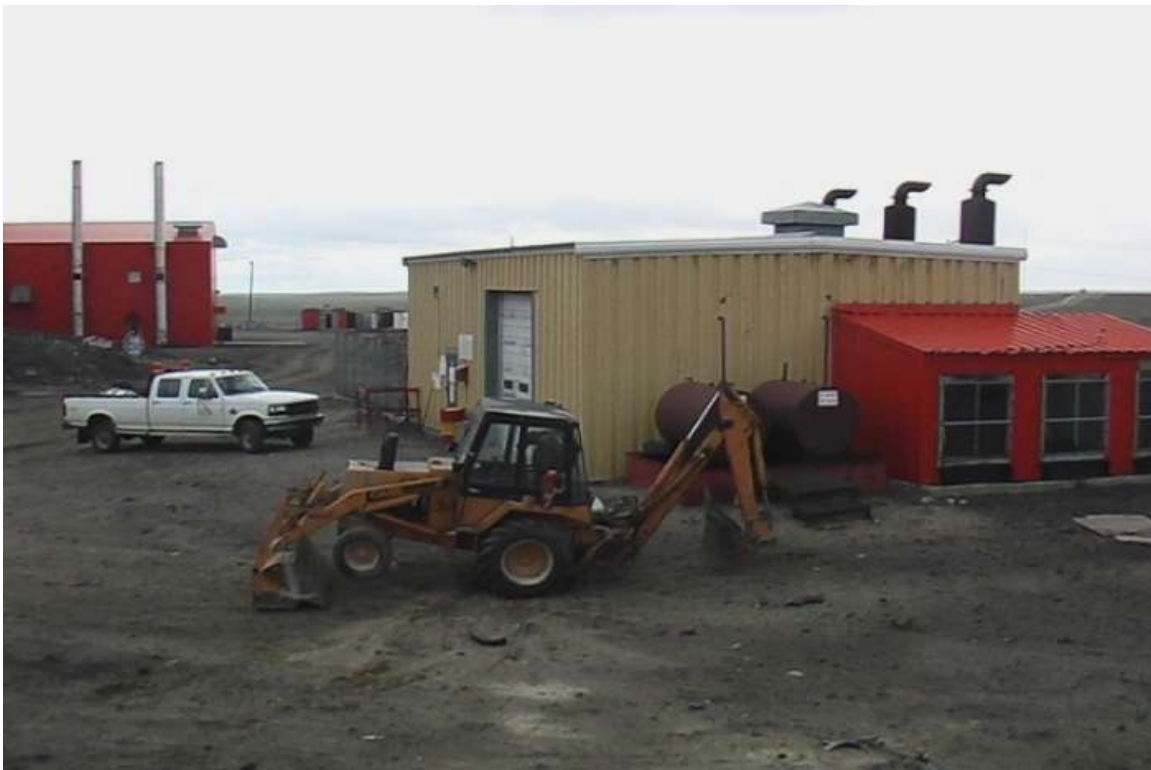
Photograph 20: View to south of test pit 05-58 being excavated at Emergency Powerhouse, July 2005 (APEC 3g).

3g	Emergency Powerhouse	Diesel fuel	Two ASTs and one transformer associated with emergency powerhouse.	20	Test pit 05-58.	BETX, PHC F1 to F4, and PAHs	n/a	n/a
3h	Brine Mix Area, Underground Equipment Fuelling and Storage area	Salt, diesel fuel, lubricants	<p>Brine was prepared for underground use in this area.</p> <p>The floor of the equipment storage area was unfinished, and evidence of spills were observed.</p> <p>An unloader for pumping fuel to underground workings was also present at this location.</p>	21	Test pit/monitoring well 05-60	CCME metals, sulphide, pH, BETX, PHC F1 to F4, PAHs, cyanide, glycols, and salinity	Dissolved metals, sulphate, BETX, F1 to F2, cyanide, glycols, routine water quality, and salinity	n/a

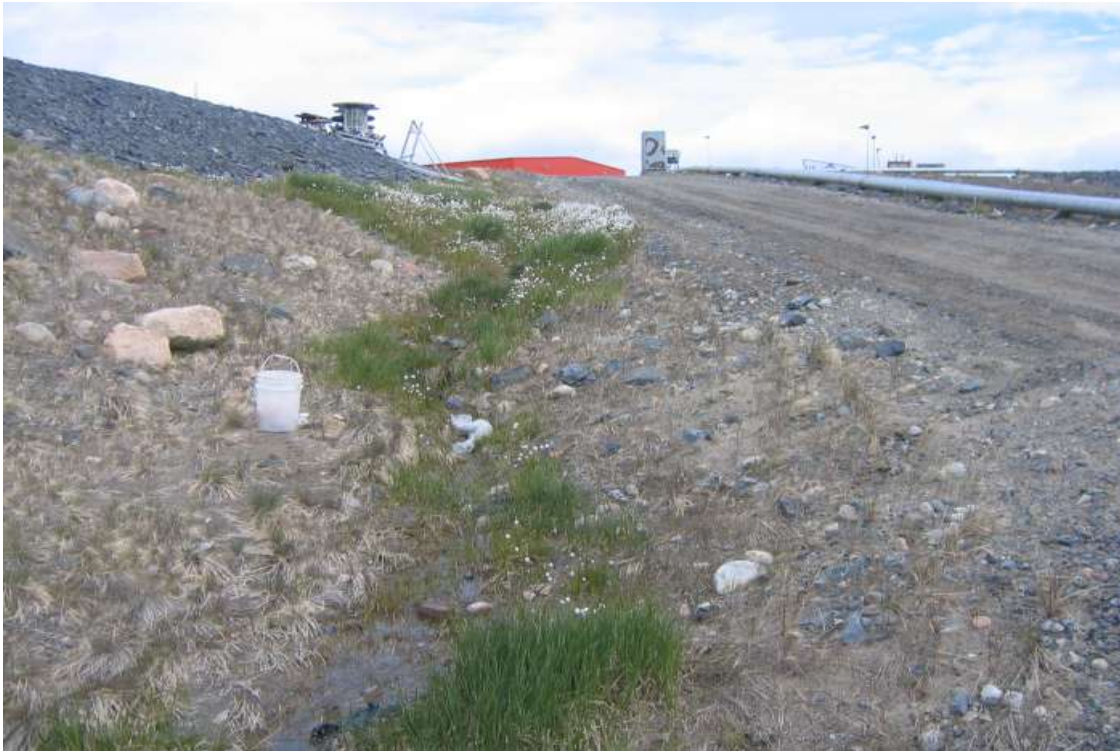
Photograph 29: View to northwest showing Seep 8 below the tailings line, July 2005 (APEC 4e).

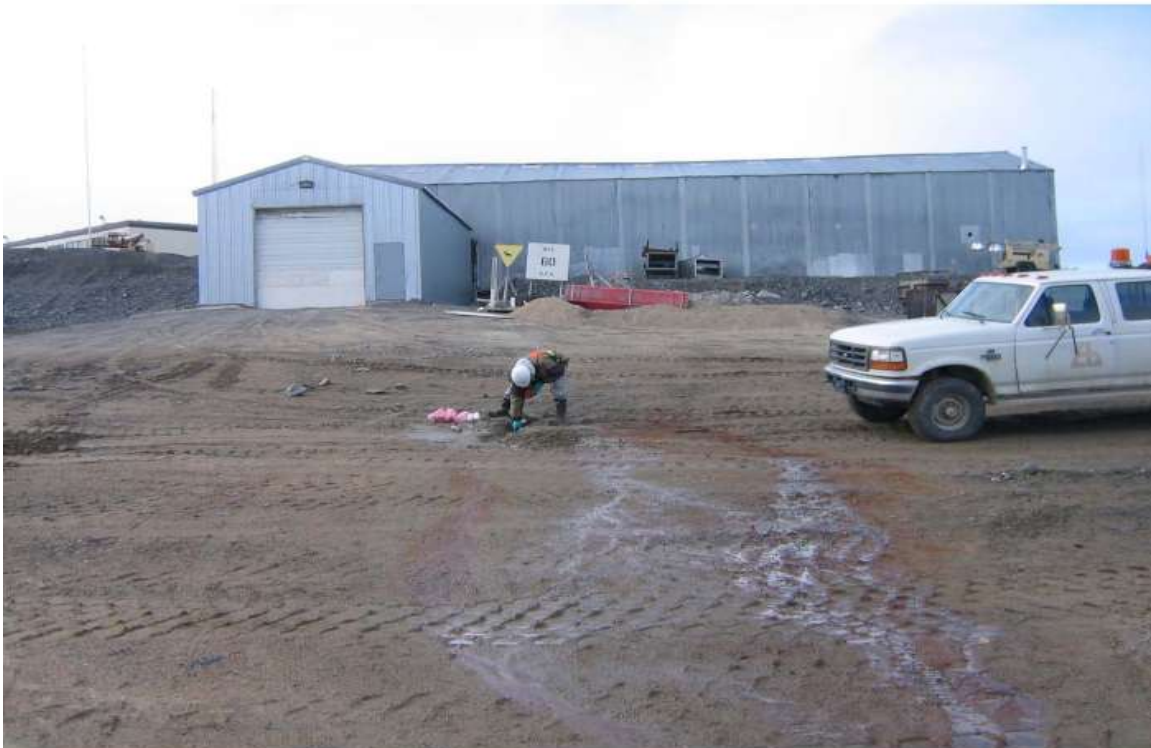
Photograph 31: Looking northeast to the RTL Shop with Seep 12 being sampled in the foreground, July 2005 (APECs 5a and 5b).

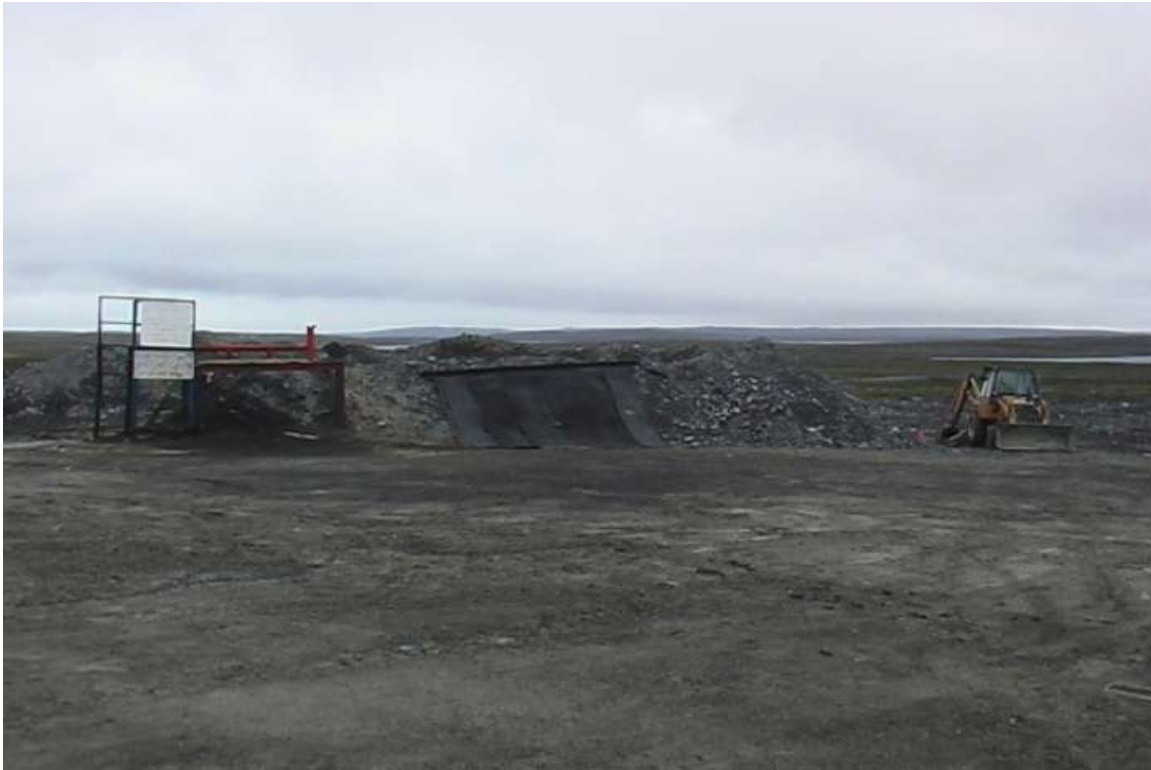
Photograph 39: Looking north to test pit 05-47 by the former north/underground Burn Pit, July 2005 (APEC 8d).

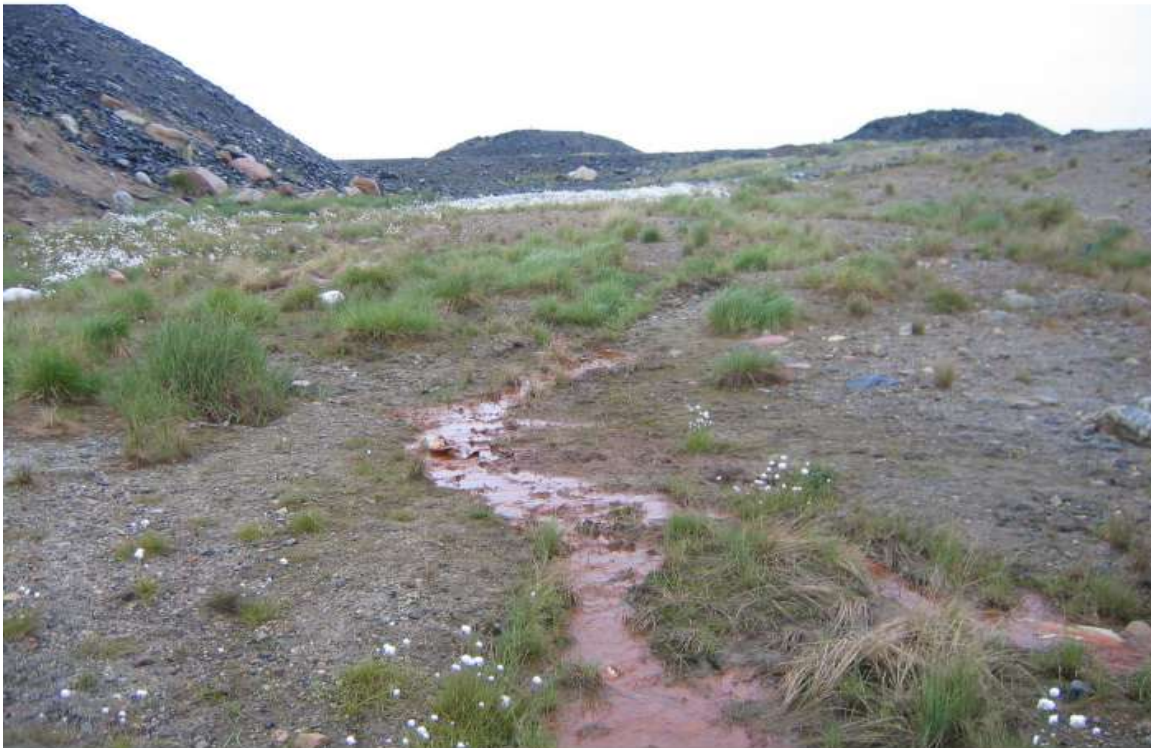
Photograph 40: View to east of Seep 3 emerging below the Land Fill, July 2005 (APEC 8e).

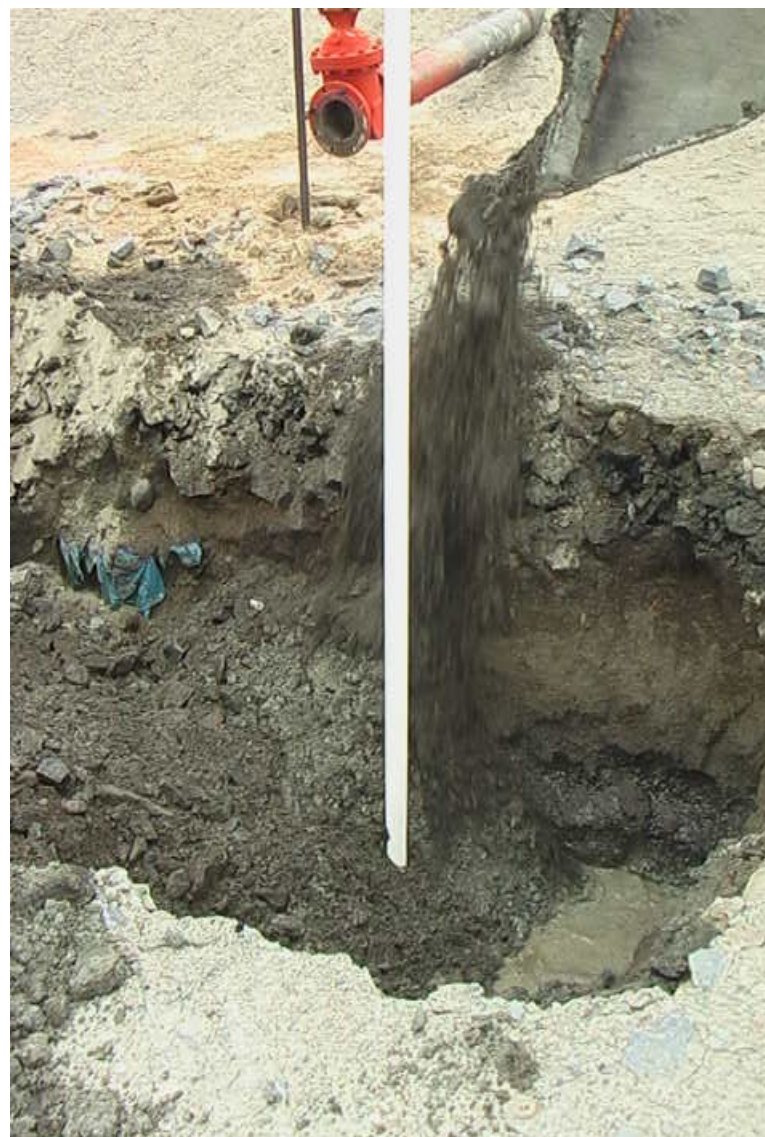
Photograph 44: Showing a typical installation of a monitoring well in a test pit, well 05-28, July 2005 (APEC 3a).

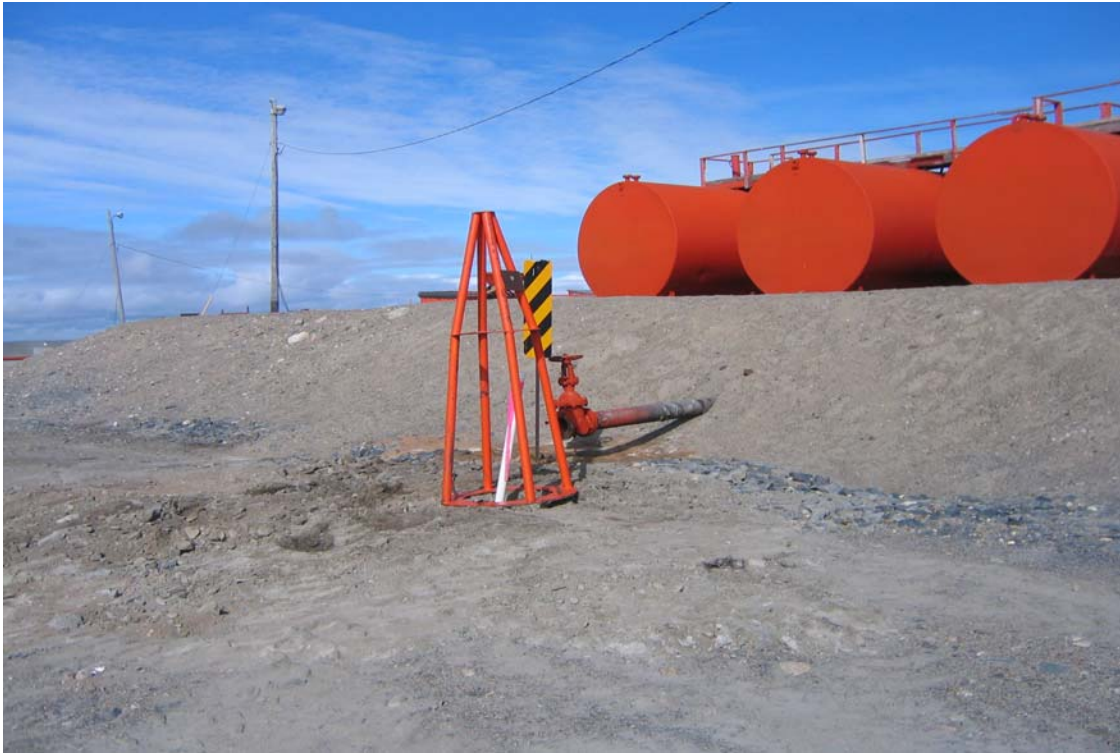
Photograph 45: Typical completed monitoring well (05-28), with "Quadra pod" placed for protection, July 2005 (APEC 3a).
