C. Portt and Associates, Fisheries Consultants

Re: Additional information regarding determining the presence/absence of fish in Goose Pit

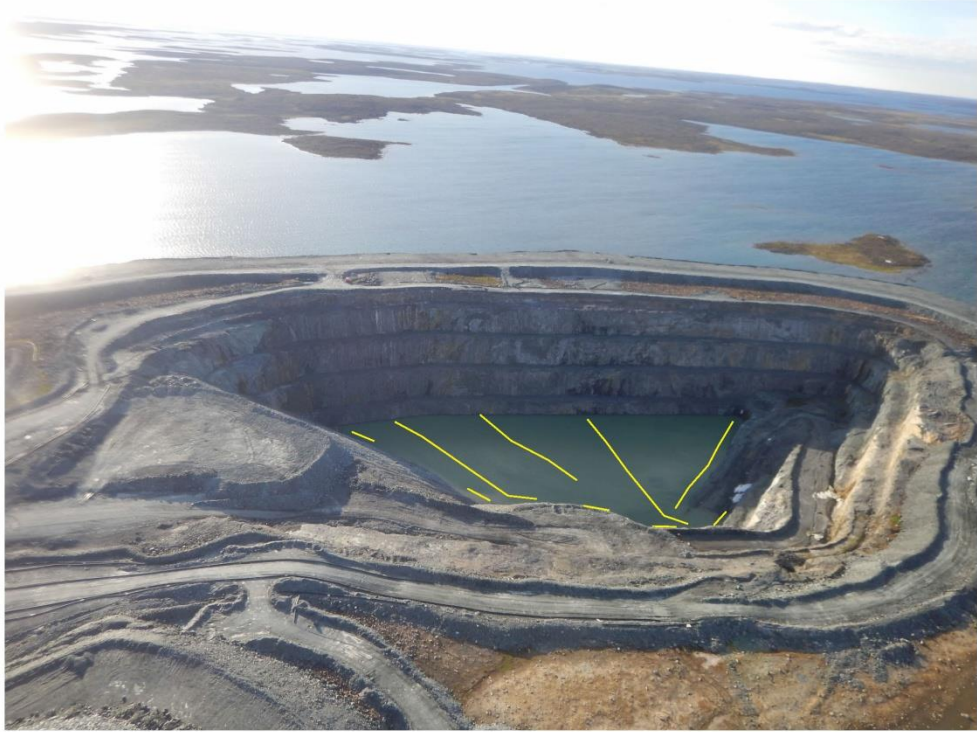
Photograph 1. Bay Goose Pit showing approximate locations of gill nets set September 22 – 27, 2017, in yellow.

The lengths of the various gill net mesh sizes that were set for 120 consecutive hours, from September 22 – 27, 2017, are provided in Table 1. Photograph 1 shows Bay Goose Pit and the approximate locations of the net sets. Photograph 2, taken during the field investigations, shows the shoreline and the floats of some of the net sets in Bay Goose Pit. The nets were checked daily. No fish were captured.

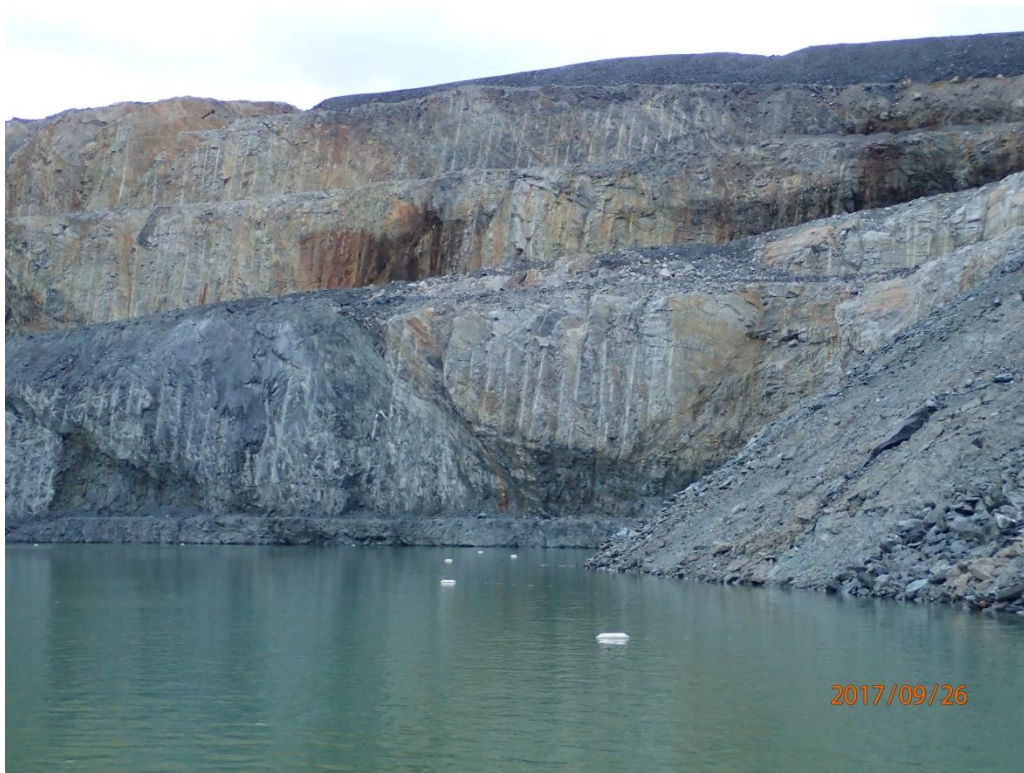
Photograph 2. Photograph taken on September, 26, 2017, showing Bay Goose Pit and floats from some of the gill net sets.
