CUMBERLAND
RESOURCES LTD.

MEADOWBANK GOLD PROJECT

BASELINE FISH HABITAT REPORT

JANUARY 2005

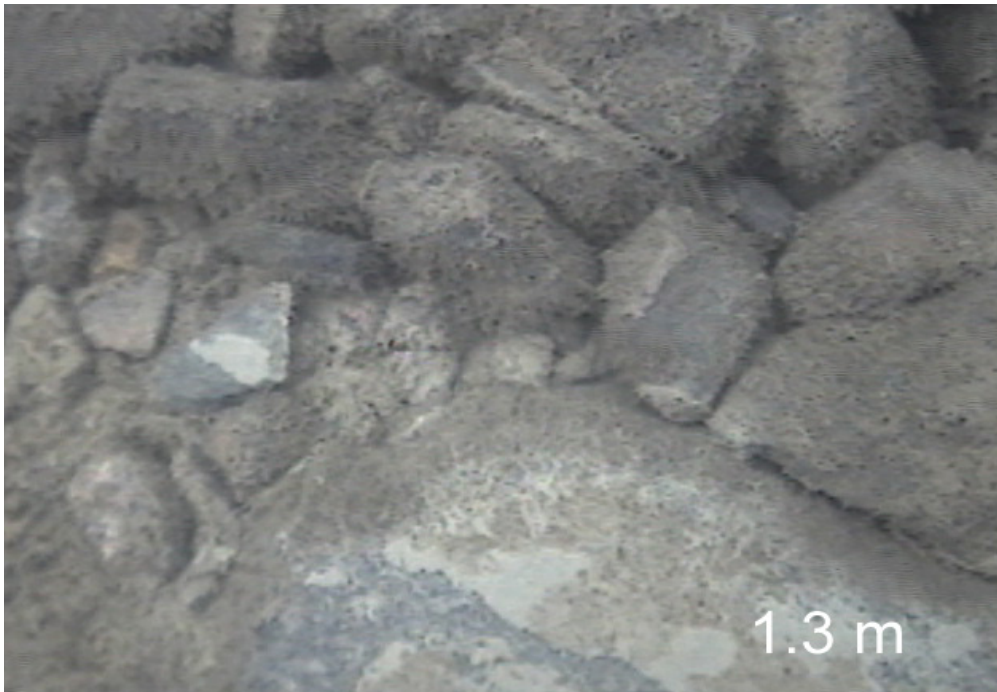
Figure 2: *Boulder Platform Habitat, Station 3P-22*

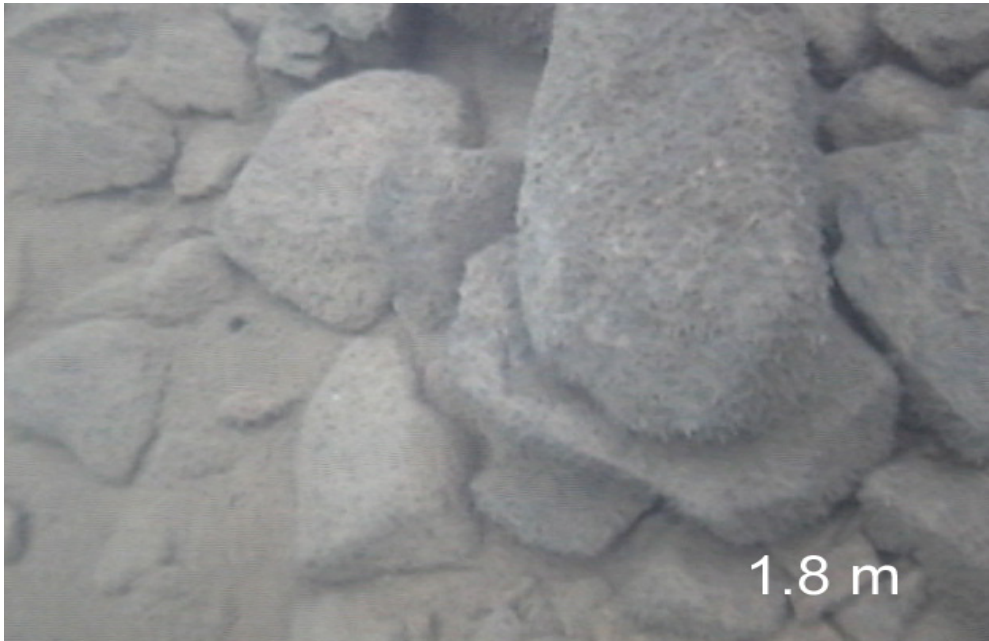
Figure 3: Boulder Apron Habitat, Station 3P-204

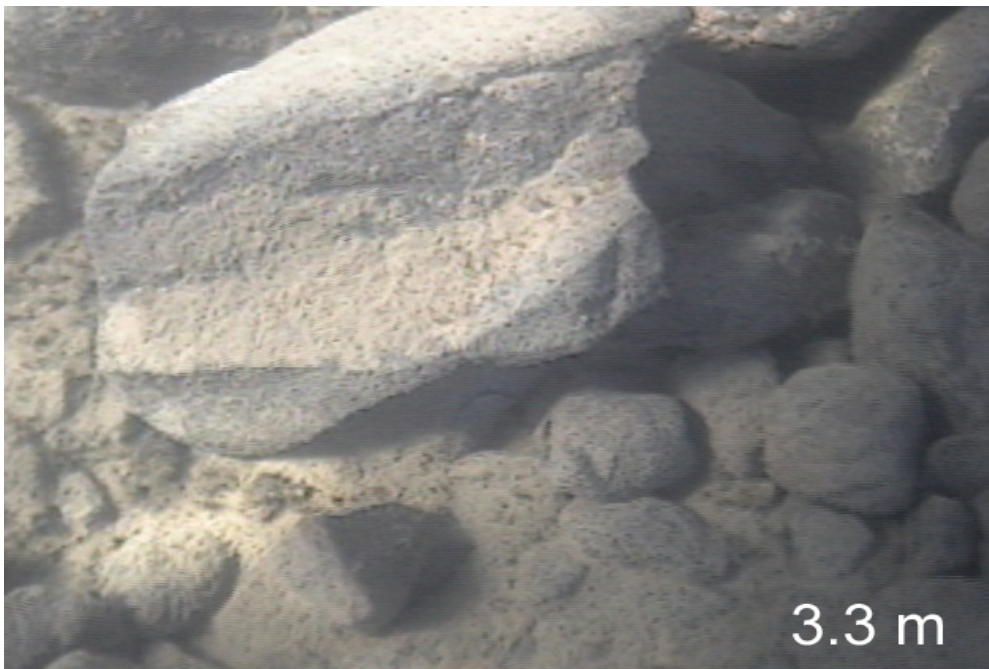
Figure 4: Boulder Apron Habitat, Station 3P-48

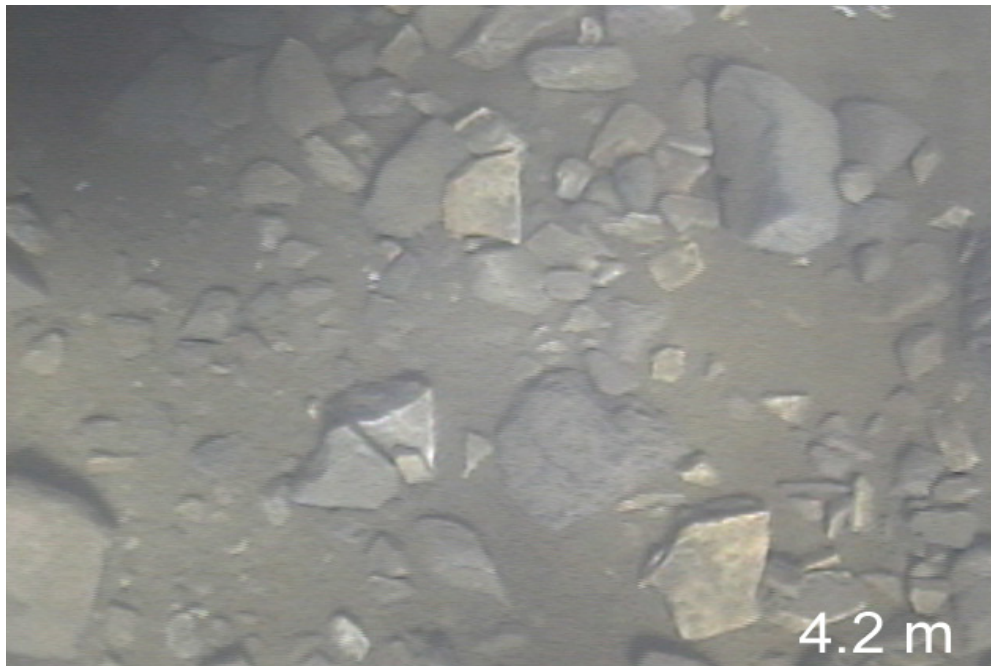
Figure 5: *Boulder Shoal Habitat, Station 3P-1*

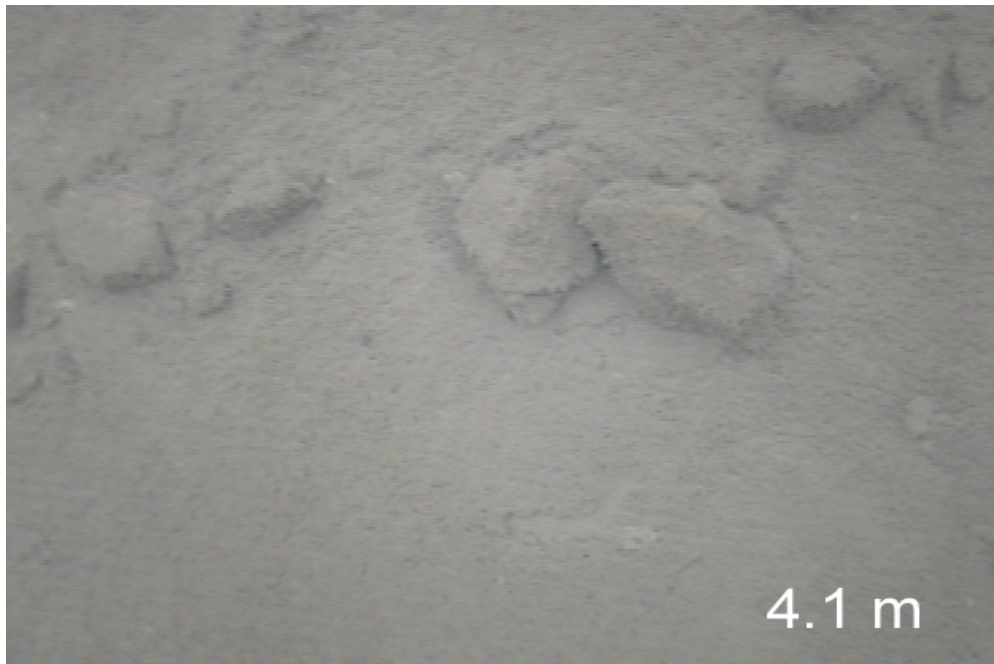
Figure 7: Mixed Sediment Apron Habitat, Station 2P-100

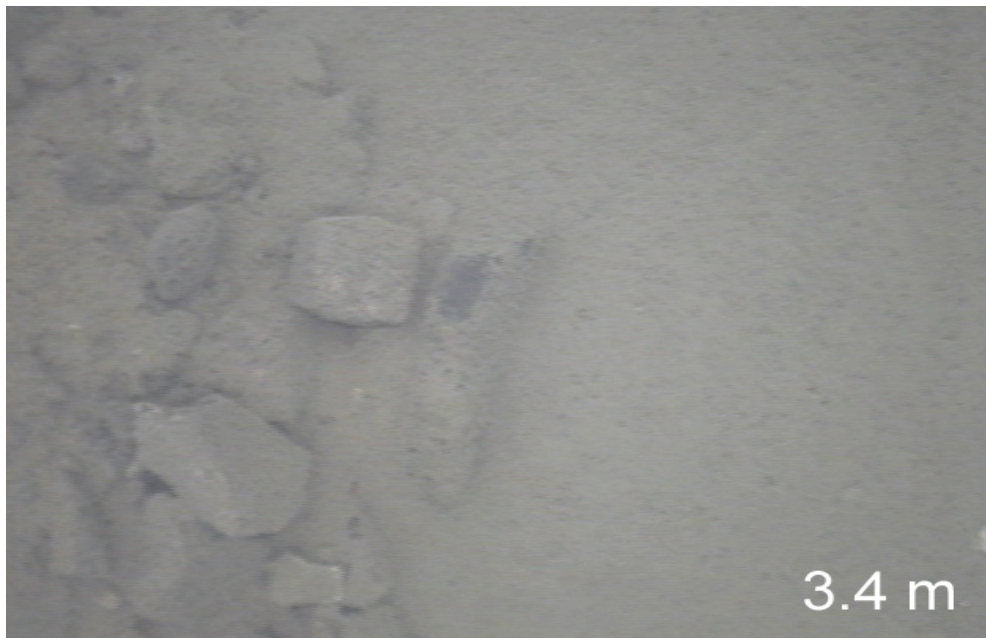
Figure 8: Mixed Sediment Apron Habitat, Station 3P-37

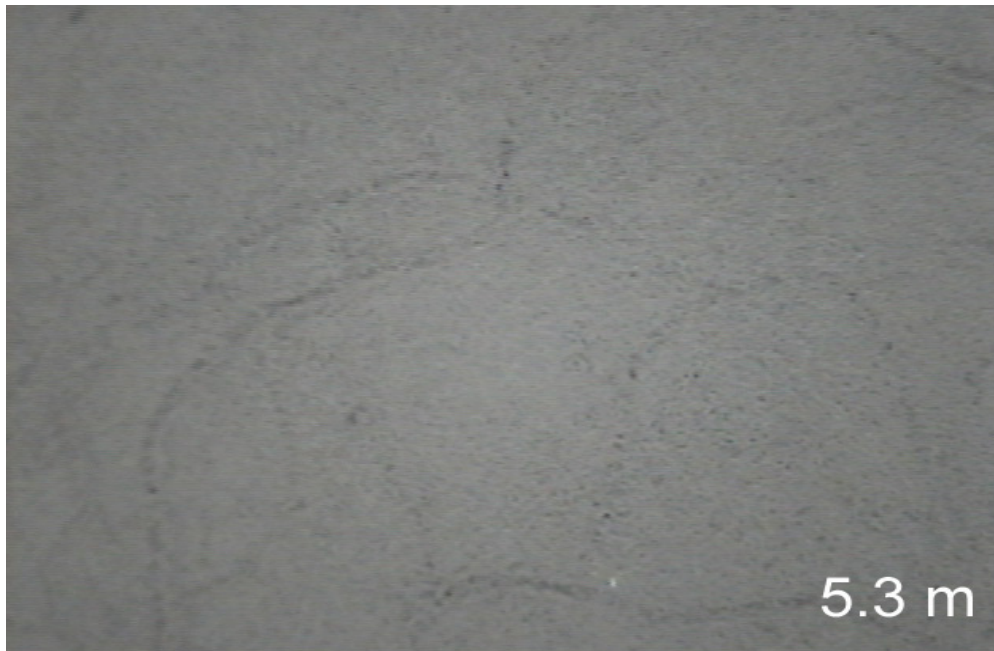
Figure 11: Sediment Basin Habitat, Station 2P-103, showing Sediment Trails

- *Sediment Fines (Silt/Clay)* – predominantly silt/clay sediment (90%) with some sand (<5%); occasionally it will have patchy boulder/cobble (<5%). Occasional worm-like trails can be observed on the sediment surface, as well as small burrows, likely created by chironomid larvae. Most common in water depths >6 m.
