## **The Nunavut Impact Review Board's 2010 – 2011 Annual Monitoring Report**

**Meadowbank Gold Project**

**Report Title:** The Nunavut Impact Review Board's 2010 – 2011 Annual Monitoring Report for the Meadowbank Gold Project (NIRB File No. 03MN107)

## **2011 Site Visit Report**

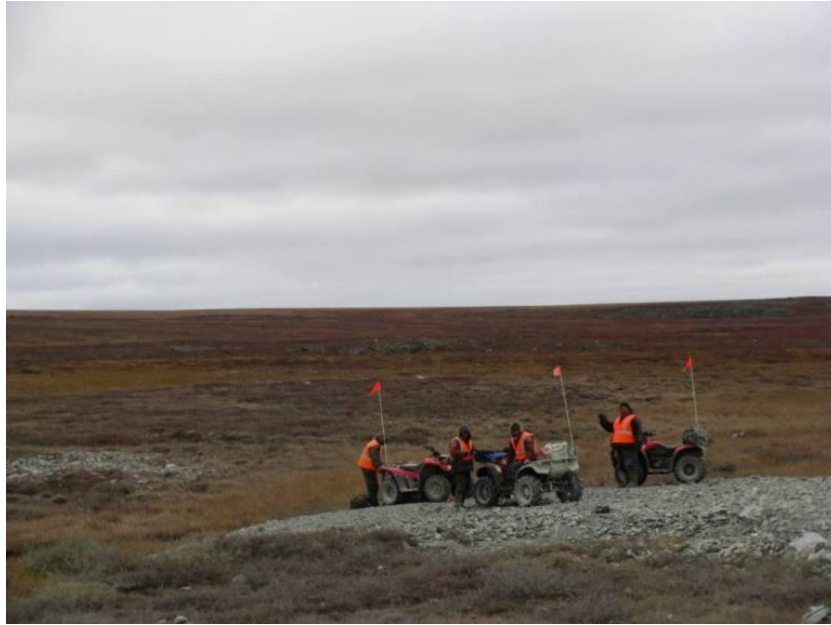
**Photo 1: Public users of the access road (photo taken 2010; courtesy A. Hanson, NIRB)**

- a.** While being driven from the hamlet of Baker Lake to the Meadowbank site and back by an AEM staff member, few wildlife observations were made. These included white-fronted geese, sand-hill cranes, snow-geese (and blue geese), sik-sik and arctic hare.
- b.** It was noted that during the drive from the hamlet of Baker Lake to the Meadowbank site, an all-terrain vehicle (ATV) travelling southbound with driver was observed near kilometre 80. When returning to Baker Lake from the Meadowbank site. It was observed that a group of travellers were travelling on the land near kilometre 50 and another ATV was observed to be parked on the side of the road near kilometre 45. All travellers had the required buggy whip installed on their ATV's and all users observed wore the safety vests loaned out by AEM (see Photo 1 for example).

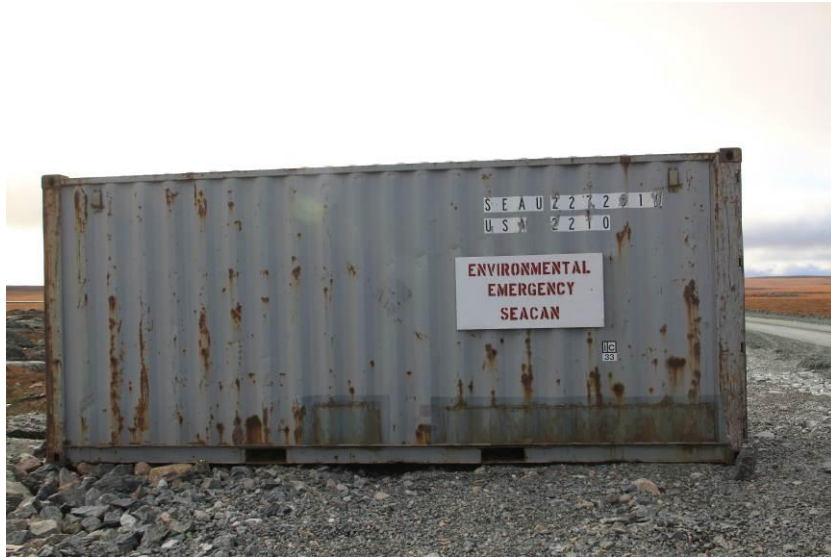
**Photo 3: Environmental Emergency Sea-can**

- d. NIRB staff were advised that environmental emergency sea-cans containing booms, shovels, absorbent pads, and other miscellaneous spill response equipment had been placed at every bridge crossing in the event of a spill (Photo 3).

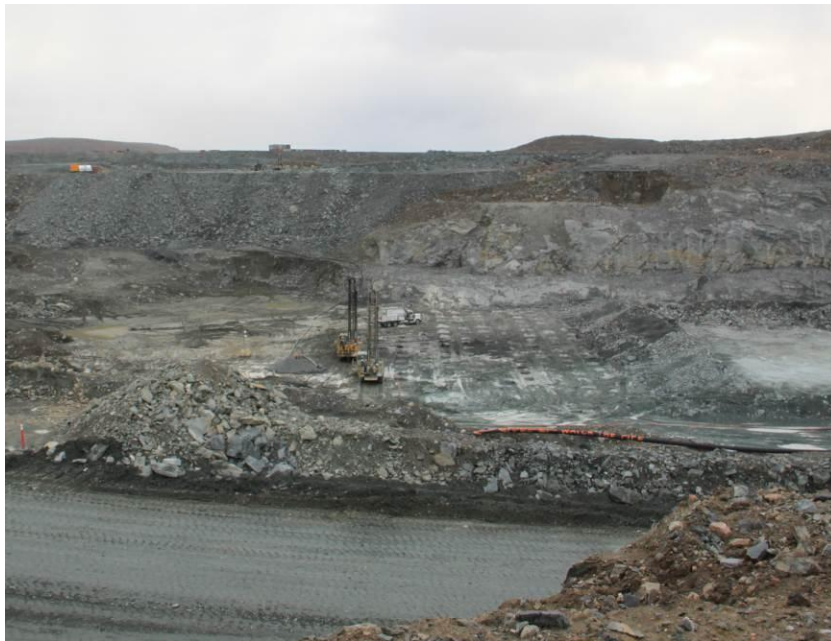
**Photo 4: Drill equipment works at the South Portage pit**

- e. Active blasting and drilling were ongoing at the North and South Portage pits, with daily geotechnical inspections being undertaken to ensure the safety of all employees and contractors working in the active mine area (Photo 4).

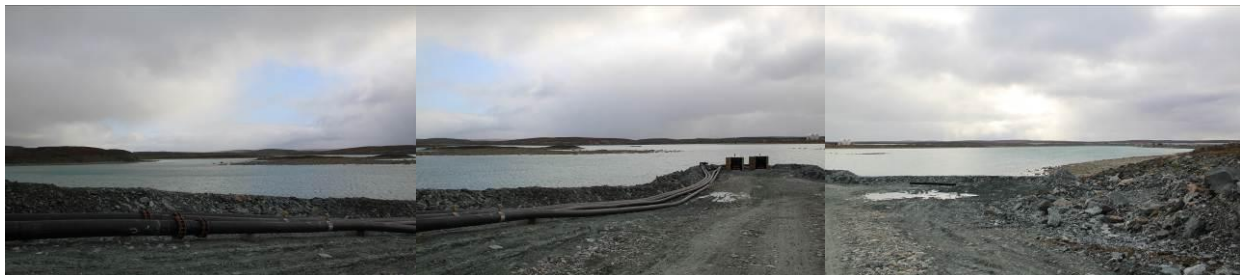
**Photo 8: Bay-Goose basin**

- h. The Bay-Goose dike and causeway was completed in 2010 with the fish out program completed in the summer of 2010. Many of the fish were transferred to Third Portage Lake. During the site visit, it was noted that the Bay-Goose basin was still being dewatered (Photo 8). Water from Bay-Goose basin and South Portage pit are tested for total suspended solids (TSS) to ensure the quality meets discharge criteria prior to release to the environment. Mr. Robert informed the Monitoring Officer that currently, water from the South Portage Pit have been treated at the water treatment facility (Photo 9) prior to discharge while water from the Bay-Goose basin have been discharged directly to the environment. At some point during the dewatering, AEM expects that the water quality from Bay-Goose will not meet the discharge criteria and at that point the water will be diverted to the water treatment facility for treatment prior to discharge.

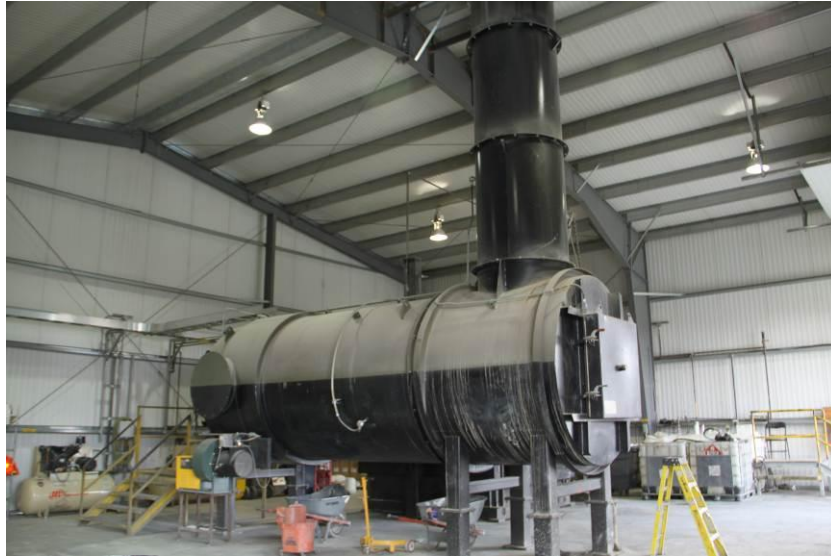
**Photo 11: Dual chamber forced air incinerator at the Meadowbank site**

- j. The Meadowbank site dual chamber forced air incinerator remains in service for the combustion of all non-hazardous, combustible materials at the site (Photo 11). Mr. Robert indicated that approximately 1.7 tonnes of domestic garbage is incinerated per day.

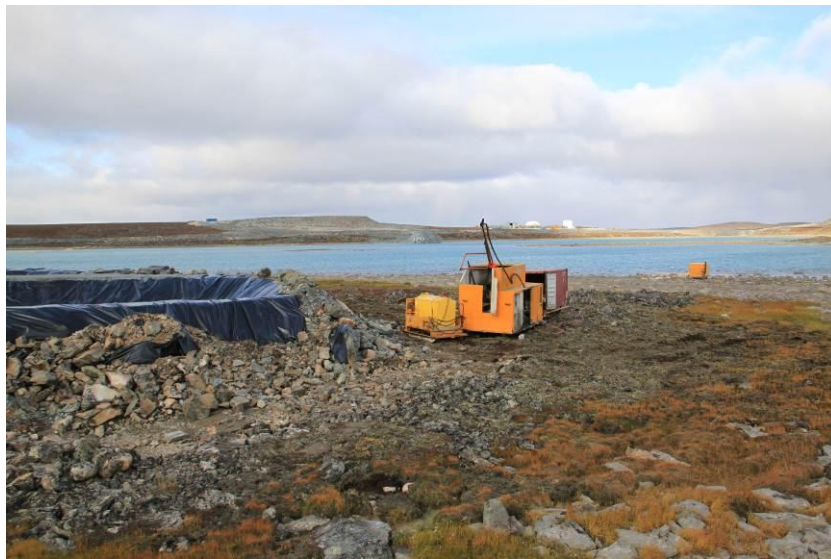
**Photo 13: Drilling of groundwater well at Bay Goose area**

At the time of the site visit, only one groundwater monitoring well was operational. The last of the four groundwater monitoring wells installed in 2003 became damaged from frost action in 2010. Some of these defective wells were replaced in 2006 and two of them were again replaced in 2008 with a more robust design. Mr. Robert indicated that AEM was drilling a new well at Bay Goose area (Photo 13) and that a second well would be added under the TSF.

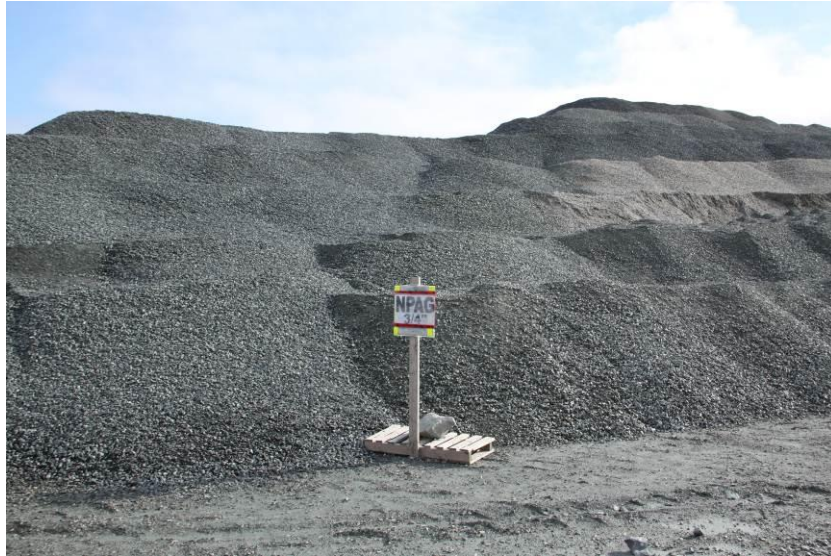
**Photo 14: NPAG waste rock material**

used by mine surveyors and geologists to delineate the dig limits within the blasted rock and to guide the shovel and loader operators in directing where the rock is to be taken. Most of the NPAG material (see Photo 14) have been used to construct the dikes, dams, roads, and pads at site, while the PAG rock have been used in the TSF, stormwater dike, and rockfill road. Any remaining PAG rock material is sent to the Portage waste rock facility.

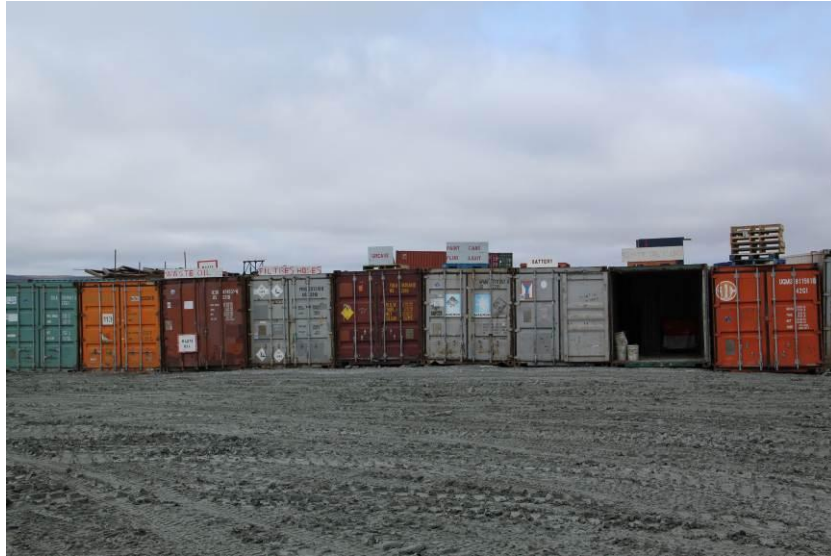
**Photo 15: Sea-cans used for waste segregation and storage area**

During the 2011 site visit, AEM appeared to be segregating and storing all domestic, hazardous, and combustible wastes in marked sea-cans prior to being incinerated or shipped to appropriate and approved off-site disposal facilities (Photo 15). Sea-cans filled with waste are backhauled via truck haul to Baker Lake and then with the annual sea lift to southern Canada.

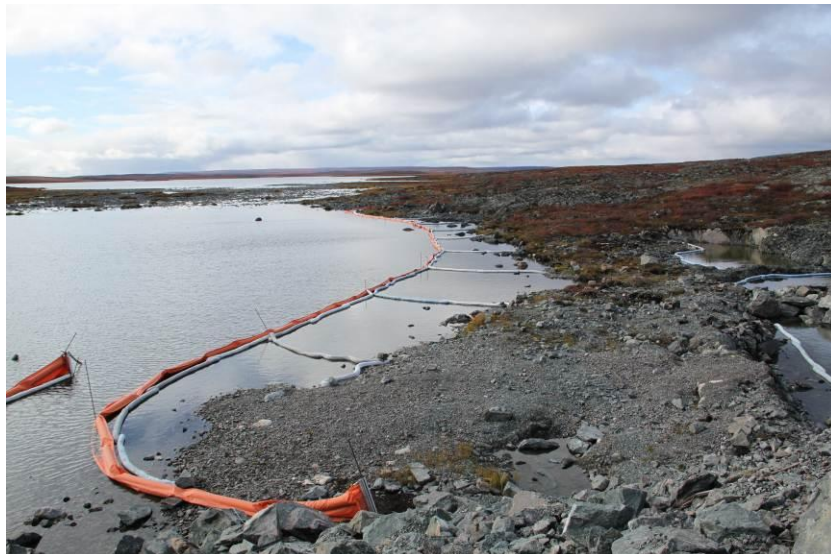
NIRB staff were advised that follow up action is still to occur for the 3,000 litre (L) fuel spill that occurred near kilometre 22 of the access road in October 2010. AEM indicated that booms deployed in the watercourse nearby are checked weekly and changed when needed (see Photo 16 and Photo 17) to ensure that contaminated water does not enter the water body. The contaminated soil (approximately 5,050 tons) was taken to Quarry 5 and will remain there until a management plan is developed and implemented that addresses the issue of the contaminated soil (see Photo 18). In addition, Mr. Robert indicated that follow up action will be completed in the spring of 2012 for this spill site. No fuel contamination or staining of the water was noted by the Monitoring Officer; however, a strong hydrocarbon odour was noticeable at the spill site.

**Photo 17: Booms and screens in place at HADD bridge to prevent any fuel from entering stream**

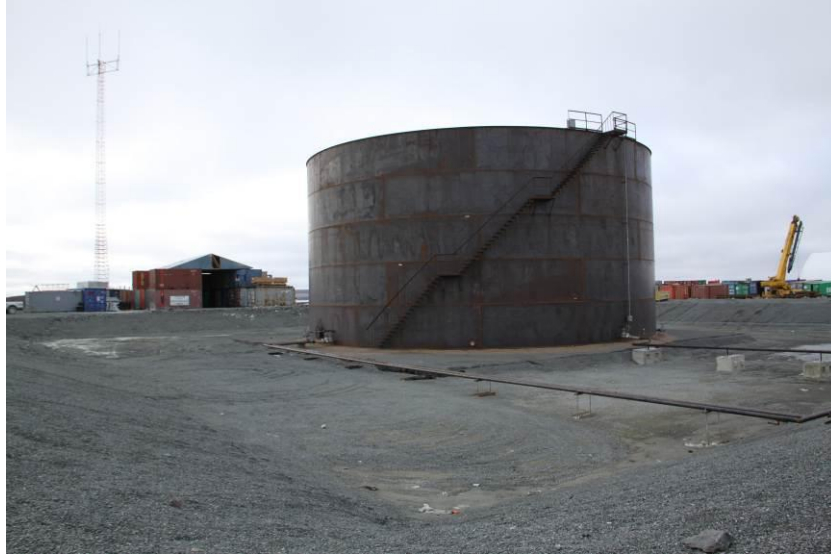
**Photo 19: Meadowbank on-site fuel tank farm**

Condition 27 requires that the Proponent use safe, environmentally protective methods for areas used to store fuel or hazardous materials. The Monitoring Officer noted that the liner at the on-site fuel tank farm was exposed.

During the 2011 site visit, the Monitoring Officer observed that all of AEM’s fuel and hazardous materials associated with the Meadowbank project appeared to be stored in a safe and environmentally protective manner (i.e. secondary containment at fuel storage areas and secure containment of hazardous materials; see Photo 19). The fuel transfer station on site appeared to be well contained and properly set up for the fuelling of vehicles (Photo 20). Hydrocarbon odours were noted at the on-site fuel tank farm and at the HADD bridge at kilometre 22, and further, the Monitoring Officer noted that the liner at the on-site fuel tank farm was exposed.

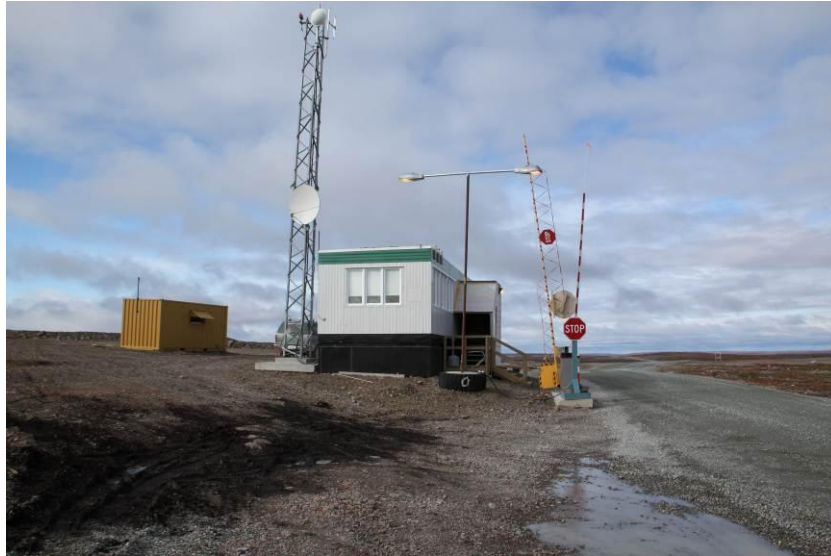
**Photo 21: Gatehouse at kilometre 5, near Baker Lake**

AEM maintains one gatehouse at kilometre 5 of the access road, and another gatehouse close to the entrance to the mine site and camp at Meadowbank. Both gatehouses are manned by guards who monitor the safety and security of all personnel using the road. All traffic is required to check in (via radio or in person) with the employee at the gatehouse prior to proceeding past either gatehouse (see Photo 21).

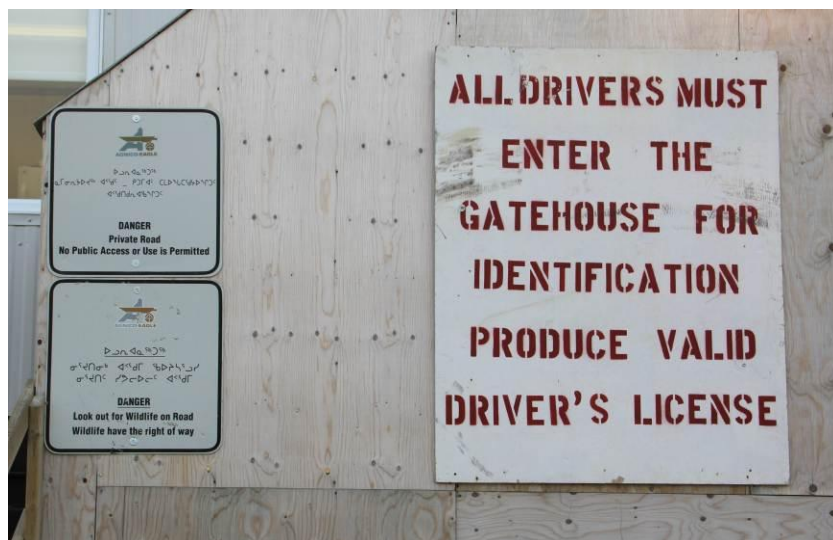
**Photo 22: Signs posted at gatehouse at kilometre 5**

The Monitoring Officer noted that the required signs as per Condition 32(d) were located at the gatehouse (Photo 22) and at 10 kilometre intervals along of the road (see Photo 23 for examples). The signs were posted in both English and Inuktitut and were placed on the sides of the emergency sea-cans which were located every 10 kilometres along the road. AEM indicated that previous free-standing sign posts had been damaged during the winter season. No signs were noted at bridge crossings.

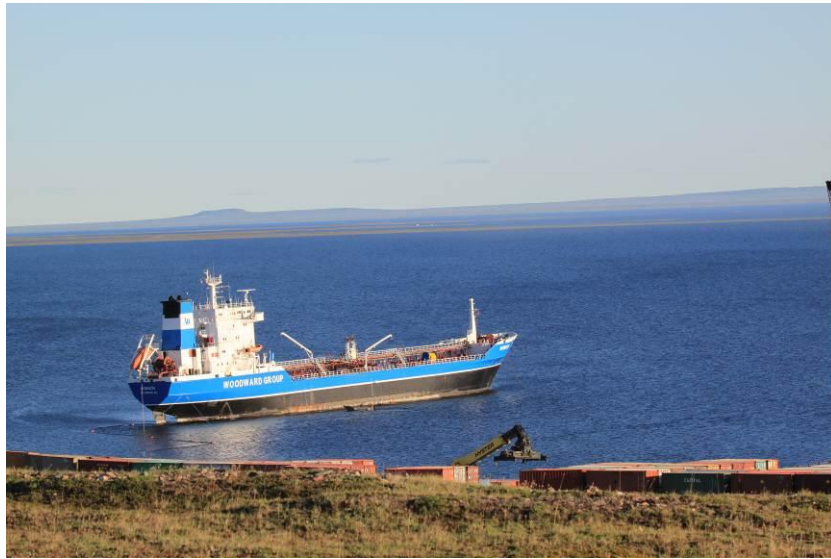
**Photo 28: Barge offloading cargo at Baker Lake barge laydown facility (photo taken July 28, 2011)**

During unofficial visits to AEM’s Baker Lake fuel tank farm and barge laydown facility, the Monitoring Officer did not observe any notable security measures in place at these sites (see Photo 28 through Photo 31). During the 2011 Site Visit, Mr. Robert indicated that all hazardous and explosive components received at the marshalling and storage area are shipped immediately to site and further, that during the sealift period, AEM ensures that 24 hour security, including surveillance cameras, are put into place.
