2011 – 2012 Annual Monitoring Report

for Agnico-Eagle Mines Ltd.'s Meadowbank Gold Project

Report Title: The Nunavut Impact Review Board's 2011 – 2012 Annual Monitoring Report for the Meadowbank Gold Project (NIRB File No. 03MN107)

Date Issued: December 7, 2012

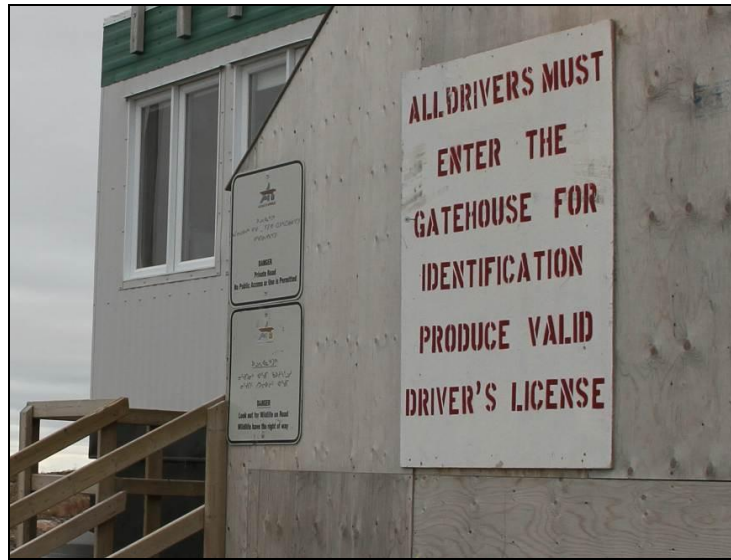
Photo 28: Signs posted at gatehouse at kilometre 5

As per Condition 32(b), AEM submitted a copy of its updated Transportation Management Plan to the NIRB on May 13, 2010. One of the features of the access road as described within the plan is the placement of refuge stations every 10 kilometres. The Monitoring Officer noted that these refuge stations (emergency sea-cans) were not located on the road and was informed by Mr. Buck that the sea-cans were removed because items within the stations were being stolen and that the refuge stations were not serving the original and intended purpose. The signs as required per Condition 32(c) were posted in both English and Inuktitut at the gatehouse (Photo 28) and at each major bridge crossing (on the side of the environmental emergency sea-cans).

However the signs were not located at 10 kilometre intervals along the road as these signs had been originally placed on the sides of the emergency sea-cans along the road. AEM indicated that the signs would be replaced as soon as possible.
