Re: NIRB 03MN107: Comments Received for Agnico Eagle Mines Ltd.'s "Meadowbank Gold Project 2013 Annual Report"

Habitat Compensation Monitoring Plan, Version 3 March 2014

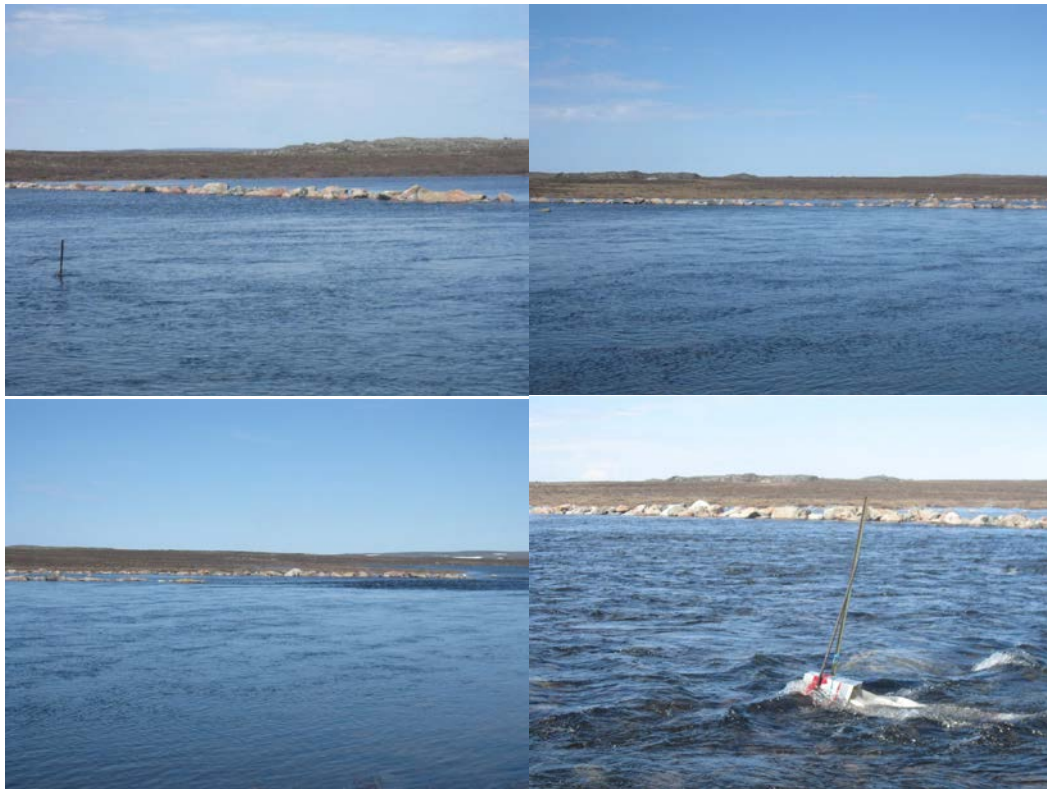
Thank you for bringing this to our attention as this was an oversight in our reporting. Typically the annual report includes photo documentation of the monitoring and all future reports will include them. Below you will find pictures of the R02 AWAR compensation features taken in summer 2013 with larval drift traps in the foreground.

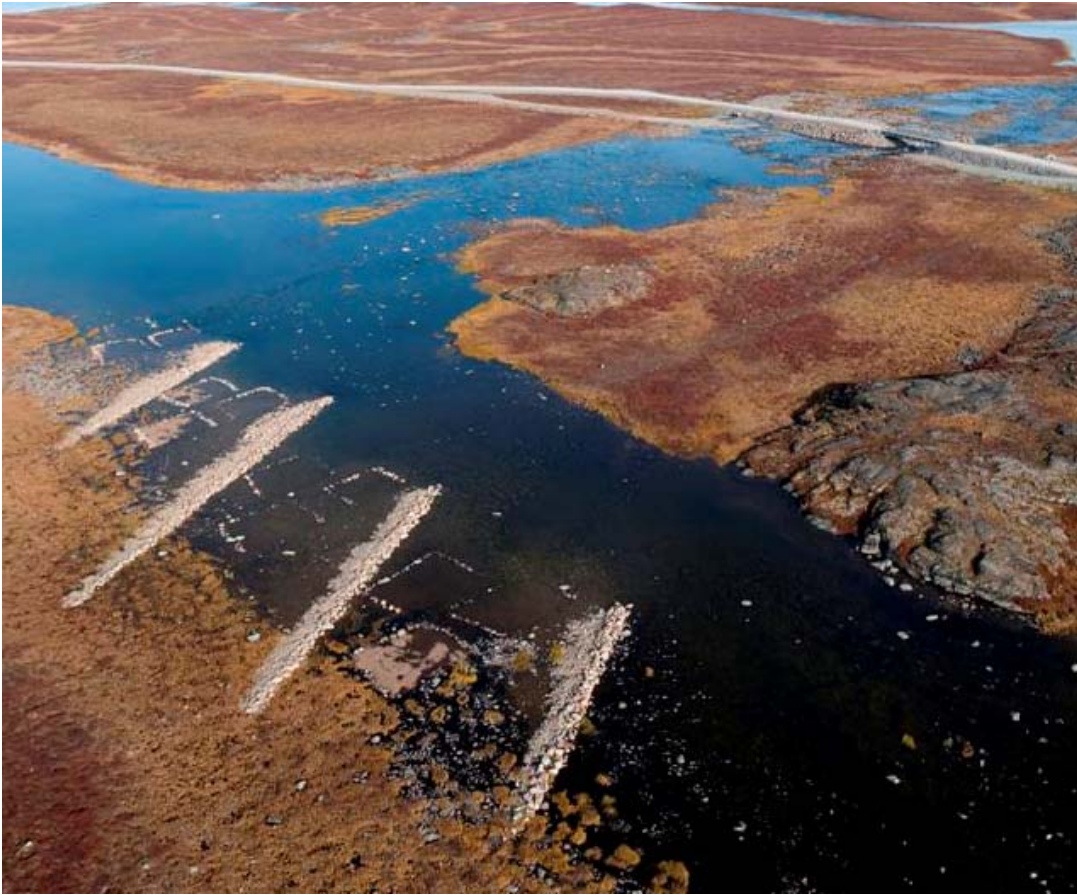
Figure 3- Aerial Photo of R02 Habitat Compensation Feature- Taken in September 2009

As part of the habitat compensation plan for construction of the roadway between Baker Lake and the mine site, a spawning pad was constructed in 2009 near bridge crossing R02 (Figure 3). This habitat compensation project was constructed according to design specifications that met biological criteria aimed at enhancing arctic grayling productivity in this stream system. The construction focused on creating high value spawning and nursing habitat to compensate for the loss of the low and medium value habitat affected by bridge abutment construction at the four crossings. An overview of the Meadowbank area post-closure, incorporating all compensation features, is shown in aerial photo below.
