# 2013 – 2014 Annual Monitoring Report

for Agnico Eagle Mines Ltd.'s Meadowbank Gold Project

**Report Title:** The Nunavut Impact Review Board's 2013-2014 Annual Monitoring Report for the Meadowbank Gold Project (NIRB File No. 03MN107)

**Date Issued:** November 2014

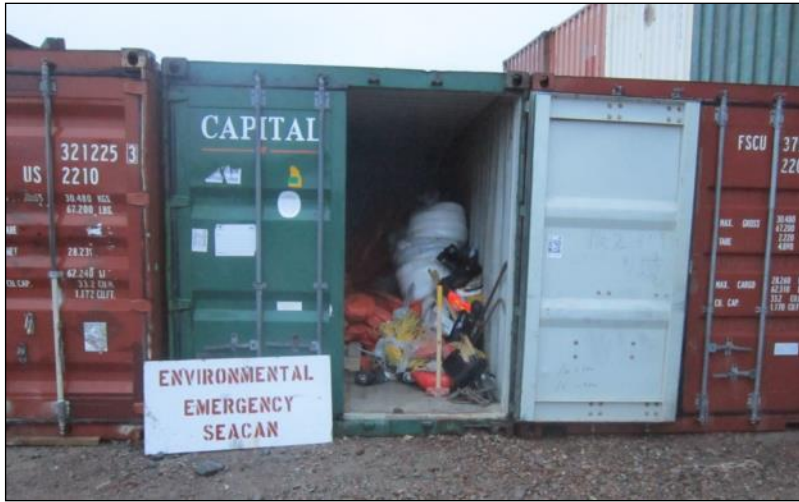
- a. The Monitoring Officer noted that the environmental emergency sea-cans containing booms, shovels, absorbent pads, and other miscellaneous spill response equipment were located at the Baker Lake laydown facility (see Photo 1). At the time of the site visit, an oil tanker was delivering AEM's annual supply of fuel; the emergency response boat was docked at the spud barge as a safety precaution (See Photo 2).

**Photo 1:** Environmental emergency sea-can located at the Baker Lake laydown facility and in close proximity to the fuel barge.

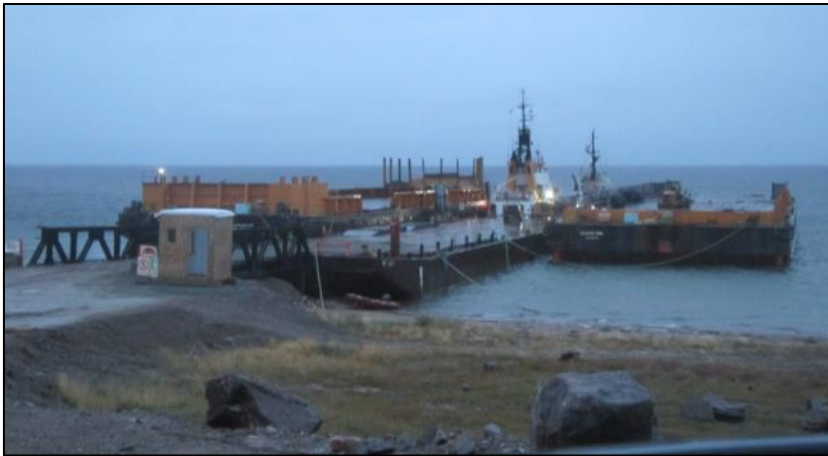
**Photo 2:** Emergency boat with motor docked at the Baker Lake barge.

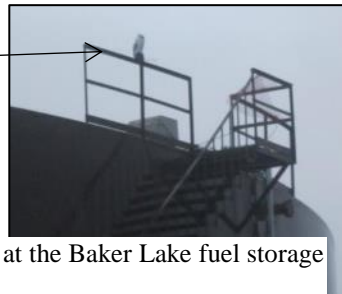
- b. The Monitoring Officer observed owl decoys located on the tops of the bulk fuel tanks at the Baker Lake fuel storage facility (see Photo 3). Mr. Robert explained that the decoys, installed throughout 2012 and 2013, were successful in deterring birds from nesting. Mr. Robert noted that similar decoys had not been deemed necessary for use at the Meadowbank site as nesting was not found to be an issue.

**Photo 3:** Owl decoy on the top of the bulk fuel storage fuel tank at the Baker Lake fuel storage facility.

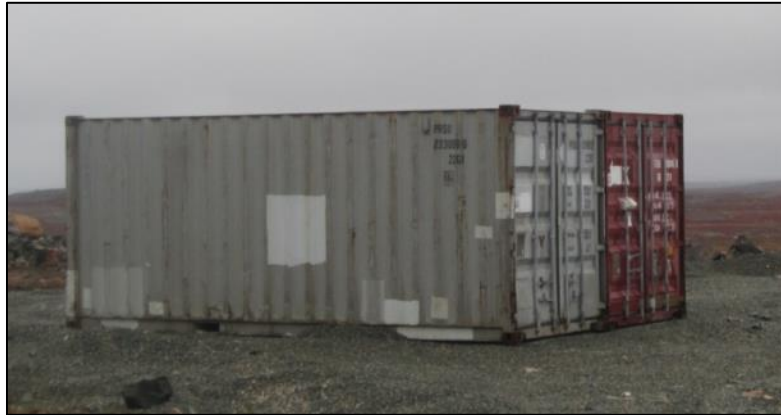
- c. Environmental emergency sea-cans were located at all bridge crossings, and the Monitoring Officer noted that some sea-cans were located closer to bridge crossings than others, depending on the availability of space. The Monitoring Officer also noted that there was no sign on the environmental emergency sea-can at kilometre 23 (third bridge from Baker Lake to Meadowbank) (see Photo 4).

**Photo 4:** Environmental emergency sea-cans at kilometre 23 with no signs.

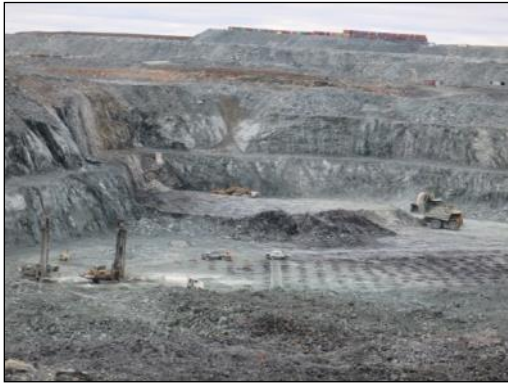
- e. While no blasting was conducted on the day of the site visit, active blasting and drilling were ongoing at the Bay-Goose, South Portage, and Vault pits, and as Mr. Robert indicated, would also resume at North Portage pit in the future (Photos 6-9, 16 and 17).

**Photo 6:** Drills, loaders and shovel in the South Portage pit (also identified as pit E), with drill hole pattern visible in front.

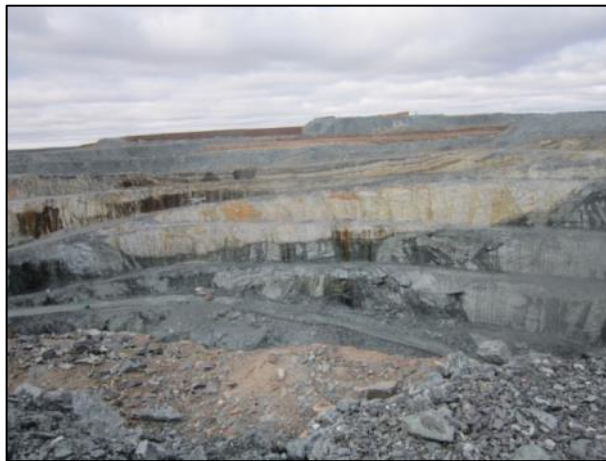
**Photo 8:** Bay-Goose pit.

- f. The Monitoring Officer observed water concerns in the Bay-Goose and Central Portage pits as well as East Dike. Significant seepage was noted through the south, west, and north walls of the Bay-Goose pit (see Photos 9 and 30). This is discussed further in [Section 2.2.1](#) of this report regarding ground water sampling.

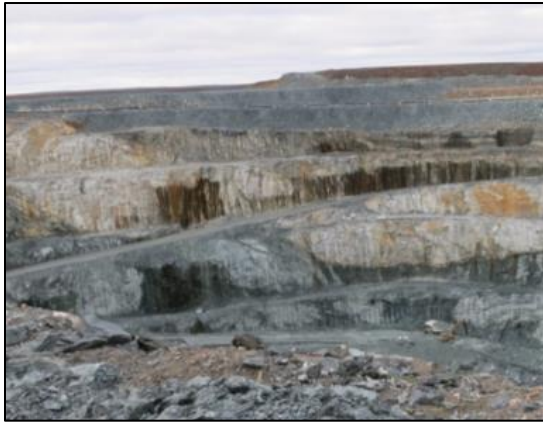
**Photo 9:** Moisture along southern wall of Bay-Goose pit.

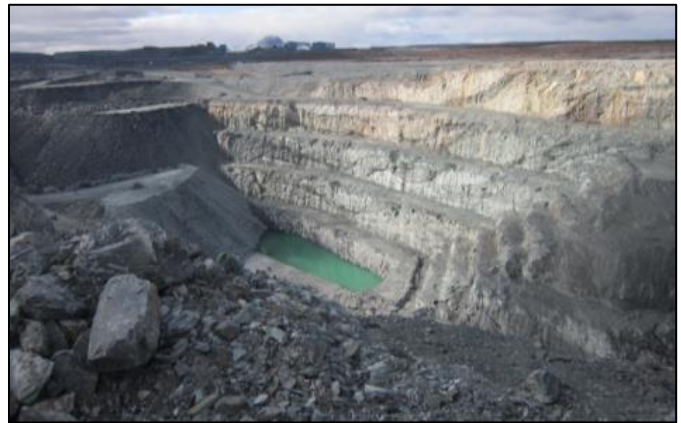
The Monitoring Officer also noted that AEM had begun to refill Central portage pit with waste rock (see Photo 10).

**Photo 10:** Green standing water in the basin of the Central Portage pit (location of sump st-19). Pit fill can be seen in the south end of the pit.

The Monitoring Officer also observed wet spots on the South Portage pit walls, and noted that standing water had begun to collect in Central Portage pit (see Photos 10 and 11).

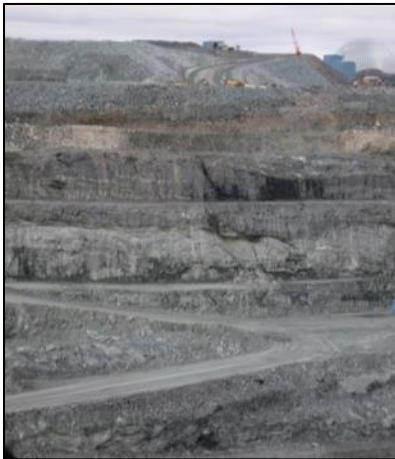
**Photo 11:** Moisture moving between the rock layers of the west wall of the South Portage pit

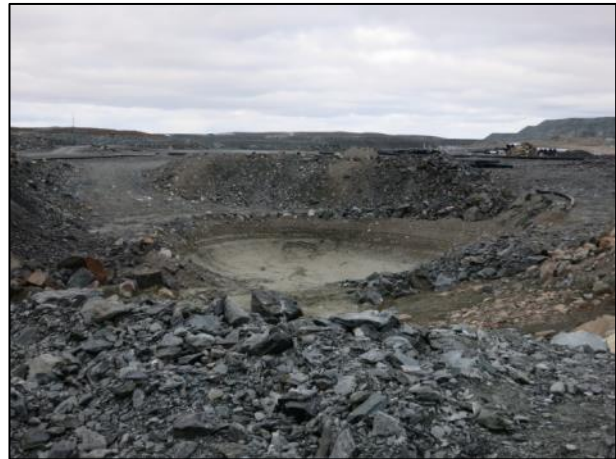
**Photo 12:** Slumping observed as water from Second Portage Lake seeps through the East dike.

AEM staff discussed seepage issues at the East dike (ST-S-1) (see Photo 12), noting that seepage water was being pumped from ST-S-1 via sump and tested pursuant to Metal Mining Effluent Regulations requirements (see Photo 13) and then pumped back to Second Portage Lake (see Photo 14). Mr. Pratt explained that the diffuser on the end of the discharge pipe is ‘U’ shaped to mitigate potential effects on the benthic environment in Second Portage Lake. The Monitoring Officer noted that, as can be seen in Photo 14, the shore line at the output location has a steep drop-off.

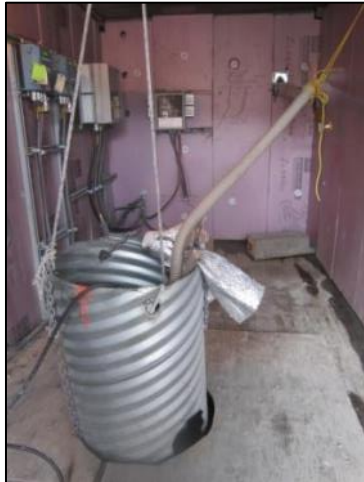
**Photo 13:** Testing of water before it is pumped back to Second Portage Lake.

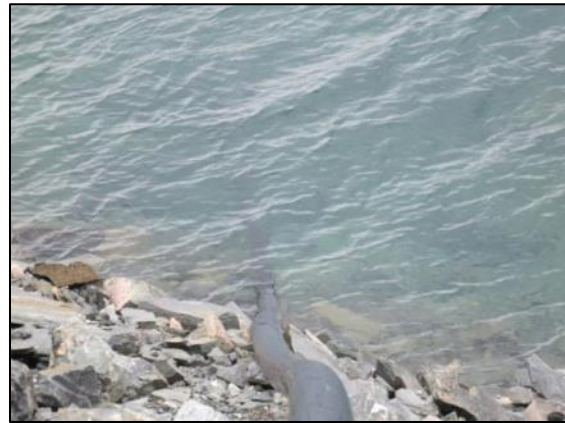
**Photo 14:** Outflow pipe into Second Portage Lake.

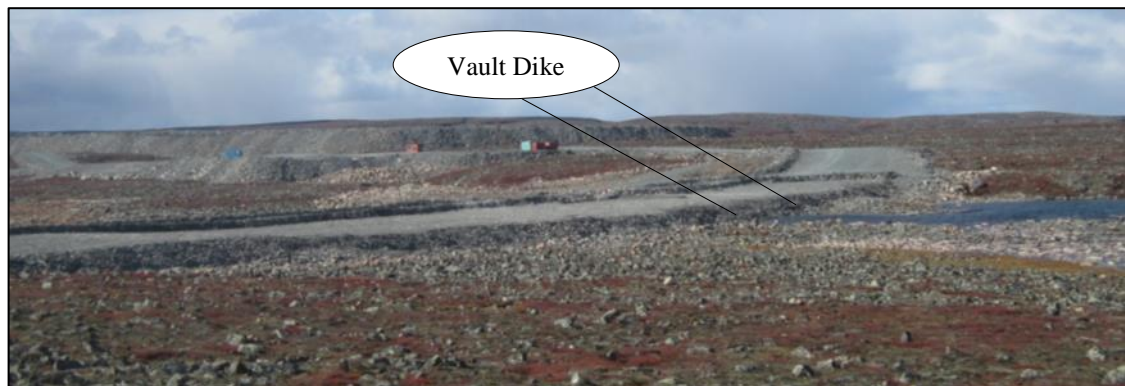
- a. AEM staff noted that construction of the Vault Dike had been completed in 2013 (see Photo 15), and that Vault Lake was dewatered with fish then transferred to Wally Lake.

**Photo 15:** Vault Dike with Wally Lake on the right.

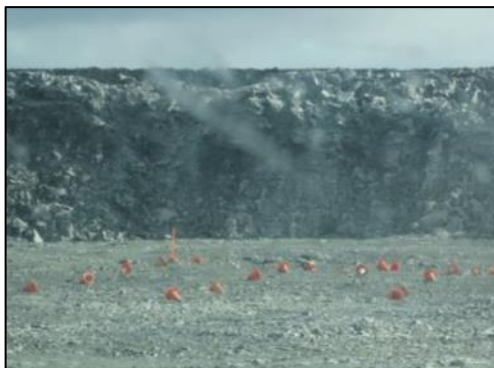
**Photo 16:** Overturned pylons denoting drill locations.

- b. AEM staff also noted that during 2014, the Proponent commenced mining of Vault pit with active blasting and drilling occurring at different locations throughout the pit (see Photos 16 and 17).

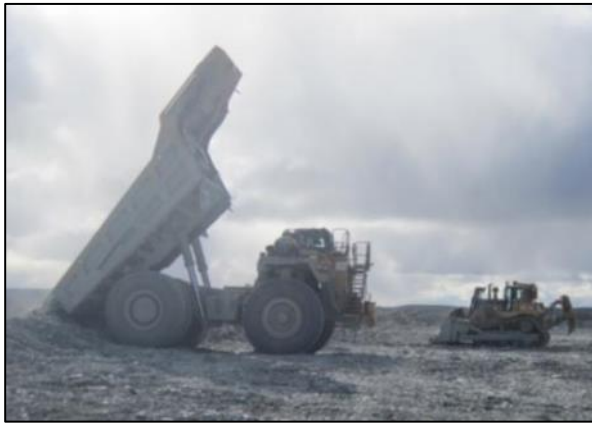
- c. Waste rock from Vault pit was stored in the Vault waste rock storage facility (see Photo 18). AEM staff noted that waste rock from the Vault pit is generally not expected to be potentially acid forming (non PAG rock), but that potentially acid forming rock would be placed in the middle of the rock pile. Non PAG gravel is stored in the Vault marginal stockpile (see Photo 19) to be re-used on-site, including on top of explosives as a cap to ensure the explosives stay in the hole to produce the desired effect, as well as for road maintenance, especially during the winter.

**Photo 18:** Dumping of waste rock to build the steps in the Vault pit waste rock storage facility.

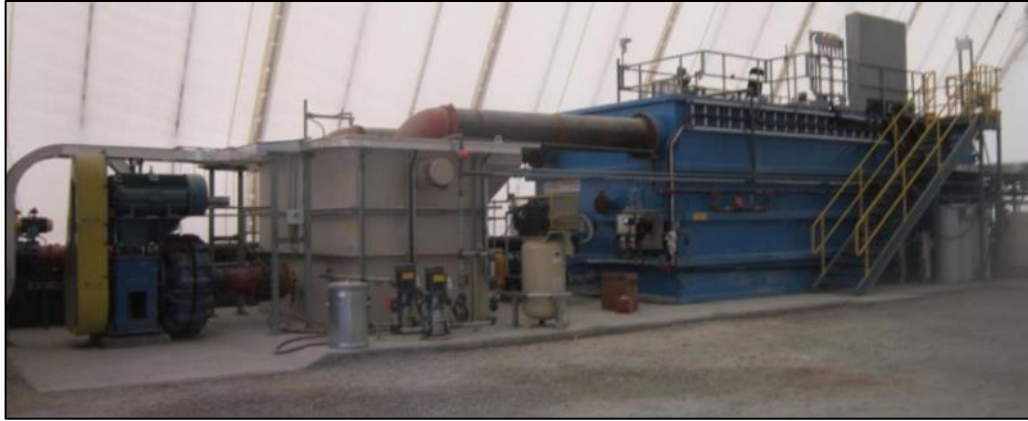
- d. The water treatment facility was not in use and was relocated to Vault Lake in anticipation of potential future needs (see Photo 21). The secondary camp, located on the Vault Road and near the Vault fuel farm, contains a secondary kitchen and would act as an emergency shelter for personnel working near the Vault pit infrastructure (see Photo 22).

**Photo 21:** Water treatment facility not in use, currently located near Vault pit.

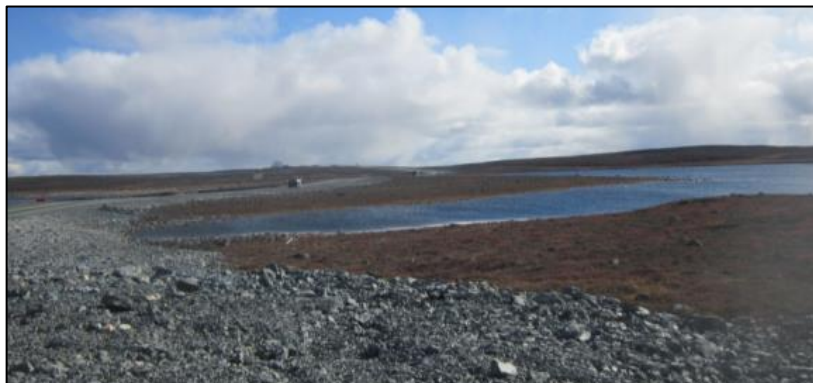
**Photo 23:** Area of proposed Vault pit expansion.

- e. In July, 2014 the NIRB received a project proposal from AEM outlining its proposed expansion of Vault pit into Phaser Lake, which, as currently proposed, would extend the life of mine (see Photo 23).

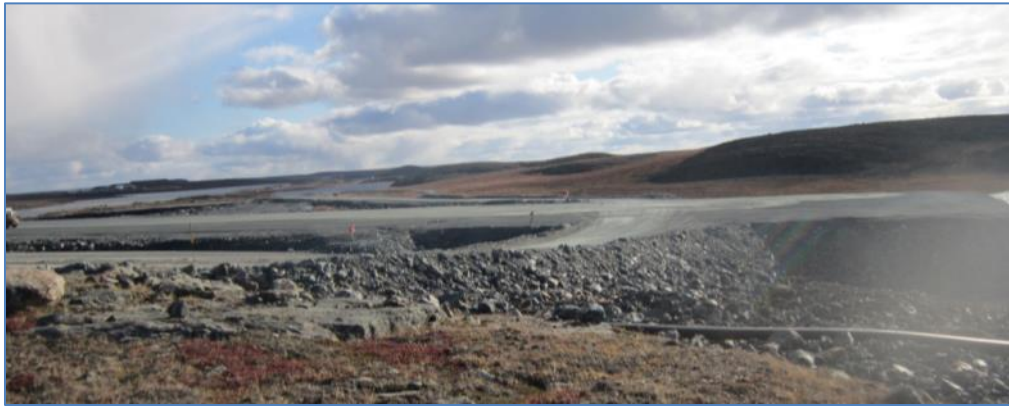
- f. The Monitoring Officer observed the airstrip extension which was screened and approved pursuant to NIRB File No. 10XN039, and which was completed by AEM in April 2013 (see Photo 24).

**Photo 24:** The western tip of the airstrip extending into Third Portage Lake.

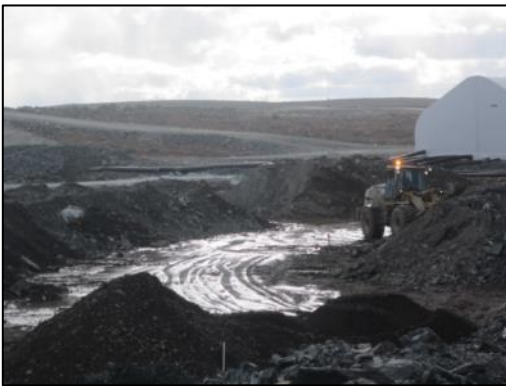
- g. While at the landfarm site, Mr. Pratt described AEM's pilot remediation program which has continued into its third year. The remediation program at the Meadowbank site uses on-site nutrients (sewage sludge) to initiate biodegradation of all contaminated hydrocarbon soil on site (see Photos 25 and 26).

**Photo 25:** Contaminated soil storage/pilot remediation site.

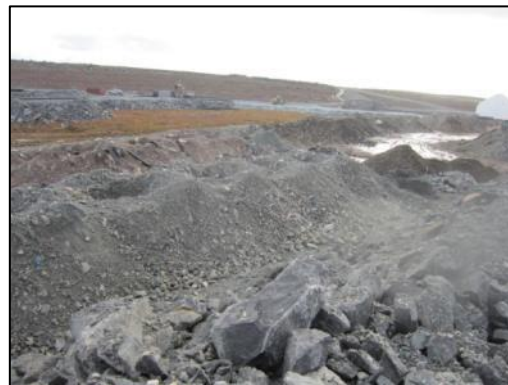
**Photo 26:** Berm around the landfarm site.

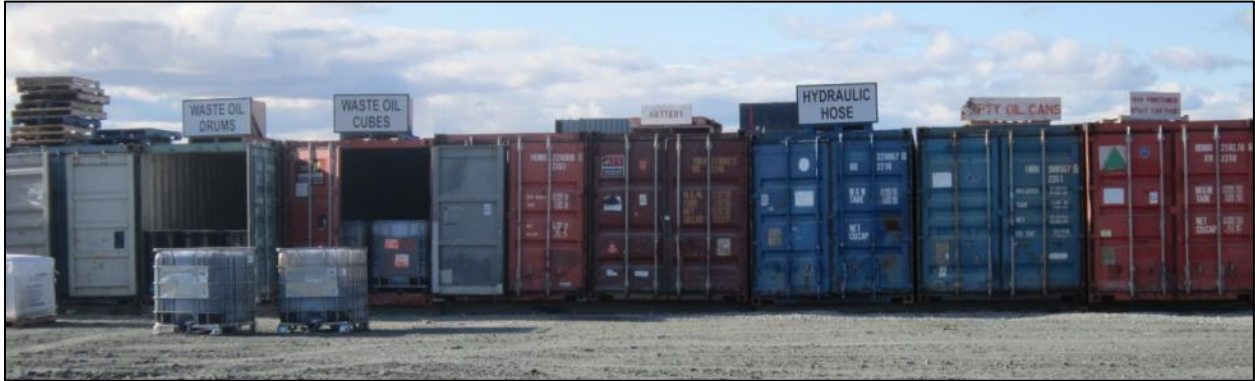
- h. During the site visit, the Monitoring Officer noted that AEM had segregated all domestic, hazardous, and combustible wastes in marked sea-cans in an area where they would be stored prior to being incinerated or shipped to approved off-site disposal facilities (see Photo 27). AEM staff noted that in 2014 it had transported 127 sea-cans of hazardous materials via barge to a recycling facility in southern Canada. AEM staff also pointed out the barcodes on some of the sea-cans in the storage area, explaining that since 2012 barcodes had progressively been added to the sea-cans as an organizational tool. To reduce waste, AEM initiated its "pallet program"; AEM staff explained that wooden

**Photo 27:** Sea-cans used for waste segregation and storage area.

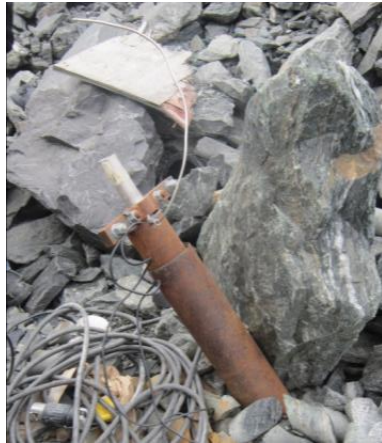
At the time of the site visit, only two groundwater monitoring wells were operational: well numbers MW 08-02 (see Photo 29) and MW 08-03. AEM reported that well number MW 11-02 was obstructed during the 2012 groundwater monitoring program due to melted tubing used to remove melt water, and noted that it is expected to be replaced in 2014. Due to low water flow, AEM staff noted that they were unable to obtain groundwater samples via the production drill holes, although sampling from the pit wall seep in Bay-Goose pit was successful (see Photo 30).

**Photo 29:** Groundwater monitoring well MW-08-02 is protected by a wooden enclosure (not pictured).

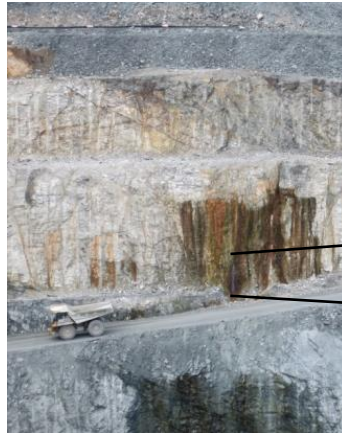
**Photo 30:** Seepage in the south wall of the Bay-Goose pit.

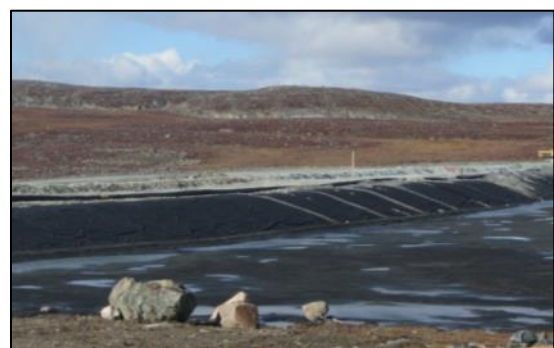
When viewing the tailings storage facility, the NIRB staff observed the thermistors installed in 2012 to measure freezeback (see Photo 31) and did not observe any apparent rips in the exposed lining of Saddle dams 1 and 2 (see Photo 32).

**Photo 32:** Saddle dam 1.

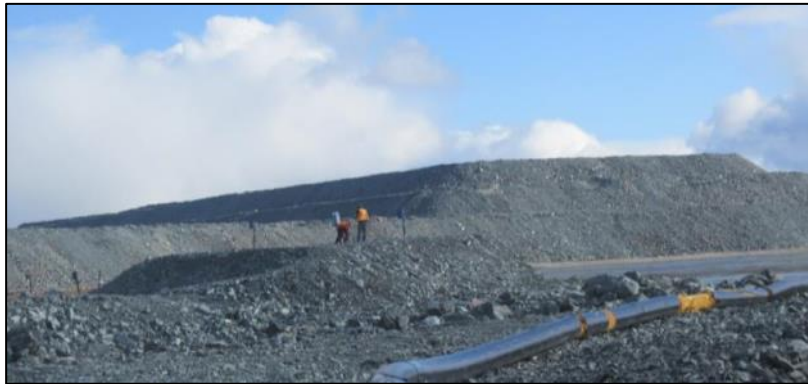
The NIRB staff also observed a test pad in the tailings storage facility wherein AEM is assessing the thickness of non-potentially acid generating (NPAG) material required to confine the potentially acid generating (PAG) material within the tailings storage facility (please see Photo 33). AEM staff explained that the mitigation strategy for PAG material is to keep it frozen by containing it within NPAG material (waste rock); this is done in the waste rock storage facility as well as the tailings storage facility. Thermistors are used to test freeze back of the material.

**Photo 33:** Test pads in the tailings storage facility for closure capping.

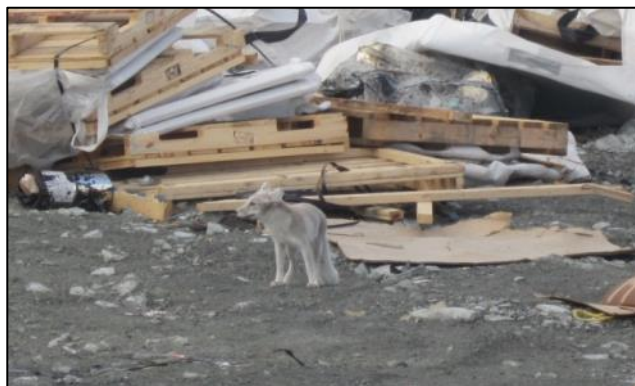
**Photo 34:** Fox in the landfill.

The Monitoring Officer observed one fox in the landfill, and AEM staff noted that although stationary deterrents are largely ineffective in discouraging wildlife and birds, the landfill is frequently inspected by employees to ward off any wildlife present (see Photo 34).

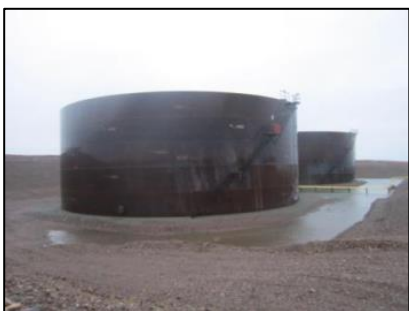
**Photo 35:** Bulk fuel tanks Baker Lake bulk fuel facility.

During the 2014 site visit, the Monitoring Officer observed that the fuel and hazardous materials associated with AEM’s Meadowbank project appeared to be stored in a safe and environmentally protective manner (see Photos 35-39). The Monitoring Officer noticed turbid water in the containment berm of the Jet-A pad at the Baker Lake storage facility (see Photo 36), however did not observe any noticeable sheen on water in any of the berms or discernable hydrocarbon odours at either of the Baker Lake facility or the Meadowbank site. The Monitoring Officer observed exposed liner-type material at the Meadowbank fuel tank farm (see Photo 37). AEM staff noted that this was likely not the liner itself but the material layer above the liner.

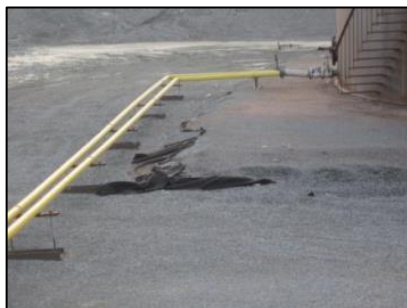
**Photo 37:** Lining at the bulk fuel tank Meadowbank site.

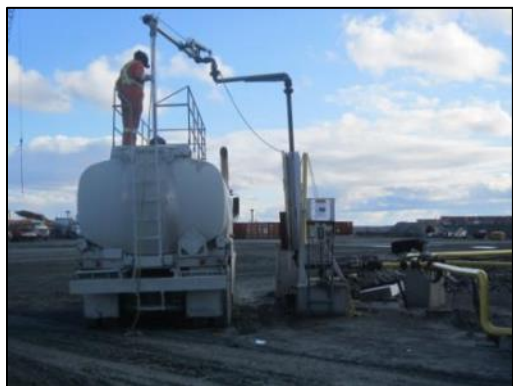
The fuel transfer stations on site (see Photo 38) and at the Baker Lake bulk fuel storage facility appeared to be well contained and properly set up for the re-fuelling of vehicles. The Monitoring Officer observed that spill pads or drip pans were not in use during refueling of vehicles the Meadowbank site; AEM staff noted that the area around the fuel tank farm was lined and that AEM intended to dispose of all materials during the mine closure.

**Photo 38:** Refueling at the Meadowbank mine site.

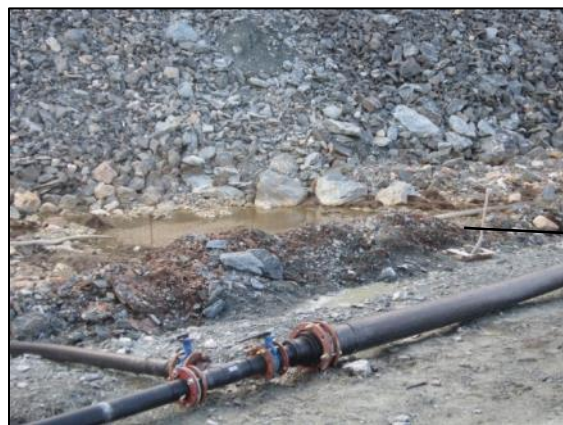
AEM reported two significant seepage incidents concerning hazardous substances that occurred during 2013/2014 (see Photos 40-43). In 2013, AEM noted seepage from the Portage waste rock storage facility for potentially acid generating rock (which has a high sulphur content, heavy metals and other contaminants) at a location near the south shore of a fish bearing lake (referred to as North Pole 2 or NP-2 lake) (see Photos 40 and 41). AEM staff noted that seepage near the lake would be monitored during the open water season.

**Photo 40:** Seepage from the Portage waste rock storage facility

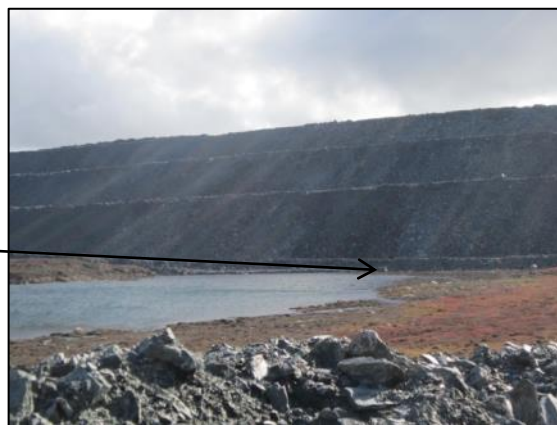
**Photo 41:** View of NP-2 Lake and the point of seepage at the Portage waste rock storage facility.

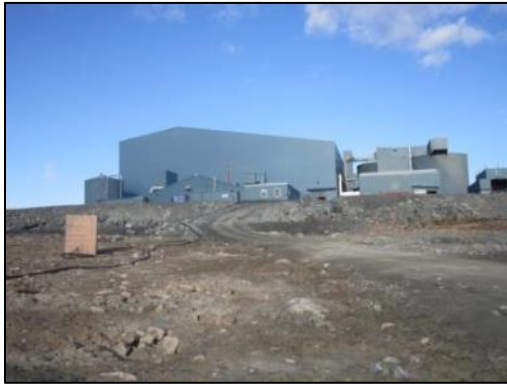
Photos 42 and 43). AEM noted that when water was discovered seeping through the road in front of the lab, test results indicated levels of cyanide, iron and copper. AEM staff indicated that it was able to determine that the Assay lab was the source of the seep, and that the water was being piped back to the tailings pond and is prevented from entering Third Portage Lake.

**Photo 42:** View of seepage water being pumped back up the road to the tailings storage facility.

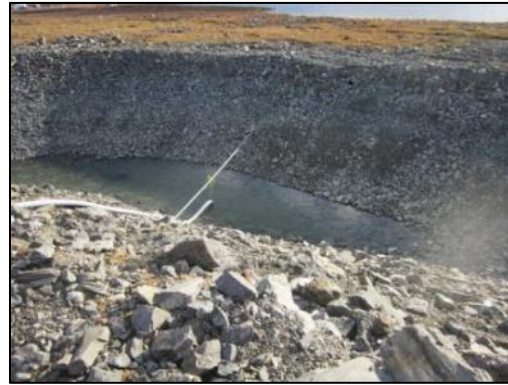
**Photo 43:** Point of seepage through the road at the Assay lab, located to the bottom right of Photo 42.

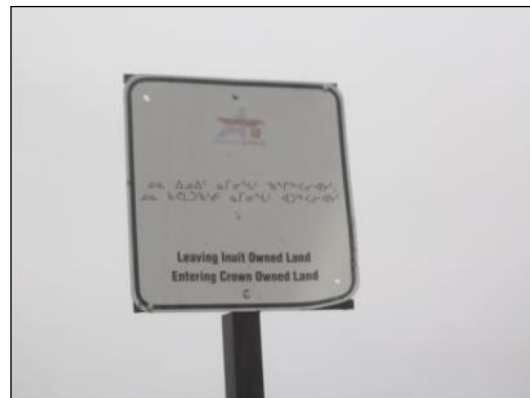
**Photo 45:** Example of the signs all along the AWAR indicating Inuit and Federally Owned Lands.

The signs as required per Condition 32(c) were posted in both English and Inuktitut at the gatehouse (see Photo 44), at each major bridge crossing (on the side of the environmental emergency sea-cans) and at every 10 kilometre intervals along the road (except, as previously noted in [Section 2.1\(c\)](#), at the sea-can at kilometre 23).

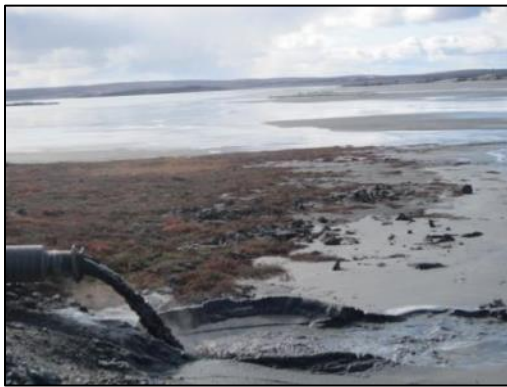
**Photo 46:** Outflow pipe at the tailings storage facility.

The Monitoring Officer observed wildlife tracks near the outflow of tailings into the tailings storage facility (see Photos 46 and 47). AEM staff discussed the use of "scare cannons" when spring bird migration commences and noted that these are then removed when no longer required, usually when birds begin their fall migration. In addition, AEM staff explained that stationary deterrents had been ineffective in deterring birds and that the "scare cannons" are repositioned every few days.

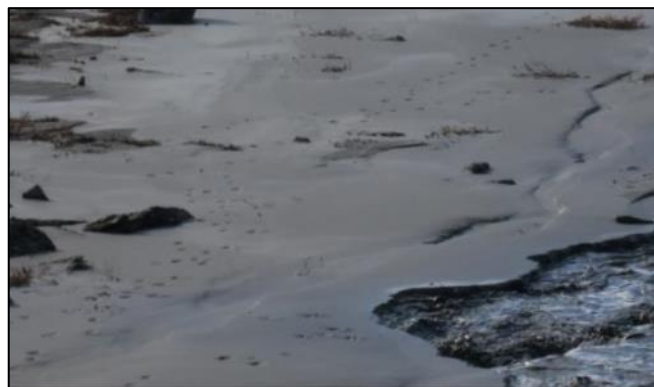
**Photo 47:** Wildlife tracks observed at the outflow pipe at the tailings storage facility.

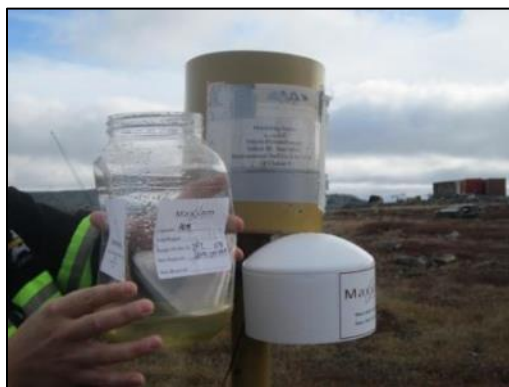
When the NIRB staff viewed the air monitoring and partisol sampling stations AEM staff noted that both dustfall and partisol monitoring occurs year round (see Photos 48 and 49).

**Photo 48:** Dustfall sampling occurs every six days.

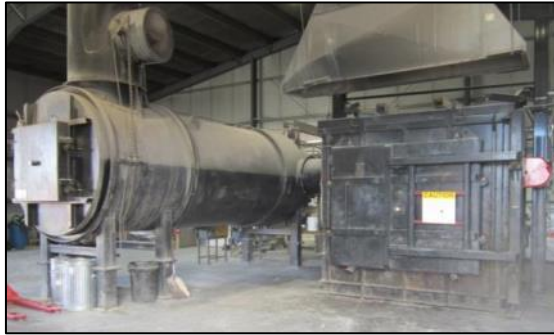
The Meadowbank site dual chamber forced air incinerator remains in service for the combustion of all non-hazardous, combustible materials at the site (see Photo 50).

**Photo 50:** Meadowbank dual chamber incinerator, with secondary chamber on the left side.

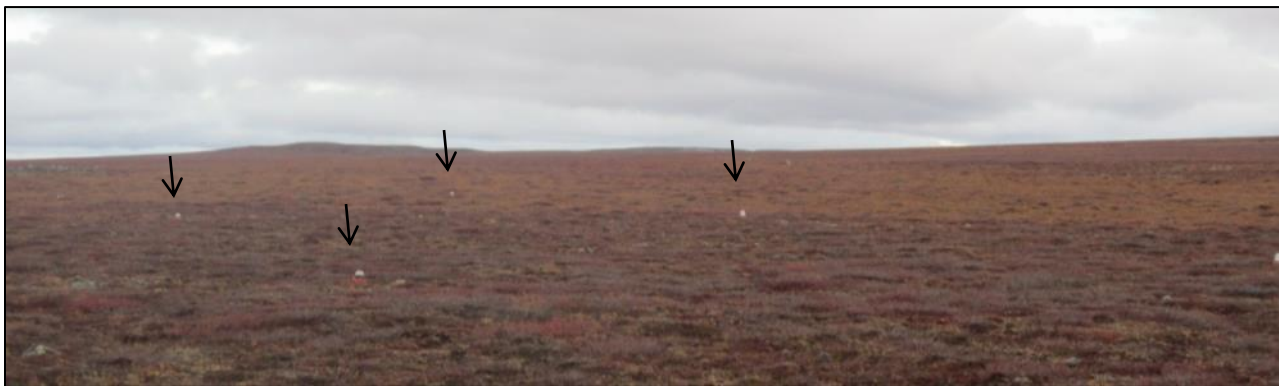
AEM staff noted that dust sampling stations were placed along the AWAR for 30 days between August and September at various distances from both the east and west sides the road in two duplicate transects (see Photo 51). AEM staff also indicated that calcium chloride and water are administered on the roads to suppress dust around the Meadowbank site and from the Baker Lake dock facility to the gatehouse. During the site visit, AEM confirmed that no dust suppressants are currently in use along the AWAR.

**Photo 51:** Dust sampling stations along the AWAR.
