Re: NWB 2AM MEA0815: Response to NWB completeness reviews of the Type A water license renewal application.

MEADOWBANK MINE, ASSAY ROAD SEEPAGE PHASE 2: ENVIRONMENTAL SITE ASSESSMENT AND ENGINEERING QA/QC

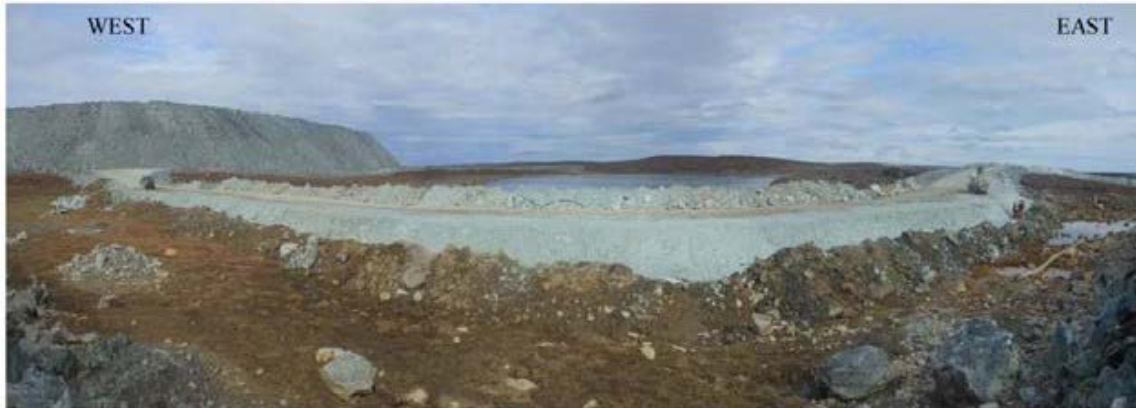
Figure 10: photo of the final result of the entire till plug from West to East. The actual pumping station and the 2 active seepage channels are visible on the eastern abutment.

A staff gauge was been placed at the seepage location to determine and visually quantify the water level increases. AEM has instructed a water truck to pump the water and dispose of it in the tailings pond should water levels become too high on the upstream side of the till plug as seen in Appendix A Figure 10.

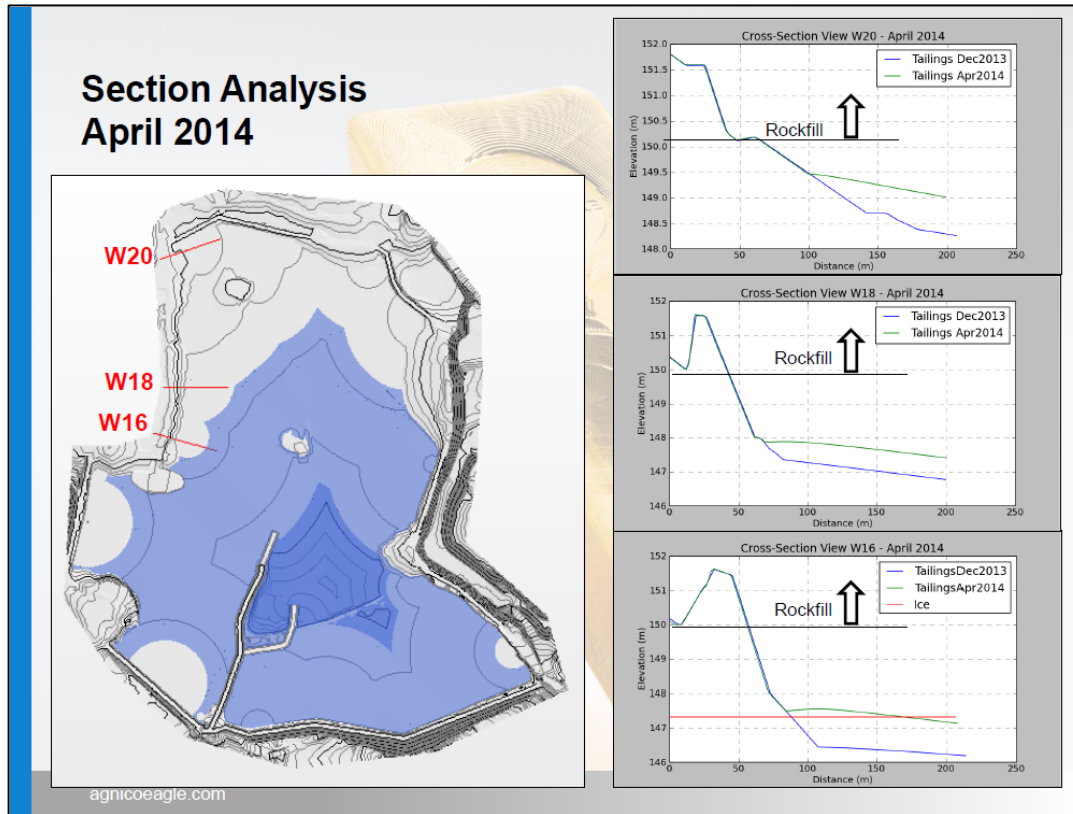
Figure 2-7: North Cell ring road seepage analysis

that risk, AEM performed a seepage analysis to evaluate the maximum elevation of the tailings beach that could be raised at the toe of the North Cell ring road. Sections have been realized at each deposition point to determine if the tailings beach will reach the toe of the road. Results presented on the Figure 2-7 showed that no tailings should reach that elevation.
