Construction Summary Report Rock Storage Facility - Interim Till Plug

**CONSTRUCTION SUMMARY REPORT
ROCK STORAGE FACILITY – INTERIM TILL PLUG**

**AGNICO-EAGLE MINES LIMITED
MEADOWBANK GOLD PROJECT**

OCTOBER 30TH, 2013

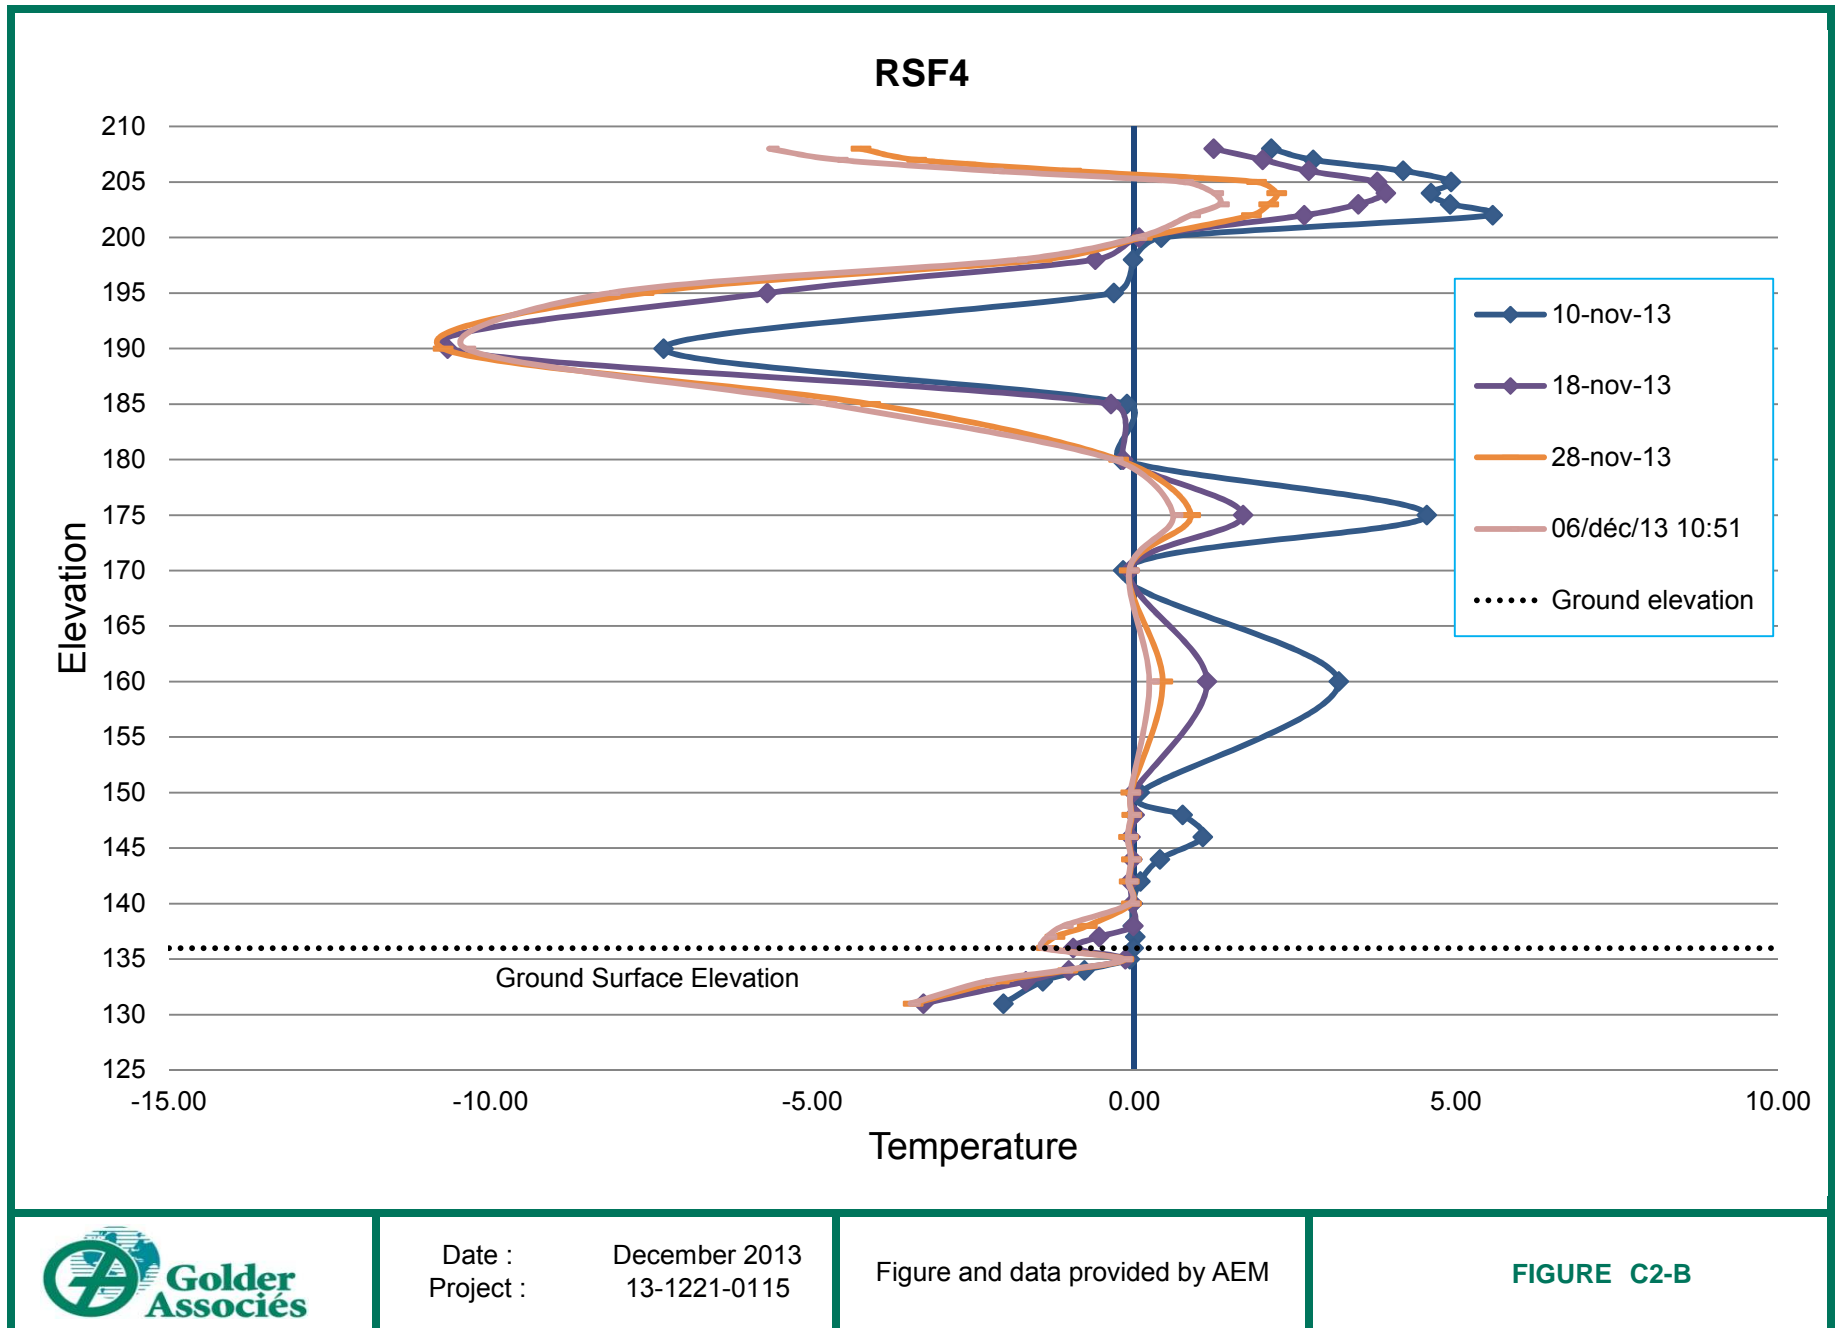
FIGURE C2-B

Portage Rock Storage Facilitie Newly Installed Thermistor

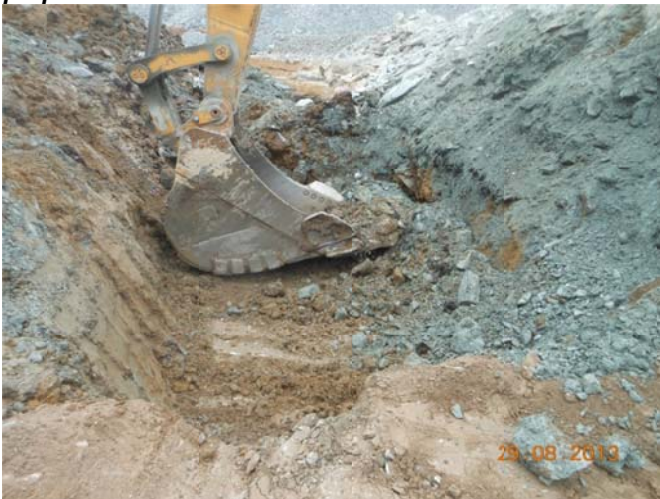
Figure 2: excavation of the foundation to permafrost / bedrock). The width of the trench at the bottom was at least one bucket wide. Note the excavated material is discarded on the upstream side.

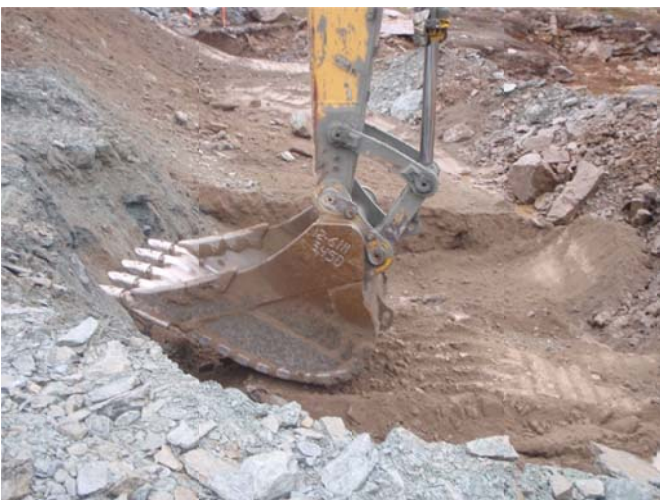
Figure 3: till placement with the excavator bucket and compaction.

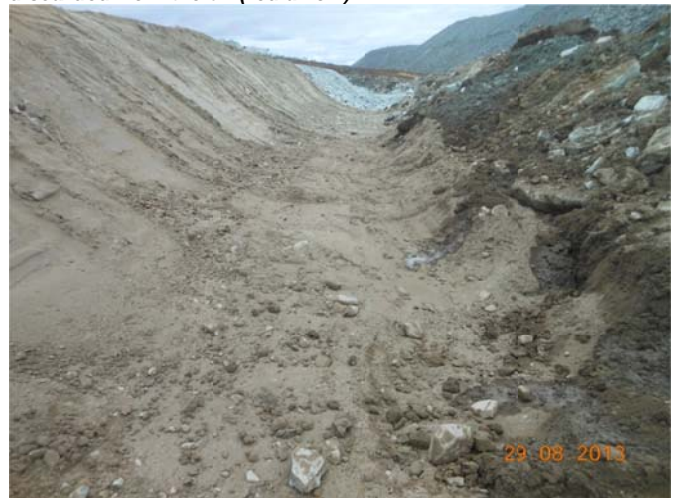
Figure 5: final till placement over an entire section after 1 day of work. The till is flattened and compacted before any rockfill placement.

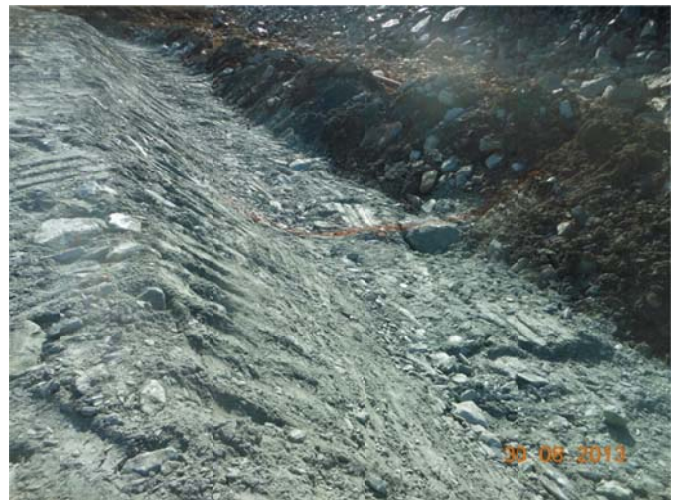
Figure 6: Final placement of soapstone rockfill protective layer (1A) over the till, once compacted.
