**MEADOWBANK MINE**

# **Preliminary AEM Report – Seepage Water From Waste Rock Storage Facility – Sample Location ST-16**

**SEPTEMBER 2013**

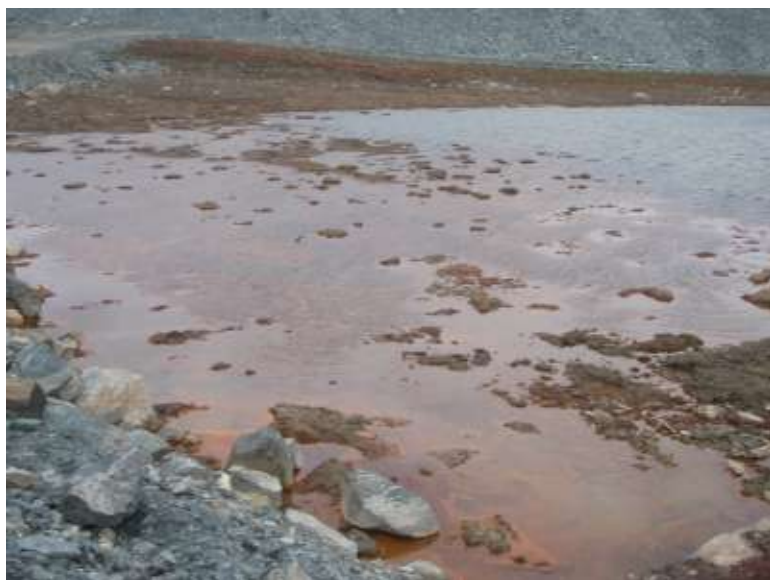
*Photo 1 – Shore of NP-2*

During an AANDC Water License inspection on July 29<sup>th</sup> and 30<sup>th</sup> 2013 it was observed that “red” colored seepage from the south - east side of the Waste Rock Storage Facility was seeping through the road perimeter into Lake NP-2. Samples were taken by both the Inspector and AEM staff (split sample). Analysis results from this sampling were received by AEM on August 16<sup>th</sup>, 2013. See Photos 1 and 2 below and Table 1.

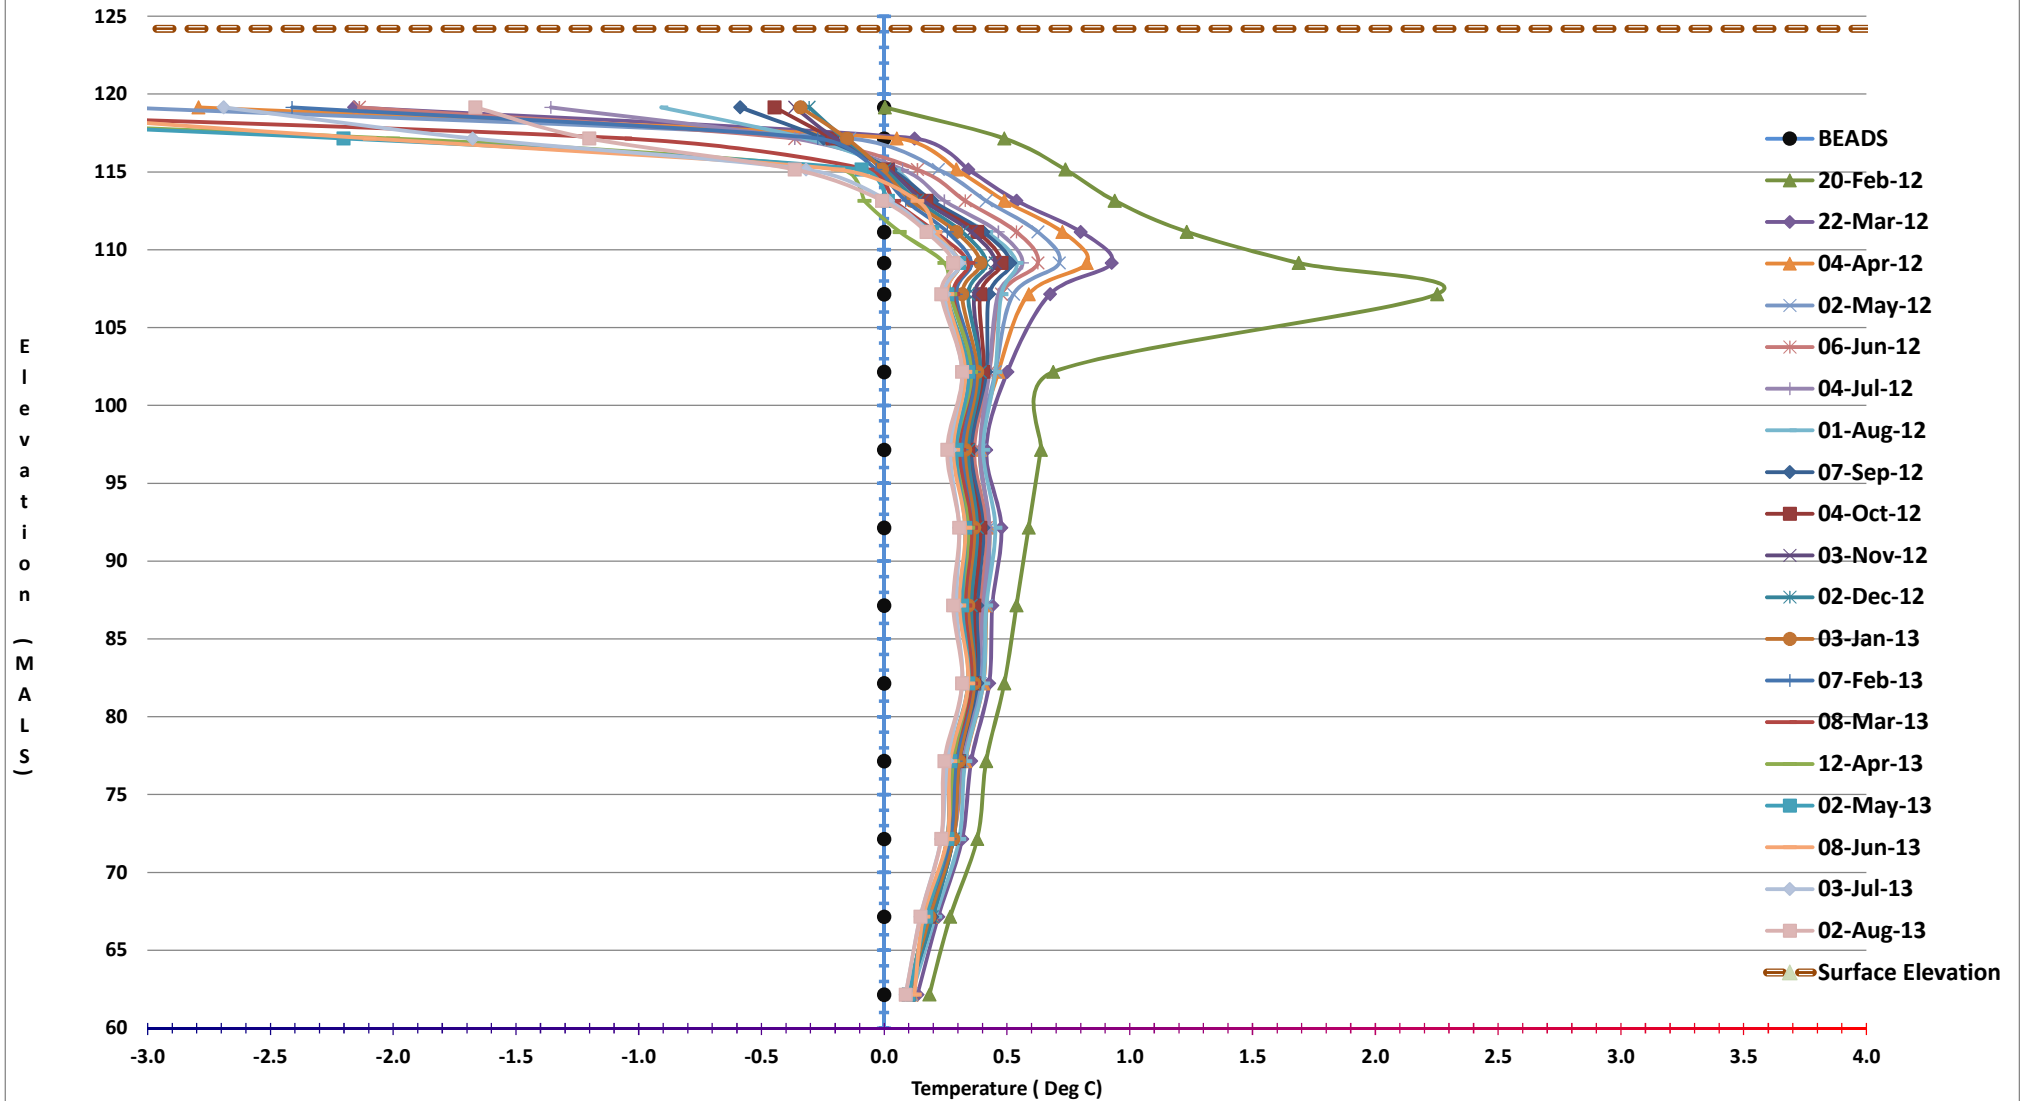
**STORMWATER DIKE - T147-1**  
Elevation vs Temperature - String # 147-1
