**Aquatic Effects Monitoring Program – Addendum to the
2008 Fish-Out of the Northwest Arm of Second Portage
Lake:**

**Habitat Mapping of the Northwest Arm of Second Portage
Lake 2009, Meadowbank Gold Project, April 2010**

Meadowbank Gold Project

Project No. AE-09-01.3

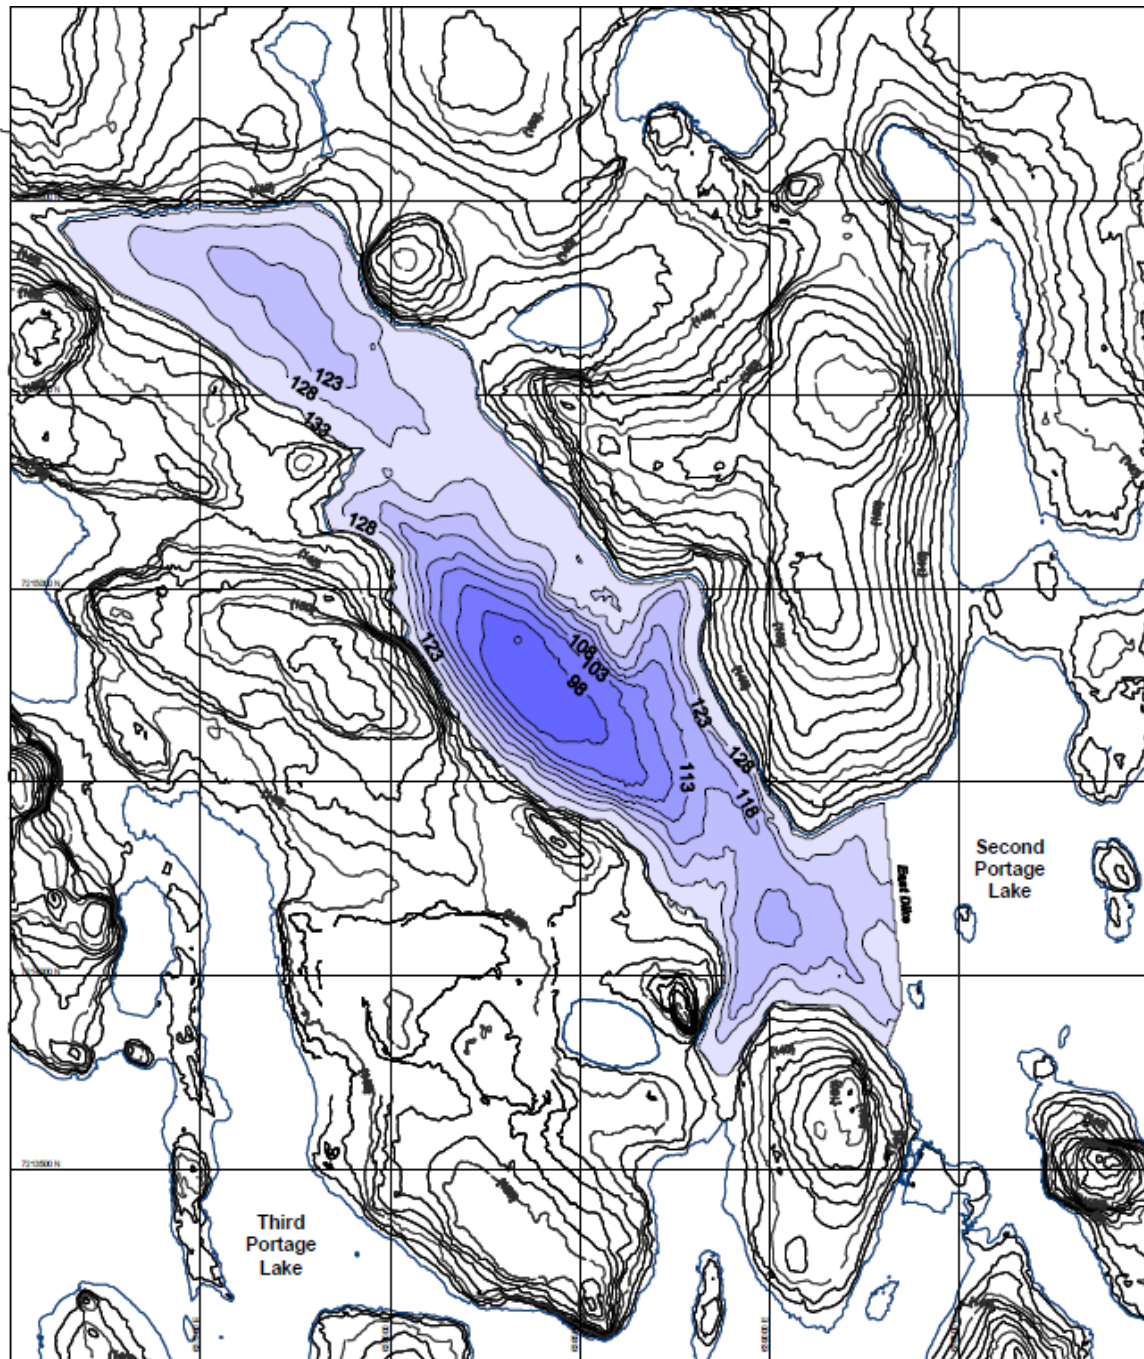
Figure 1-1. Bathymetric map of NW arm of Second Portage Lake behind East Dike.

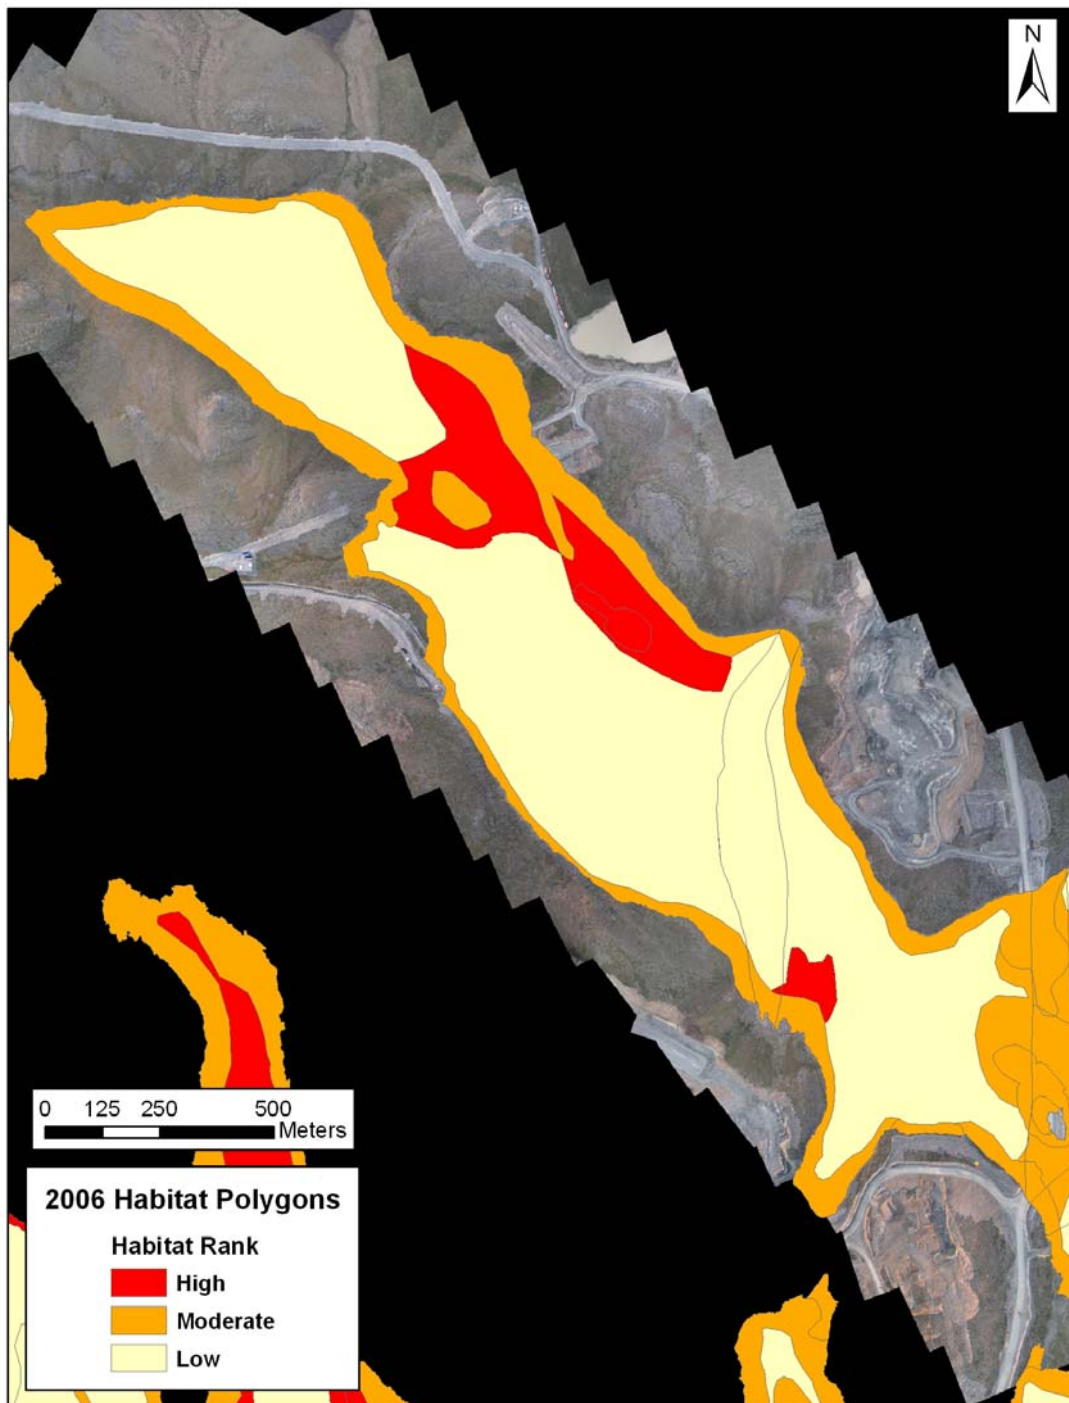
Figure 2-1. Habitat values of NW arm derived from 2006 aerial photographic interpretation through water.

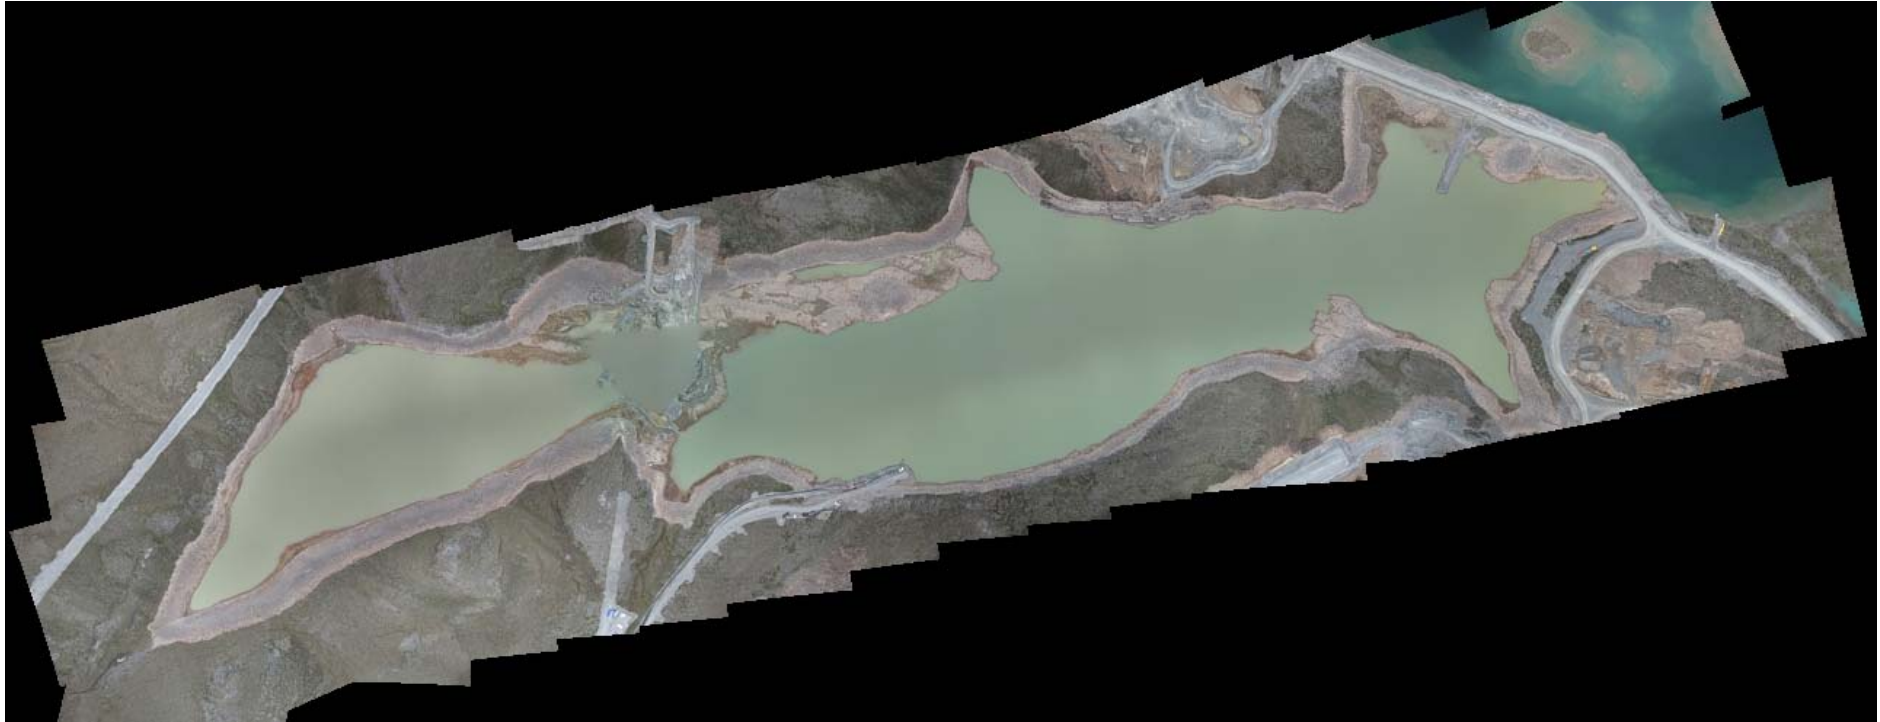
Figure 3-1. Composite image of 2009 air photos of partially de-watered NW arm, Second Portage Lake.

For example, the steep habitat band that was easily observed on the ground was very difficult to identify in the air photographs. Although there are detectable changes in substrate characteristics, it was not possible to definitively associate this with a change in slope or in morphology. Thus, changes in substrate characteristics were not sufficiently different to allow for apron habitat to be distinguished from nearshore platform habitat and the two habitat types were often lumped together.

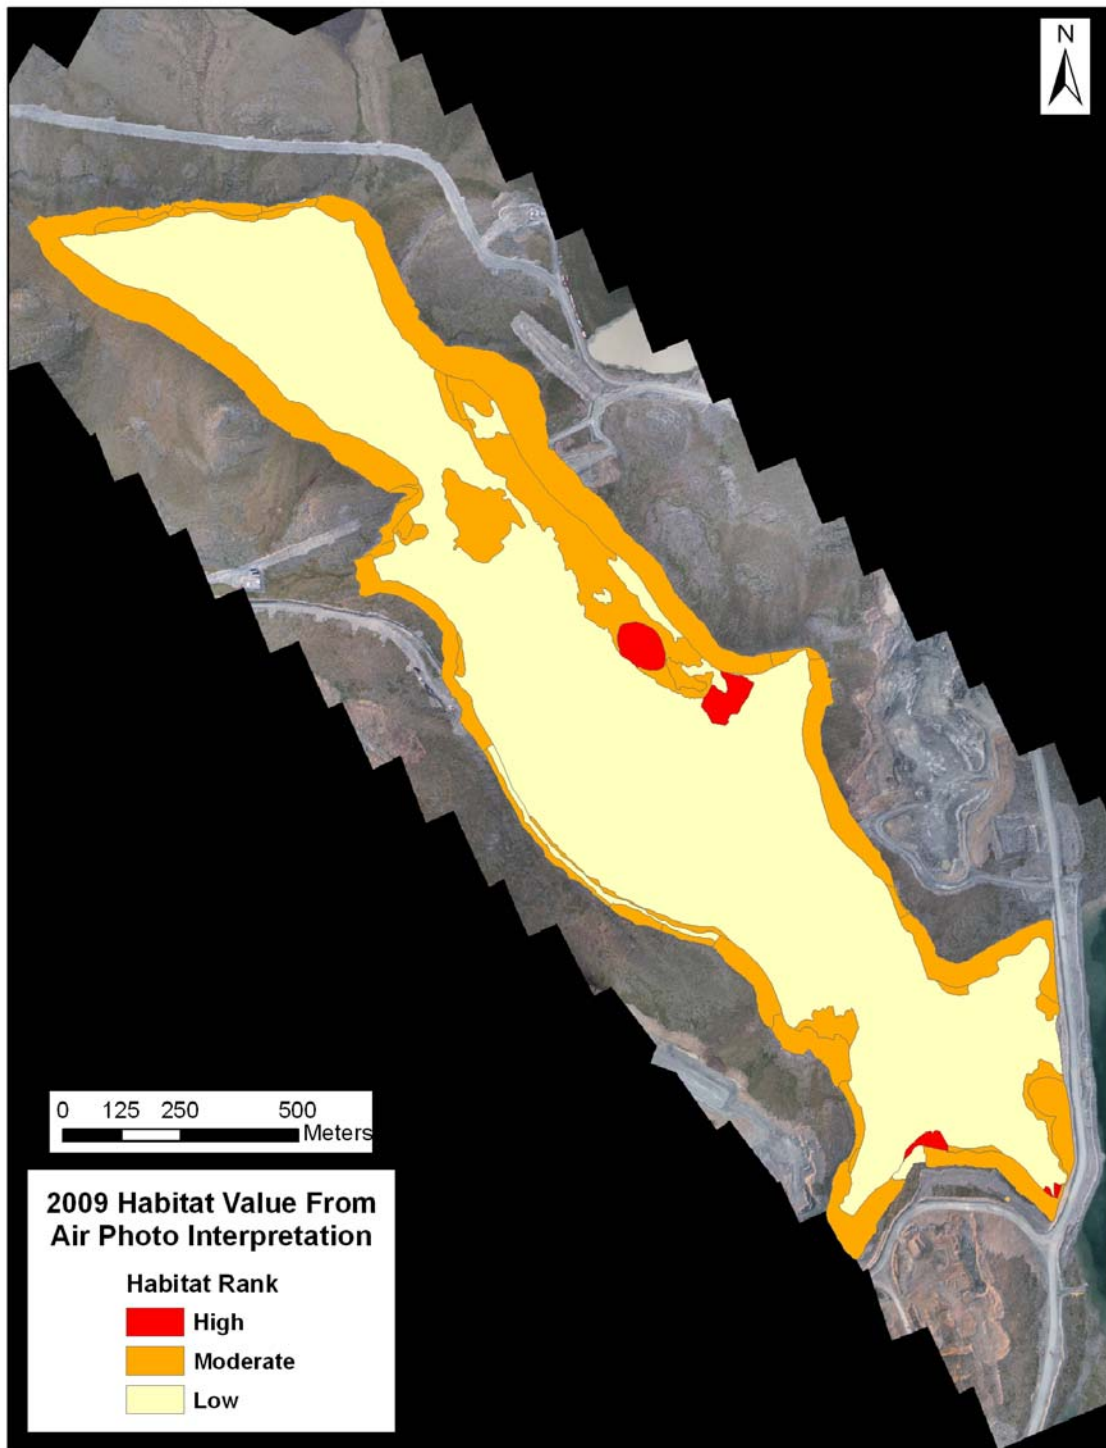
Figure 3-2. Map depicting habitat values of unbiased interpretation of 2009 aerial photographs.

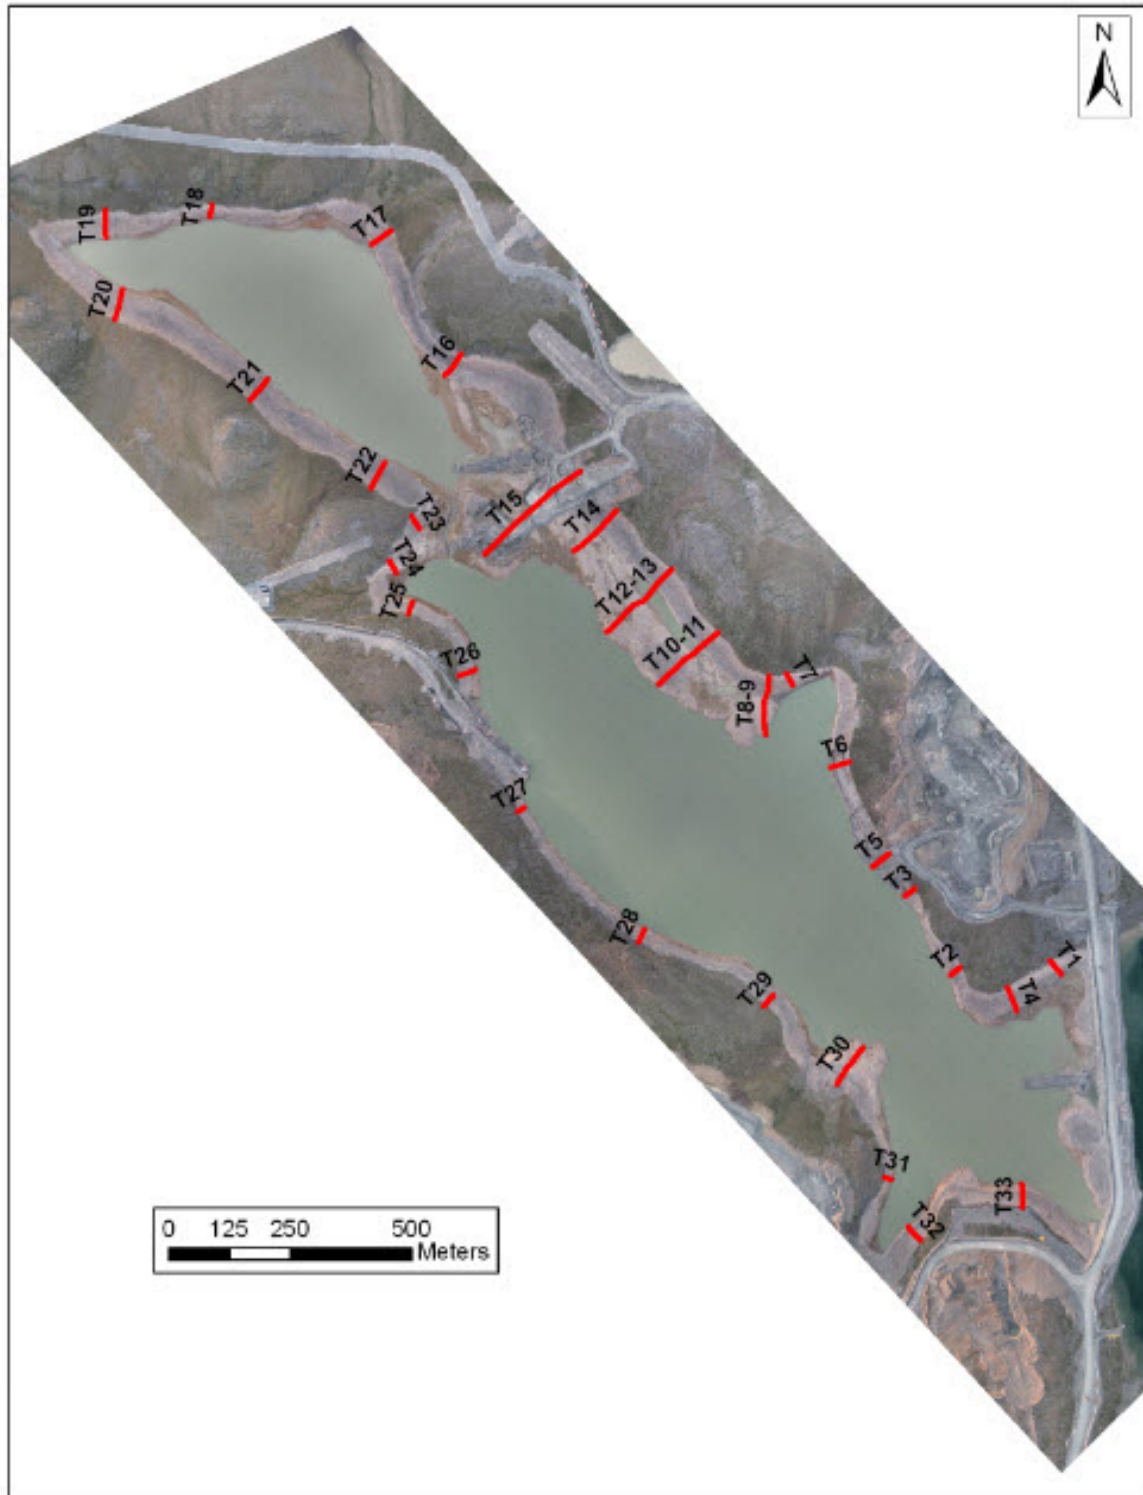
Figure 4-1. Map showing location of 2009 ground survey transects of NW arm of Second Portage Lake.

Following is a summary of differences to the general pattern described above as observed along the ground survey transects of the impoundment area (**Figure 4-1**).

- There was a shoal presumed to be visible at T30 in the 2006 mapping exercise that extended for 170 m offshore that was ranked as high value habitat. However, this shoal was not observed the 2009 aerial (90 m) and ground surveys (94 m) and substrate complexity was ranked much lower from the ground than what was assumed when viewed from the air. Thus this area was ranked as moderate value habitat, which was the largest discrepancy between the two major surveys.

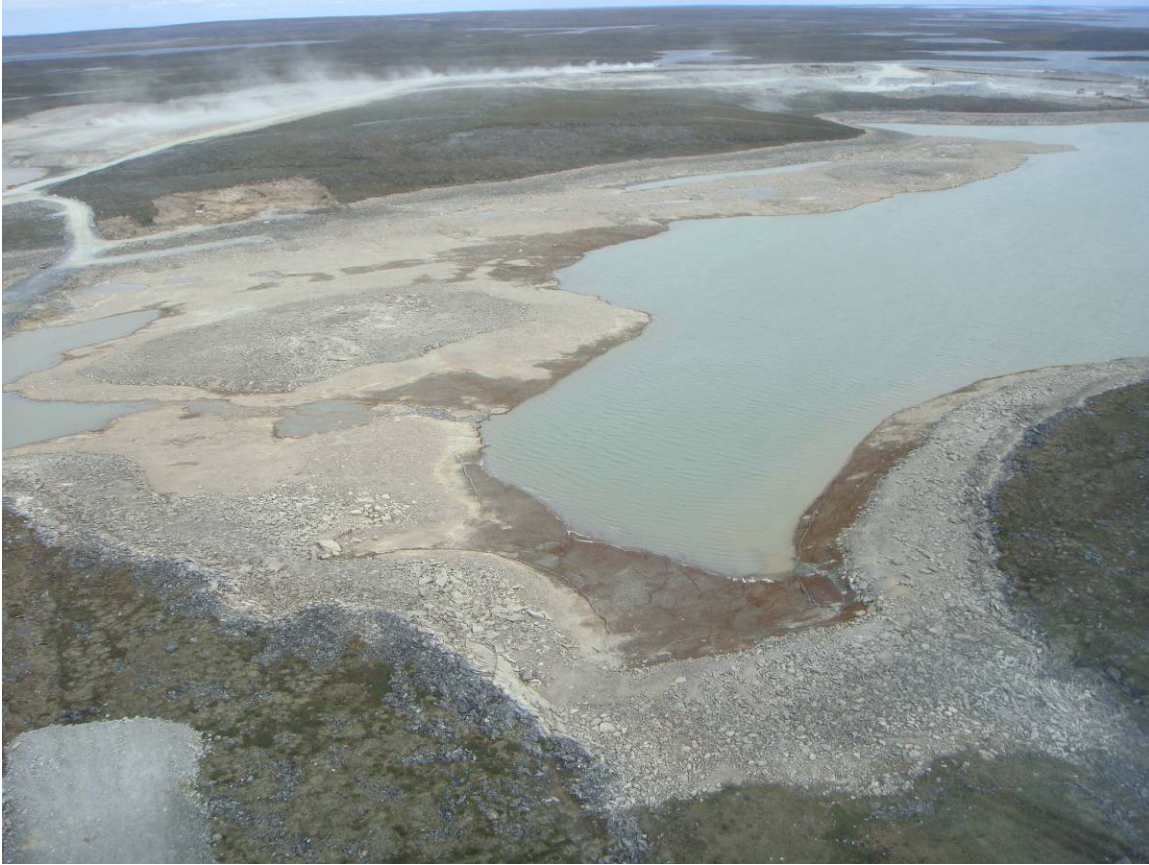
Figure 4-2. Photo of sill area (taken on 22 July 2009) looking east towards the central basin of the northwest arm.

Note: The foreground (lower right portion away from the sill) shows typical habitat zonation found in the northwest arm.

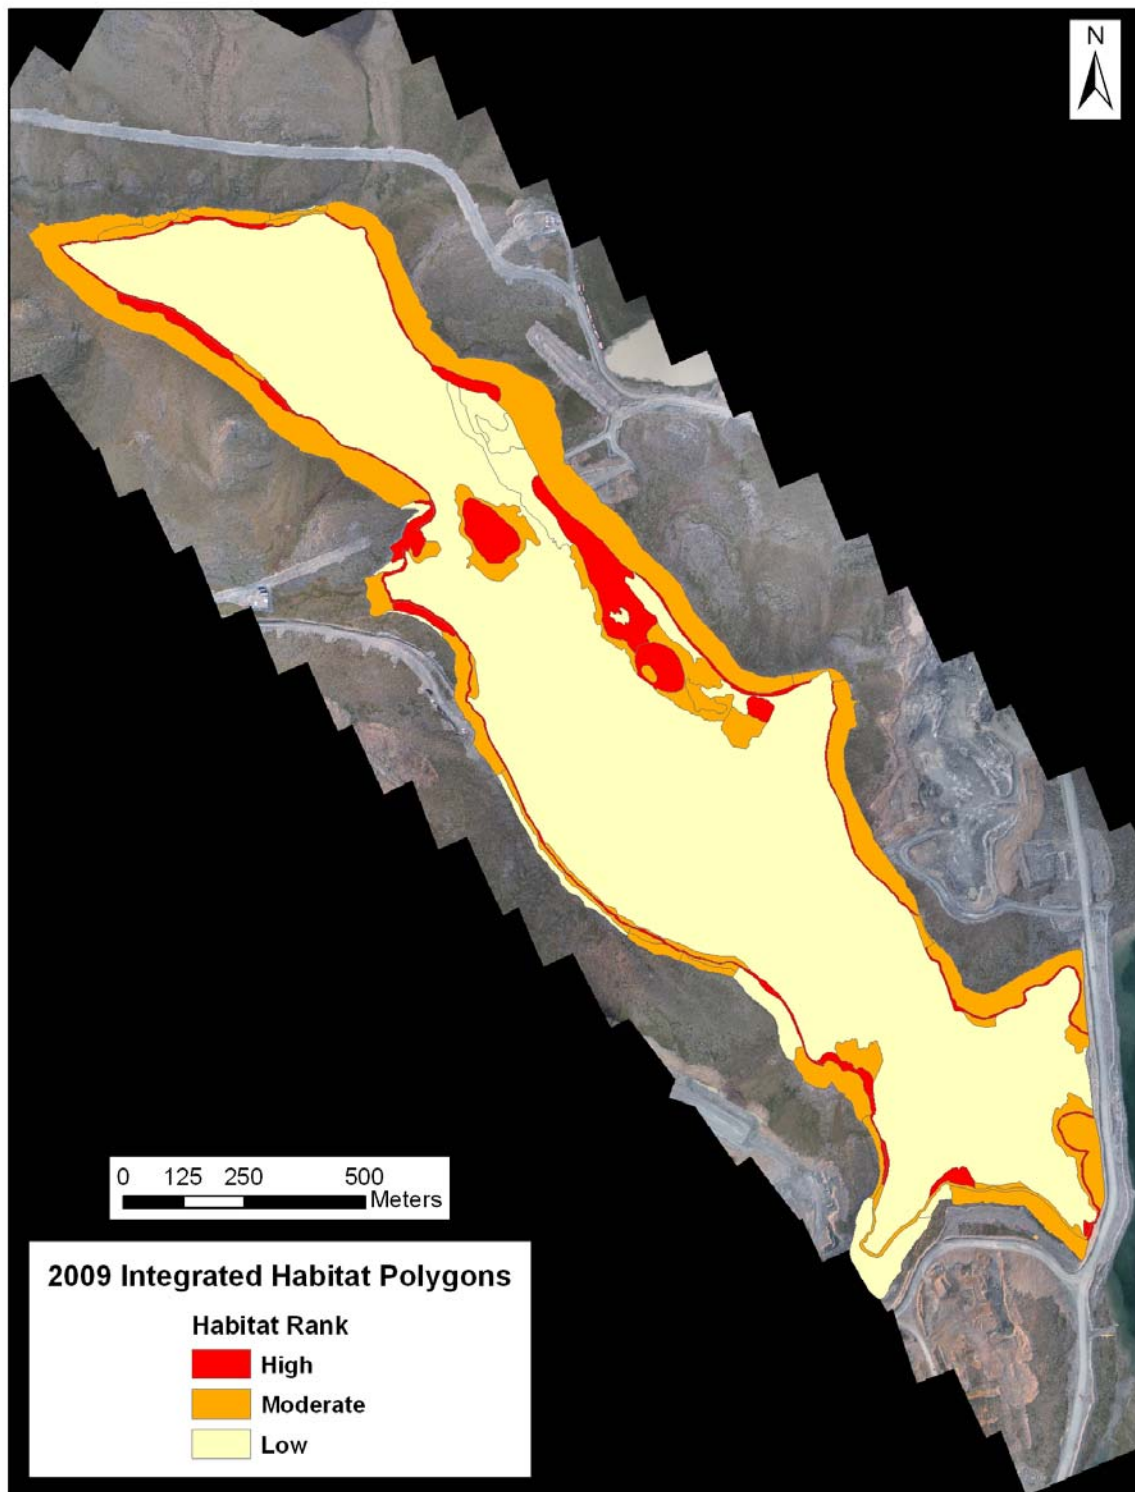
Figure 6-1. Map showing habitat values of 2009 integrated map of ground survey and air photo information.

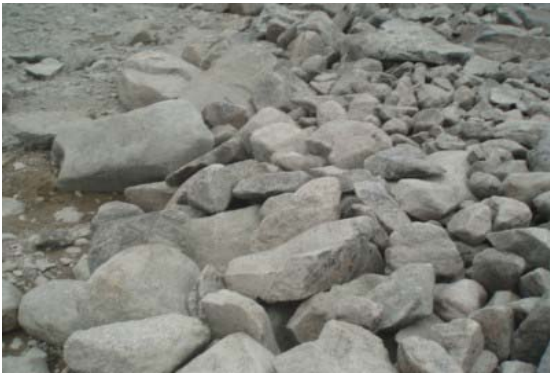
Photo 25: T11B-C

T11	B - C	638480	7215057	1.91	4.2	B	S	C	25	Short steep boulder wall to top of shoal. Periphyton coverage on boulders; nice transition to submerged shoal
T11	C - D	638477	7215054	2.73	73.0	B	F	C	26	Large shoal consisting of broken and fractured rock. Few large cobble patches. Good peri coverage over the shoal. Ice scour at top of rocks suggest that most of the base of the shoal is ice free. Possible spawning habitat. The knoll of the shoal is frozen in winter.
T11	D - E	638425	7215004	5.50	9.0	BS	S	M	27	Relatively stable but steep slope to mud at toe. Moderately complex but not much interstitial space, sparse peri growth. At top of slope good boulder cover and spawning habitat.
T11	E	638507	7215080							
T12	A - B	638462	7215249	2.22	46.4	B	F	M	28	Shallow sloping boulder field consisting of medium size boulders, a few large and some small. Few cobble patches. Heavy peri cover; broken rock jumbled leading towards lip of ledge at B, 46 m away. Substrate gets more cobbly at end.

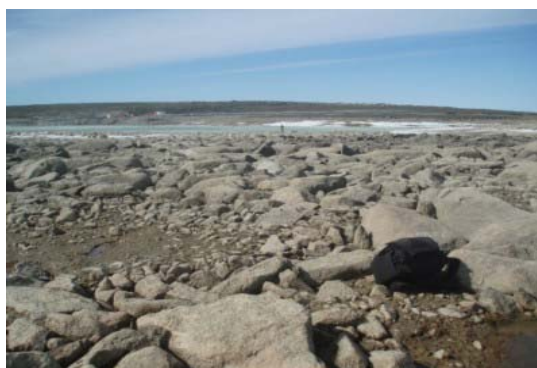
Photo 34: T14A-B

T13	D	638327	7215121							
T14	A - B	638342	7215368	43.46	59.20	BS	F	M	34,35	Periphyton covered heterogeneous mixture of large, medium boulder, angular rock, rounded, fractured ice covered. Few patches of large cobble interspersed 1m squared boulders. Slope is v gradual. Ends abruptly with 0.5 m drop to B-C
T14	B - C	638302	7215325	2.49	44.50	SB	F	C	36	Below small 0.5 m drop, all flat v heterogeneous mix of large boulder to 45% fines and patchy. Some peri on larger rocks; sandy patches in depressions. Very heterogeneous mix to edge of C where slope changes with transition to fines.
T14	C - D	638269	7215295	4.18	17.00	S	S	M		Short moderate slope to 100% fines at edge of slope before sharp turn to fines. Water ~2m below D, uniform fines beyond D. Some periphyton on top of boulders.
T14	D	638254	7215286

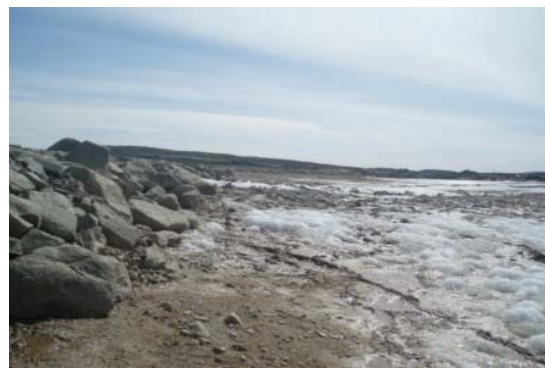
Photo 41: T16A-B

T15	F	638066	7215270							
T16	A - B	638017	7215682	1.90	34.8	B	F	M	41	Very large uniform angular boulder field, broken rock very jumbled and mixed- preiphyton cover good; fine sediment (dried) on everything in this area ~2m below transition to heterogeneous mix of gravelly boulder cobble of very mixed size and composition; patchy, flat ice compressed and probably ice covered except in interstitial spaces
T16	B - C	637998	7215652	2.2	17.00	BS	F	C	42	Short steep boulder wall with sharp drop to mud bottom at foot of boulder wall- no transition to anything except fines
T16	C - D	637986	7215641	4.02	4.3	BS	S	C	43	
T16	D	637983	7215638							
T17	A - B	637874	7215937	2.52	46.2	B	F	MC	44	Large boulder slightly rounded with cobbly patches of moderate complexity; good peri cover flat, shallow slope, ice to bottom
T17	B - C	637836	7215910	3.77	4.3	B	S	M	45	short steep boulder slope to edge of very deep shelf soft silt clay mud at C

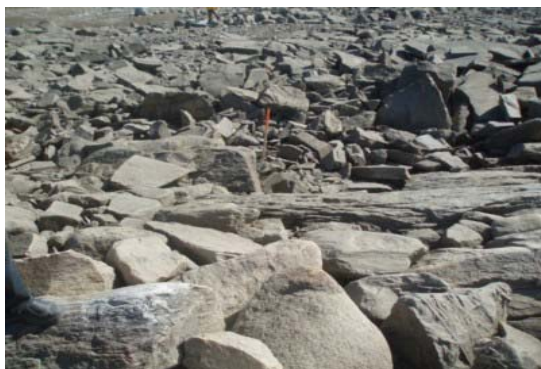
Photo 61: T23A-B

T23	A - B	637916	7215349	8.18	9.3	S	F	U	61	Steep bedrock shelf. Slope to 2 m and near bottom of ice level, beginning shallow sloping boulder
T23	B - C	637919	7215341	2.43	18.2	B	F	C	62	Heterogeneous mix of boulder, cobble, broken rocks few gravel/sandy materials and complexity- leading to boulder shelf/slope
T23	C - D	637929	7215327	3.2	4.2	B	S	C	63	short steep (1m) boulder wall to fine sediment.
T23	D	637932	7215323							Shoal. Thin layer of fines with cobble boulder mix (30%). 1 to 1.5 m elevation below current elevation. About 40 m away to good shoal.
T24	A - B	637870	7215257	2.71	22.2	S	F	U	64	Steep sloping large fractured rock slabs extending from shoal to ~ 3m depth. Some bedrock face, boulder very very large boulder extending to foot of slope. Peri moderate.
T24	B - C	637881	7215239	4.01	7.8	BS	S	C	65	At foot of B, transition to heterogeneous mix of cobble rock and small boulder. Appears to be good species spawning habitat wrt depth, slope, cover, interstitial spacing. At foot of C, rapid transition to clay.

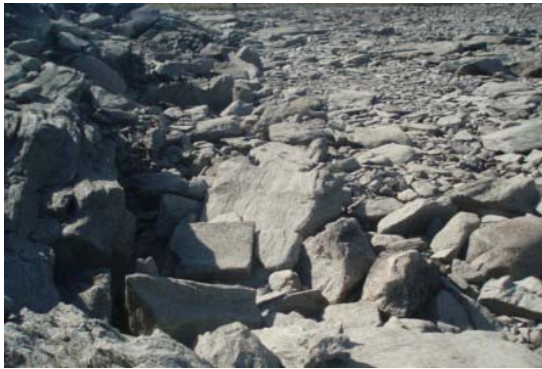
Photo 67: T25A-B

T24	C	637884	7215232							
T25	A - B	637907	7215144	1.88	5.1	S	S	U	67	Very short, very steep slope ~3m to floor consisting of fractured bedrock and boulder, rubble field to below ice scour zone.
T25	B - C	637909	7215148	2.25	18.4	BS	F	C	69	Long flat base of heterogeneous mix of boulder and cobble, large and small. Lots of good spawning habitat, some peri. Beneath rubble is sand. Toe of table grain size diminishes to cobble boulder mix to toe of slope at C
T25	C - D	637915	7215166	4.04	5.4	B	S	C	70	Steep short loose small boulder, large cobble field. 4-5 m depth to intersection with fines. Very oxidized surface, reddish colour vs grey elsewhere
T25	D	637917	7215170

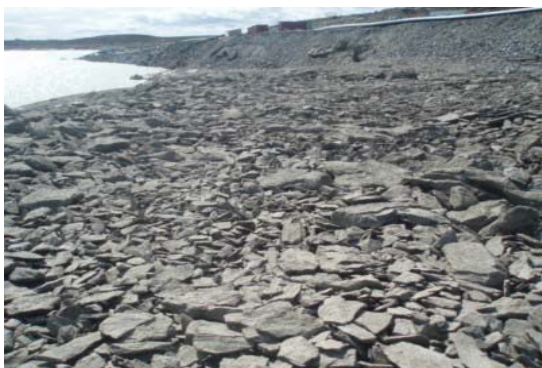
Photo 71: T26A-B

T26	A - B	638007	7215019	2.4	31	B	F	C	71	Initially, a drop of 1 m to 10 m away, flattening. Substrate is fractured rock and cobble, relatively small size interspersed with small boulders. Excellent peri cover, nice flat shelf probably good for foraging/rearing. Probably ice covered to end of slope before steep drop.
T26	B - C	638036	7215029	4.5	5.2	B	S	C	72	Short steep boulder wall falling quickly to mud. Bottom a few m away. Over 2 m elevation
T26	C	638041	7215031							
T27	A - B	638133	7214742	1.7	9.1	S	S	M	73,74	Short steep slope of bedrock, fractured bedrock and boulder. A bit of ice scour and poor peri coverage. Heterogeneous mix of boulder, cobble, broken rocks at toe of slope.
T27	B - C	638140	7214746	2.19	6.9	BS	S	M	75,76	Transition to flat slope ~1.5m depth with v heterogeneous mix of substrates including gravel and sand. Excellent peri growth. Probably ice covered late winter. Very good complexity with different materials and sizes.

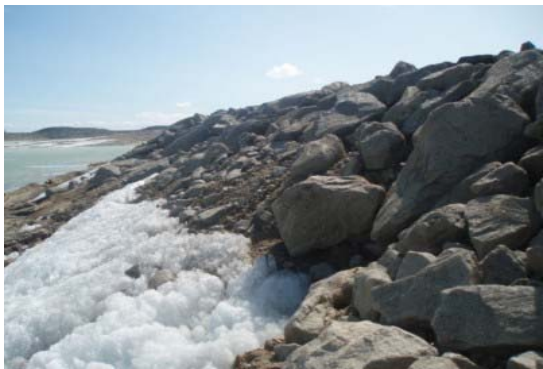
Photo 81: T29B-C

T29	B - C	638660	7214364	5.5	9.2	SB	S	M	81	Very steep unstable slope of large boulder. Some cobble. At top of slope few ridges of small cobble, large gravel. At toe of slope, transition to mud.
T29	C	638662	7214376							
T30	A - B	638789	7214181	2.61	39.3	B	F	M	82	Moderate sloping boulder field of broken rock, angular slab descending down with even pitch. Moderate peri growth. Toe of slope ~2m or at ice level and transitions to short slope down to foot of rocky shoal.
T30	B - C	638809	7214214	4.65	17.4	SB	S	M	83	Transition zone from boulder across heterogeneous mix of materials to foot of shoal. Some fines, gravel, small cobble and sand.
T30	C - D	638821	7214227	3.8	11.1	SB	F	M	84	Increase in elevation to rocky shoal of compacted gravel/cobble. Mostly flat surface. Not much vertical diversity. Moderate periphyton coverage
T30	D - E	638828	7214235	6.42	26.3	SB	S	M	85	Same as above, but less slope to mud in lake.

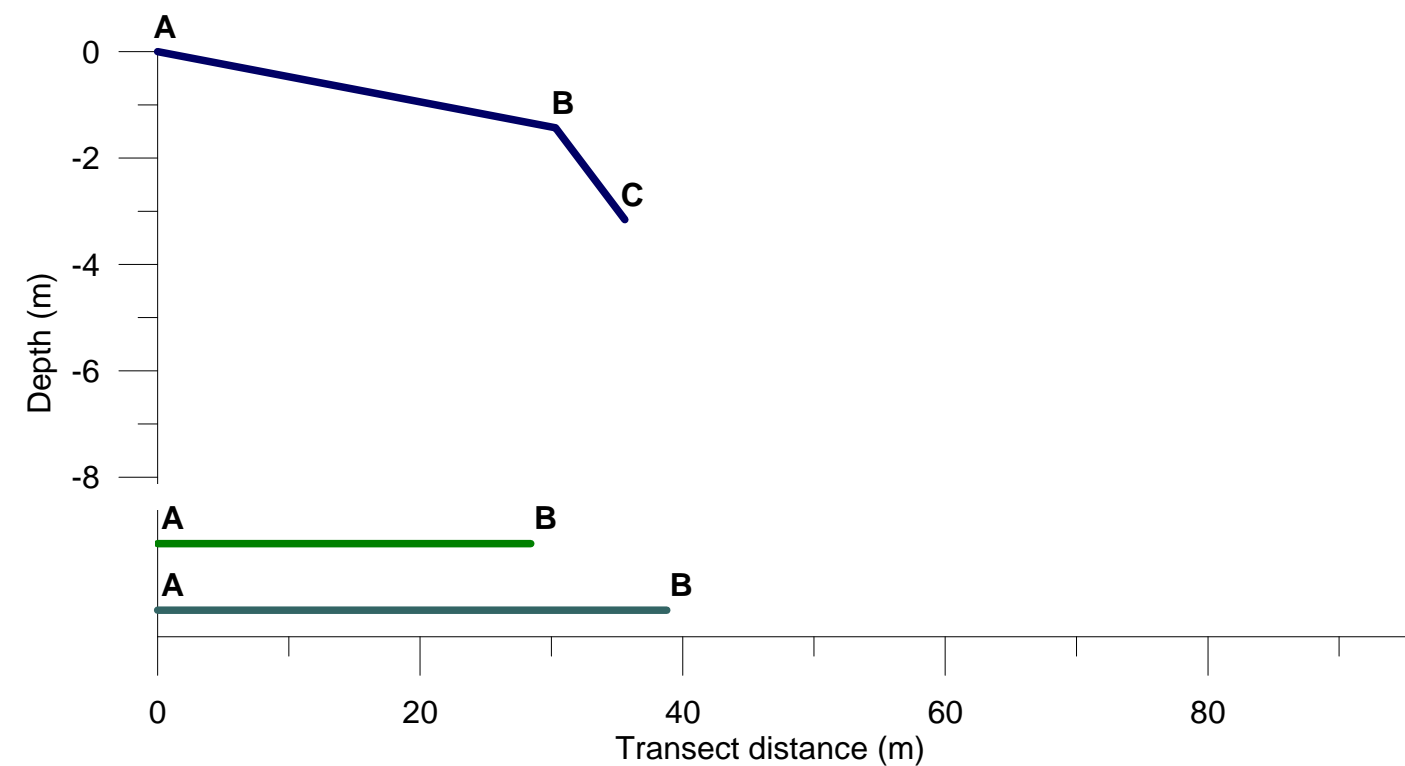
T1	Section	Habitat Value	Depth	Slope	Ice Scour	Substrate	Morphology	Complex
2009 Ground	A-B	M	S	F	Y	B	P	M
	B-C	H	M	S	N	B	P	C
	C-D							
	D-E							
	E-F							
2006 Air	A-B	M	S	F	Y	BS	P	C
	B-C	-	-	-	-	-	-	-
	C-D							
2009 Air	A-B	M	S	F	Y	B	P	C
	B-C	-	-	-	-	-	-	-
	C-D							
	D-E

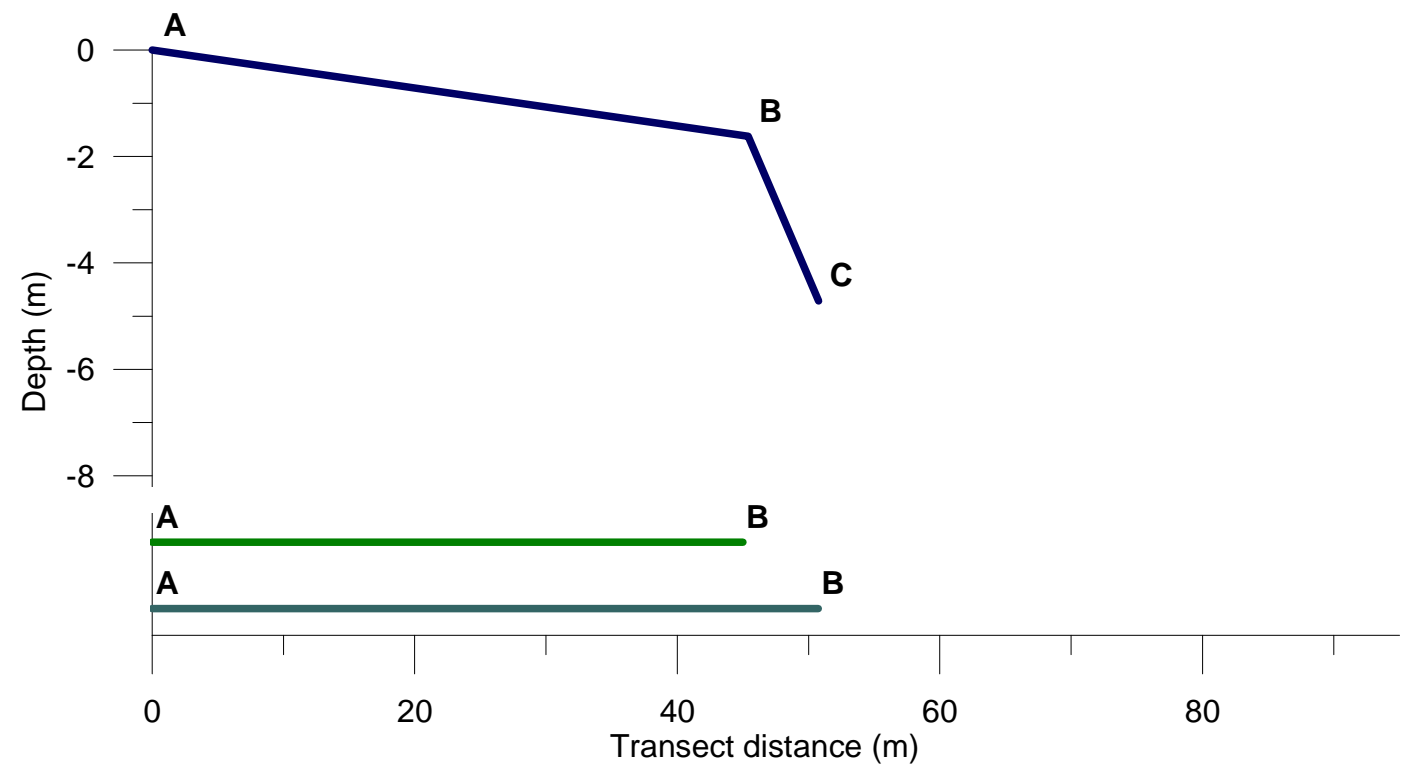
T4	Section	Habitat Value	Depth	Slope	Ice Scour	Substrate	Morphology	Complex
2009 Ground	A-B	M	S	F	Y	B	P	M
	B-C	H	S	F	N	B	P	C
	C-D							
	D-E							
	E-F							
2006 Air	A-B	M	S	F	Y	BS	P	C
	B-C	-	-	-	-	-	-	-
	C-D							
2009 Air	A-B	M	S	F	Y	B	P	C
	B-C	-	-	-	-	-	-	-
	C-D							
	D-E

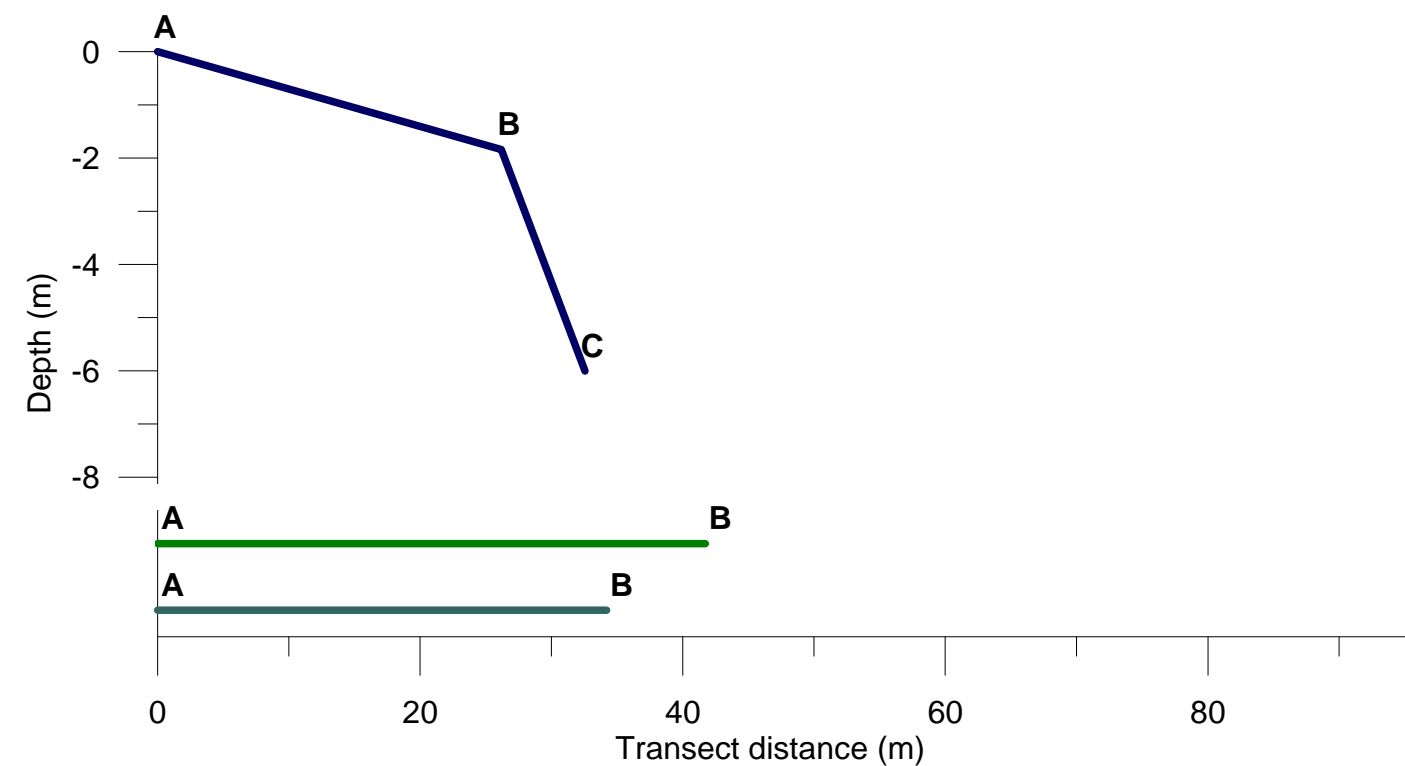
T2	Section	Habitat Value	Depth	Slope	Ice Scour	Substrate	Morphology	Complex
2009 Ground	A-B	M	S	F	Y	B	P	U
	B-C	H	M	S	N	BS	P	M
	C-D							
	D-E							
	E-F							
2006 Air	A-B	M	S	F	Y	BS	P	C
	B-C	-	-	-	-	-	-	-
	C-D							
2009 Air	A-B	M	S	F	Y	B	P	C
	B-C	-	-	-	-	-	-	-
	C-D							
	D-E

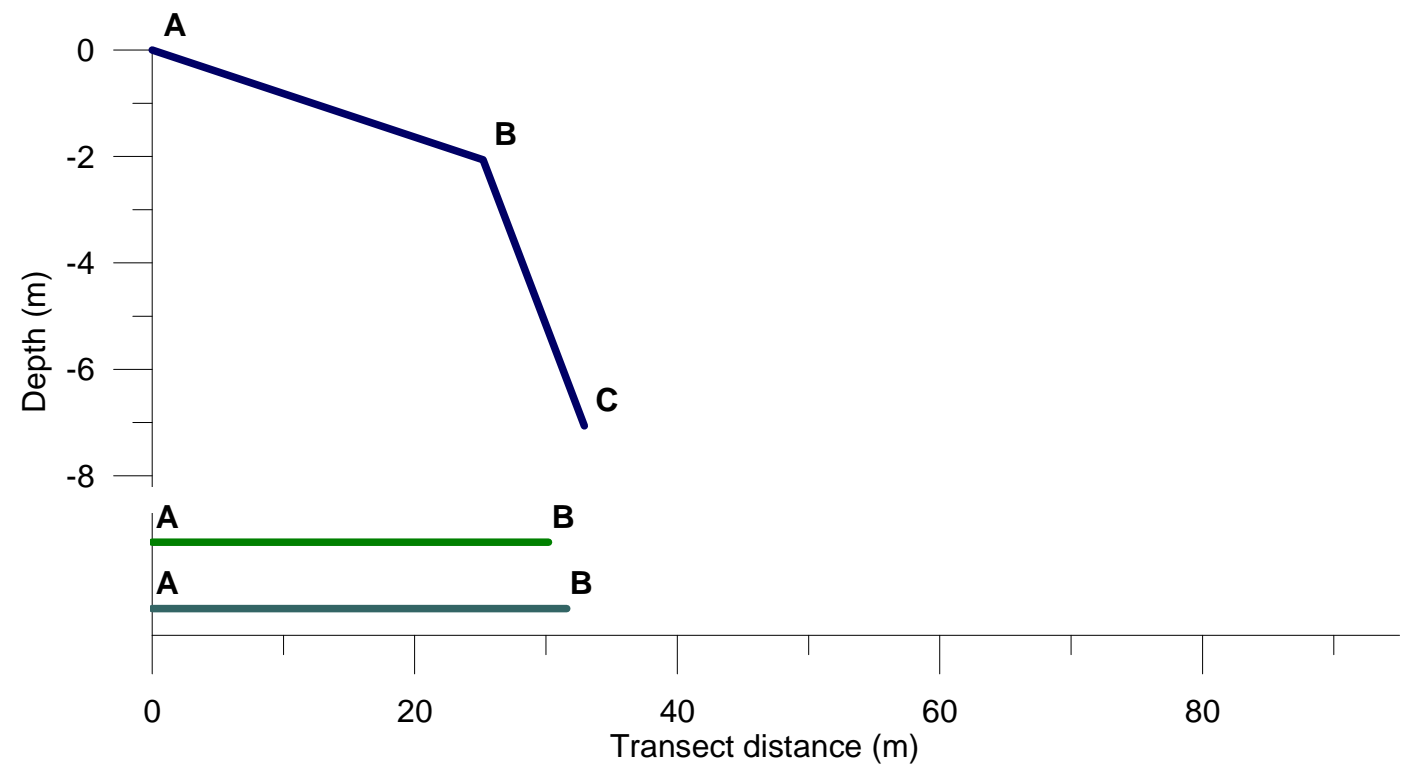
T3	Section	Habitat Value	Depth	Slope	Ice Scour	Substrate	Morphology	Complex
2009 Ground	A-B	M	S	F	Y	B	P	M
	B-C	H	M	S	N	B	P	M
	C-D							
	D-E							
	E-F							
2006 Air	A-B	M	S	F	Y	BS	P	C
	B-C	-	-	-	-	-	-	-
	C-D							
2009 Air	A-B	M	S	F	Y	B	P	C
	B-C	-	-	-	-	-	-	-
	C-D							
	D-E

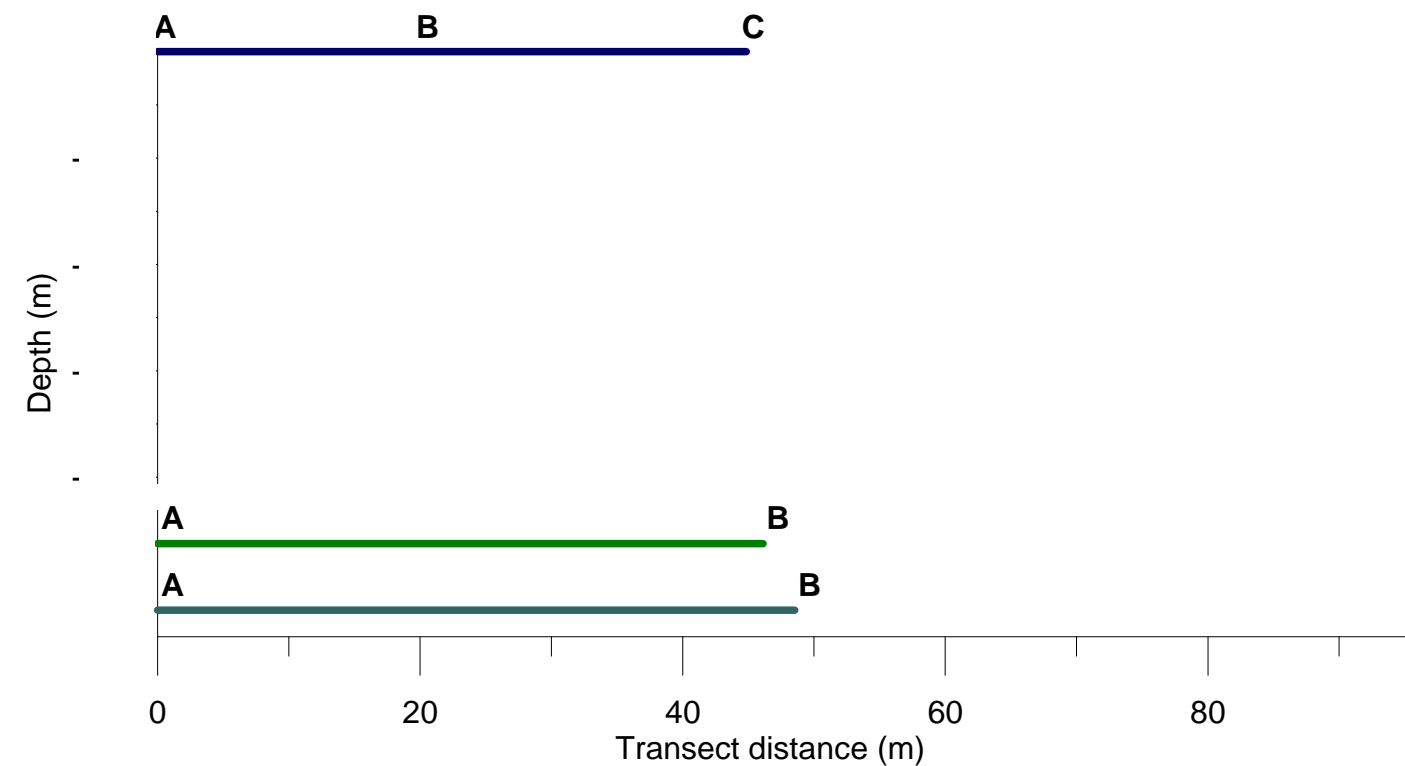
T5*

T5	Section	Habitat Value	Depth	Slope	Ice Scour	Substrate	Morphology	Complex
2009 Ground	A-B	M	S	F	Y	B	P	C
	B-C	H	D	S	N	B	A	C
	C-D							
	D-E							
	E-F							
2006 Air	A-B	M	S	F	Y	BS	P	C
	B-C	-	-	-	-	-	-	-
	C-D							
2009 Air	A-B	M	S	F	Y	B	P	C
	B-C	-	-	-	-	-	-	-
	C-D							
	D-E

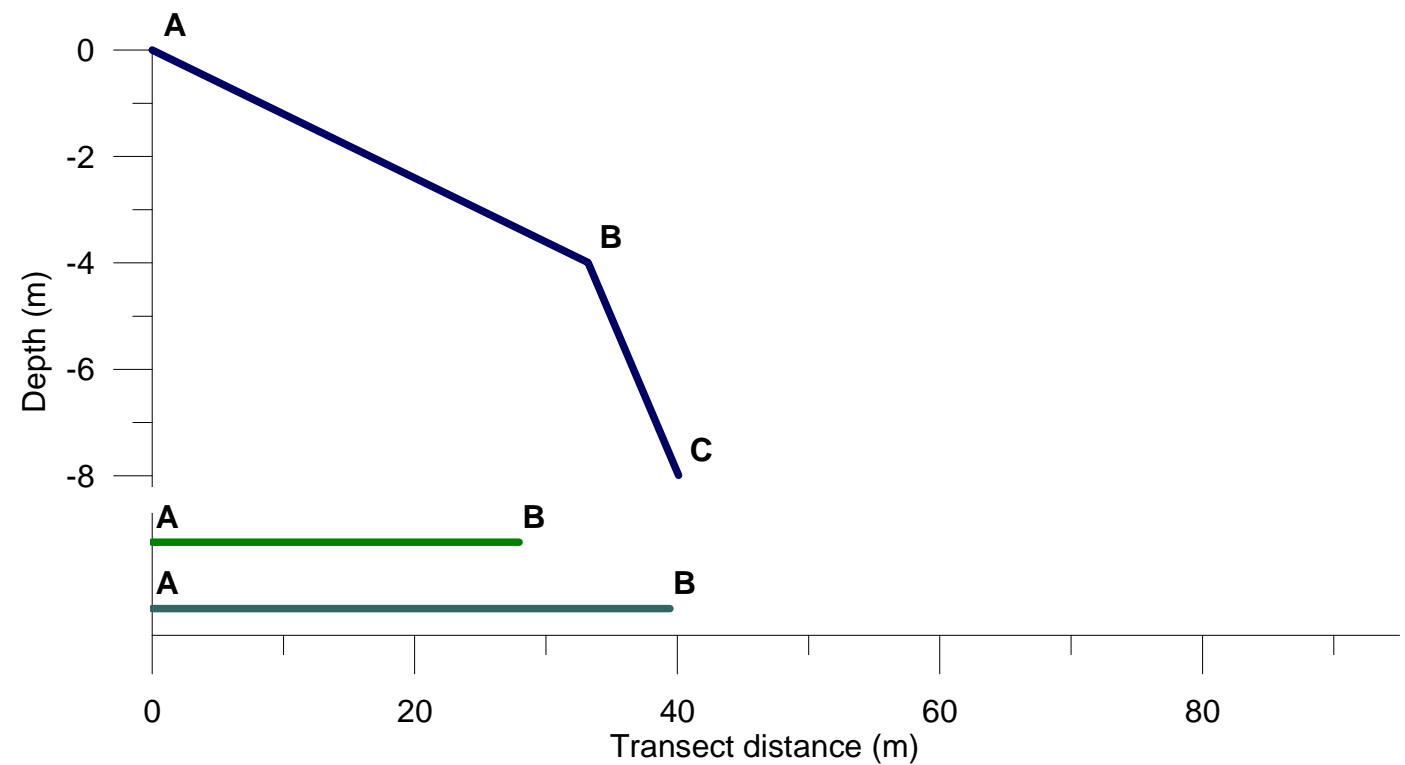
T6	Section	Habitat Value	Depth	Slope	Ice Scour	Substrate	Morphology	Complex
2009 Ground	A-B	M	S	F	Y	B	P	C
	B-C	H	M	S	N	B	P	C
	C-D							
	D-E							
	E-F							
2006 Air	A-B	M	S	F	Y	BS	P	C
	B-C	-	-	-	-	-	-	-
	C-D							
2009 Air	A-B	M	S	F	Y	B	P	C
	B-C	-	-	-	-	-	-	-
	C-D							
	D-E

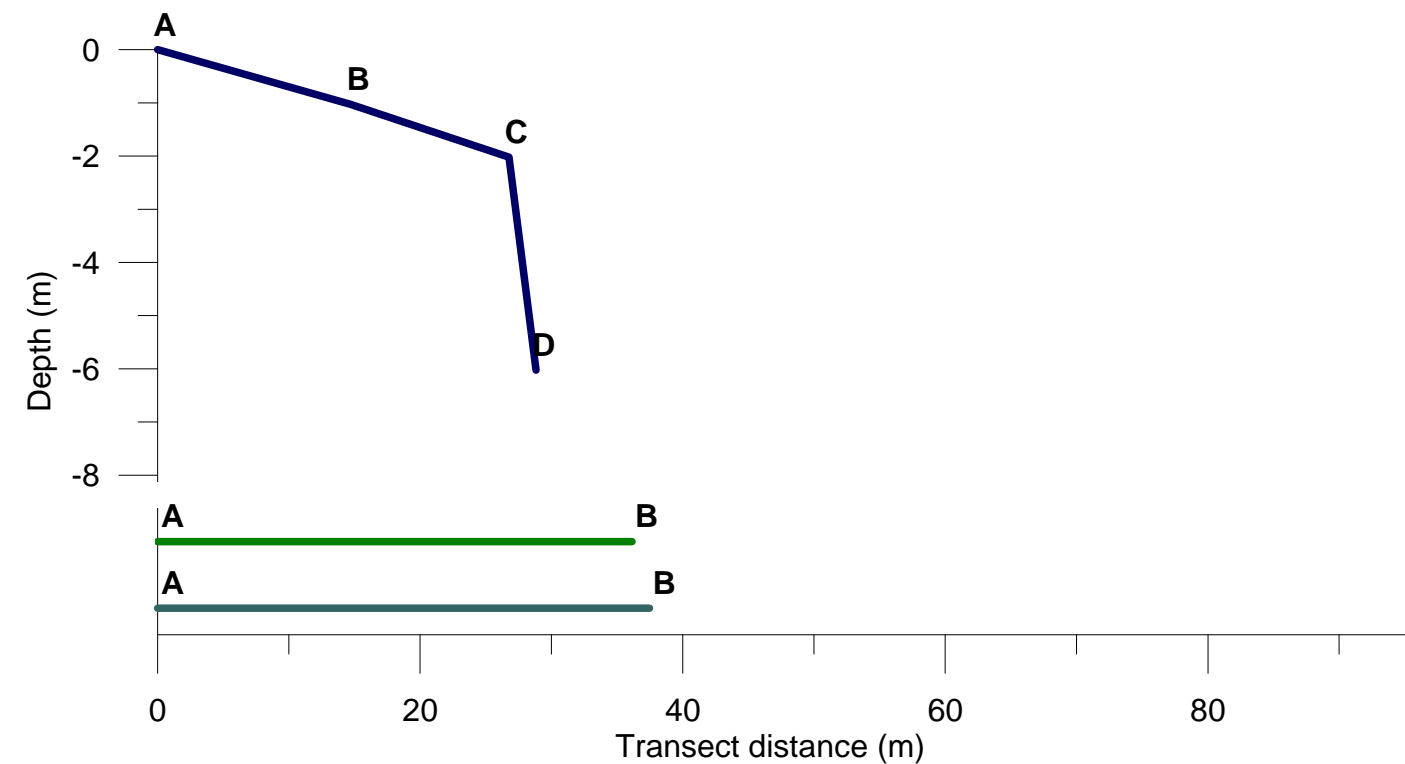
T7	Section	Habitat Value	Depth	Slope	Ice Scour	Substrate	Morphology	Complex
2009 Ground	A-B	M	S	F	Y	BS	P	C
	B-C	M	S	F	Y	B	P	C
	C-D	H	M	S	N	BS	A	C
	D-E							
	E-F							
2006 Air	A-B	M	S	F	Y	BS	P	C
	B-C	-	-	-	-	-	-	-
	C-D							
2009 Air	A-B	M	S	F	Y	B	P	C
	B-C	-	-	-	-	-	-	-
	C-D							
	D-E
