**Aquatic Effects Monitoring Program – Addendum to the
2008 Fish-Out of the Northwest Arm of Second Portage
Lake:**

**Habitat Mapping of the Northwest Arm of Second Portage
Lake 2009, Meadowbank Gold Project, April 2010**

Meadowbank Gold Project

Project No. AE-09-01.3

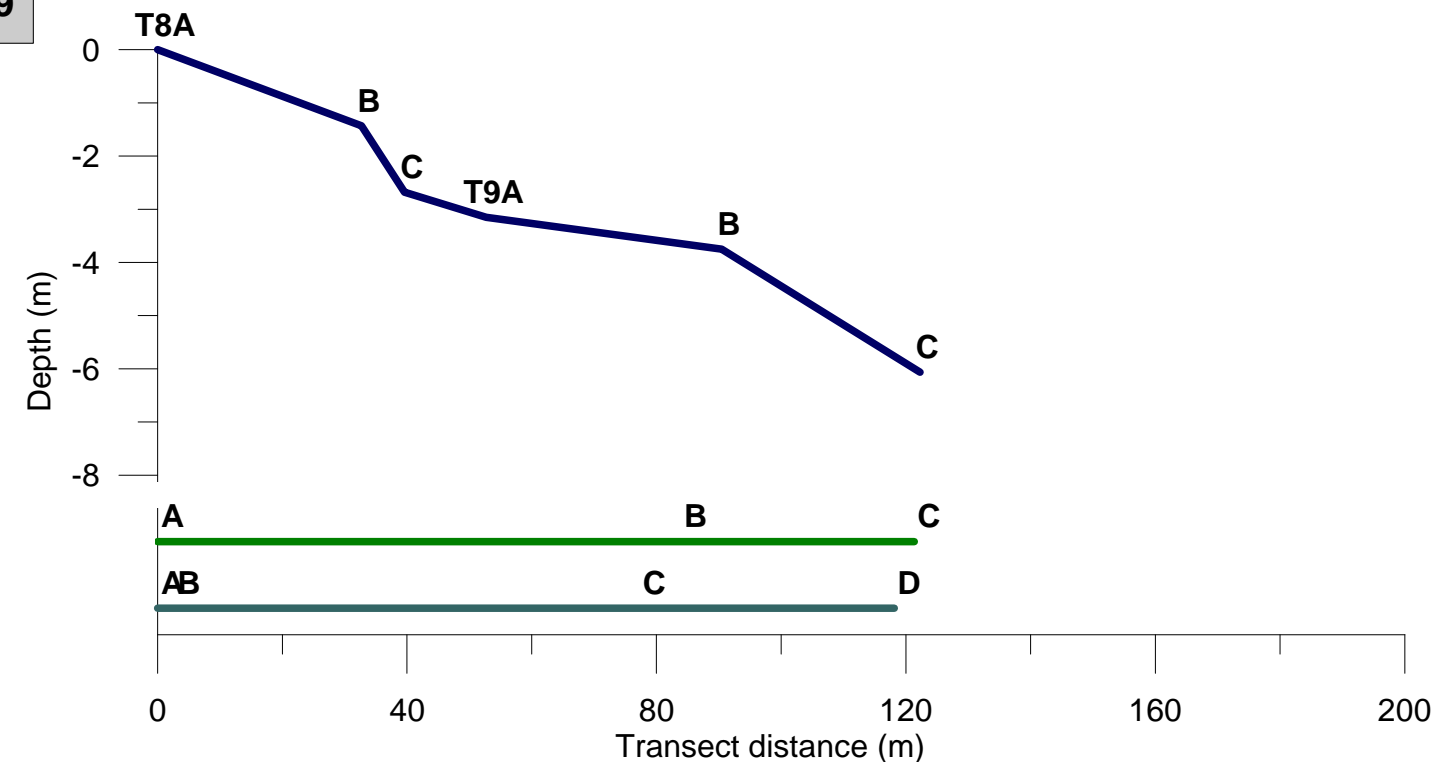
T8&9

T8 & 9	Section	Habitat Value	Depth	Slope	Ice Scour	Substrate	Morphology	Complex
2009 Ground	A-B	H	S	F	Y	BS	P	C
	B-C	H	M	S	Y	B	A	C
	A-B	L	M	S	N	SB	SB	U
	B-C	H	M	F	N	BS	S	M
	C-D	M	M	F	N	SB	S	M
2006 Air	A-B	H	M	M	N	SB	S	M
	B-C	M	S	F	Y	BS	P	C
	C-D	-	-	-	-	-	-	-
2009 Air	A-B	L	VD	F	N	F	SB	U
	B-C	H	M	F	N	BS	S	M
	C-D	M	S	F	Y	B	P	C
	D-E	-	-	-	-	-	-	-

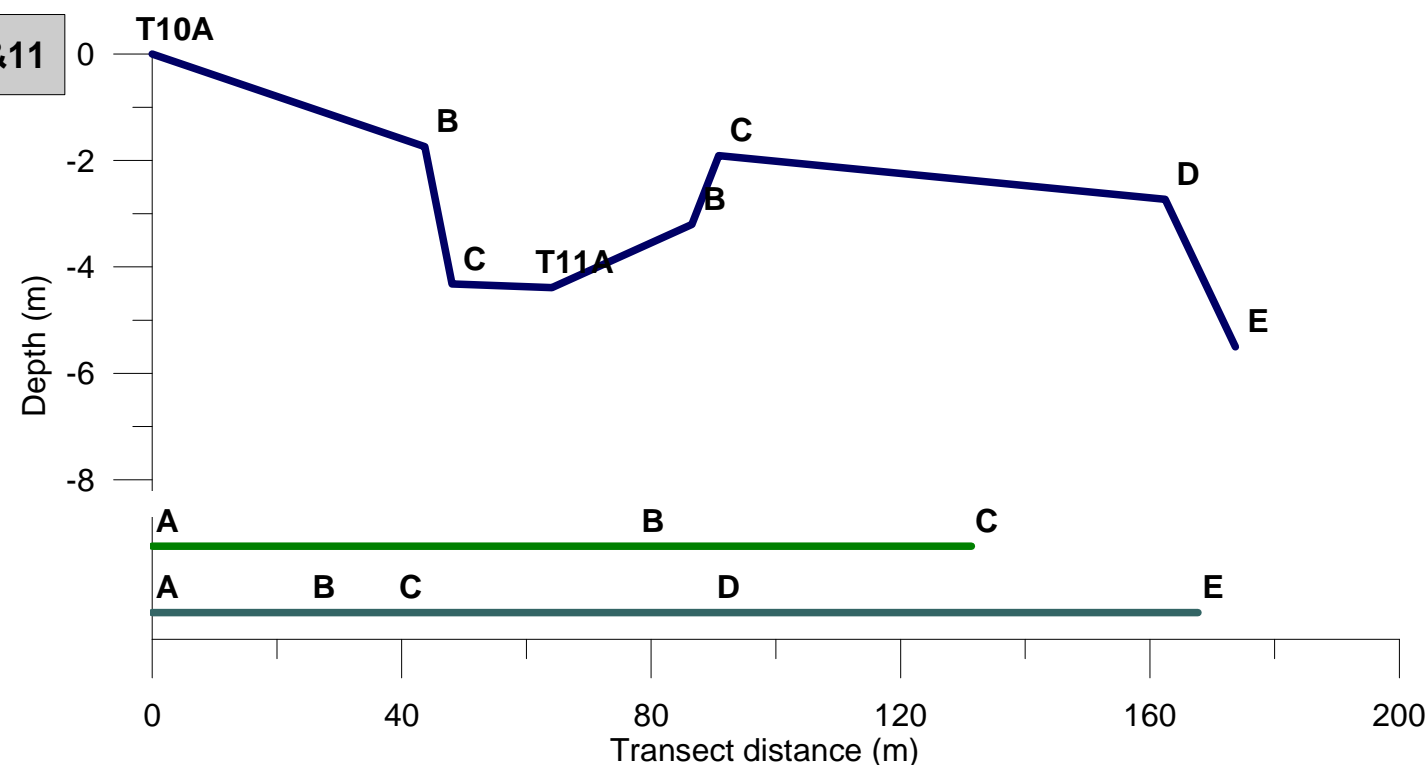
T10&11

T10 & 11	Section	Habitat Value	Depth	Slope	Ice Scour	Substrate	Morphology	Complex
2009 Ground	A-B	M	S	F	Y	BS	P	M
	B-C	H	M	S	N	BS	P	C
	A-B	L	M	F	N	SB	SB	U
	B-C	M	M	S	N	SB	S	M
	C-D	H	M	S	N	B	S	C
	D-E	H	M	F	N	B	S	C
	E-F	H	M	S	N	BS	S	M
2006 Air	A-B	H	M	M	N	BS	S	C
	B-C	H	M	M	N	SB	S	M
	C-D	M	S	F	Y	BS	P	C
2009 Air	A-B	M	M	F	N	SB	P	M
	B-C	L	D	F	N	F	SB	U
	C-D	M	S	F	Y	B	P	C
	D-E	H	M	S	N	BS	S	M

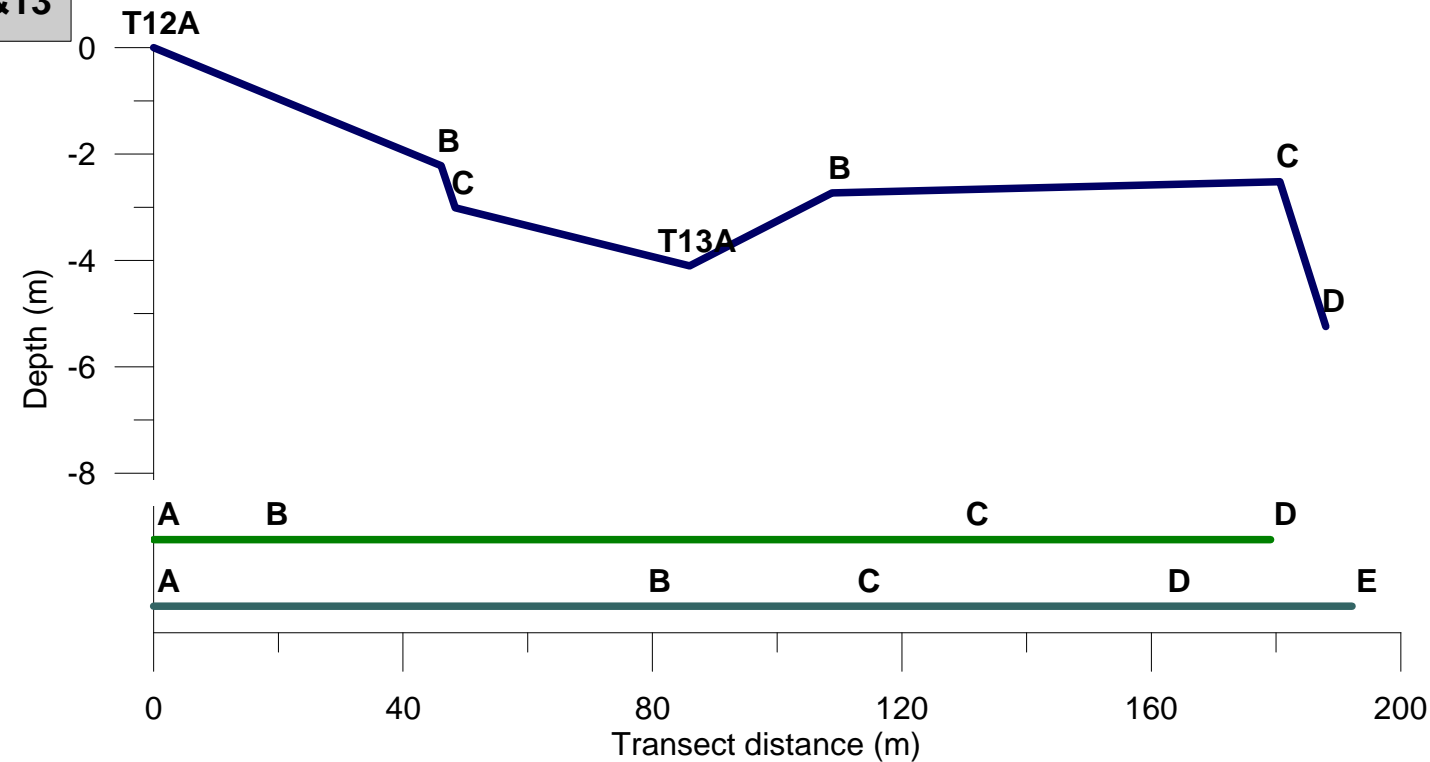
T12&13

T12 & 13	Section	Hab Value	Depth	Slope	Ice Scour	Substrate	Morphology	Complex
2009 Ground	A-B	M	S	F	Y	B	P	M
	B-C	H	M	S	N	B	P	M
	C-D	L	M	F	N	SB	SB	U
	D-E	H	M	F	N	SB	S	C
	E-F	H	M	F	N	SB	S	C
	F-G	M	M	S	N	SB	S	M
2006 Air	A-B	H	M	M	N	BS	S	C
	B-C	H	M	M	N	SB	S	M
	C-D	M	S	F	Y	BS	P	C
2009 Air	A-B	M	M	F	N	SB	P	M
	B-C	L	D	F	N	F	SB	U
	C-D	M	S	F	Y	B	P	C
	D-E	L	D	F	N	F	SB	U

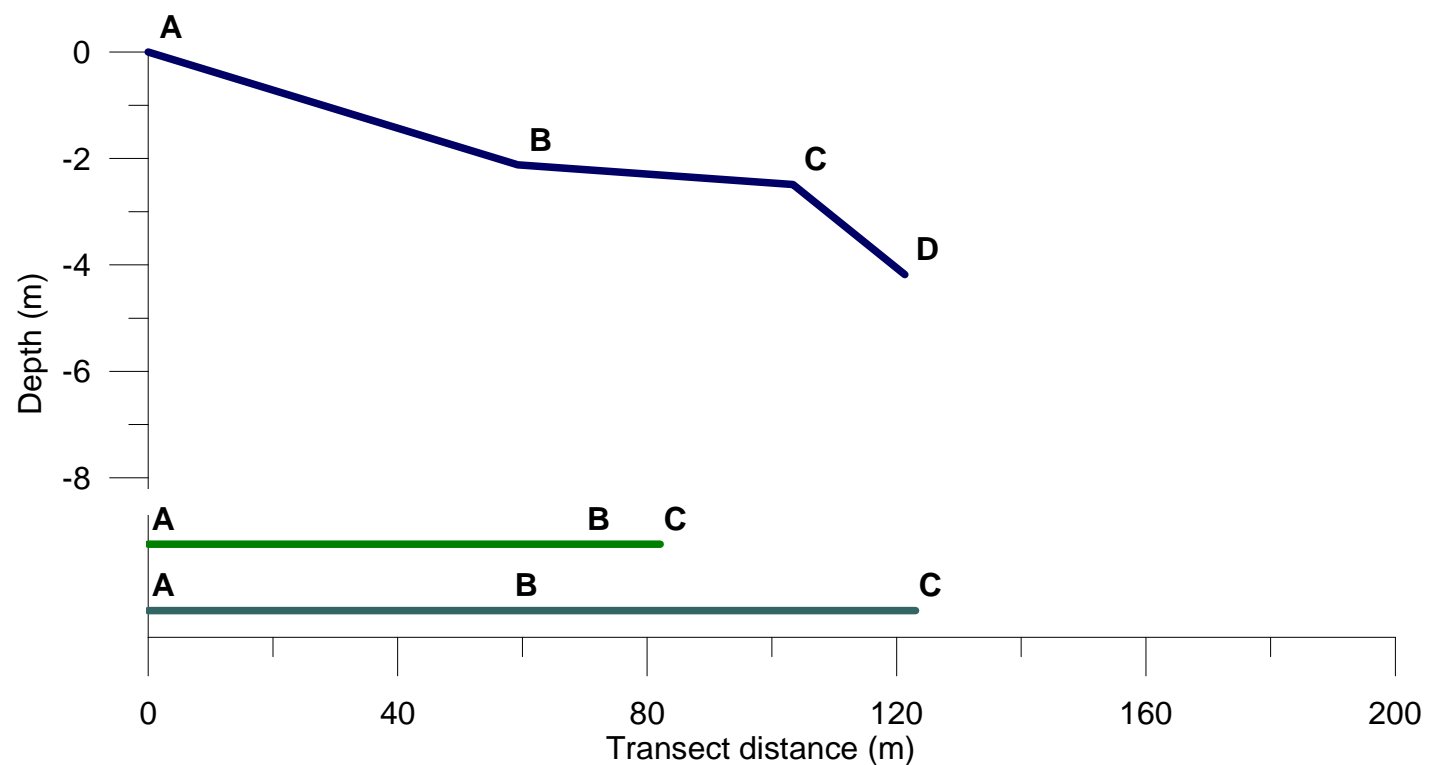
T14	Section	Habitat Value	Depth	Slope	Ice Scour	Substrate	Morphology	Complex
2009 Ground	A-B	M	S	F	Y	BS	P	M
	B-C	H	M	F	N	SB	P	C
	C-D	M	M	S	N	S	P	M
	D-E							
	E-F							
2006 Air	A-B	H	M	M	N	SB	S	M
	B-C	H	M	M	N	SB	S	M
	C-D	M	S	F	Y	BS	P	C
2009 Air	A-B	M	M	F	N	SB	P	M
	B-C	M	S	F	Y	B	P	C
	C-D	-	-	-	-	-	-	-
	D-E

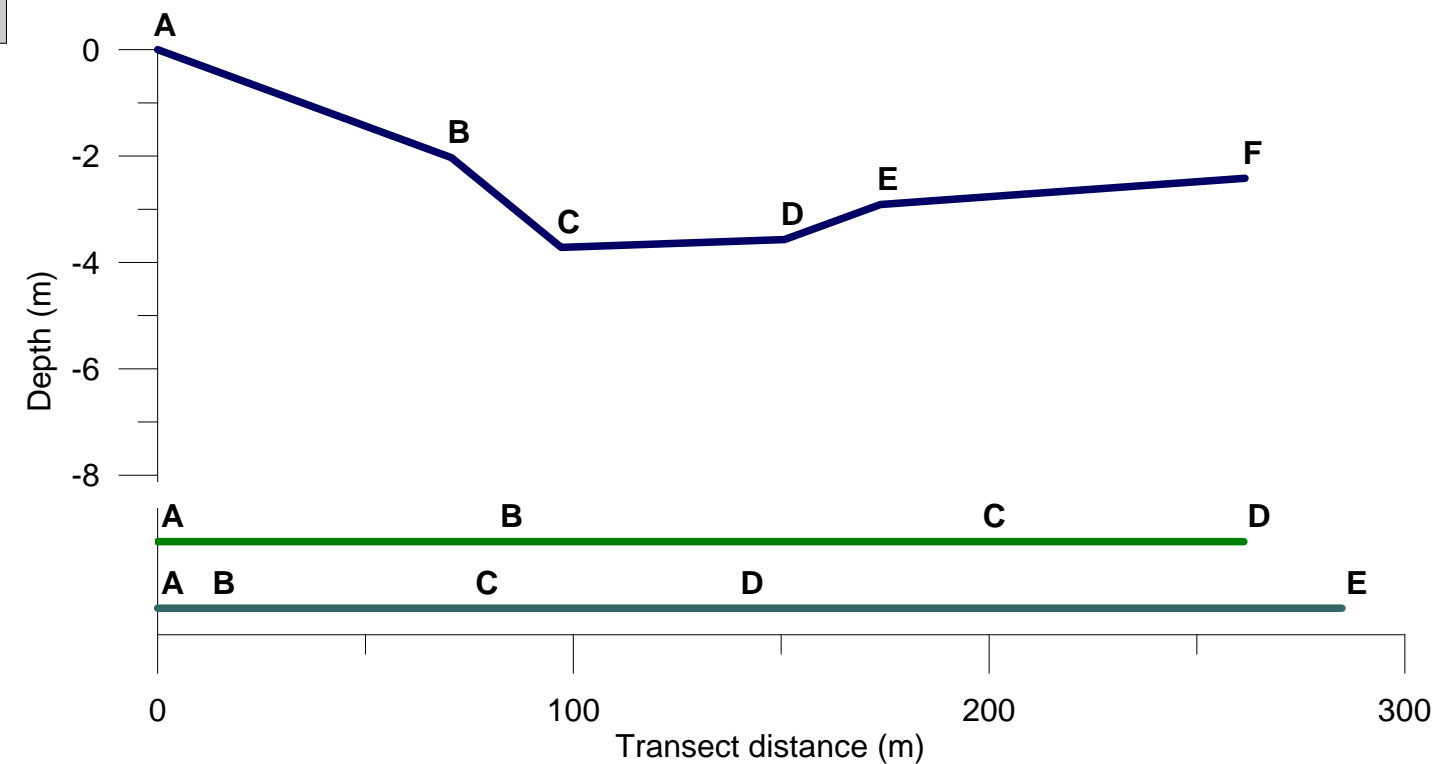
T15	Section	Habitat Value	Depth	Slope	Ice Scour	Substrate	Morphology	Complex
2009 Ground	A-B	M	S	F	Y	B	P	M
	B-C	H	M	F	N	BS	P	M
	C-D	M	M	F	N	S	S	U
	D-E	M	M	F	N	SB	S	U
	E-F	H	M	F	N	BS	S	C
2006 Air	A-B	M	S	F	Y	BS	S	C
	B-C	H	M	M	N	SB	S	M
	C-D	M	S	F	Y	BS	P	C
2009 Air	A-B	L	VD	F	N	F	SB	U
	B-C	M	M	F	N	SB	P	M
	C-D	M	S	F	Y	B	P	C
	D-E	M	M	F	N	SB	S	M

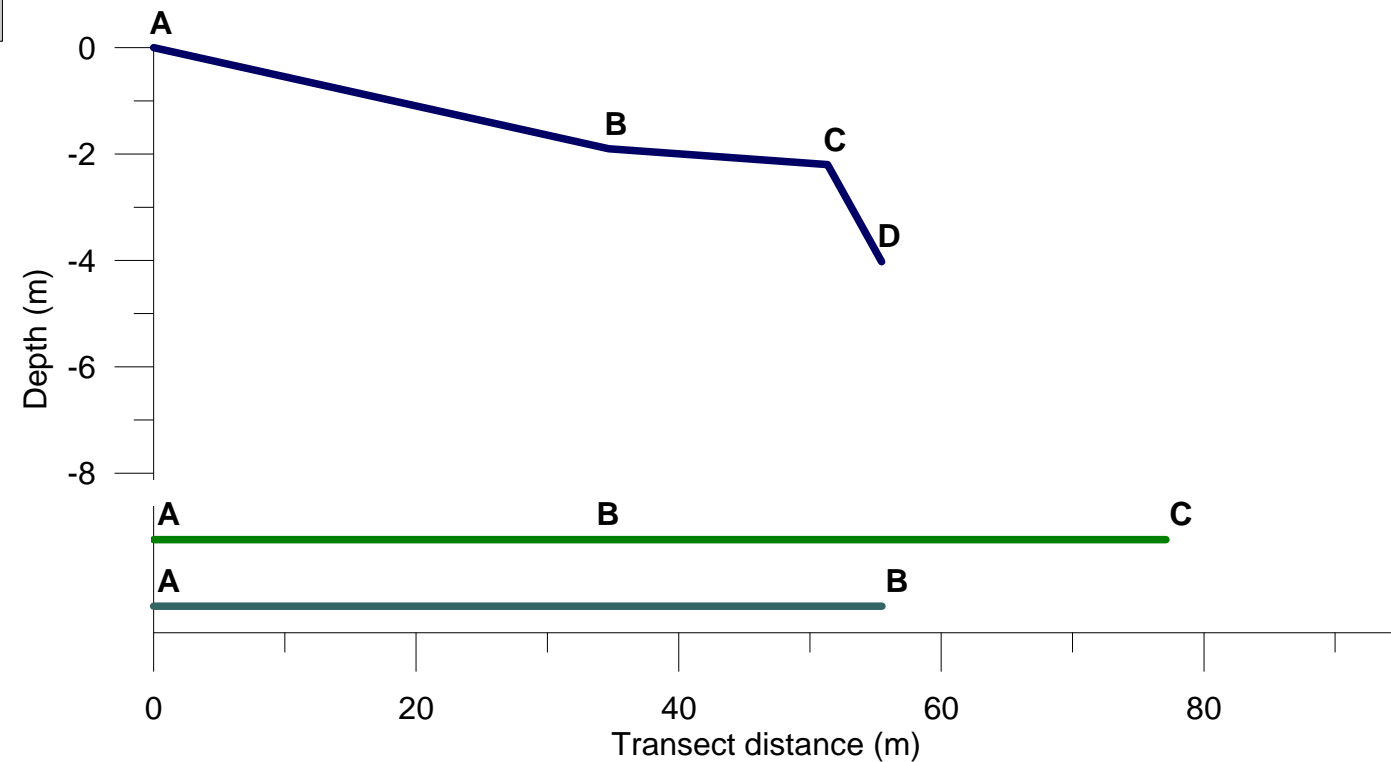
T16	Section	Habitat Value	Depth	Slope	Ice Scour	Substrate	Morphology	Complex
2009 Ground	A-B	M	S	F	Y	B	P	M
	B-C	H	M	F	N	BS	P	C
	C-D	H	M	S	N	BS	P	C
	D-E							
	E-F							
2006 Air	A-B	H	M	M	N	SB	S	M
	B-C	M	S	F	Y	BS	P	C
	C-D	-	-	-	-	-	-	-
2009 Air	A-B	M	S	F	Y	B	P	C
	B-C	-	-	-	-	-	-	-
	C-D							
	D-E

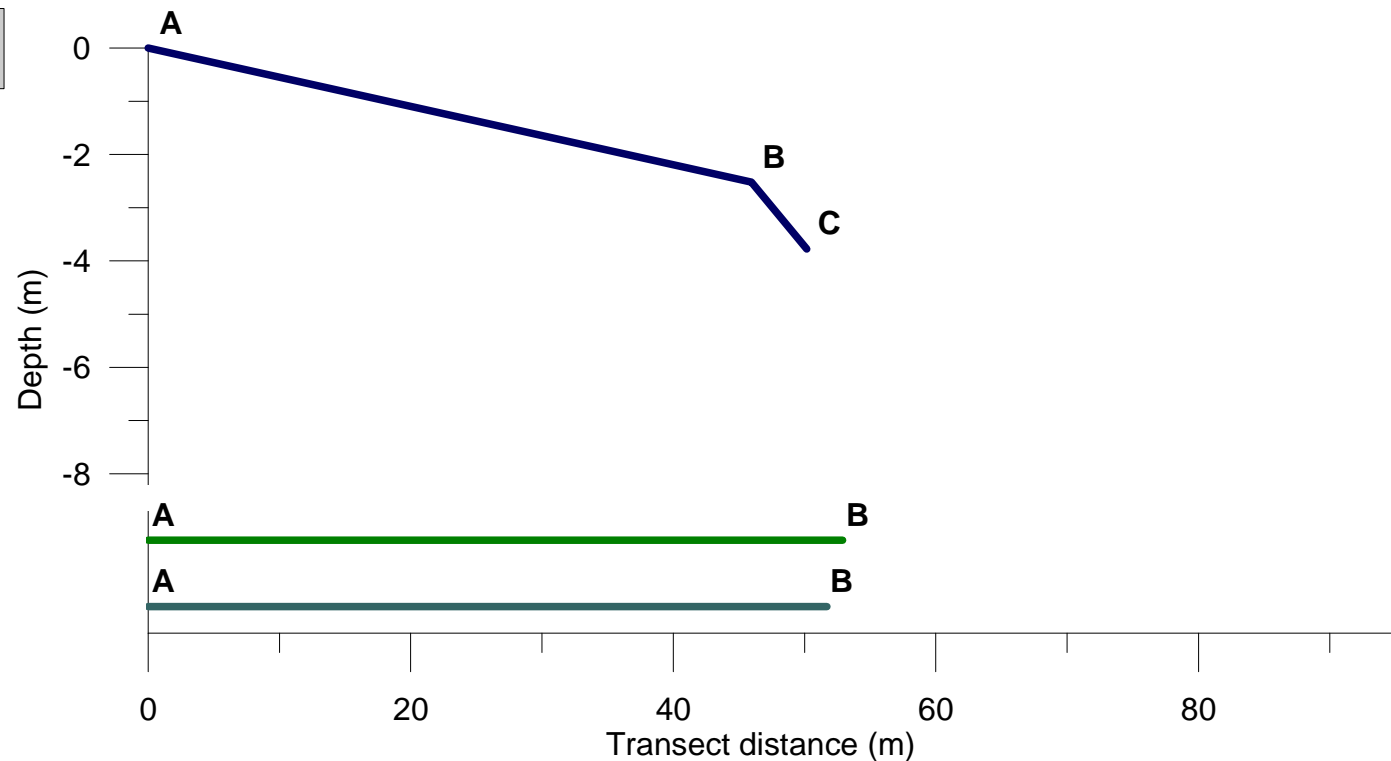
T17	Section	Habitat Value	Depth	Slope	Ice Scour	Substrate	Morphology	Complex
2009 Ground	A-B	M	S	F	Y	B	P	M
	B-C	H	M	S	N	B	P	M
	C-D							
	D-E							
	E-F							
2006 Air	A-B	M	S	F	Y	BS	P	C
	B-C	-	-	-	-	-	-	-
	C-D							
2009 Air	A-B	M	S	F	Y	B	P	C
	B-C	-	-	-	-	-	-	-
	C-D							
	D-E

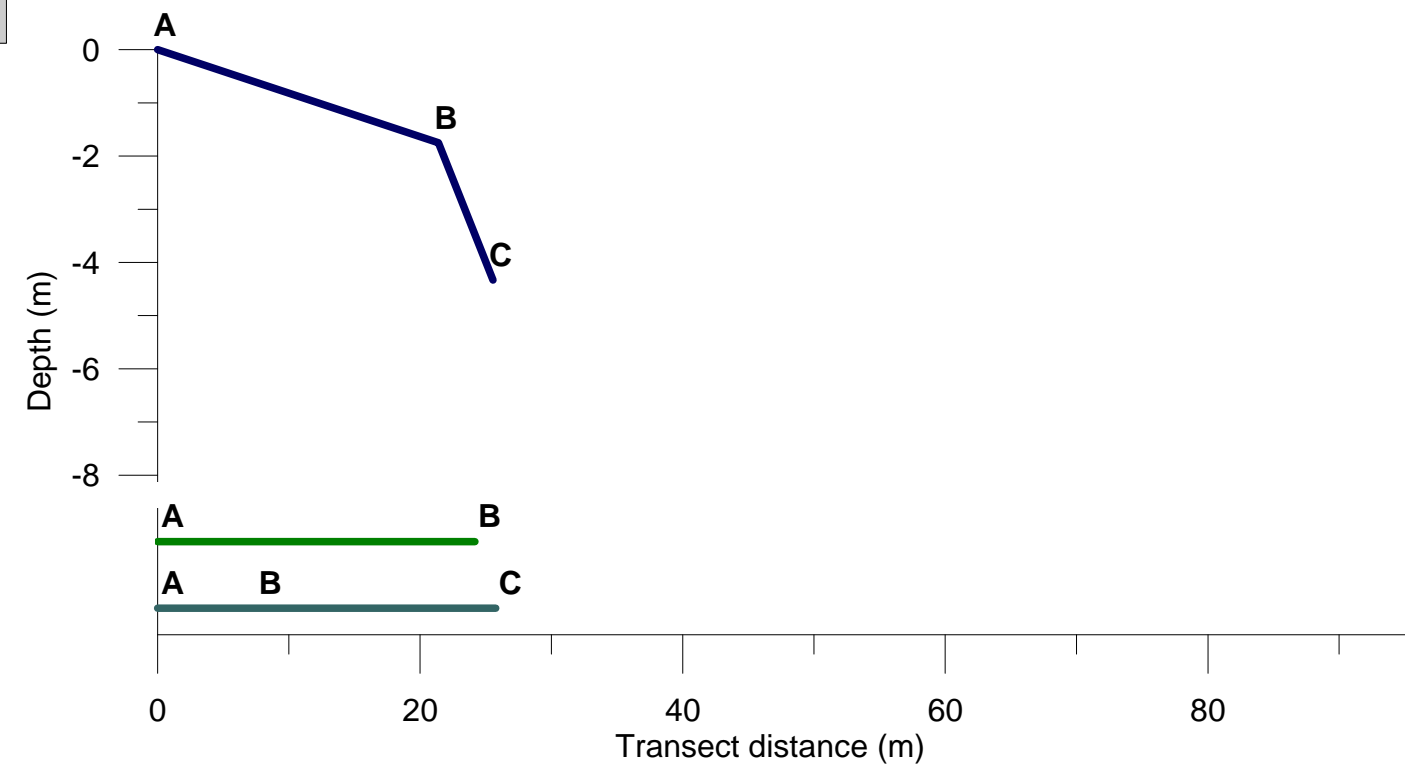
T18	Section	Habitat Value	Depth	Slope	Ice Scour	Substrate	Morphology	Complex
2009 Ground	A-B	M	S	F	Y	B	P	M
	B-C	H	M	S	N	BS	P	C
	C-D							
	D-E							
	E-F							
2006 Air	A-B	M	S	F	Y	BS	P	C
	B-C	-	-	-	-	-	-	-
	C-D							
2009 Air	A-B	M	M	F	N	SB	P	M
	B-C	M	S	F	Y	B	P	C
	C-D	-	-	-	-	-	-	-
	D-E

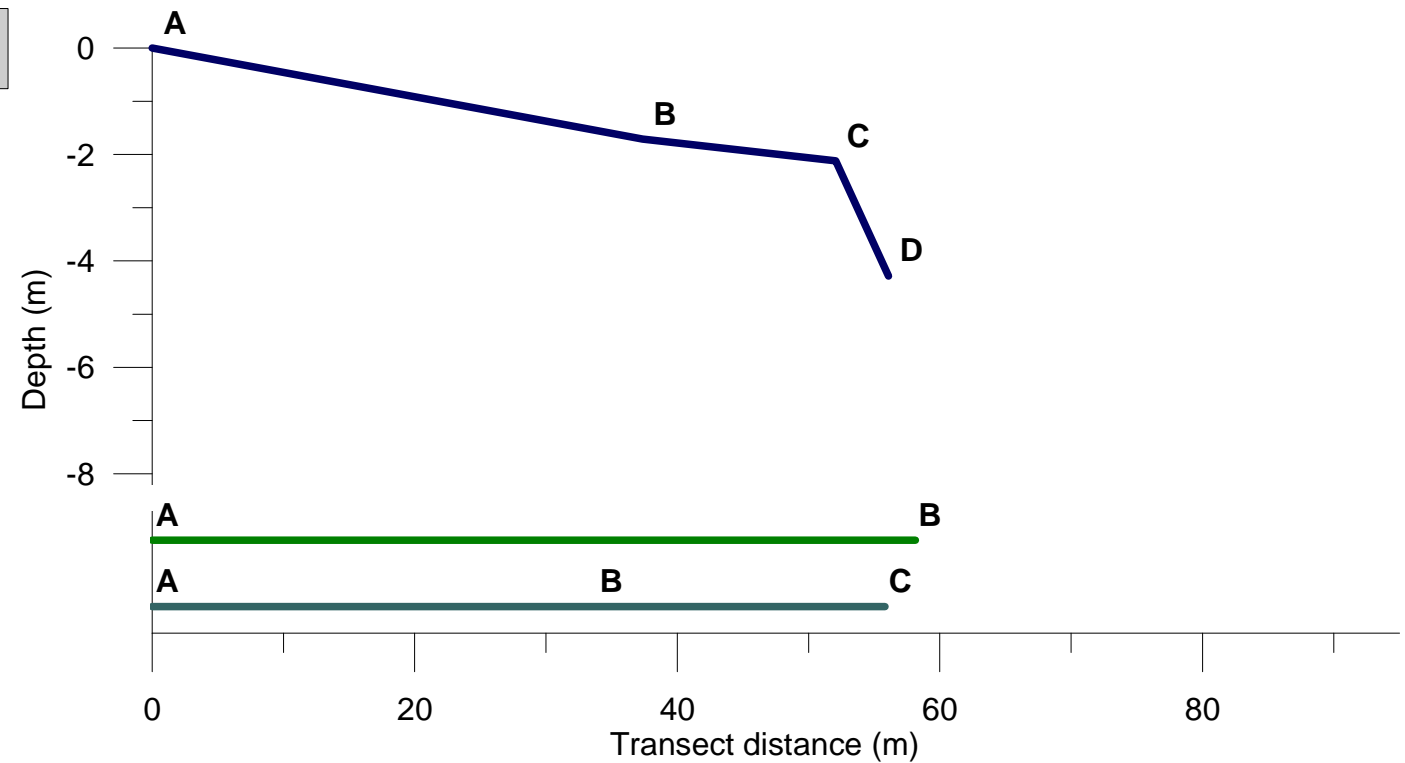
T19	Section	Habitat Value	Depth	Slope	Ice Scour	Substrate	Morphology	Complex
2009 Ground	A-B	M	S	F	Y	BS	P	C
	B-C	M	S	F	Y	BS	P	C
	C-D	H	M	S	N	BS	P	C
	D-E							
	E-F							
2006 Air	A-B	M	S	F	Y	BS	P	C
	B-C	-	-	-	-	-	-	-
	C-D							
2009 Air	A-B	M	S	F	Y	B	P	C
	B-C	M	M	F	N	SB	P	M
	C-D	-	-	-	-	-	-	-
	D-E

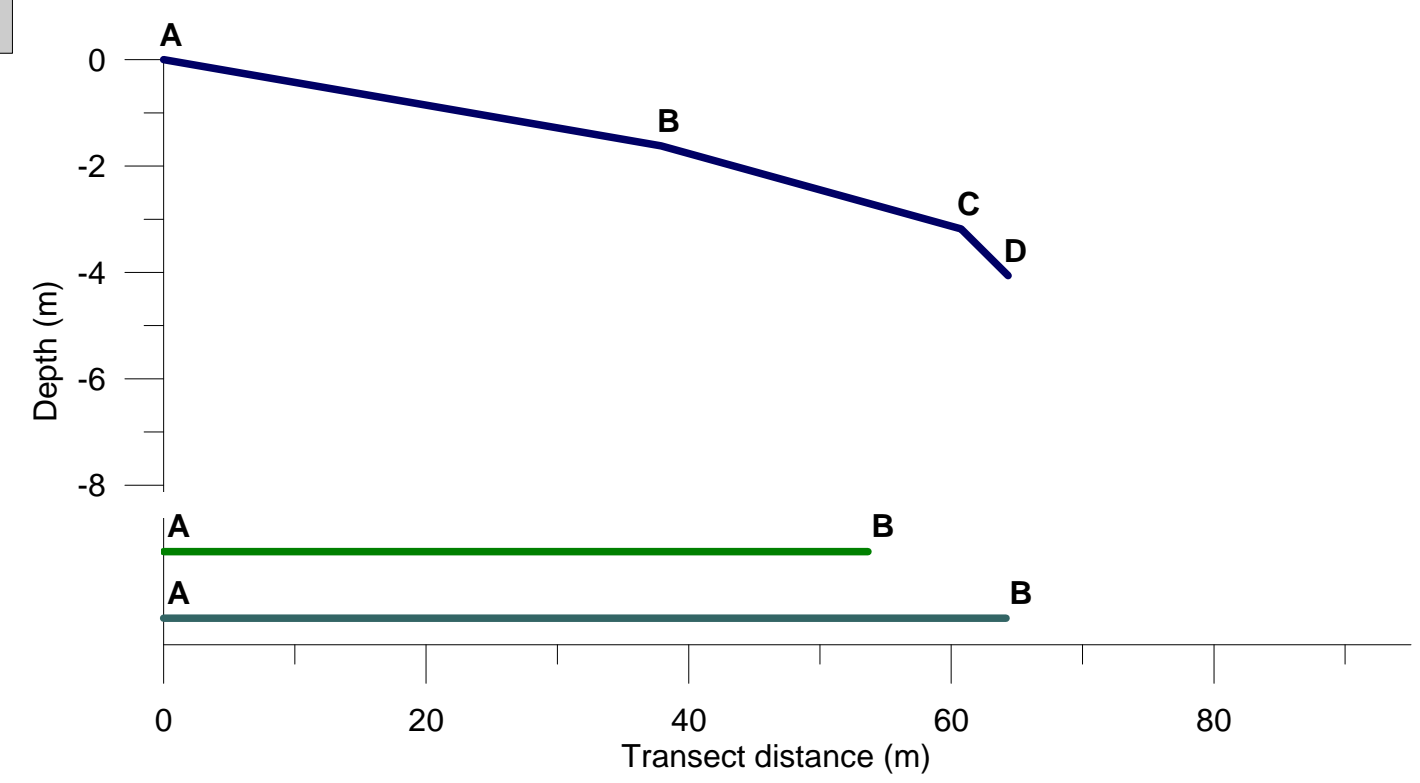
T20	Section	Habitat Value	Depth	Slope	Ice Scour	Substrate	Morphology	Complex
2009 Ground	A-B	M	S	F	Y	B	P	M
	B-C	H	M	F	N	BS	P	C
	C-D	H	M	S	N	BS	P	C
	D-E							
	E-F							
2006 Air	A-B	M	S	F	Y	BS	P	C
	B-C	-	-	-	-	-	-	-
	C-D							
2009 Air	A-B	M	S	F	Y	B	P	C
	B-C	-	-	-	-	-	-	-
	C-D							
	D-E

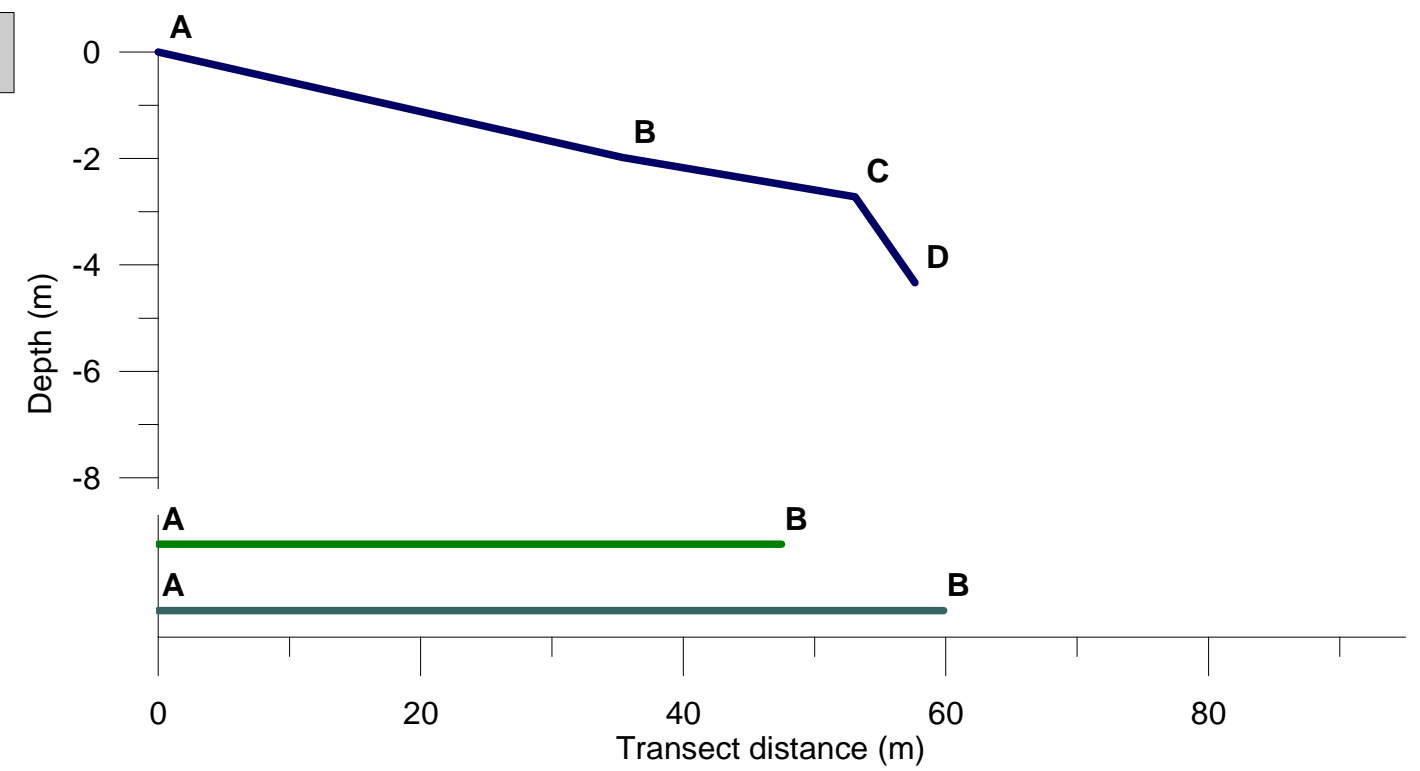
T21	Section	Habitat Value	Depth	Slope	Ice Scour	Substrate	Morphology	Complex
2009 Ground	A-B	M	S	F	Y	B	P	M
	B-C	H	M	F	N	BS	P	M
	C-D	H	M	S	N	B	P	M
	D-E							
	E-F							
2006 Air	A-B	M	S	F	Y	BS	P	C
	B-C	-	-	-	-	-	-	-
	C-D							
2009 Air	A-B	M	S	F	Y	B	P	C
	B-C	-	-	-	-	-	-	-
	C-D							
	D-E

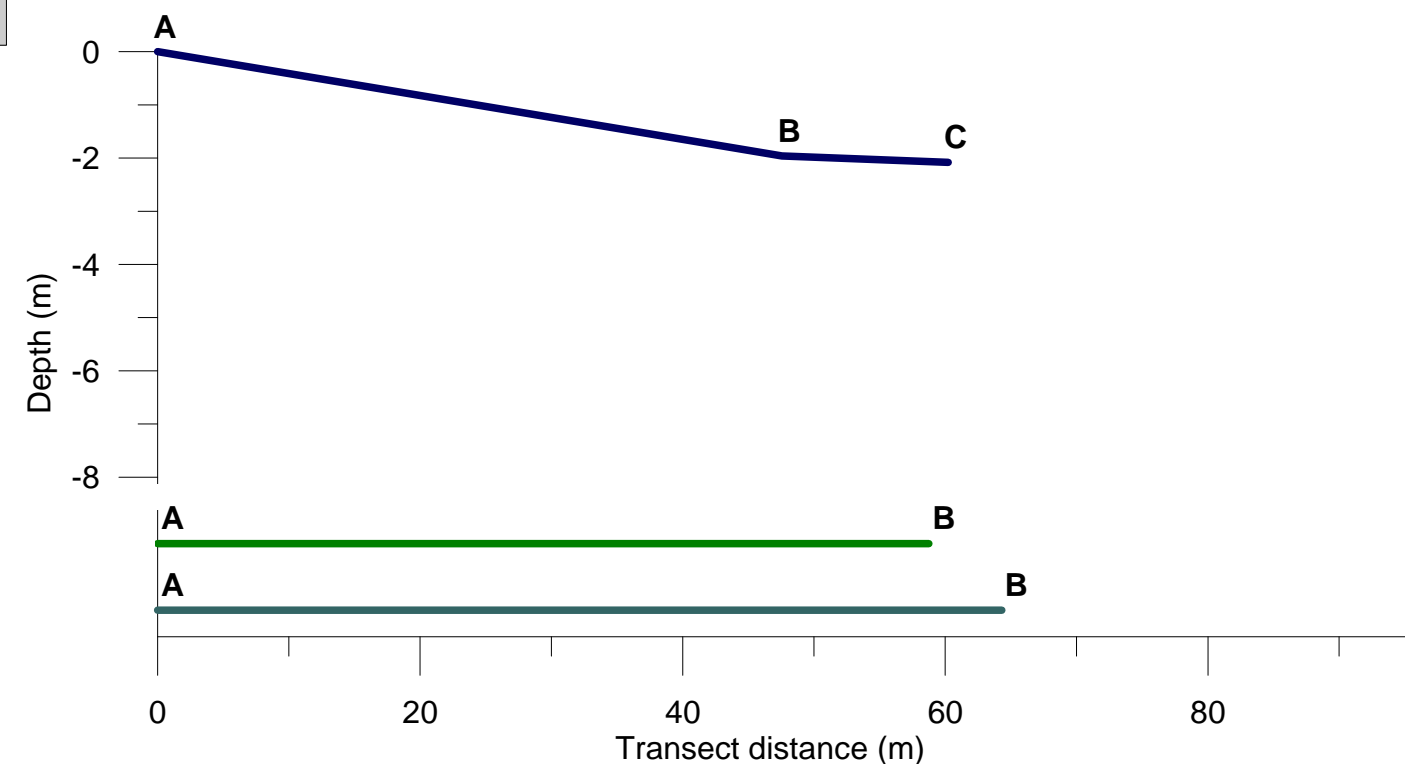
T22	Section	Habitat Value	Depth	Slope	Ice Scour	Substrate	Morphology	Complex
2009 Ground	A-B	M	S	F	Y	B	P	M
	B-C	M	S	F	Y	B	P	M
	C-D	H	M	S	N	B	P	C
	D-E							
	E-F							
2006 Air	A-B	M	S	F	Y	BS	P	C
	B-C	-	-	-	-	-	-	-
	C-D							
2009 Air	A-B	M	S	F	Y	B	P	C
	B-C	-	-	-	-	-	-	-
	C-D							
	D-E

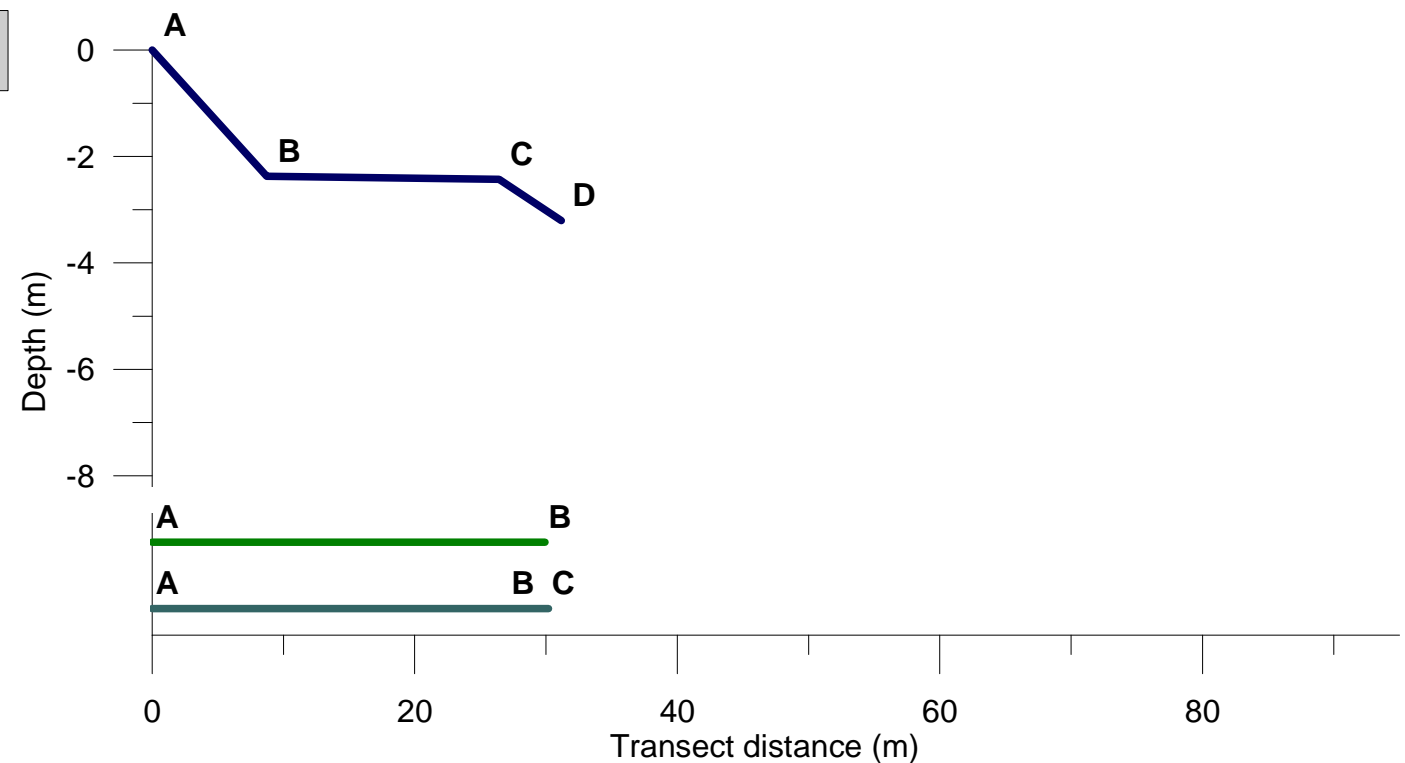
T23	Section	Habitat Value	Depth	Slope	Ice Scour	Substrate	Morphology	Complex
2009 Ground	A-B	L	S	S	Y	S	P	U
	B-C	H	M	F	N	B	P	C
	C-D	H	M	S	N	B	P	C
	D-E							
	E-F							
2006 Air	A-B	M	S	F	Y	BS	P	C
	B-C	-	-	-	-	-	-	-
	C-D							
2009 Air	A-B	M	S	F	Y	B	P	C
	B-C	M	S	S	Y	B	P	C
	C-D	-	-	-	-	-	-	-
	D-E

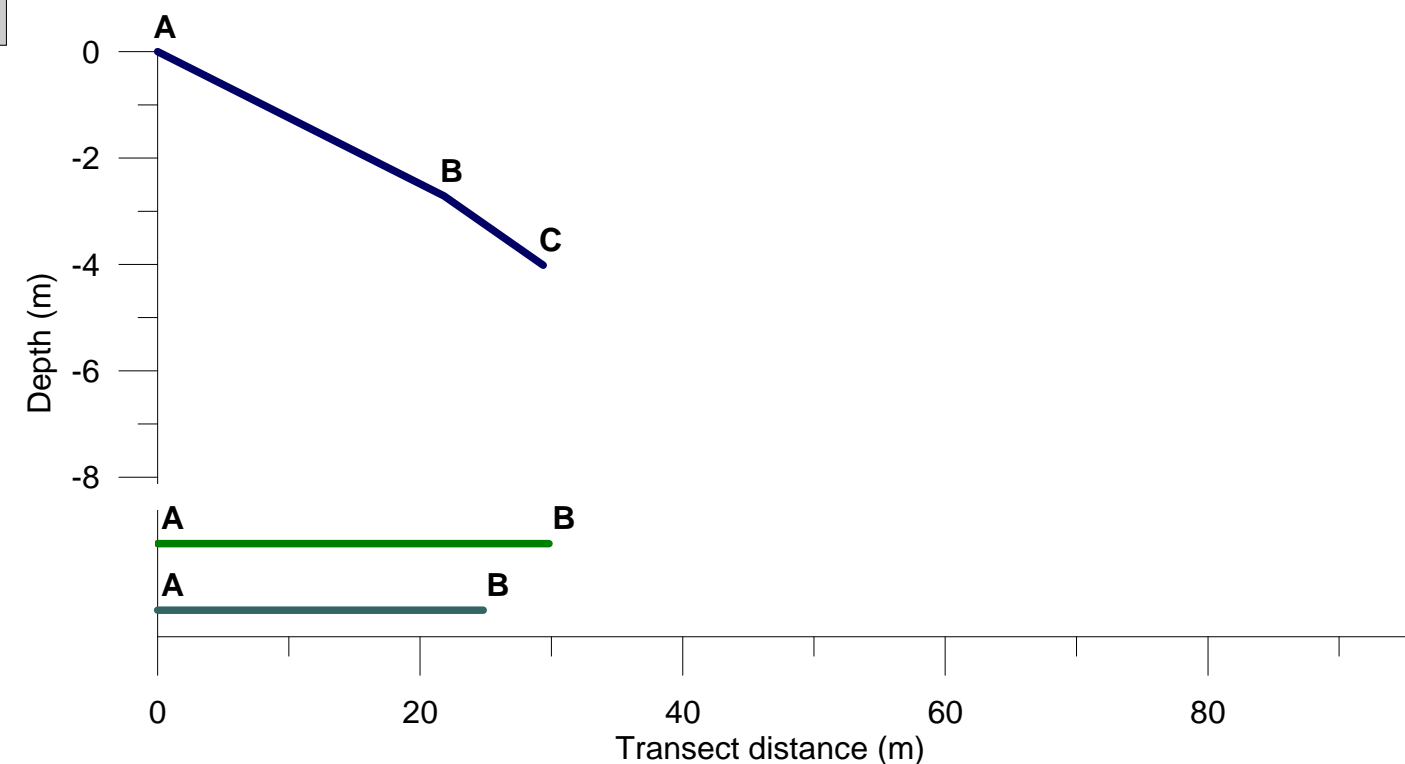
T24	Section	Habitat Value	Depth	Slope	Ice Scour	Substrate	Morphology	Complex
2009 Ground	A-B	L	S	S	Y	S	SB	U
	B-C	H	M	S	N	BS	P	C
	C-D							
	D-E							
	E-F							
2006 Air	A-B	M	S	F	Y	BS	P	C
	B-C	-	-	-	-	-	-	-
	C-D							
2009 Air	A-B	M	S	S	Y	B	P	C
	B-C	-	-	-	-	-	-	-
	C-D							
	D-E

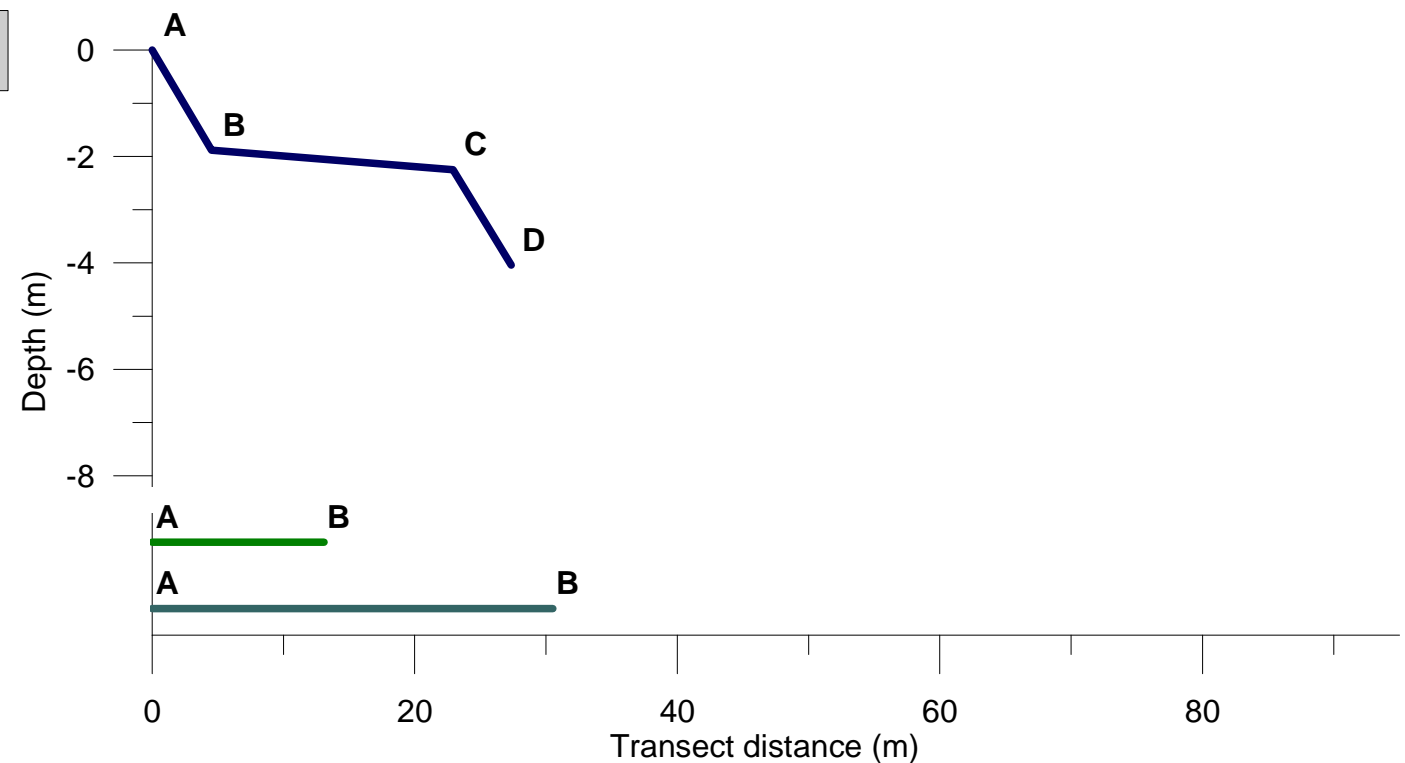
T25	Section	Habitat Value	Depth	Slope	Ice Scour	Substrate	Morphology	Complex
2009 Ground	A-B	L	S	S	Y	S	SB	U
	B-C	H	M	F	N	BS	P	C
	C-D	H	M	S	N	B	P	C
	D-E							
	E-F							
2006 Air	A-B	M	S	F	Y	BS	P	C
	B-C	-	-	-	-	-	-	-
	C-D							
2009 Air	A-B	M	S	F	Y	B	P	C
	B-C	-	-	-	-	-	-	-
	C-D							
	D-E

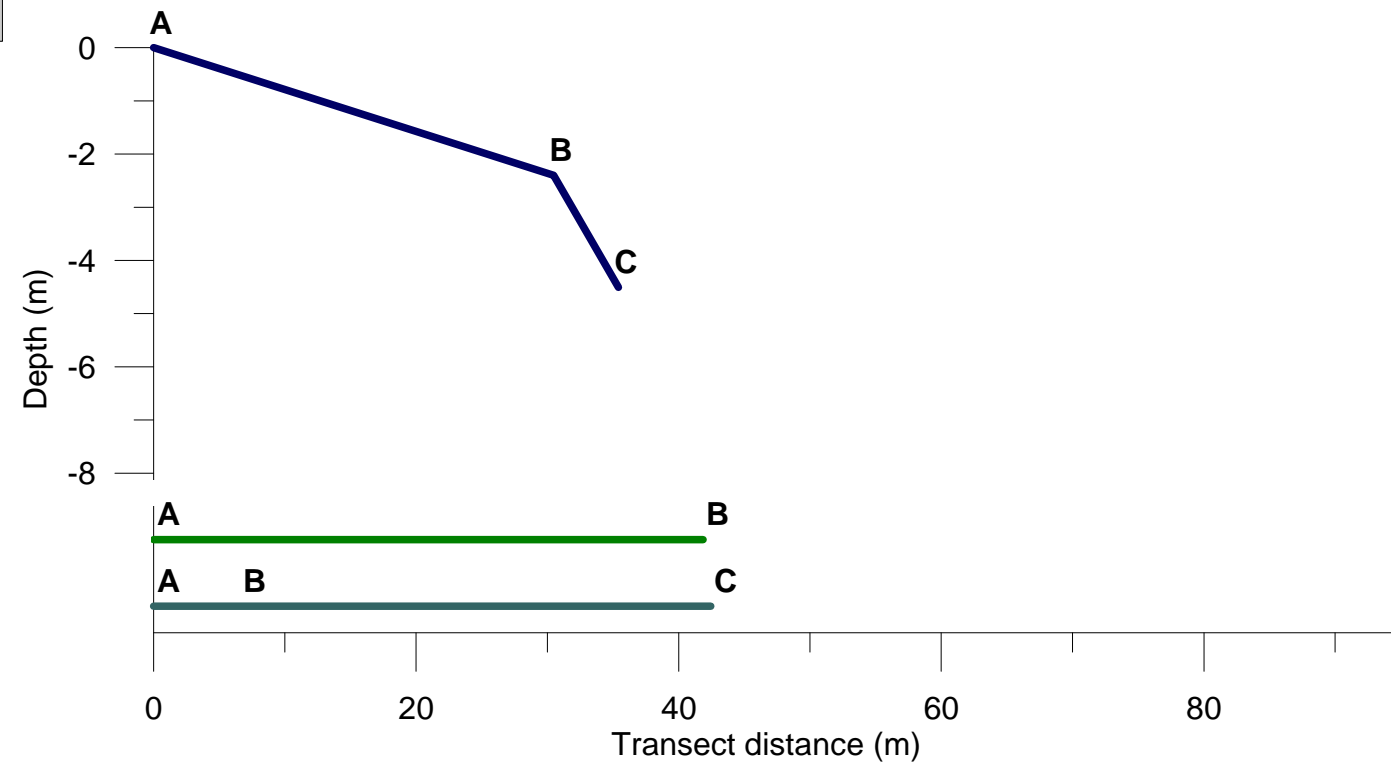
T26	Section	Habitat Value	Depth	Slope	Ice Scour	Substrate	Morphology	Complex
2009 Ground	A-B	M	S	F	Y	B	P	C
	B-C	H	M	S	N	B	P	C
	C-D							
	D-E							
	E-F							
2006 Air	A-B	M	S	F	Y	BS	P	C
	B-C	-	-	-	-	-	-	-
	C-D							
2009 Air	A-B	M	M	F	N	SB	A	M
	B-C	M	S	F	Y	B	P	C
	C-D	-	-	-	-	-	-	-
	D-E

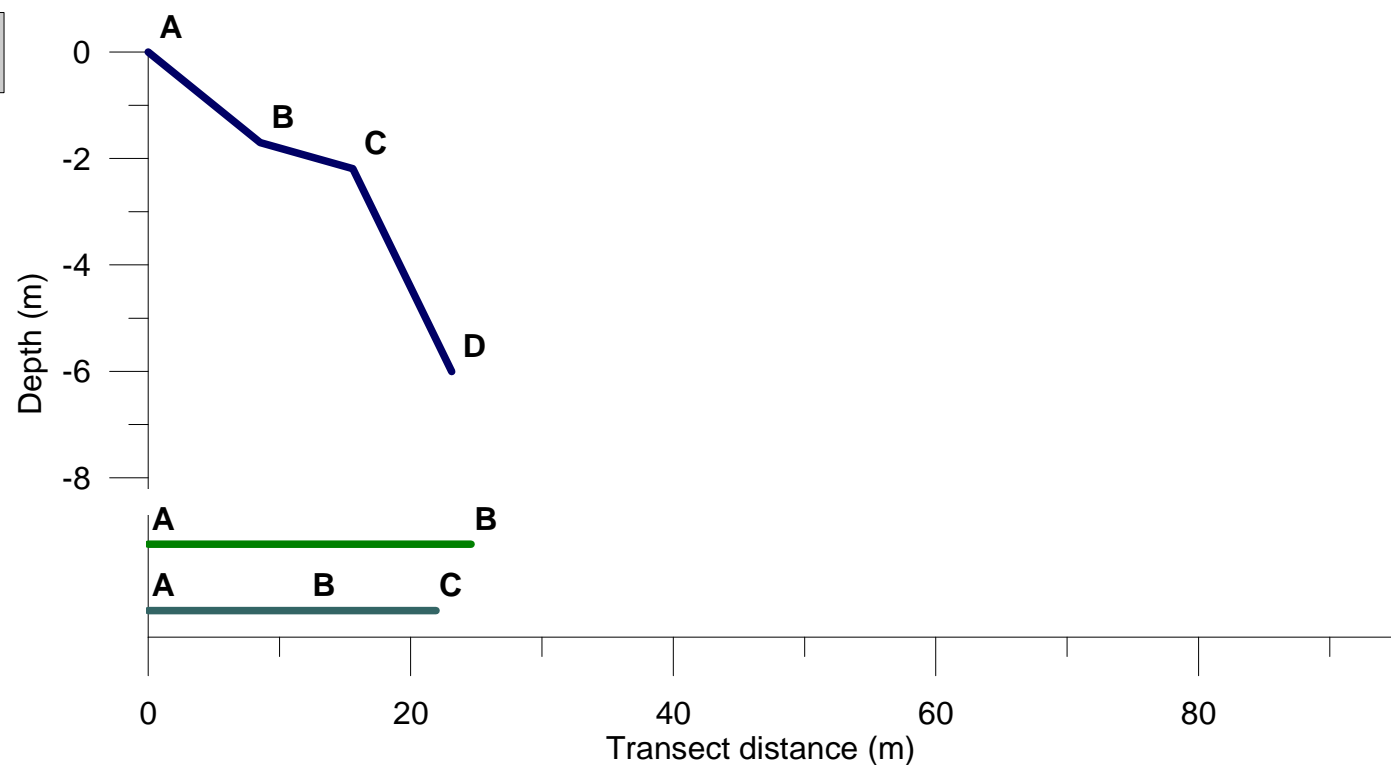
T27	Section	Habitat Value	Depth	Slope	Ice Scour	Substrate	Morphology	Complex
2009 Ground	A-B	L	S	S	Y	S	SB	M
	B-C	M	S	F	Y	BS	P	M
	C-D	H	M	S	N	BS	P	C
	D-E							
	E-F							
2006 Air	A-B	M	S	F	Y	BS	P	C
	B-C	-	-	-	-	-	-	-
	C-D							
2009 Air	A-B	M	S	S	Y	B	P	C
	B-C	L	S	F	Y	SB	P	M
	C-D	-	-	-	-	-	-	-
	D-E

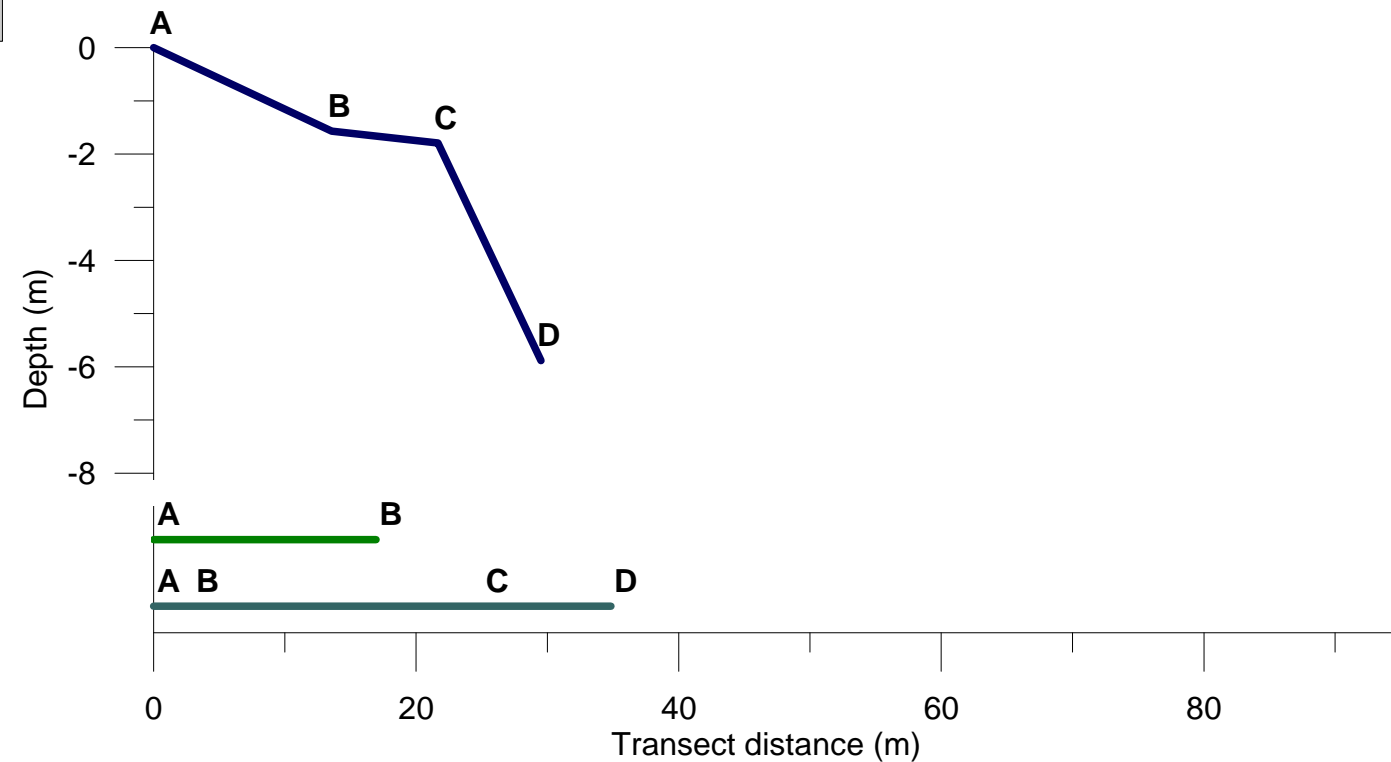
T28	Section	Habitat Value	Depth	Slope	Ice Scour	Substrate	Morphology	Complex
2009 Ground	A-B	M	S	F	Y	B	P	M
	B-C	M	S	F	Y	B	P	C
	C-D	H	M	S	N	B	P	C
	D-E							
	E-F							
2006 Air	A-B	M	S	F	Y	BS	P	C
	B-C	-	-	-	-	-	-	-
	C-D							
2009 Air	A-B	M	M	F	N	SB	A	M
	B-C	M	S	F	Y	B	P	C
	C-D	L	S	F	Y	SB	P	M
	D-E	-	-	-	-	-	-	-

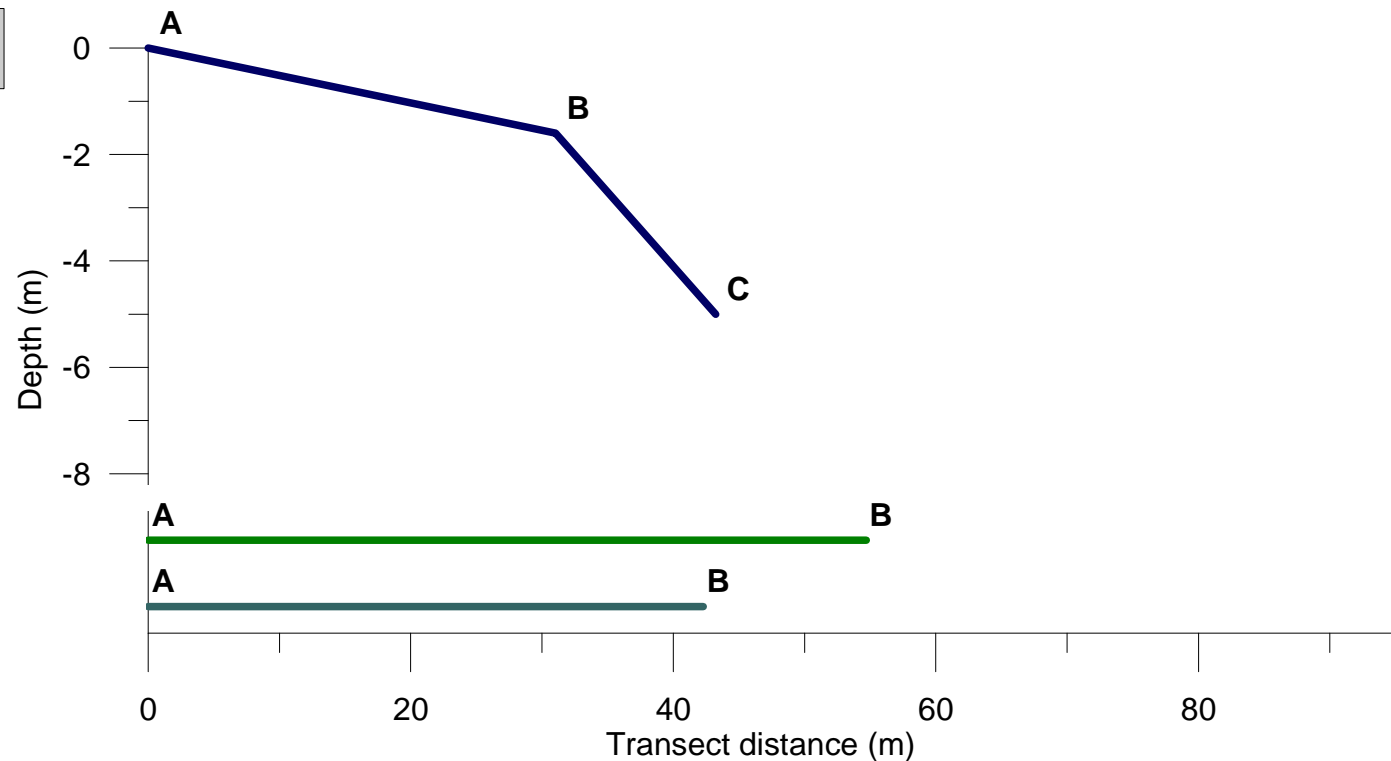
T29	Section	Habitat Value	Depth	Slope	Ice Scour	Substrate	Morphology	Complex
2009 Ground	A-B	M	S	F	Y	SB	P	M
	B-C	H	M	S	N	SB	P	M
	C-D							
	D-E							
	E-F							
2006 Air	A-B	M	S	F	Y	BS	P	C
	B-C	-	-	-	-	-	-	-
	C-D							
2009 Air	A-B	M	S	F	Y	B	P	C
	B-C	-	-	-	-	-	-	-
	C-D							
	D-E
