**Aquatic Effects Monitoring Program – Addendum to the
2008 Fish-Out of the Northwest Arm of Second Portage
Lake:**

**Habitat Mapping of the Northwest Arm of Second Portage
Lake 2009, Meadowbank Gold Project, April 2010**

Meadowbank Gold Project

Project No. AE-09-01.3

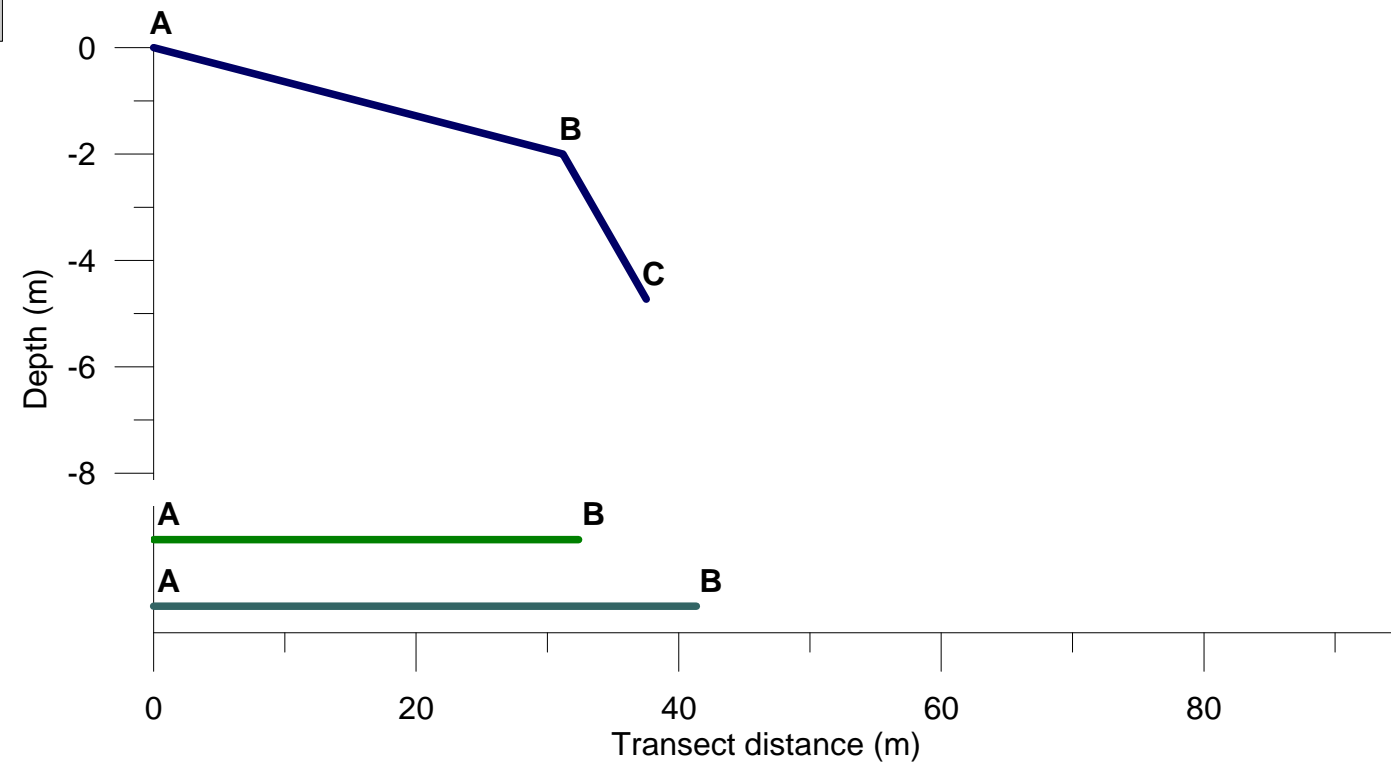
T32	Section	Habitat Value	Depth	Slope	Ice Scour	Substrate	Morphology	Complex
2009 Ground	A-B	M	S	F	Y	B	P	U
	B-C	H	M	S	N	B	P	U
	C-D							
	D-E							
	E-F							
2006 Air	A-B	M	S	F	Y	BS	P	C
	B-C	-	-	-	-	-	-	-
	C-D							
2009 Air	A-B	M	S	F	Y	B	P	C
	B-C	-	-	-	-	-	-	-
	C-D							
	D-E

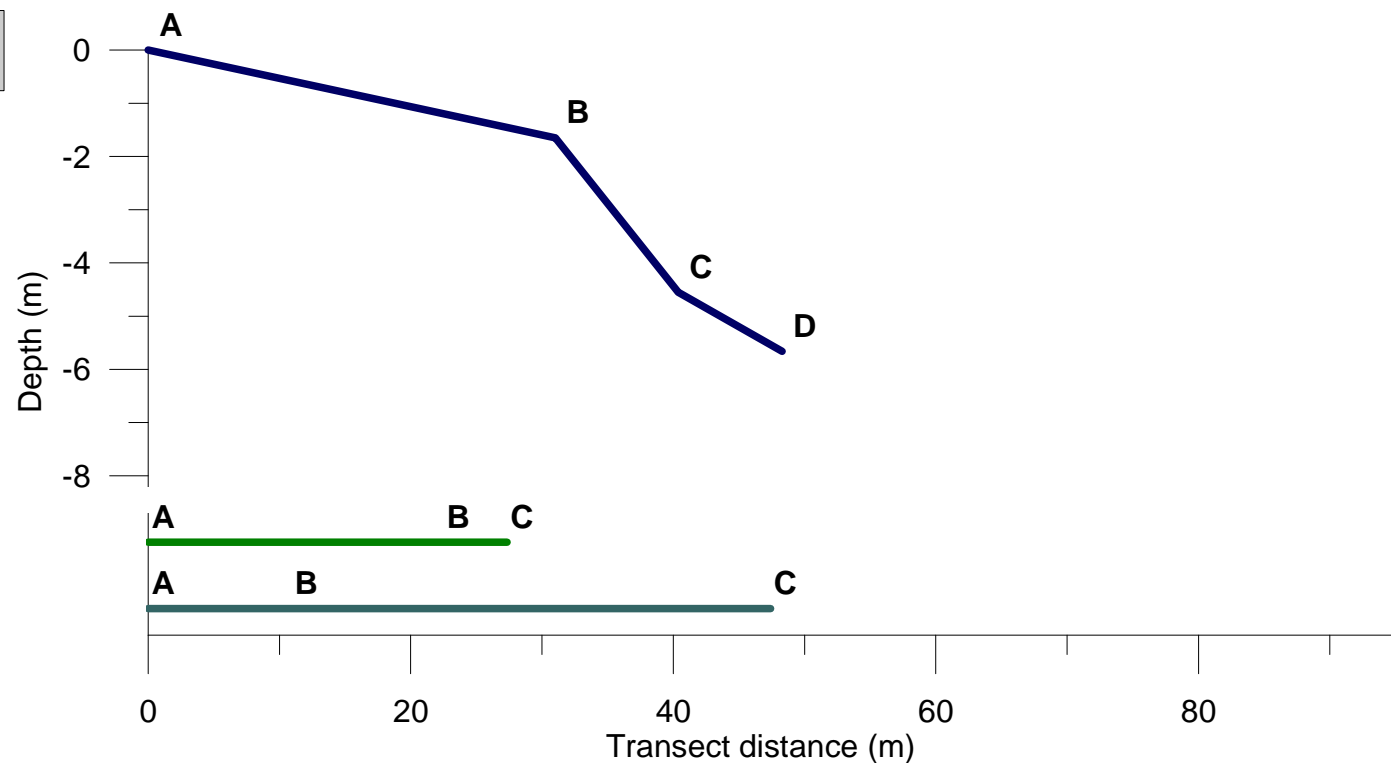
T33	Section	Habitat Value	Depth	Slope	Ice Scour	Substrate	Morphology	Complex
2009 Ground	A-B	M	S	F	Y	B	P	M
	B-C	M	M	S	N	SB	P	U
	C-D	M	M	S	N	S	P	U
	D-E							
	E-F							
2006 Air	A-B	M	S	F	N	B	P	C
	B-C	M	S	F	Y	BS	P	C
	C-D	0	0	0	0	0	0	0
2009 Air	A-B	M	M	F	N	SB	P	M
	B-C	M	S	F	Y	B	P	C
	C-D	0	0	0	0	0	0	0
	D-E

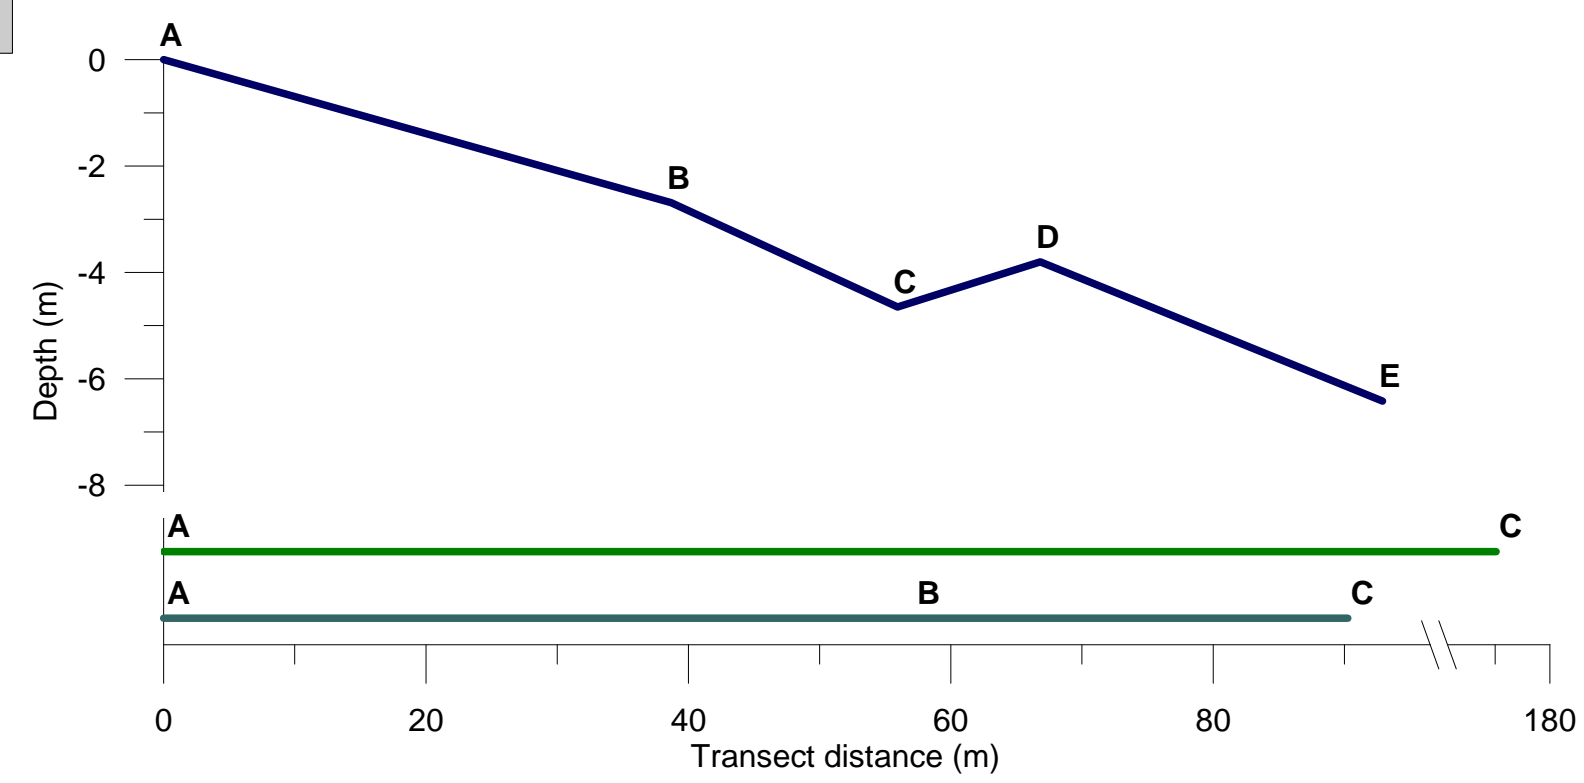
T30	Section	Habitat Value	Depth	Slope	Ice Scour	Substrate	Morphology	Complex
2009 Ground	A-B	M	S	F	Y	B	P	M
	B-C	H	M	S	N	BS	P	C
	C-D	M	M	F	N	SB	S	M
	D-E	M	D	S	N	SB	S	M
	E-F							
2006 Air	A-B	H	M	S	N	S	A	U
	B-C	M	S	F	Y	BS	P	C
	C-D	-	-	-	-	-	-	-
2009 Air	A-B	M	M	F	N	SB	P	M
	B-C	M	S	F	Y	B	P	C
	C-D	-	-	-	-	-	-	-
	D-E

- There was a shoal presumed to be visible at T30 in the 2006 mapping exercise that extended for 170 m offshore that was ranked as high value habitat. However, this shoal was not observed the 2009 aerial (90 m) and ground surveys (94 m) and substrate complexity was ranked much lower from the ground than what was assumed when viewed from the air. Thus this area was ranked as moderate value habitat, which was the largest discrepancy between the two major surveys.

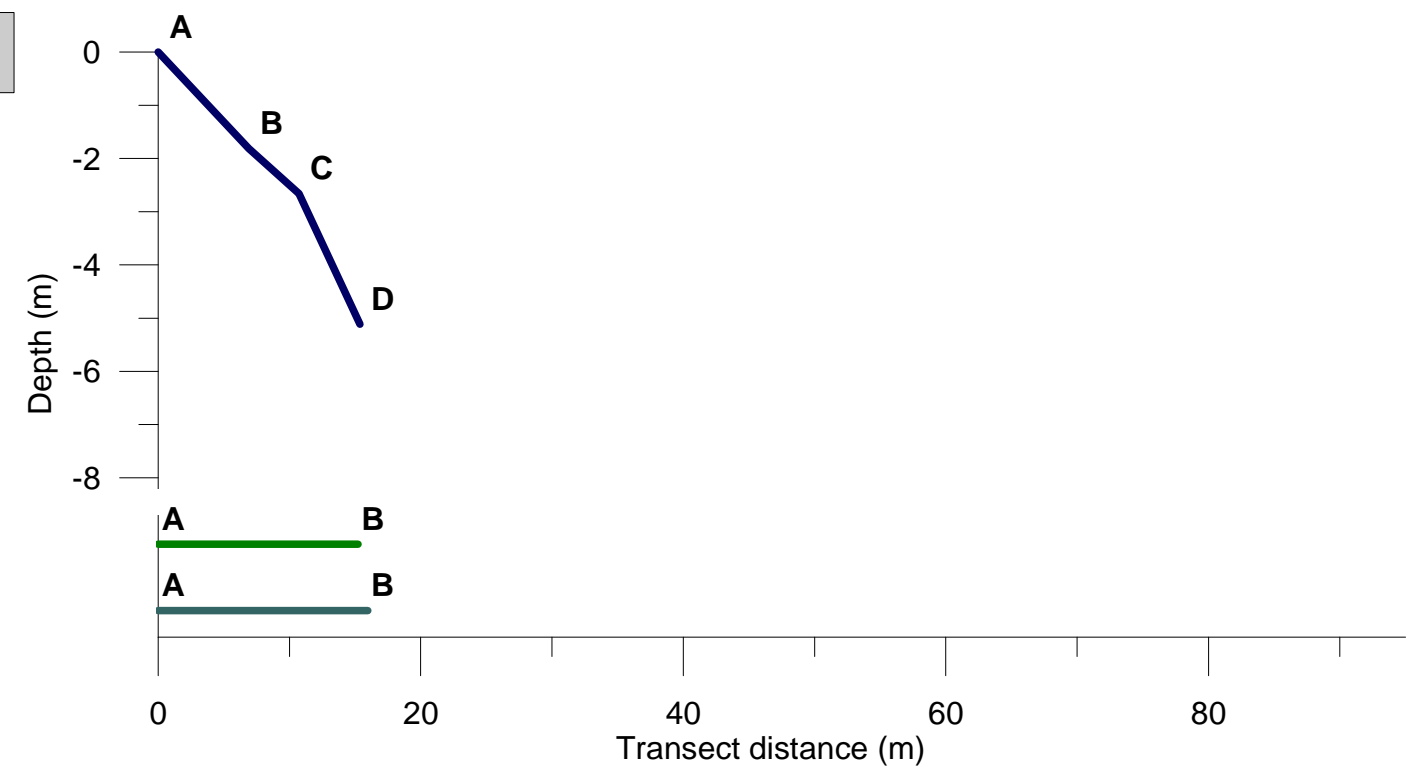
T31	Section	Habitat Value	Depth	Slope	Ice Scour	Substrate	Morphology	Complex
2009 Ground	A-B	M	S	S	Y	B	P	C
	B-C	H	M	S	N	B	P	C
	C-D	M	M	S	N	S	S	U
	D-E							
	E-F							
2006 Air	A-B	M	S	F	Y	BS	P	C
	B-C	-	-	-	-	-	-	-
	C-D							
2009 Air	A-B	M	S	F	Y	B	P	C
	B-C	-	-	-	-	-	-	-
	C-D							
	D-E
