Appendix I1

Document: *Inspection Reports*

WATER USE INSPECTION REPORT

Date: July 5, 2011	Licensee Rep. (Name/Title): Ryan Vanengen & Jeffrey Pratt
Licensee: Agnico Eagle Mines Ltd.	Licence No.: 2AM-MEA0815

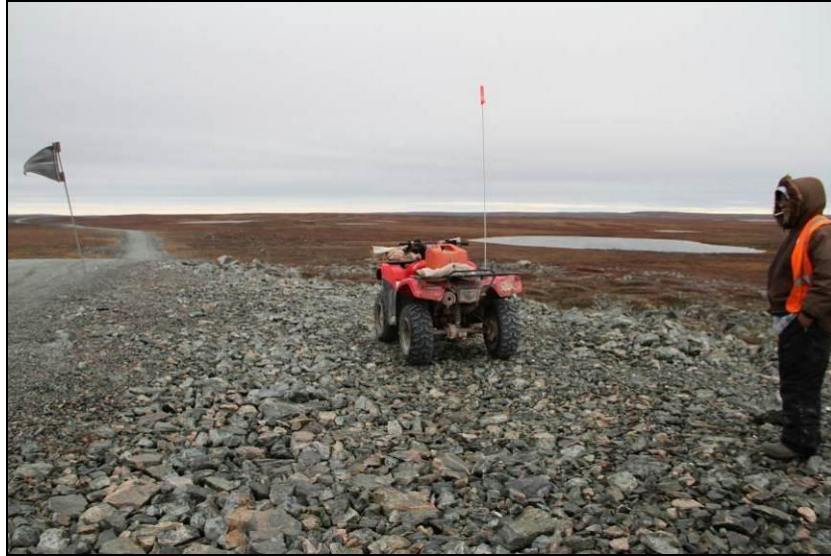
Photo 2: Public user of the access road using safety vest and buggy whip installed – near kilometre 50

- b. During the bus ride from the hamlet of Baker Lake to the Meadowbank site on September 12, 2012, an all-terrain vehicle (ATV) travelling northbound was observed near kilometre 28, and another ATV was observed on the land near kilometre 76. When returning to the hamlet of Baker Lake from the Meadowbank site on September 13, 2012, one ATV travelling southbound was observed near kilometre 50. All public users of the access road had the required buggy whip installed on their ATV's and were observed to be wearing the safety vests loaned out by AEM (see Photo 2).

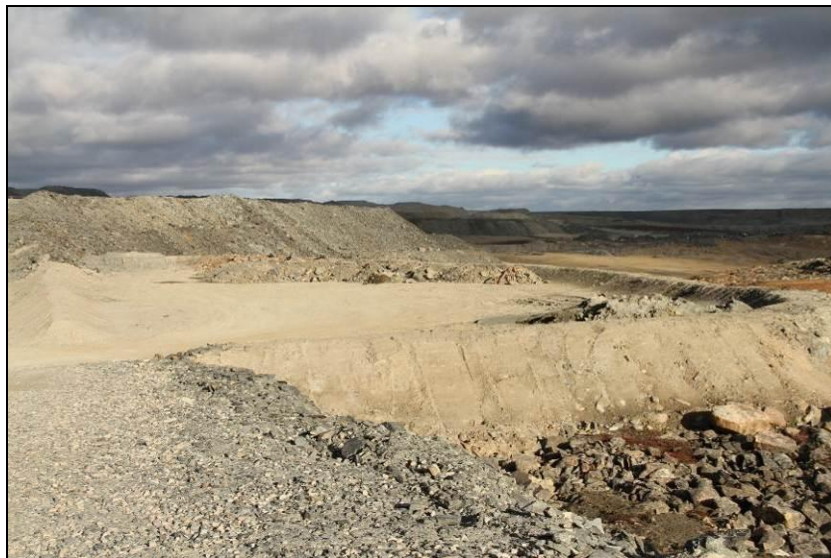
Photo 3: Contaminated soil storage/pilot remediation site

- c. Mr. Buck mentioned that while AEM may not develop a landfarm, it was considering the development of a contaminated soil storage/pilot remediation site. The plan as explained would be to use on-site nutrients to initiate bioremediation in the hydrocarbon contaminates soils. The current site being used to conduct the initial study for the contaminated soil storage/pilot remediation program is located on the south side of the stormwater dike, upstream of the future south cell of the tailings storage facility (TSF). This location was selected to allow capture of any contaminated water that might leach out of the contaminated soils into the TSF (see Photo 3).

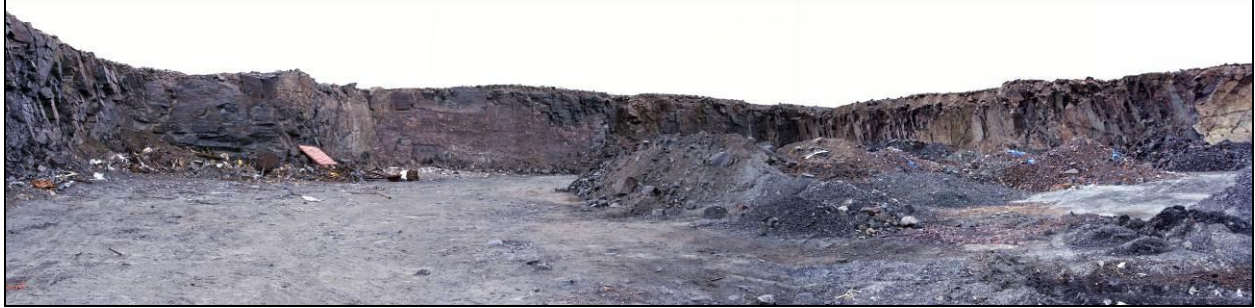
Photo 6: Quarry 22 serving as storage for contaminated soil

- f. Quarry 22 remains in service as a temporary land farm and storage area for contaminated soils. AEM indicated that it plans to remove the contaminated soil to the pilot remediation site in the near future. Currently, Quarry 22 is not being used to store other material as had been the case in the past (see Photo 6).

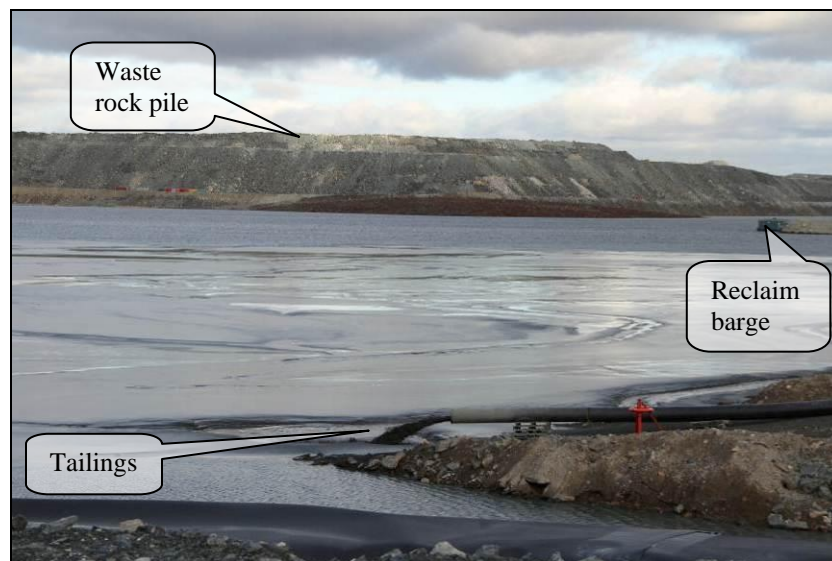
- j. By the end of 2011, approximately 4.07 million tonnes of tailings had been placed in the TSF (Photo 12) since the start of the project. A structure known as the ‘reclaim barge’ is used to re-circulate water from the TSF back to the mill for reuse within the processing cycle (Photo 12). It was noted during the 2012 site visit that the TSF did not contain as much water as was observed during the 2011 site visit. The diversion ditch north of the TSF had been completed in the fall of 2011, preventing water from entering the TSF during the freshet season, a situation that had occurred in 2011 prior to the completion of the diversion ditch. As mentioned in the 2011 Site Visit Report, AEM noted that tailings with a dryer consistency to the tailings deposited within the TSF provide something of a “beach” in the TSF which helps to protect the dikes and to prevent ice formation (see Photo 13). There did not appear to be any apparent rips to the liners that were exposed within Saddle Dam #1 and Saddle Dam #2 (Photo 13).

Photo 12: Tailings storage facility – north cell

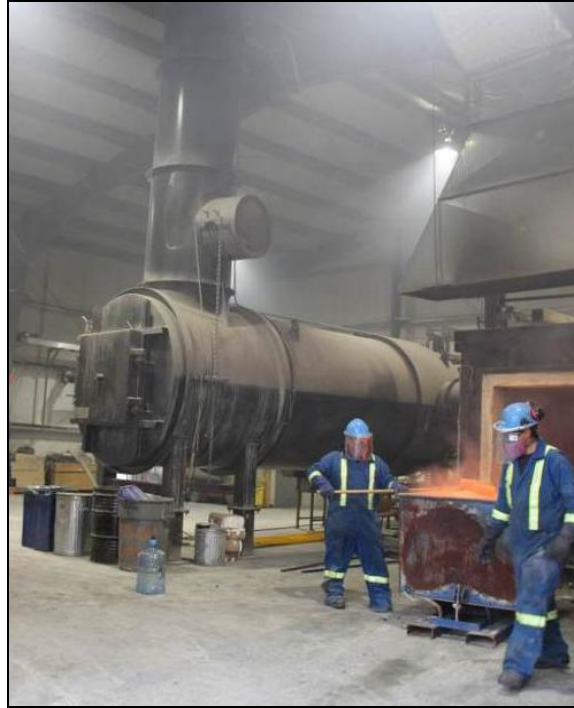
The Meadowbank site dual chamber forced air incinerator remains in service for the combustion of all non-hazardous, combustible materials at the site (Photo 19). Approximately 1.7 tonnes of domestic garbage is incinerated per day; however, Mr. Buck indicated that there are plans in place to improve waste management by reducing the amount of domestic garbage produced at site. Some examples provided include replacing paper coffee cups with plastic coffee cups, using plastic lunch boxes and trays instead of paper bags, recycling wood products by finding a second use for it at site or taking it to Baker Lake where it could be used by community members. It was also noted during the site visit that open burning was being conducted of some of the non-hazardous wastes on site (Photo 20).

Photo 19: Dual chamber forced air incinerator at the Meadowbank site

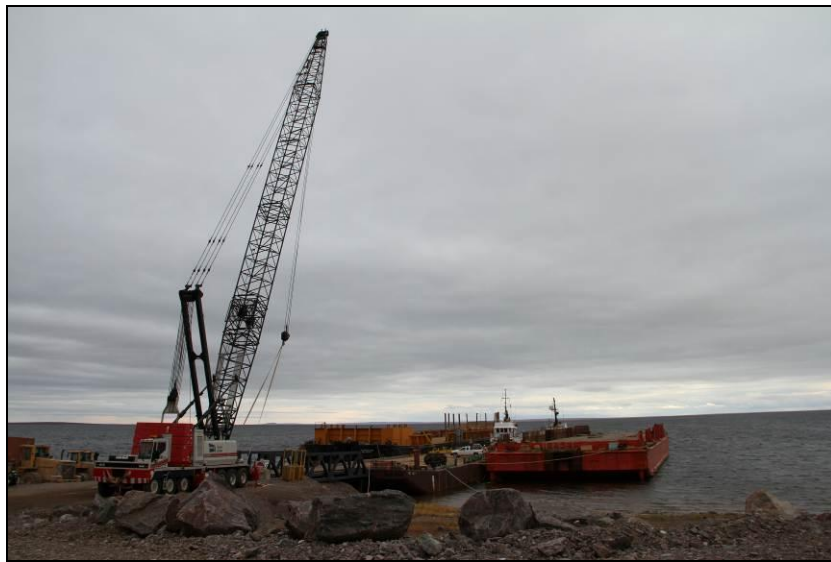
Photo 32: Baker Lake dock and laydown facility

Further, the Monitoring Officer did note that these areas were kept impressively clean with sea-cans well organized during the 2012 site visit (see Photo 32 and Photo 33).

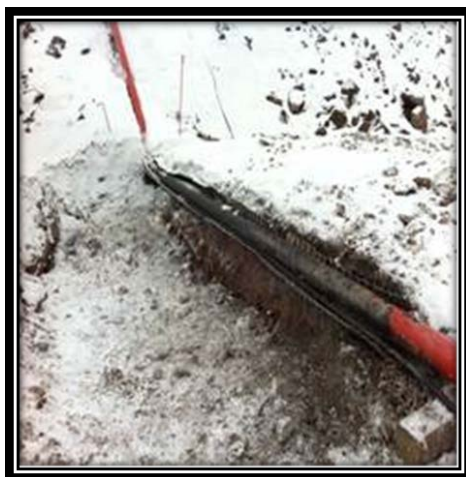
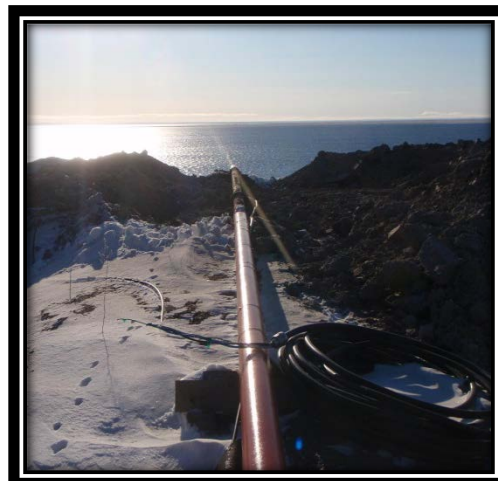
1. SINGLE WALLED UNDERGROUND PIPING

The single walled pipes outside of secondary containment have been removed from underground use and are now above ground to allow for visual inspection of these pipes. It is our belief these actions bring us into compliance, and that this system can now have petroleum products transferred into the storage tank system in 2013.

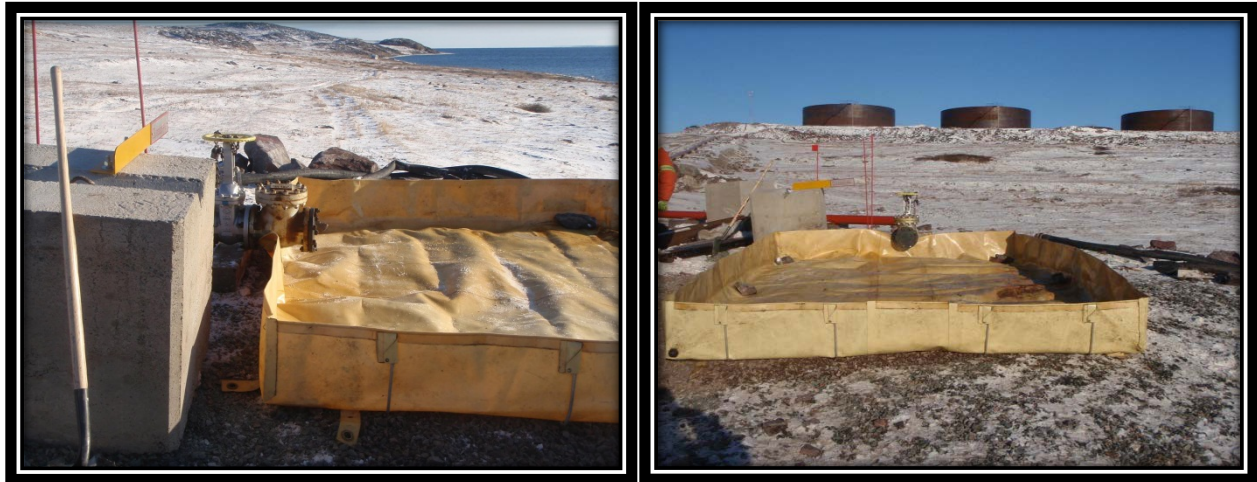
Secondary containment for the transfer area has been installed. Need to refer to the email he sent acknowledging that this meets the regulations – you should have a copy.

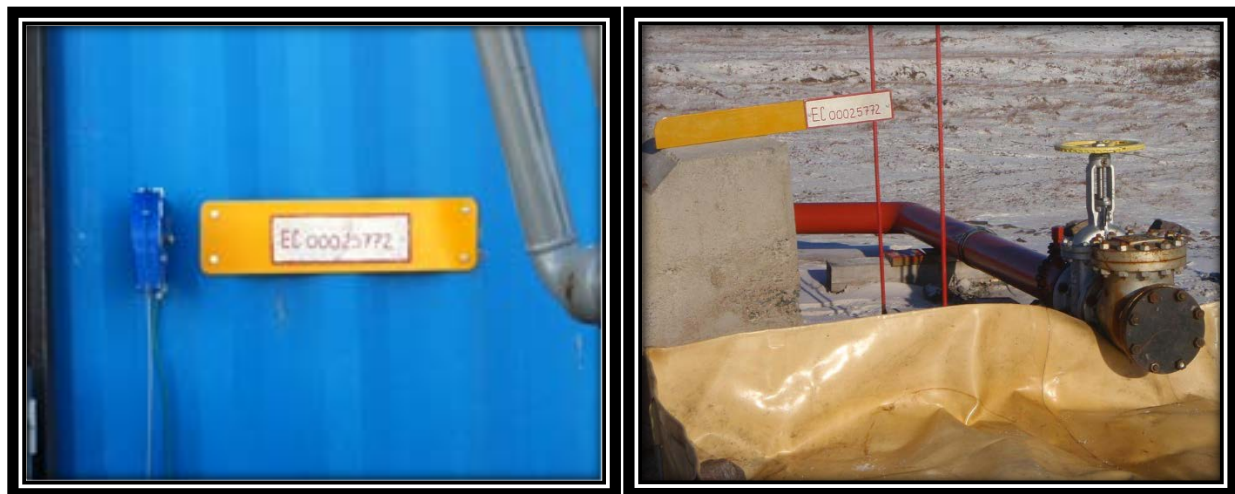
3. DISPLAY EC IDENTIFICATION NUMBER

The EC identification signs have been installed in two locations. The first one is at the intake i.e. where the boat is connecting when delivering the fuel. The second one is at the loading area. As per your email received by Kevin Buck on November 1, 2012, this meets the requirement of the regulations.
