### **Report: *RSF Seepage Golder Report***

## **REPORT ON**

# **Rock Storage Facility Seepage - Meadowbank Gold Mine, Nunavut**

**Report Number: Doc 1447 1312210115\_0103\_14 - MB**

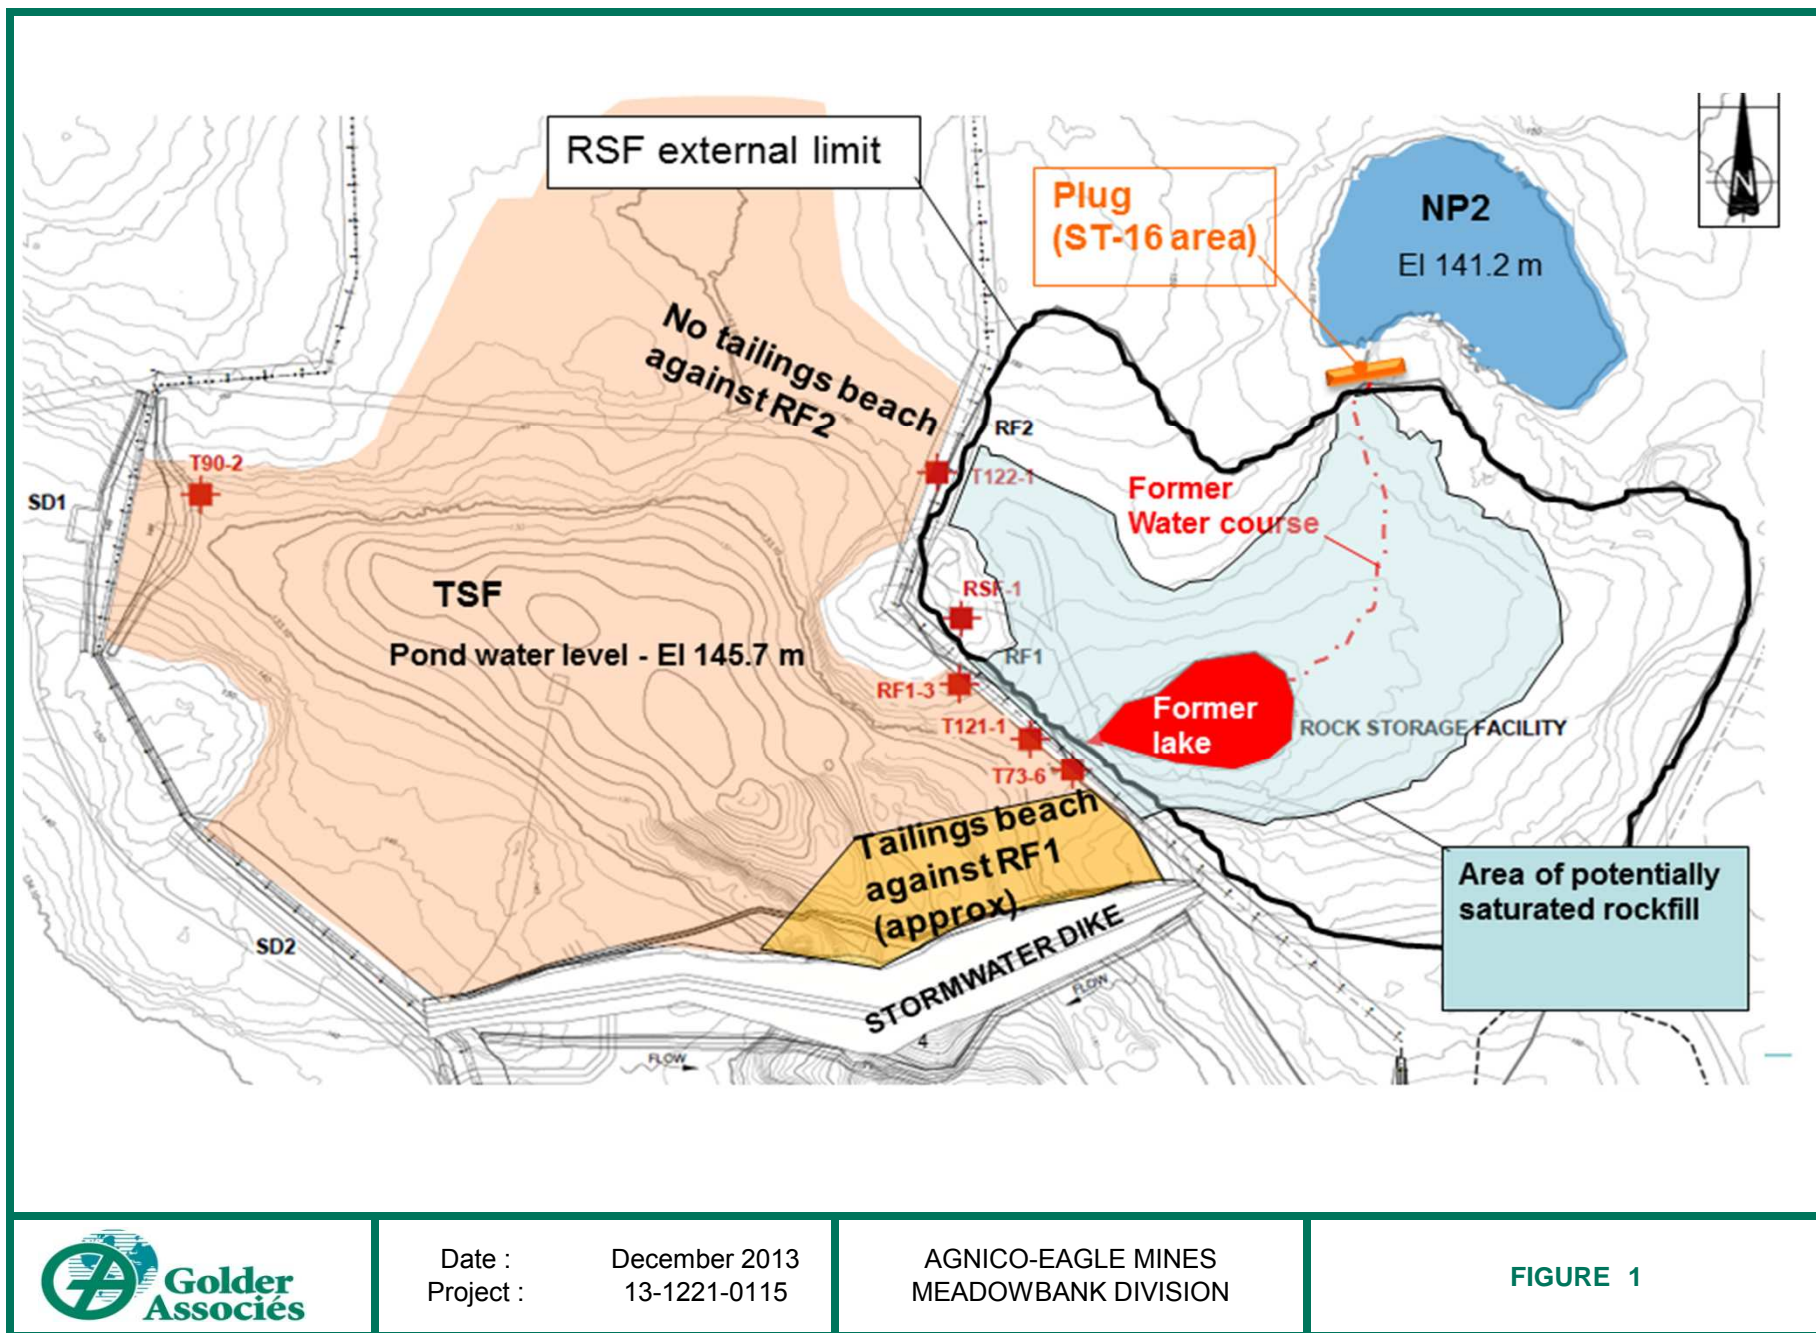
FIGURE 1

## GENERAL CONFIGURATION OF THE TSF AND RSF FACILITIES

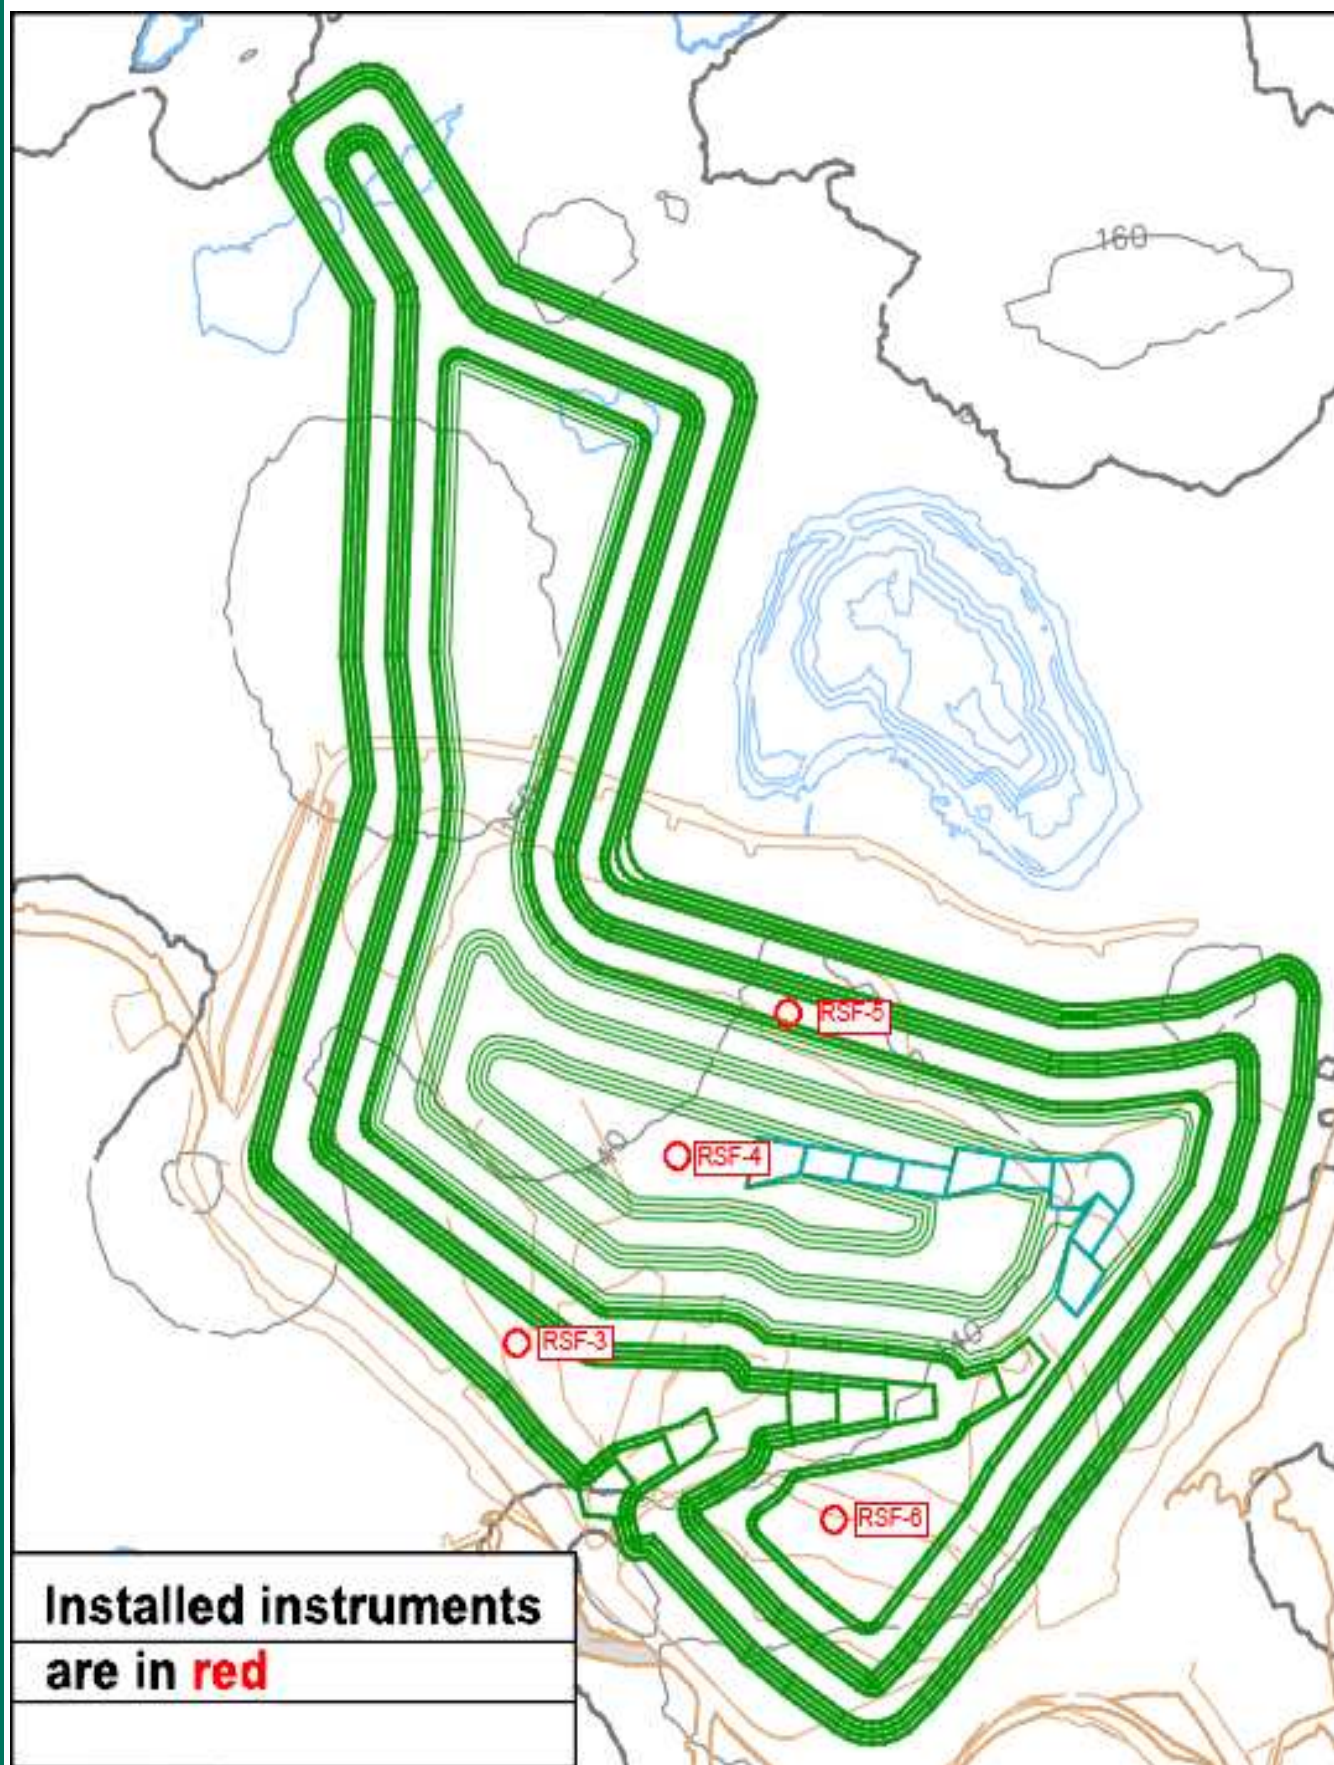
## LOCATION OF THERMISTOR INSTALLED IN THE RSF IN NOVEMBER 2013

The following are noted based on a review of the data to December 6, 2013 for thermistors RSF3 to RSF6, inclusive:

Thermistors RSF3 to RSF6, inclusive, show that the thermistors continue to adjust to the ground temperature conditions; this is expected due to their recent installation dates. Continued monitoring of these thermistors is required for future interpretation.

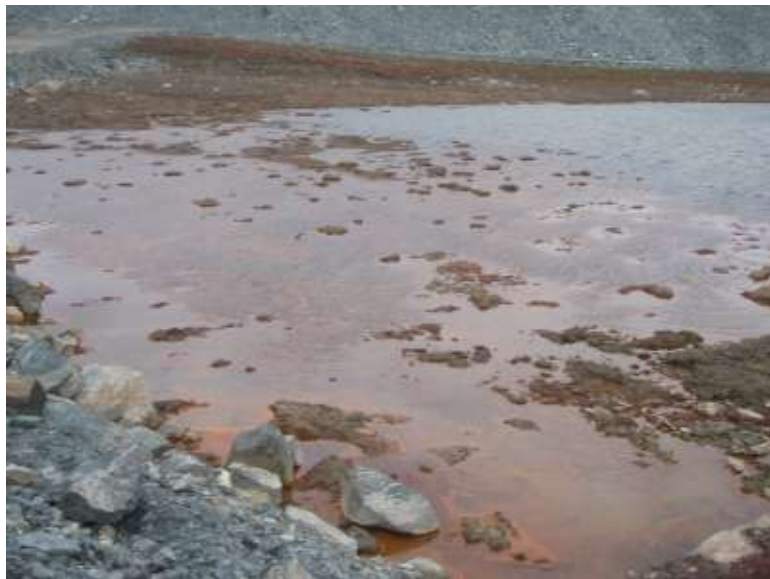
*Photo 1 – Shore of NP-2*

During an AANDC Water License inspection on July 29<sup>th</sup> and 30<sup>th</sup> 2013 it was observed that “red” colored seepage from the south - east side of the Waste Rock Storage Facility was seeping through the road perimeter into Lake NP-2. Samples were taken by both the Inspector and AEM staff (split sample). Analysis results from this sampling were received by AEM on August 16<sup>th</sup>, 2013. See Photos 1 and 2 below and Table 1.

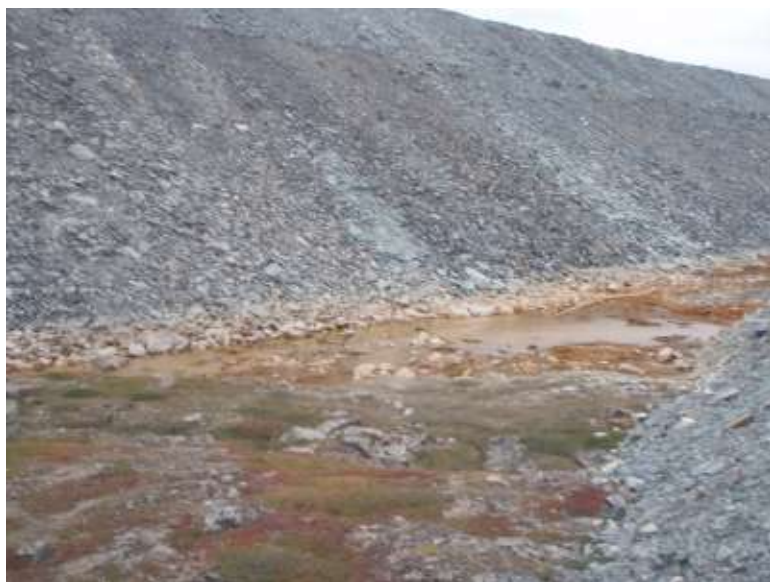
*Photo 2 – ST-16 Waste Rock seepage.*

As mentioned the AANDC inspector was on site July 29<sup>th</sup> and 30<sup>th</sup>, 2013 and split samples were taken. The seepage was evident in the Lake, along the near shore only (see photo 2), and we increased the removal of the seep water from the ST-16 sample location. Please see Figure 1 below for sample locations.

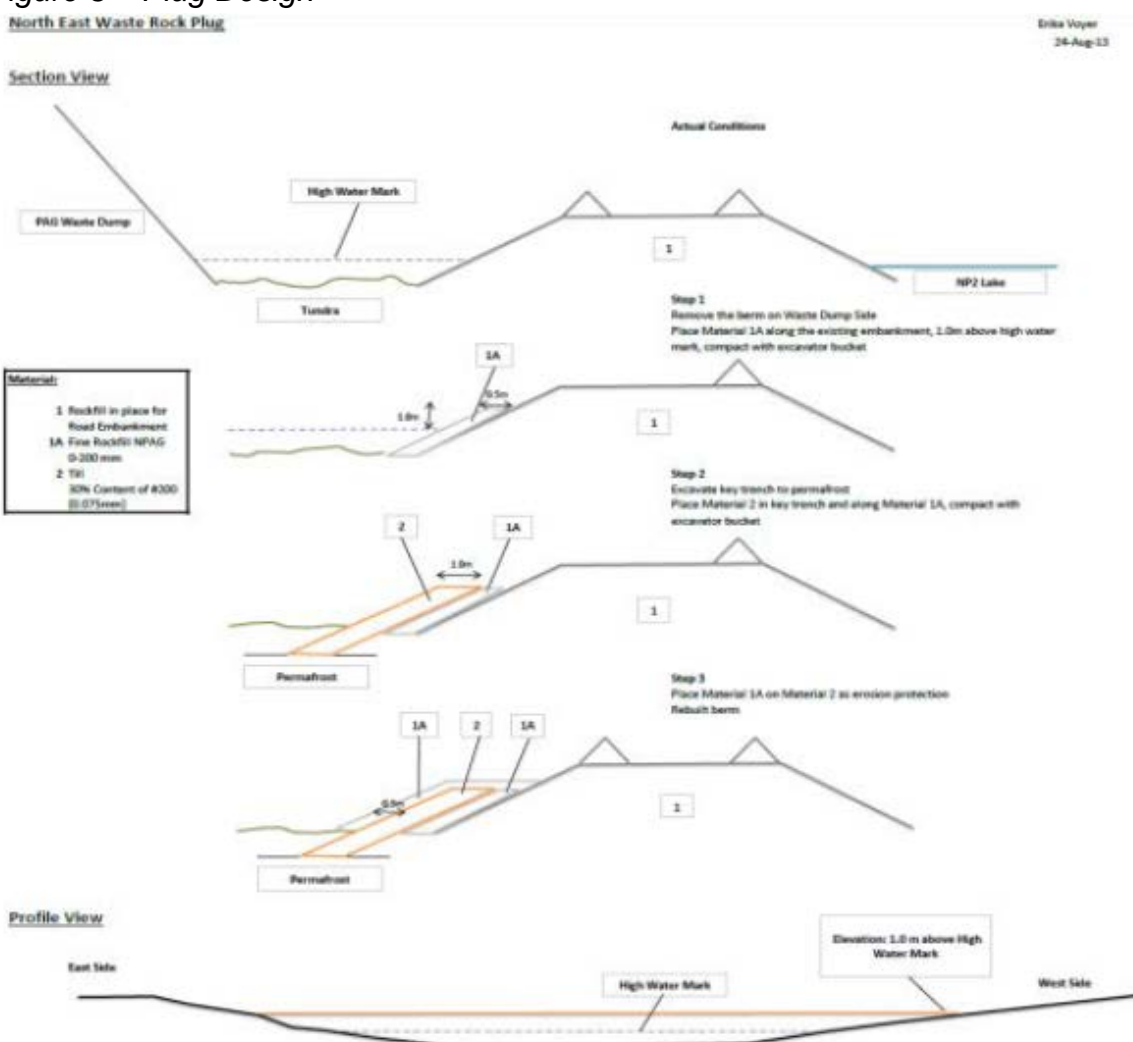
The investigation continued and a Plug/Dike design request to prevent any seepage from migrating through the road to NP-2 Lake was submitted to AEM's Engineering Department. A design was produced (see Figure 3 below). This was an additional measure taken to augment the pumping of the seep water. Construction of the Waste Rock Plug commenced on August 26<sup>th</sup>, 2013. Also, it was observed, after the pumping out of the water to a low level, that water was still seeping from the waste rock and this included two distinct areas in close proximity (approximately 15 m apart) to each other. One was "red" colored and the other "brown" - see photos 3 and 4 below.

Figure 3 – Plug Design

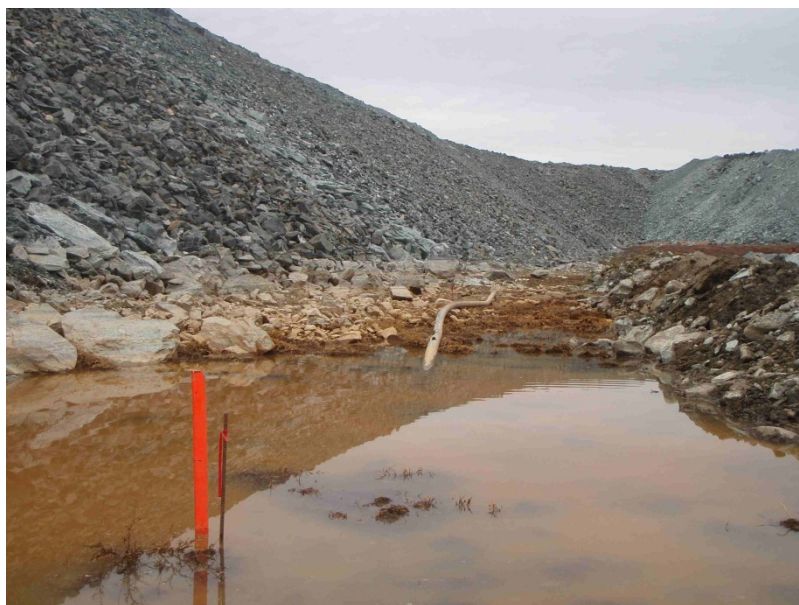
*Photo 5 – Seepage Staff Gauge*

A staff gauge has been placed at the seepage to determine the water level increases more definitively – see photo 5 below.

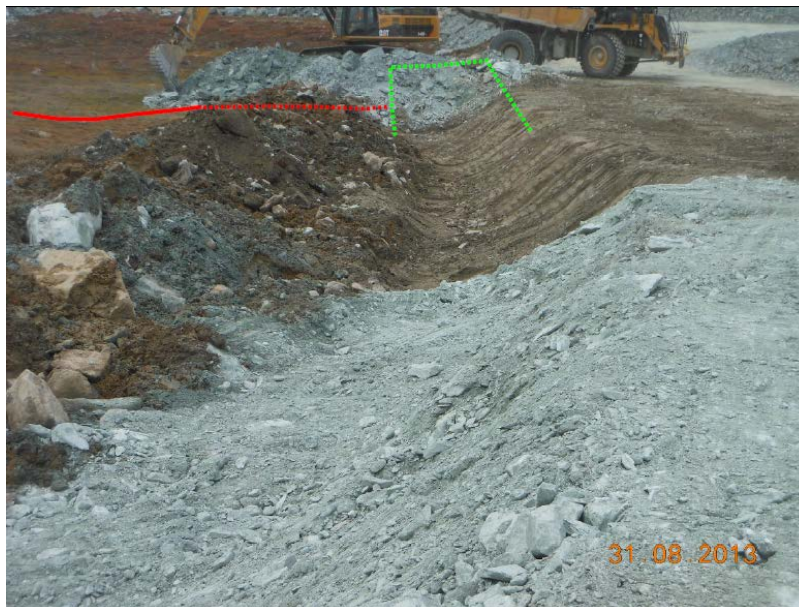
*Photo 7 – Construction of Waste Rock Plug*

Construction of the Waste Rock Plug was completed on September 1<sup>st</sup>. The seep areas are segregated and have been kept at low levels – see photo 7 below.

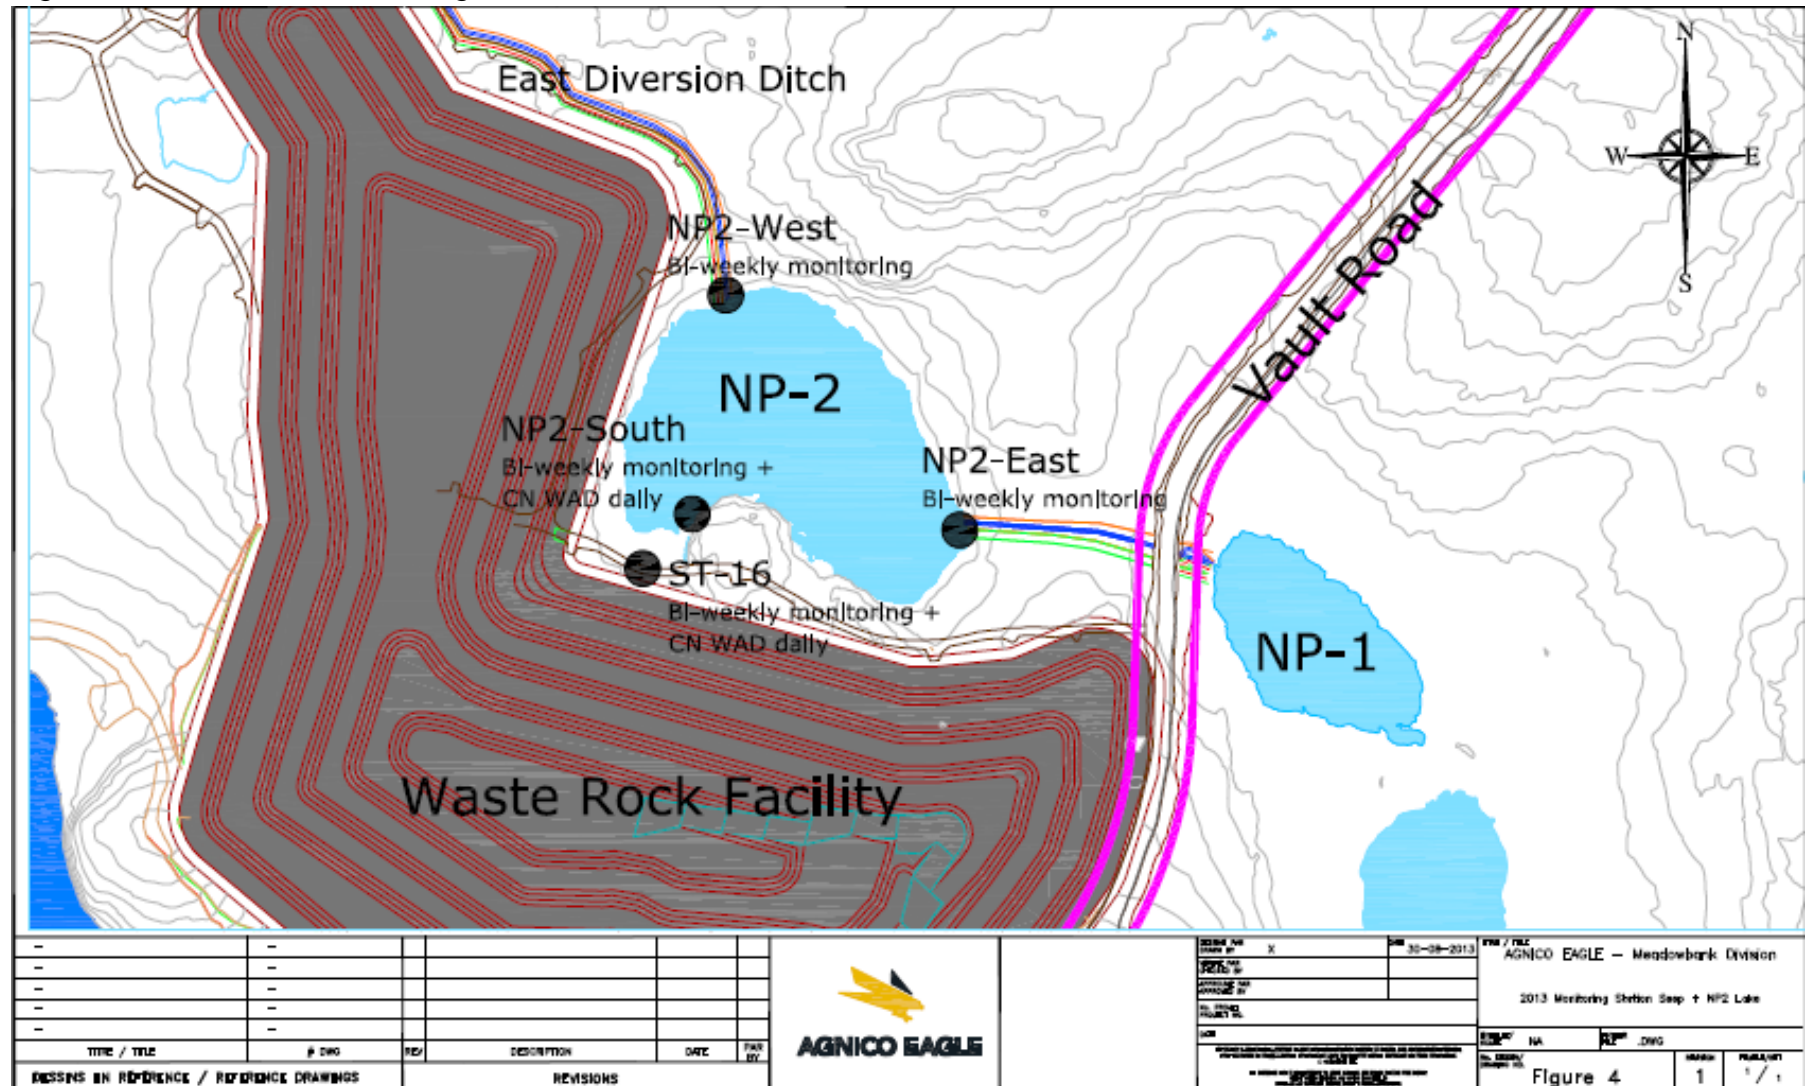
Figure 4 – Short term monitoring stations

- AEM has submitted (on September 2<sup>nd</sup>) a request for proposal from a third party engineering firm to assess why this seepage has occurred, verify the pathway under the waste rock storage area, if there any additional short term measures that can be implemented, further suggestions for management of freshet, whether an engineered collection and sump system is required for the seepage area, an evaluation of the seepage risk in the TSF and provision of recommendations for a permanent solution.

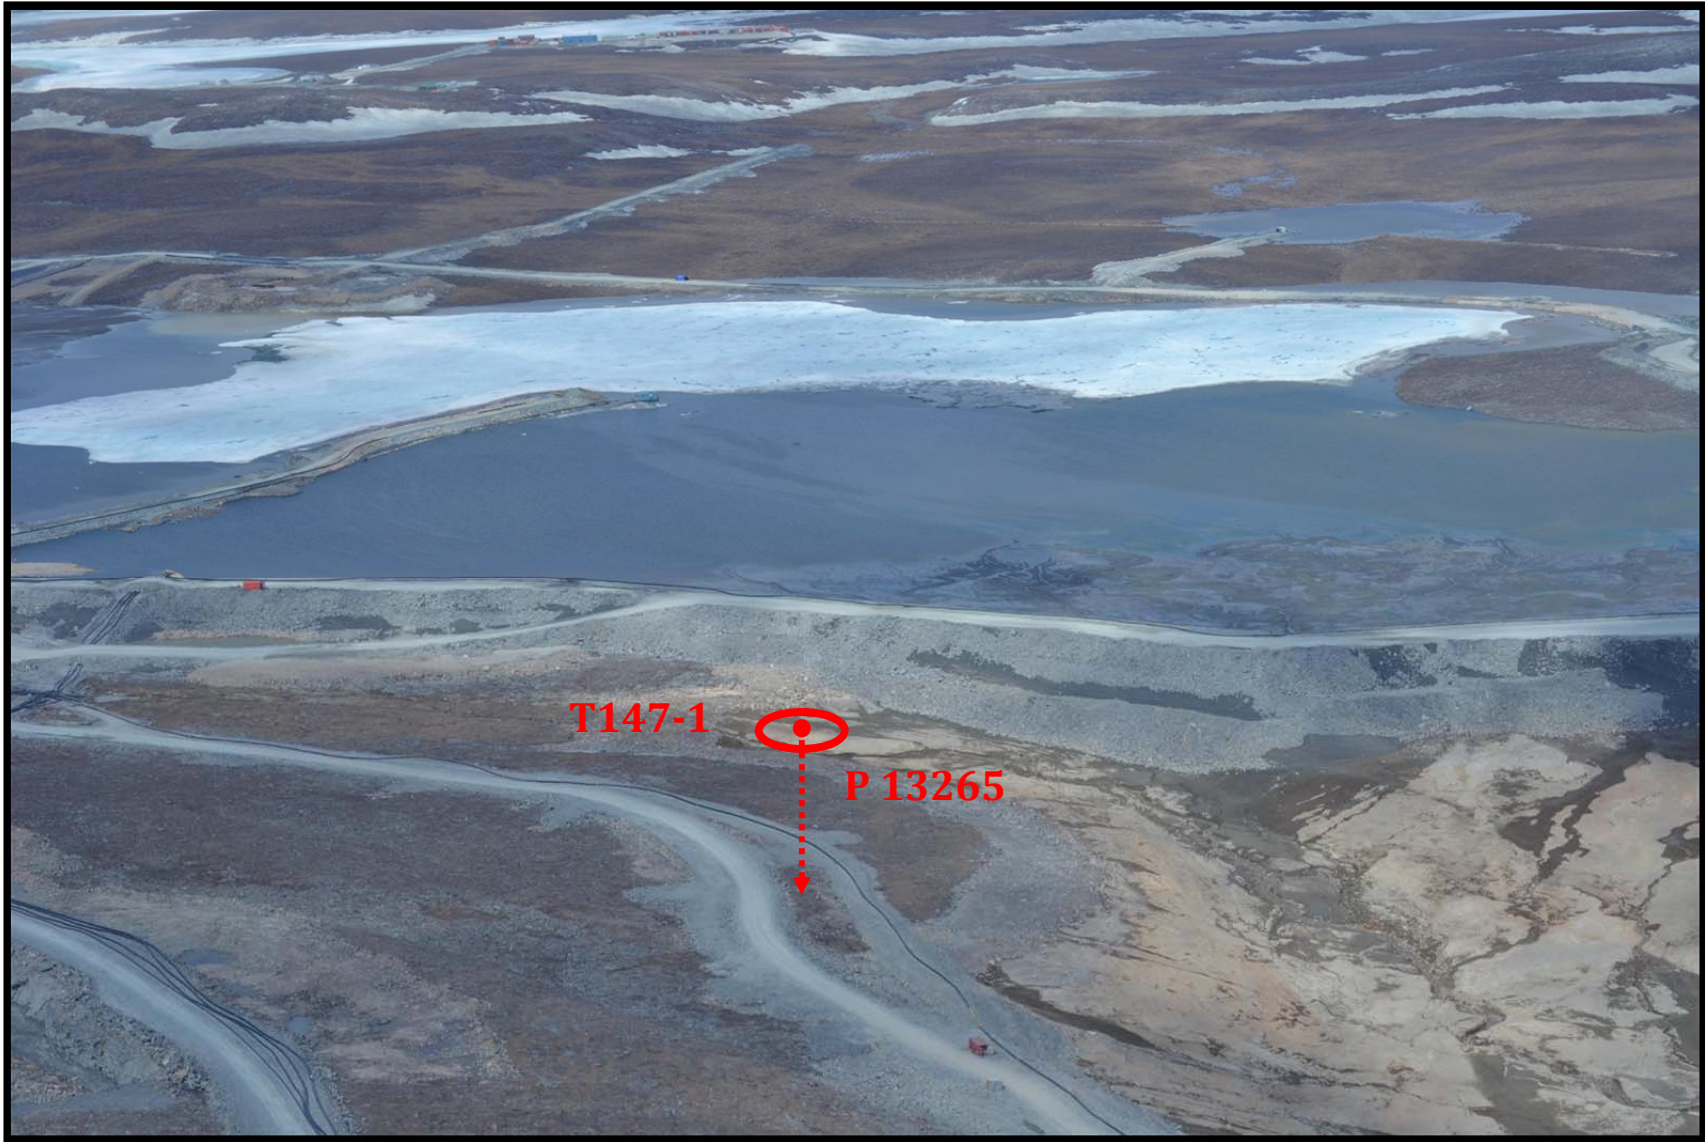
**STORMWATER DIKE - T147-1**  
Elevation vs Temperature - String # 147-1

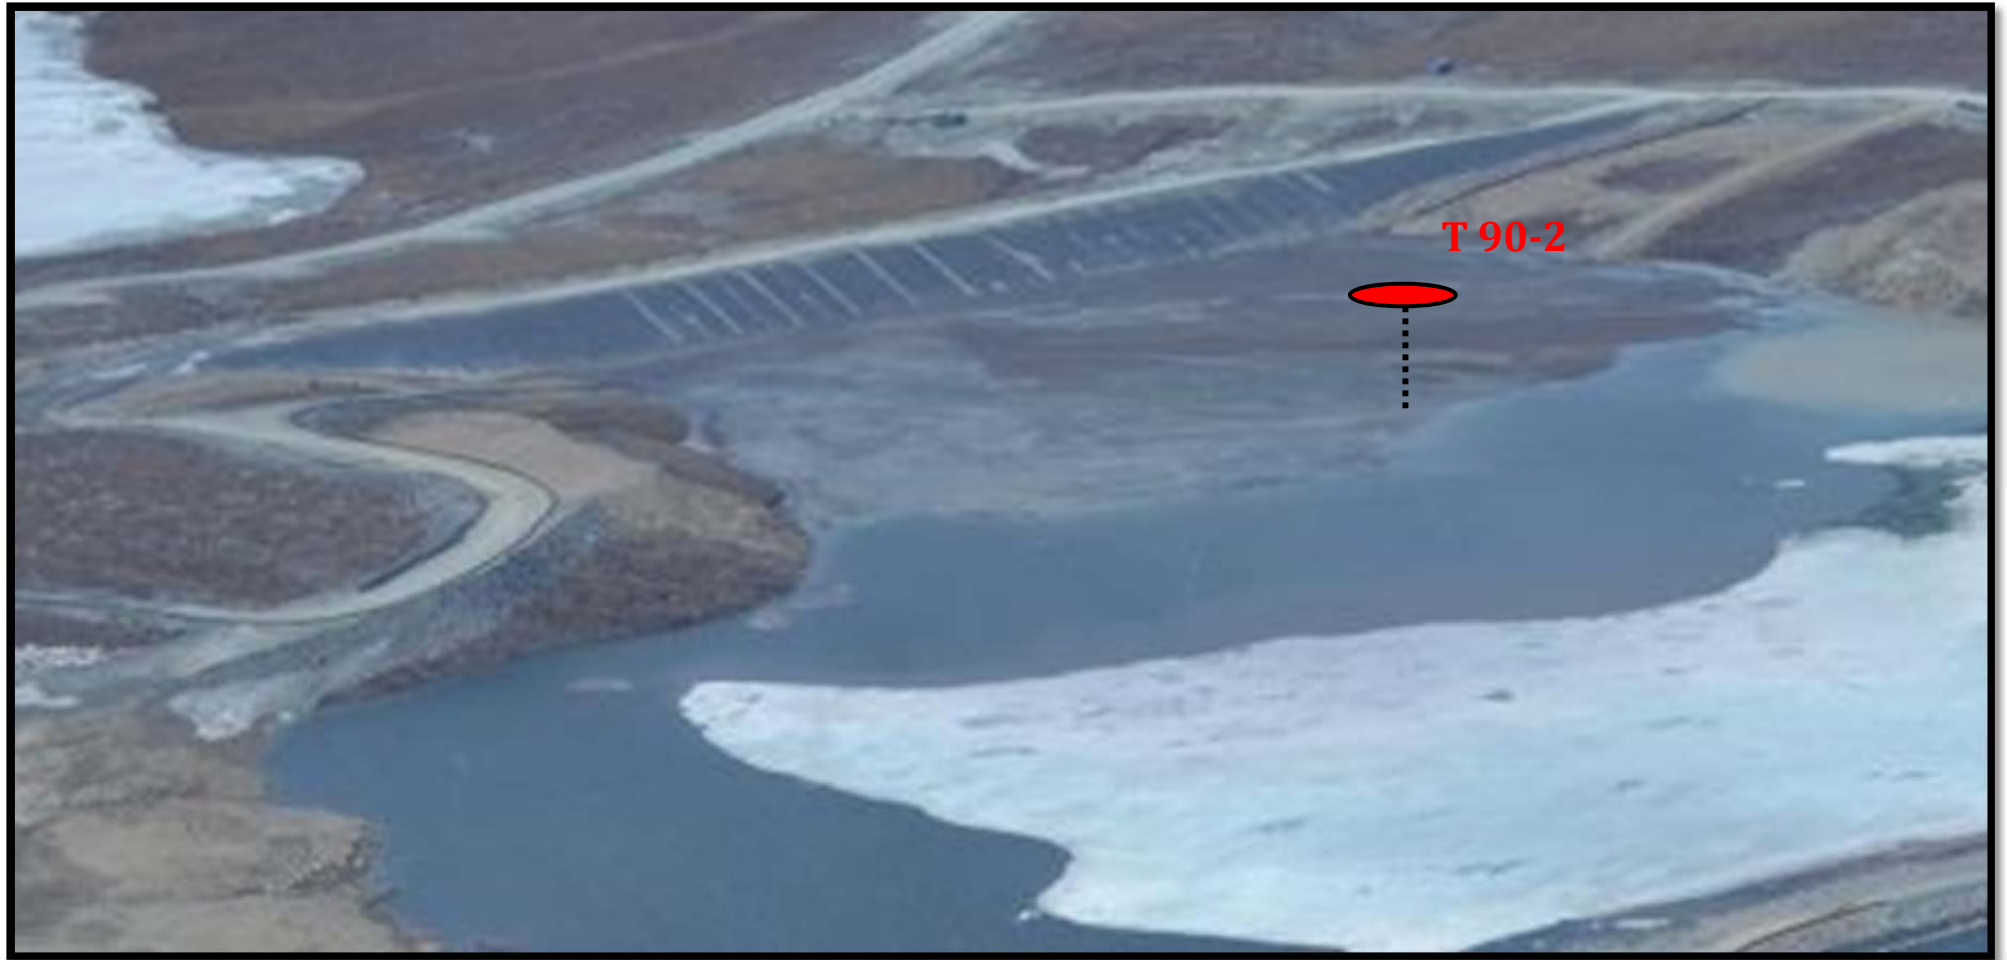
# String # 90-2 - Elev. vs Temp Tailing thermistor monitoring

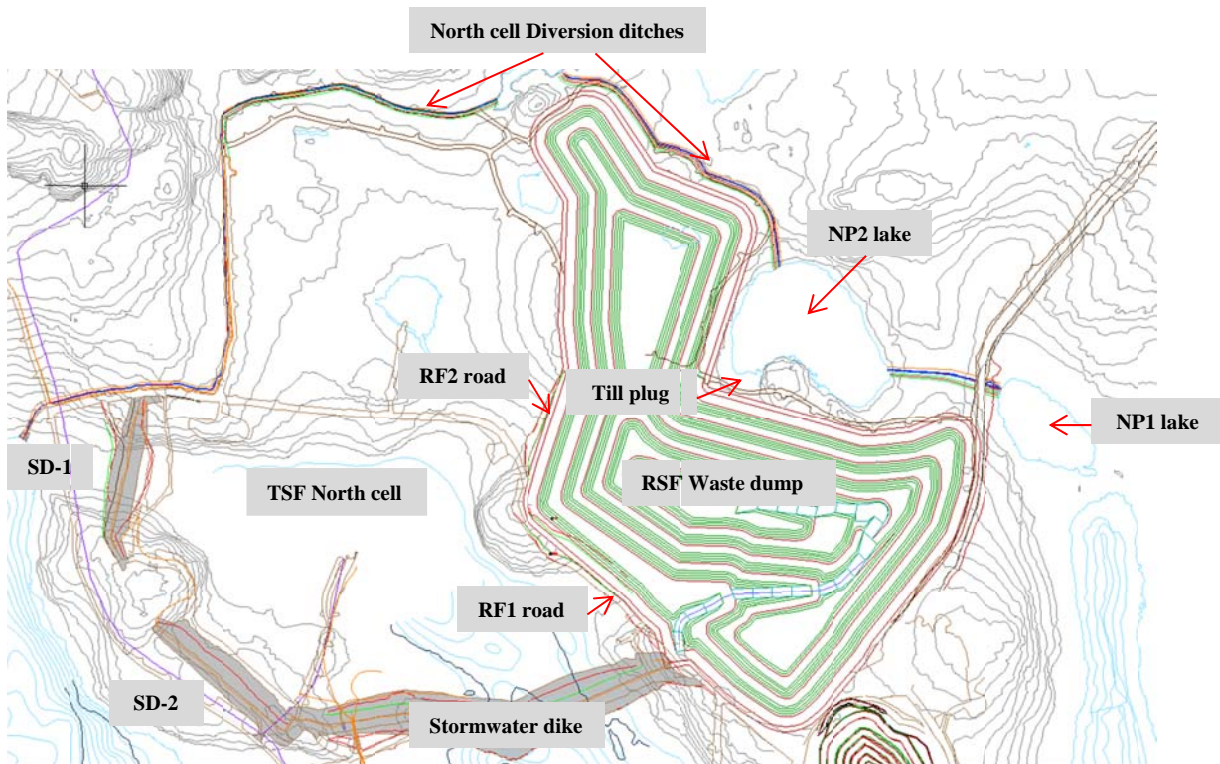
**Figure 1: General arrangement of the TSF and RSF**

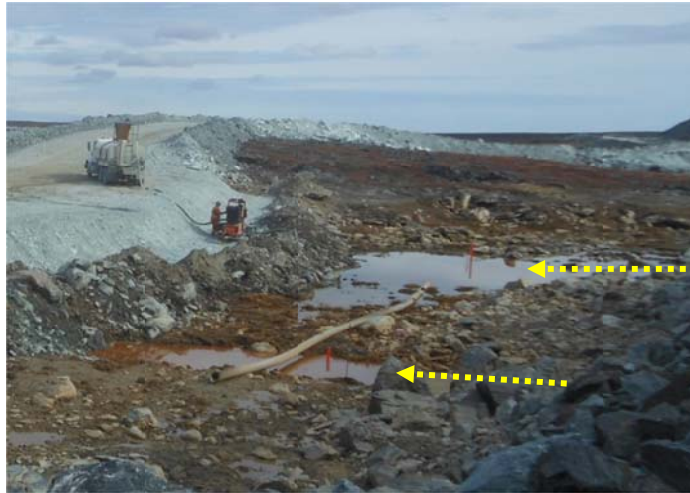
The first step prior to all works in the area is to pump the seepage water from the two main channels out of the till plug area. In order to control the water level through the entire construction period, a water truck from SANA was hauling (as needed) 14,000 litres of seepage water and disposed of it in the tailings pond over the Stormwater dike. A 3" diesel pump (model Godwin CD103) was placed within the 2 main deepest channels to keep them as empty as possible to allow the working area to be as dry as possible for the beginning of the excavation. The pump was moved as the work progresses.

**Figure 3: view of the 2 main channels and the pumping station after the completion of the works.**

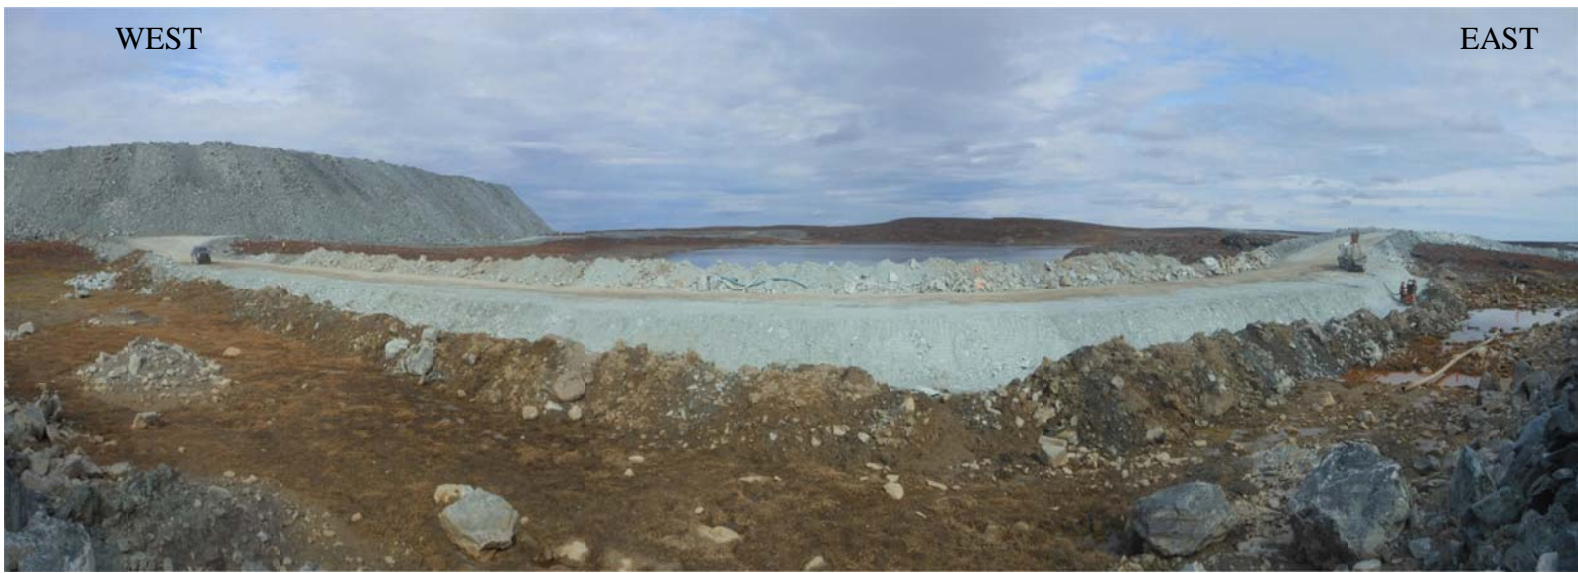
***Figure 10: photo of the final result of the entire till plug from West to East. The actual pumping station and the 2 active seepage channels are visible on the eastern abutment.***

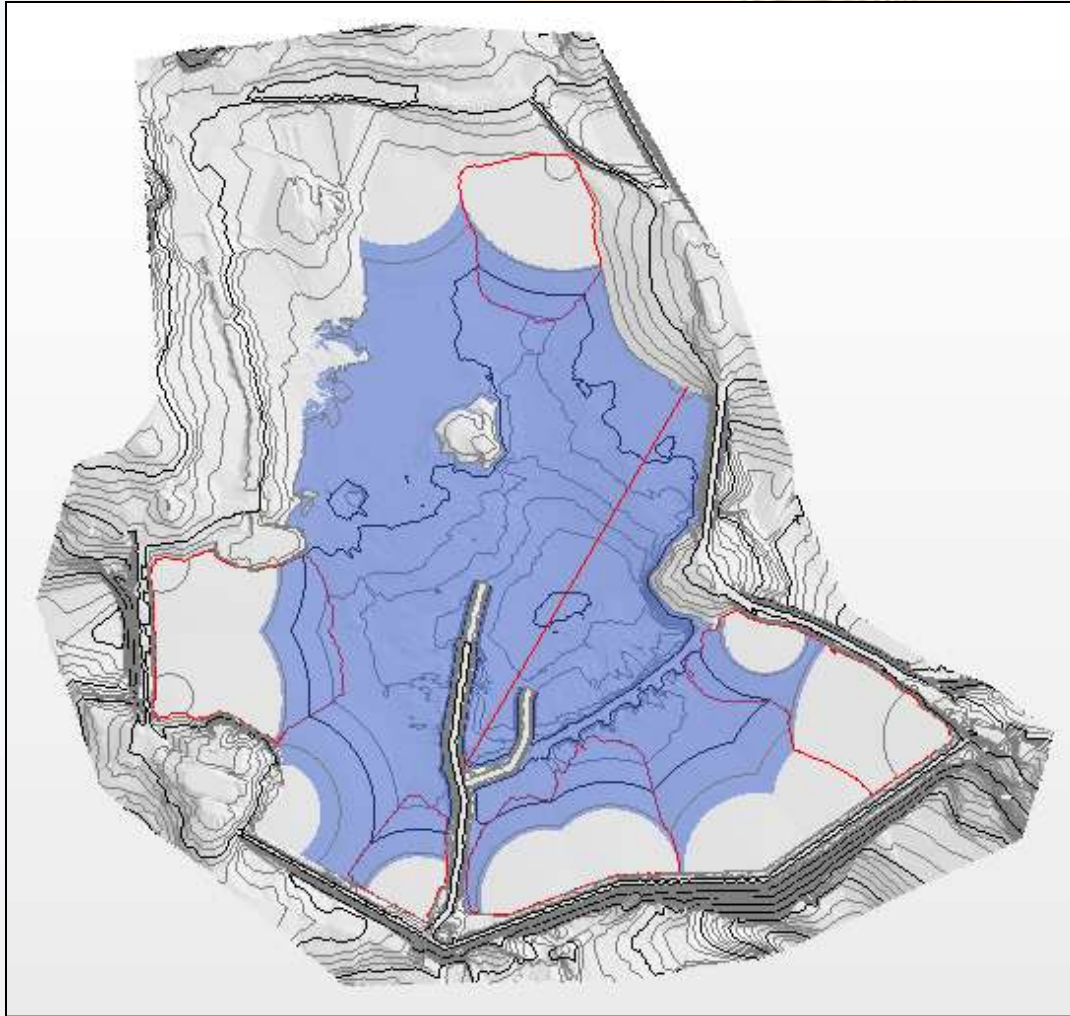
# Section View Plot

A section view along the alignment shown on the diagram will be included for each month. This will show a section view plotted on an elevation graph to show the change in pond topography across the reclaim water barge area. Left limit of the chart represents the barge area and as you look to the right on the graph you are going towards deposition point 7 (North-eastern direction).
