## Appendix J1

### Report: *Inspection Reports*

**RE: Response to Environmental Legal Compliance Audit Report - Agnico-Eagle Meadowbank Mine**

**Full Report Title:** 2013 Site Visit Report for the Nunavut Impact Review Board's Monitoring of Agnico-Eagle Mines Ltd.'s Meadowbank Gold Project (NIRB File No. 03MN107)

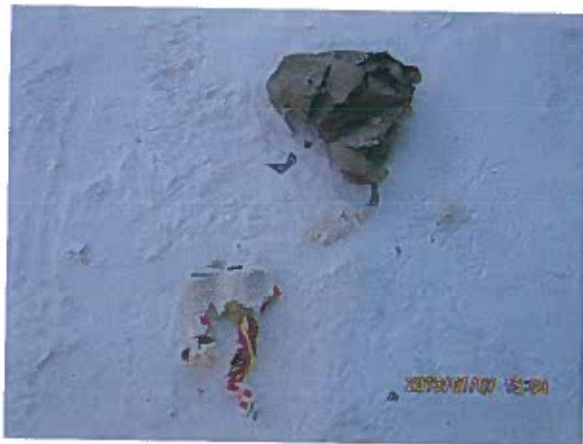
Chewed Garbage

**IMPORTANT:** Any person caught *feeding animals* or disposing of food related waste (wrappers and coffee) in an improper manner, including not disposing of food waste in the proper containers or at the landfill, will be met with disciplinary measures.

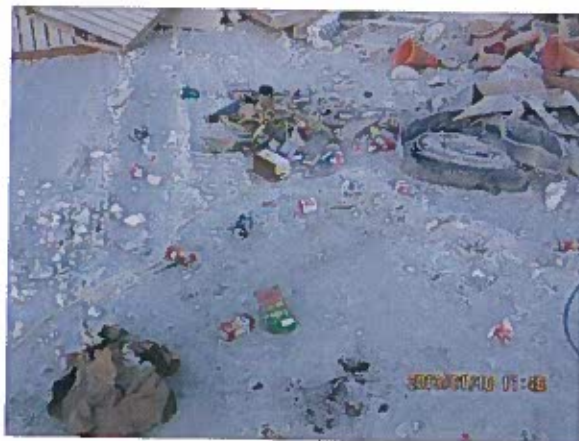
Food waste at Landfill

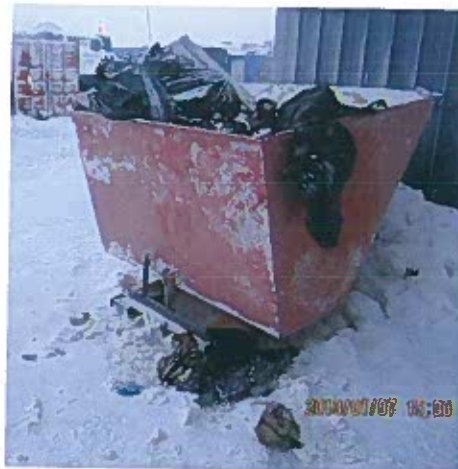
No Garbage Bags in Red Bins

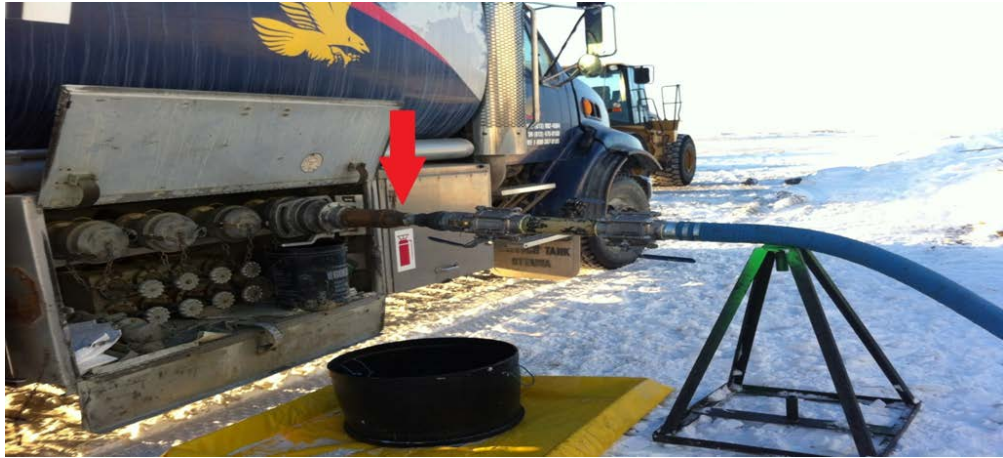
Prevent incident and /or accident</p>
<p>2- The road supervisor or Arctic Fuel Services supervisor, level 2 needs to unlock the valve at the tank with the identified key located in the key storage in the Baker Lake office.</p>	
<p>3- Both ends need to be prepared with environmental container (black container and yellow bottom container) as seen on the picture on top. Make sure to use the Ground from the truck and connect it to the tank in use.</p>

<p>4- The road supervisor or Arctic Fuel Services supervisor, level 2 needs to get the part that is to be connected to the truck. You can get that part in the fuel farm in a warm area. As shown with the red arrow.</p>

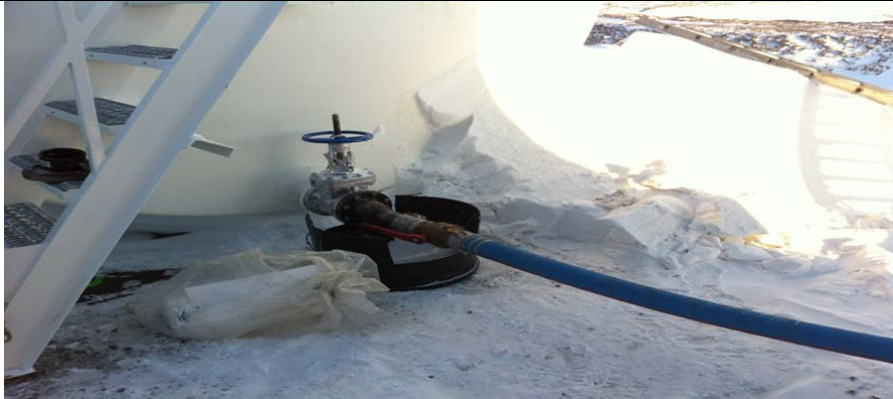
- 5- When all the containment is in place, connect the hose to the adaptor already connected to the truck, as shown on the picture below with the yellow arrow.

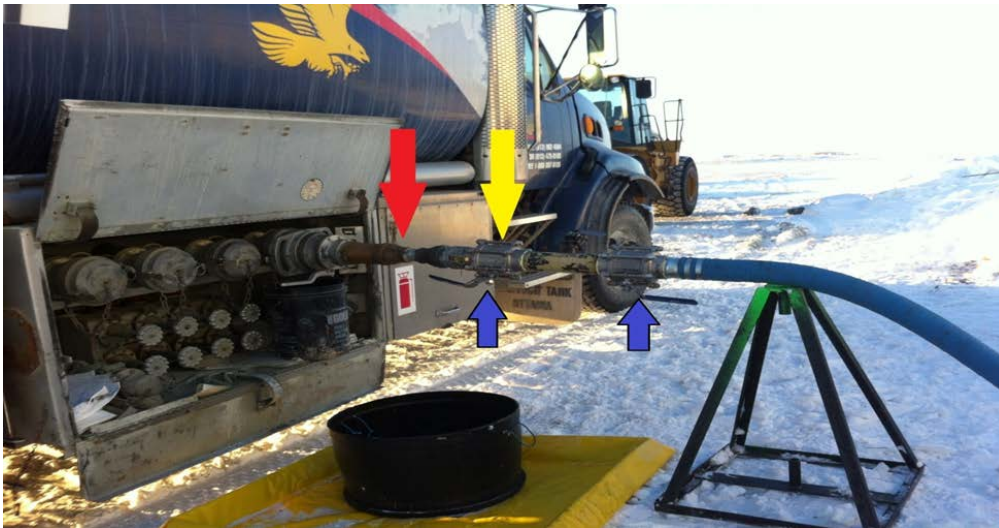
- 7- When all of this has been done, you can now unlock the 2 locks located on the main valve. As seen on the picture below with the blue arrow.

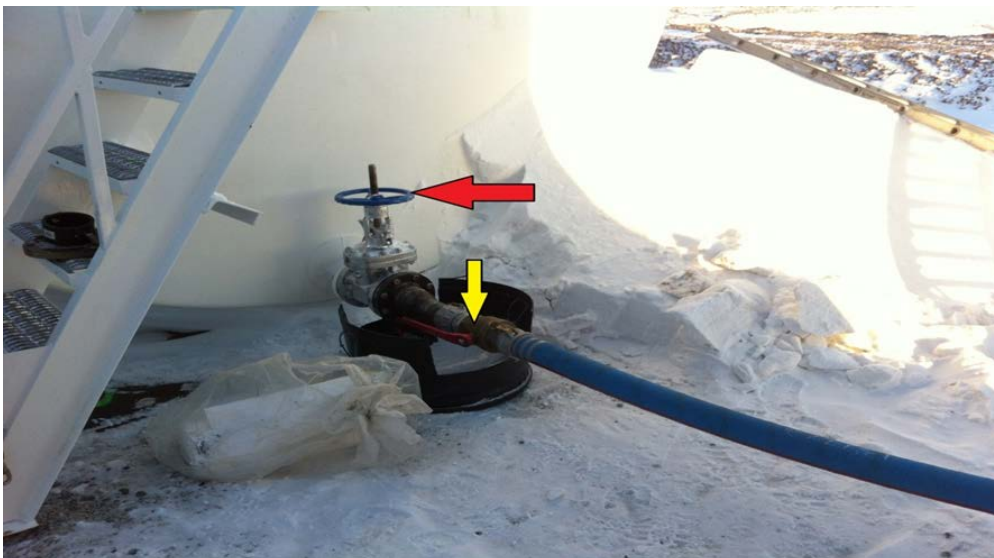
- 9- Open the Jet-A tank main valve all the way as shown on the picture below with the red arrow and then open the other valve as indicated by the yellow arrow in the exact position shown in the picture.

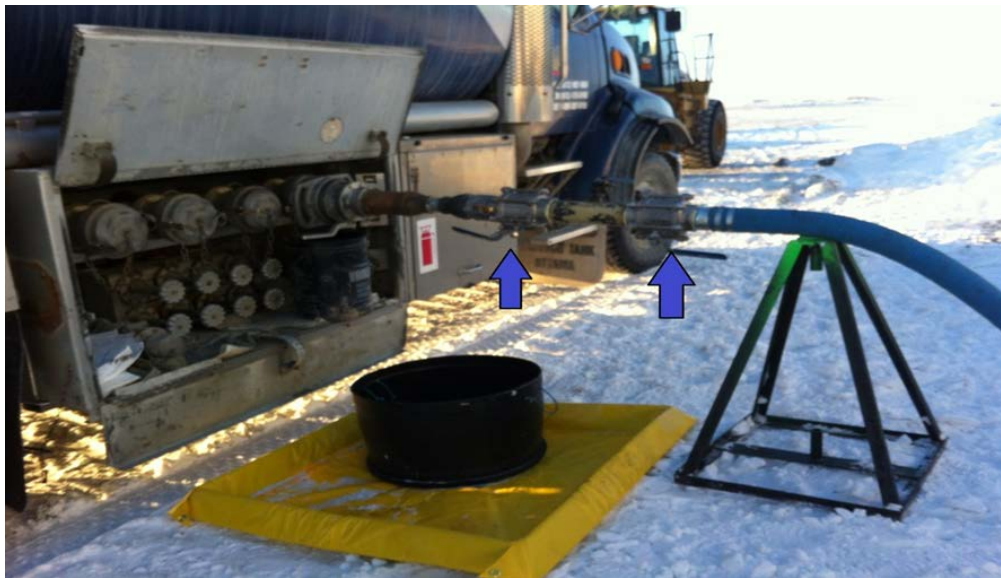
10- After, the person standing by the 2 main valves at the truck (as shown on the picture below) can open both valves to start loading the truck (gravity feed only).

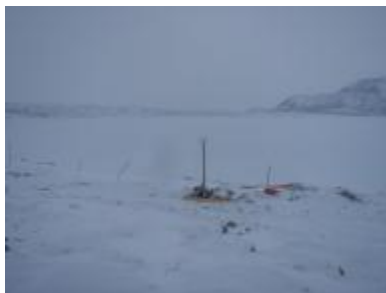
ST-5

The following are our locations with the signage:

**8) WL, Part F, s. 9:** *Signage was not posted at sampling locations as required by the permit. Corrective actions were being initiated at the time of the audit. Recommendations: Continue with ongoing actions.*

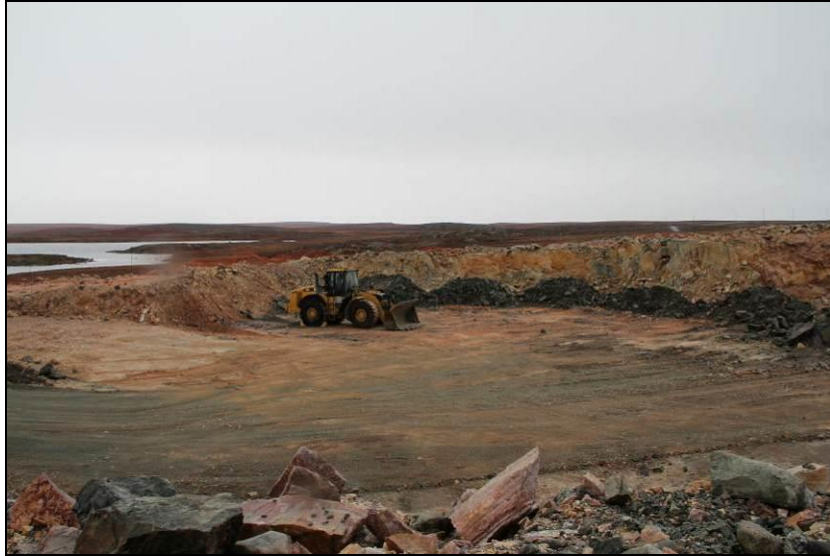
**Photo 3:** Quarry 5 in 2012

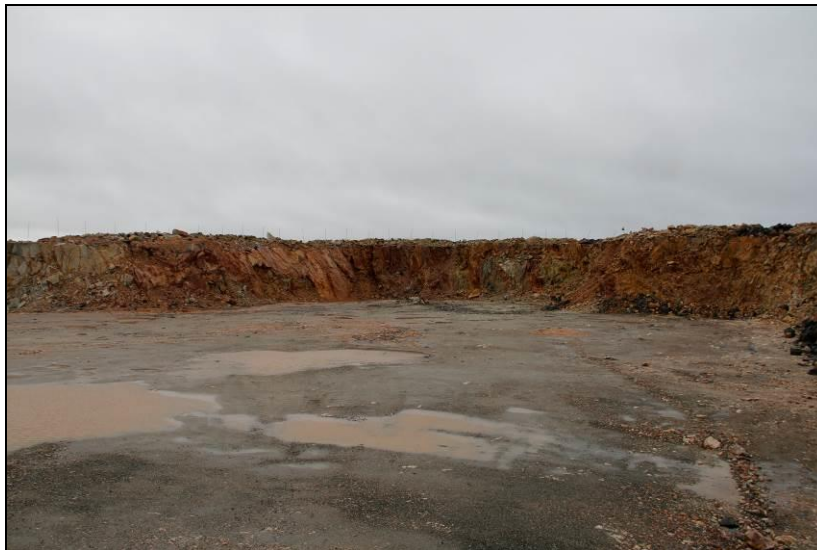
- c. AEM indicated that additional grid samples would be taken at both Quarry 5 and Quarry 22 (both sites previously used for storage of contaminated hydrocarbon soil) and confirmed that if samples indicate that no hydrocarbons are present, remediation of both quarries would commence. Photo 2 through Photo 4 show the condition of Quarry 5 from the storage of contaminated soils in 2011 to clean-up in 2013, while Photo 5 and Photo 6 show the condition of Quarry 22 in 2012 and 2013.

**Photo 4:** Quarry 5 in 2013

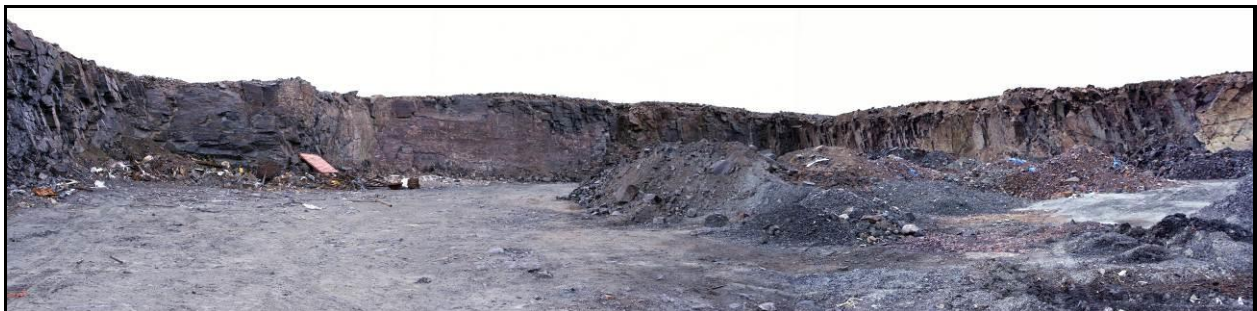
**Photo 5:** Quarry 22 in 2012, serving as a storage area for contaminated soil

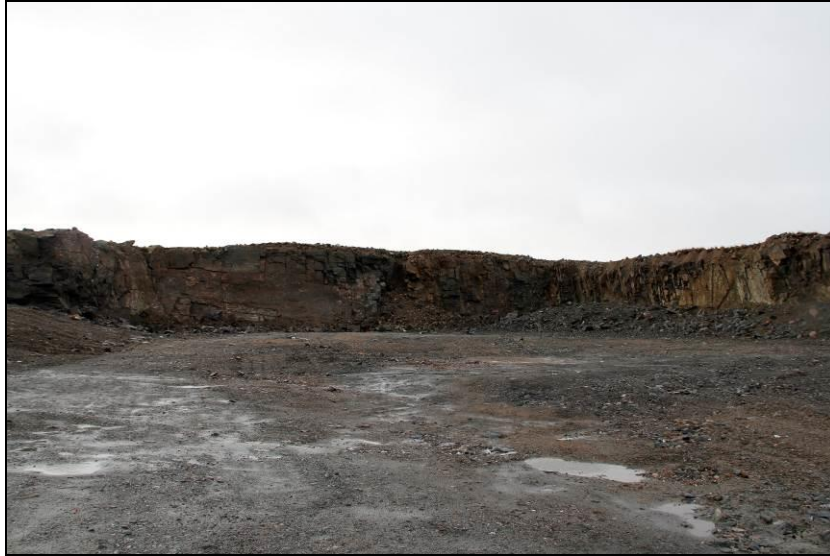
**Photo 6:** Quarry 22 in 2013

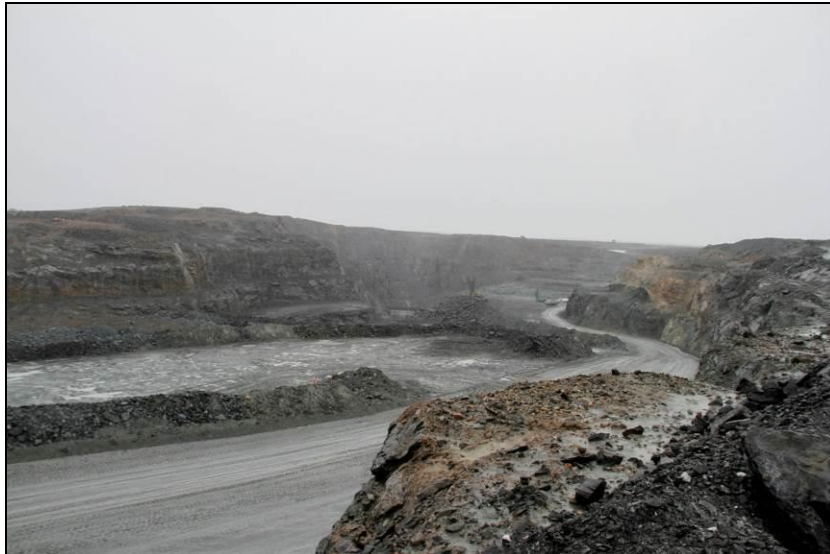
- d. The Monitoring Officer noted that the environmental emergency sea-cans containing booms, shovels, absorbent pads, and other miscellaneous spill response equipment were located at most bridge crossing (one was not observed at the km 22/23 bridge). Further, two additional environmental emergency sea-cans, one containing spill response equipment and another containing a boat with motor were located at the Baker Lake laydown facility.
- e. Active blasting and drilling were ongoing at the North, Central and South Portage pits, with daily geotechnical inspections being undertaken to ensure the safety of all employees and contractors working in the active mine area (see Photo 7).

**Photo 7:** Portage Pit

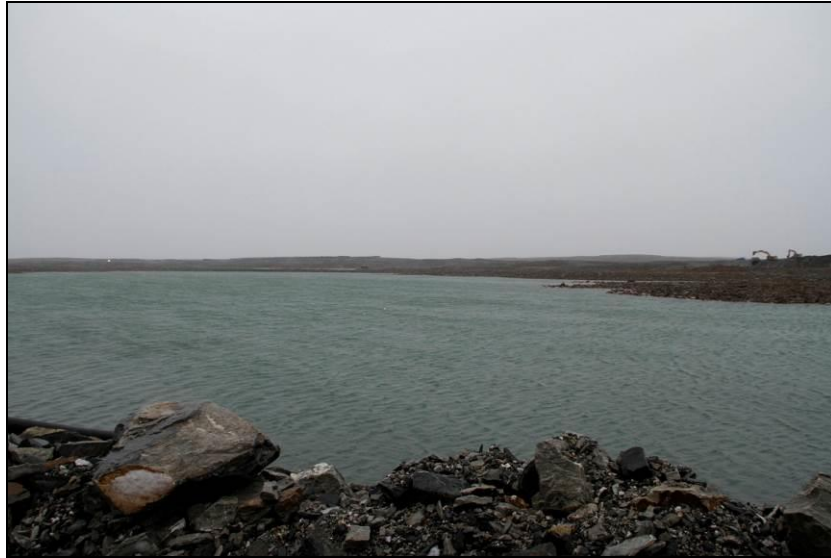
- g. Construction of the Vault Road was completed by the end of 2012 and AEM commenced stripping, quarrying and related construction activities in 2013 (Photo 9). During the site visit, it was noted that dewatering of Vault Lake would commence in late September, once the fish-out program had been completed (see Photo 10). Mining of Vault Pit is planned for 2014.

**Photo 10:** Site of future Cell B, Vault Lake Pit

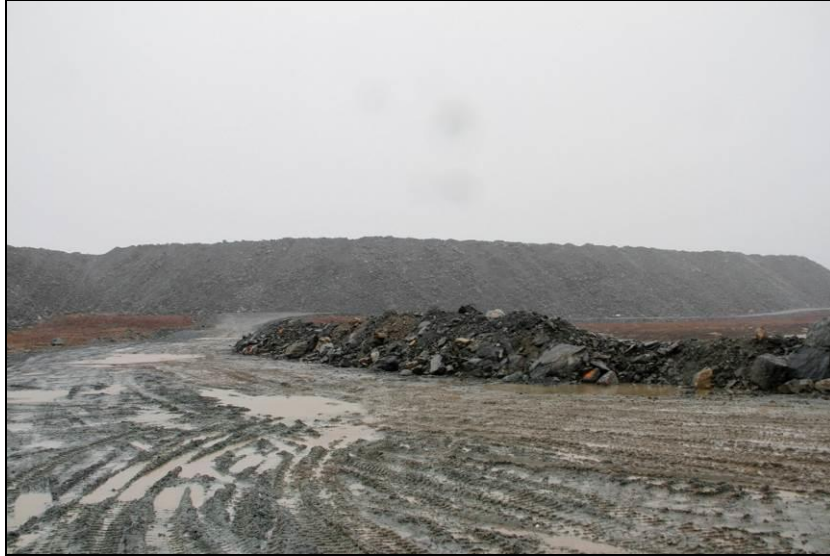
As per previous site visits, the Monitoring Officer noted in 2013 that AEM continued to segregate and store all domestic, hazardous, and combustible wastes in marked sea-cans prior to these materials being incinerated or shipped to appropriate and approved off-site disposal facilities (Photo 15). AEM indicated that sea-cans filled with waste are backhauled via truck haul to Baker Lake and are then moved via the annual sea lift to southern Canada (Photo 16). AEM has also initiated other recycling programs to reduce the amount of wastes going to the landfill; e.g., puncturing aerosol cans which could then be recycled as metal (Photo 17 and Photo 18).

**Photo 18:** Waste rock facility

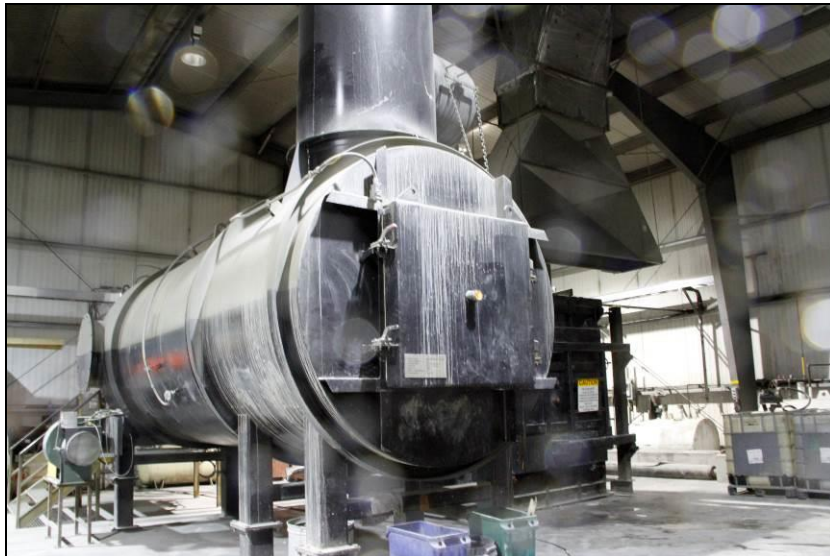
The Meadowbank site dual chamber forced air incinerator remains in service for the combustion of all non-hazardous, combustible materials at the site (Photo 19). AEM staff noted that approximately 1.7 tonnes of domestic garbage is incinerated per day; however, Mr. Buck indicated AEM has plans in place to continually improve waste management by reducing the amount of domestic garbage produced at site. Some examples include completely replacing paper coffee cups with plastic coffee cups, using plastic lunch boxes and trays instead of paper bags, recycling wood products by finding second uses for these at site or by backhauling it to Baker Lake where it may be claimed and used by community members.

**Photo 19:** Dual chamber forced air incinerator at the Meadowbank site

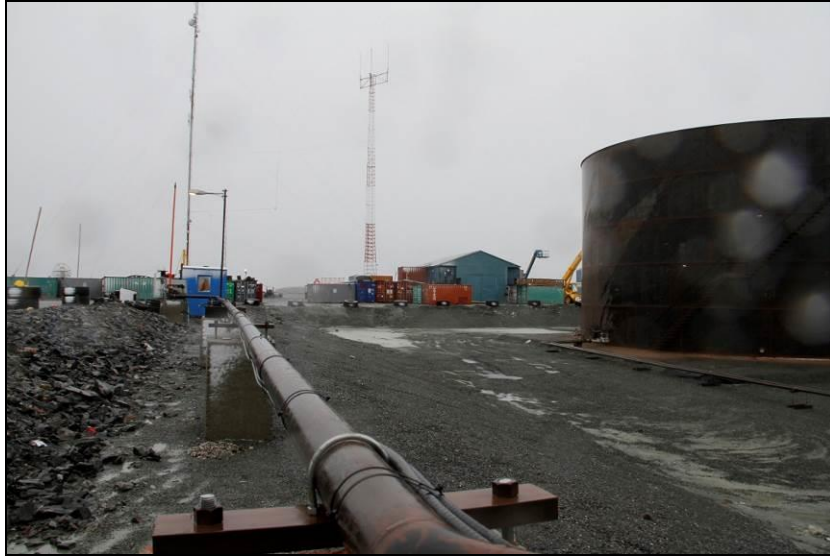
During the 2013 site visit, the Monitoring Officer observed that all of AEM’s fuel and hazardous materials associated with the Meadowbank project appeared to be stored in a safe and environmentally protective manner (i.e. secondary containment at fuel storage areas and secure containment of hazardous materials; see Photo 21 and Photo 22).

**Photo 21:** Meadowbank on-site fuel tank farm

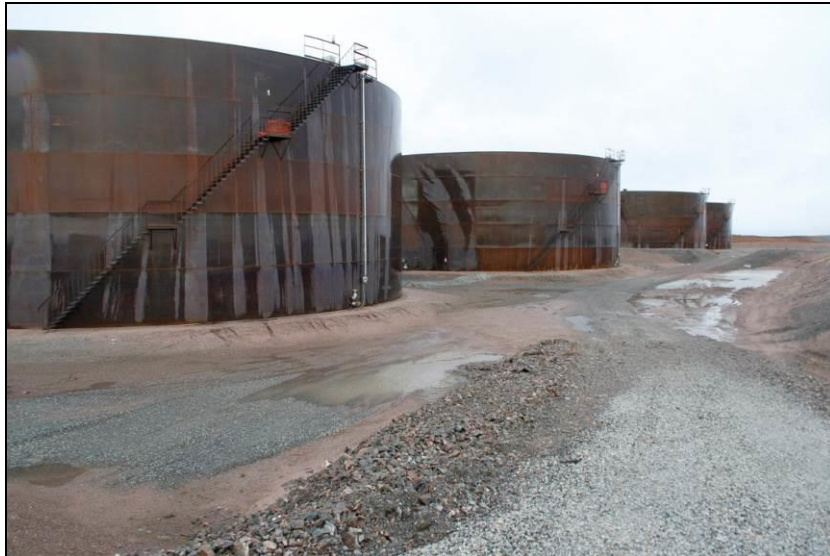
**Photo 22:** Baker Lake bulk fuel storage facility

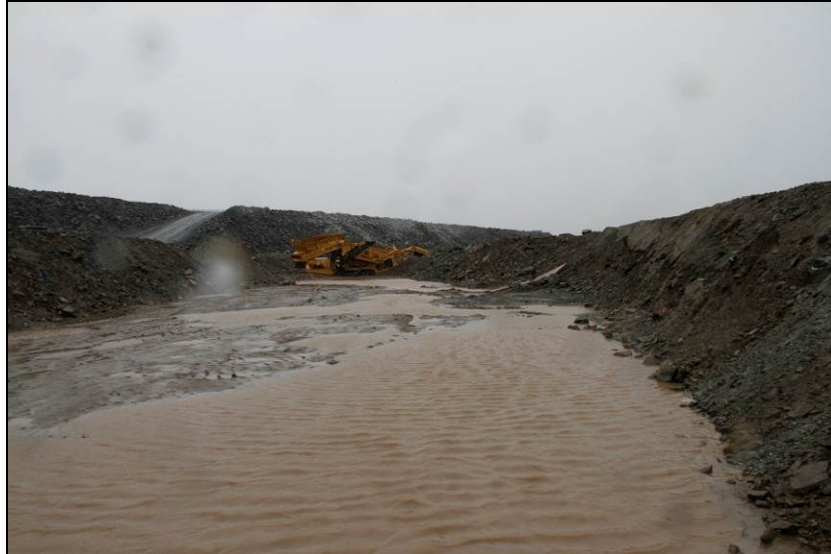
**Photo 1:** Contaminated soil storage/pilot remediation site

contaminated hydrocarbon soil worked very well and that AEM was planning on using the same technique next year for all hydrocarbon contaminated soils (see Photo 1). This method would be used instead of general landfarming techniques (see Landfarm Plan for further information [AEM, 2013]).

The Monitoring Officer notes that the pilot remediation program undertaken this year at the Meadowbank mine site appeared to have worked well. The Monitoring Officer was informed that the rate of biodegradation of the contaminated soil containing nutrients (sewage sludge) was faster compared to contaminated soils with no nutrients added. AEM indicated that it plans to use this method again next year for the treatment of all of its contaminated soils.

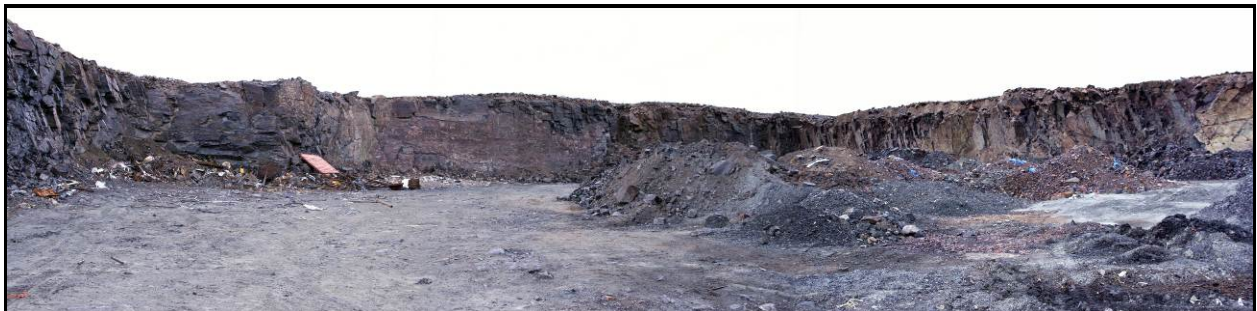
- c. AEM indicated that additional grid samples would be taken at both Quarry 5 and Quarry 22 (both sites previously used for storage of contaminated hydrocarbon soil) and confirmed that if samples indicate that no hydrocarbons are present, remediation of both quarries would commence. Photo 2 through Photo 4 show the condition of Quarry 5 from the storage of contaminated soils in 2011 to clean-up in 2013, while Photo 5 and Photo 6 show the condition of Quarry 22 in 2012 and 2013.

**Photo 5:** Quarry 22 in 2012, serving as a storage area for contaminated soil

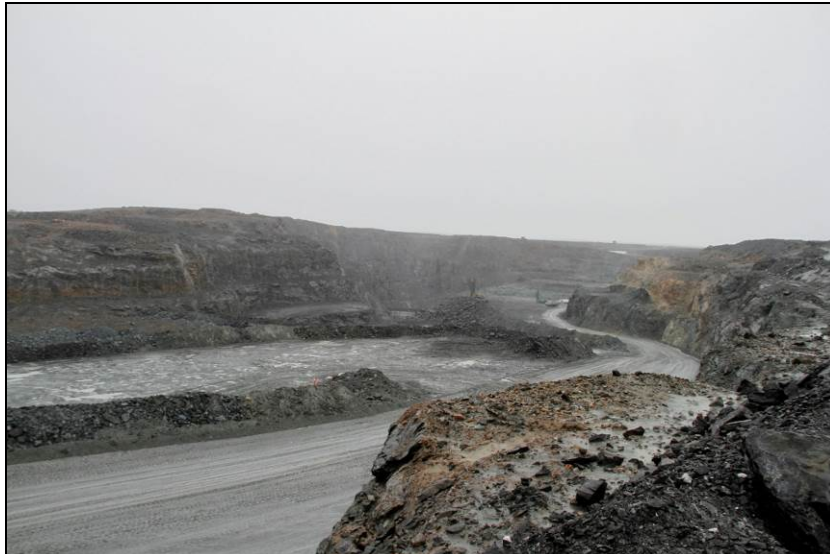
**Photo 7:** Portage Pit

- d. The Monitoring Officer noted that the environmental emergency sea-cans containing booms, shovels, absorbent pads, and other miscellaneous spill response equipment were located at most bridge crossing (one was not observed at the km 22/23 bridge). Further, two additional environmental emergency sea-cans, one containing spill response equipment and another containing a boat with motor were located at the Baker Lake laydown facility.
- e. Active blasting and drilling were ongoing at the North, Central and South Portage pits, with daily geotechnical inspections being undertaken to ensure the safety of all employees and contractors working in the active mine area (see Photo 7).

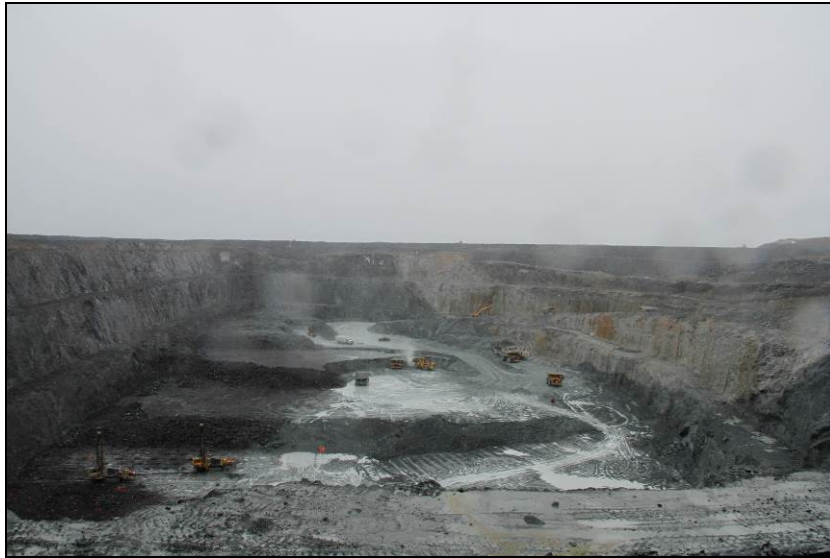
**Photo 8:** Bay-Goose basin

- f. Development of the Bay-Goose Dike and causeway was completed in 2010 with the instrumentation on the Bay-Goose Dike and the jet grouting program completed in 2011. Mining of the Bay-Goose basin started in May 2012 (Photo 8).

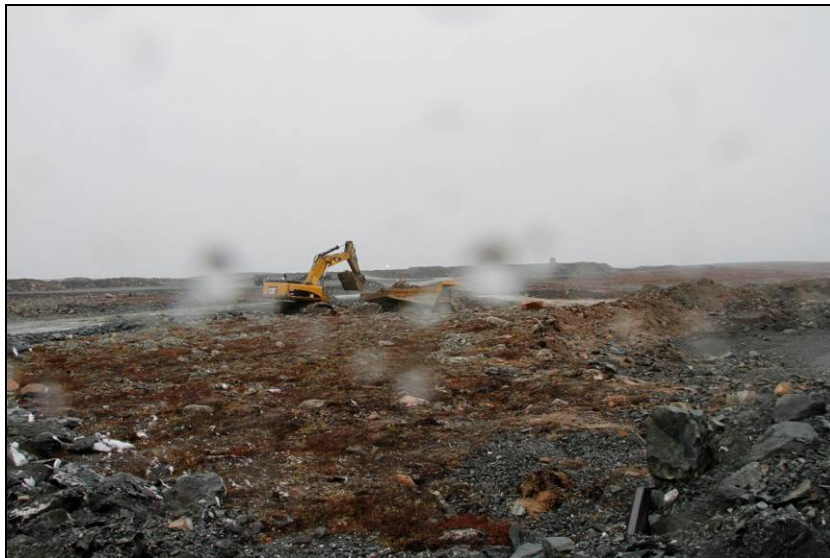
**Photo 9:** Vault Lake Quarry site

- g. Construction of the Vault Road was completed by the end of 2012 and AEM commenced stripping, quarrying and related construction activities in 2013 (Photo 9). During the site visit, it was noted that dewatering of Vault Lake would commence in late September, once the fish-out program had been completed (see Photo 10). Mining of Vault Pit is planned for 2014.

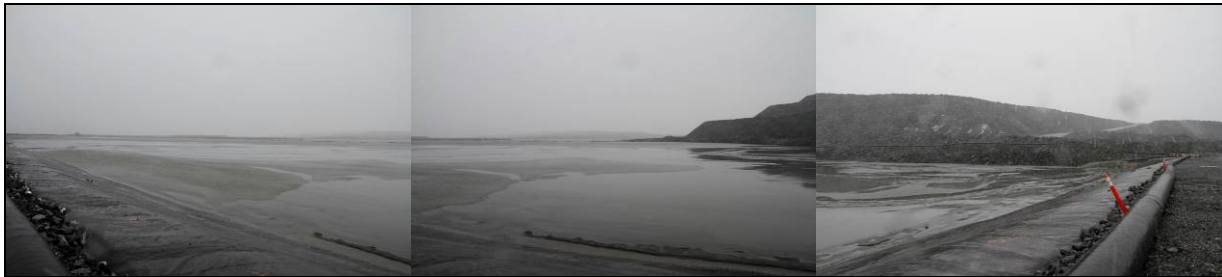
**Photo 11:** Tailings storage facility

- h. Inspection of the tailings storage facility did not reveal any apparent rips to the liners that were exposed within Saddle Dam #1 and Saddle Dam #2 (Photo 11).

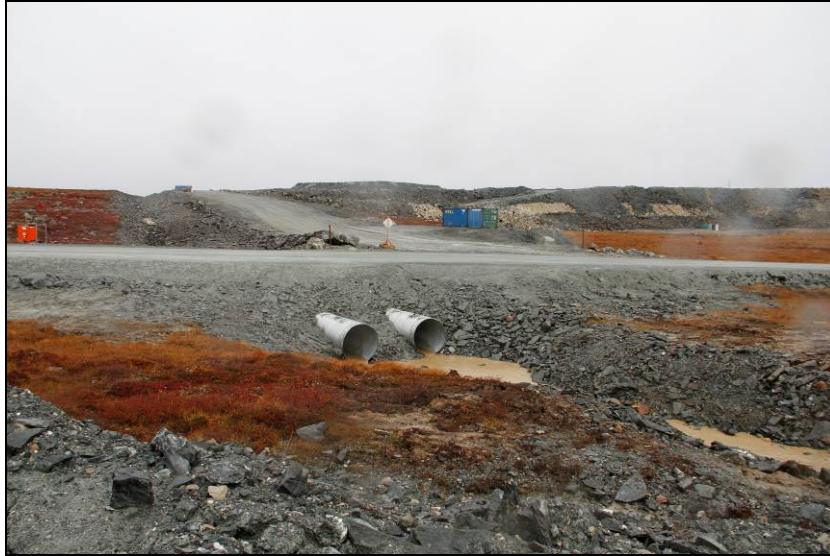
**Photo 12:** Diversion ditch around tailings facility

- i. Mr. Buck indicated that the extension of the airstrip was completed in April 2013. This extension was previously screened and approved pursuant to NIRB File No. 10XN039.
- j. The Monitoring Officer noted that the water within the diversion ditch constructed around the tailings facility and flowing into Third Portage Lake appeared to be turbid, likely due to the high volume of rainfall over the previous few days (see Photo 12). Further, the silt curtains installed in Third Portage Lake did not appear to be functioning properly as there was evidence of turbid water/sediment along the shoreline of Third Portage Lake and flowing into the lake. The diversion ditch was built to control freshet water from entering the tailings facility (see Photo 13).

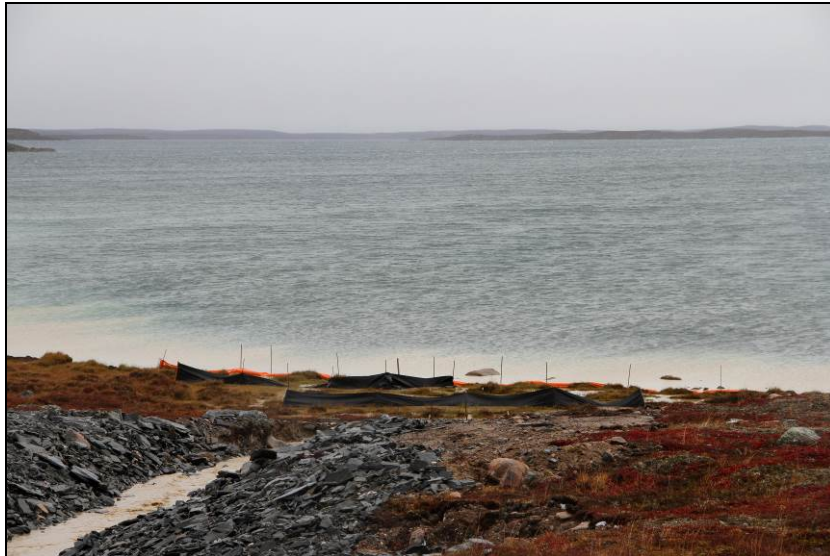
**Photo 13:** Turbid water entering Third Portage Lake

The Monitoring Officer also noted that the silt curtains put in place downstream of the diversion ditch flowing into Third Portage Lake did not appear to be functioning properly as sedimentation was evident around the shoreline and flowing into the lake.

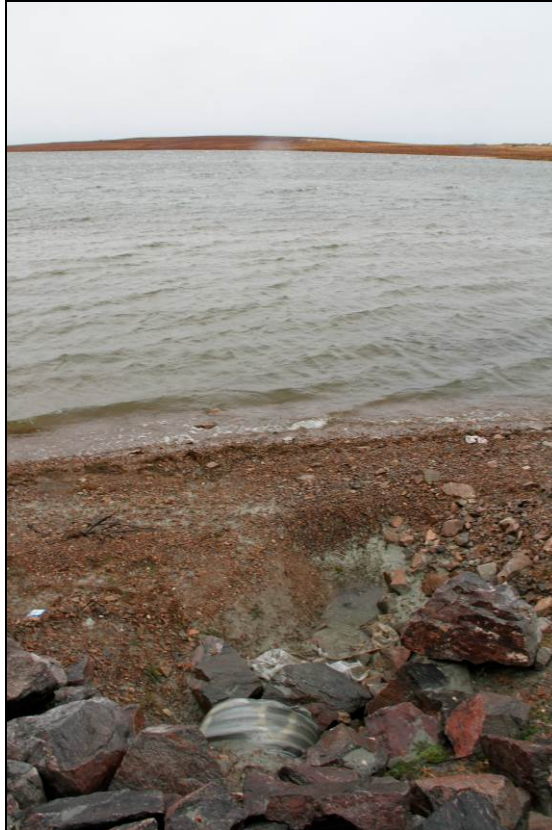
- k. While travelling along the access road from Meadowbank back to Baker Lake, the Monitoring Officer noted that the culvert crossing at kilometre 1 was damaged and that there was evidence of sediment deposit at the outflow of the culvert into Airport Lake. AEM indicated that it would assist the hamlet of Baker Lake in any work(s) required to upgrade/repair the culvert. AEM indicated that this particular section of the access road is owned by the hamlet and is not leased by AEM (see Photo 14).

**Photo 14:** Culvert crossing at kilometre 1

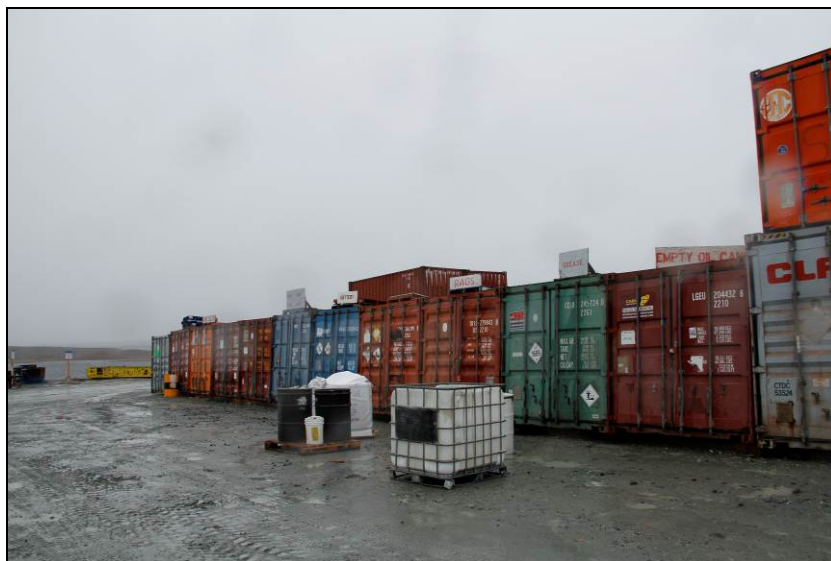
As per previous site visits, the Monitoring Officer noted in 2013 that AEM continued to segregate and store all domestic, hazardous, and combustible wastes in marked sea-cans prior to these materials being incinerated or shipped to appropriate and approved off-site disposal facilities (Photo 15). AEM indicated that sea-cans filled with waste are backhauled via truck haul to Baker Lake and are then moved via the annual sea lift to southern Canada (Photo 16). AEM has also initiated other recycling programs to reduce the amount of wastes going to the landfill; e.g., puncturing aerosol cans which could then be recycled as metal (Photo 17 and Photo 18).

**Photo 15:** Sea-cans used for waste segregation and storage area

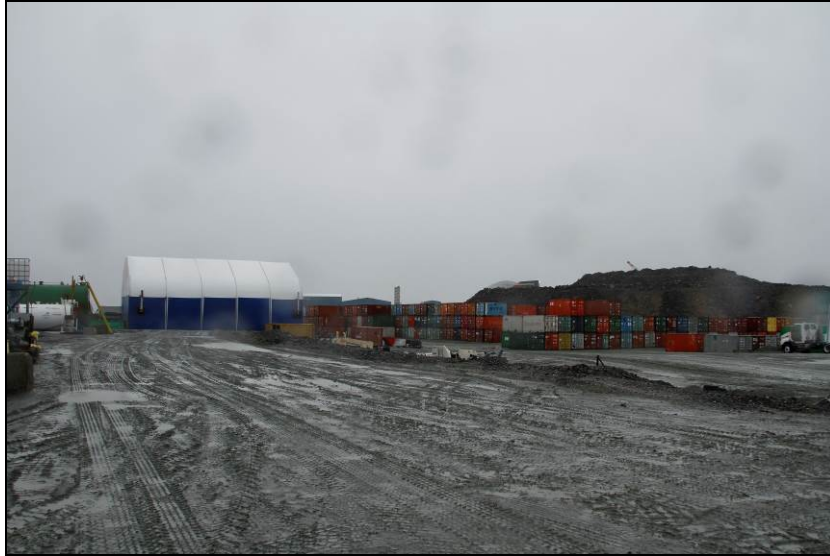
**Photo 16:** Sea-cans waiting to be backhauled

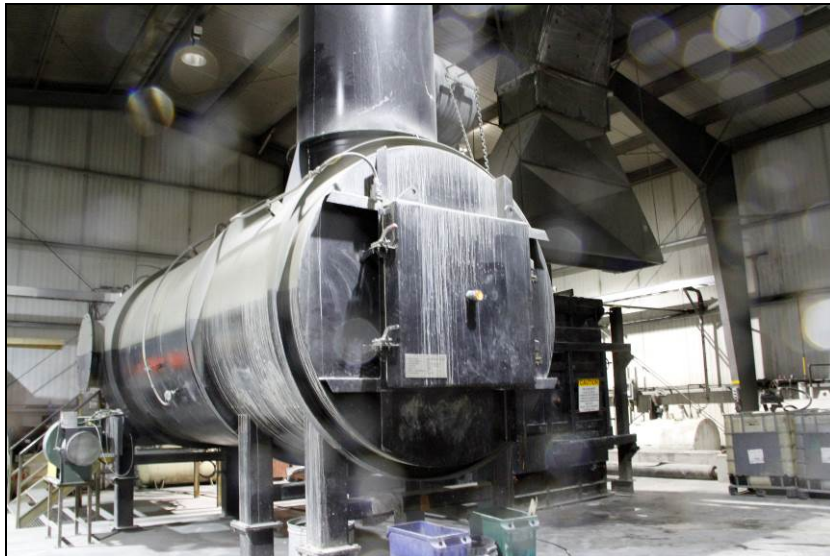
**Photo 19:** Dual chamber forced air incinerator at the Meadowbank site

The Meadowbank site dual chamber forced air incinerator remains in service for the combustion of all non-hazardous, combustible materials at the site (Photo 19). AEM staff noted that approximately 1.7 tonnes of domestic garbage is incinerated per day; however, Mr. Buck indicated AEM has plans in place to continually improve waste management by reducing the amount of domestic garbage produced at site. Some examples include completely replacing paper coffee cups with plastic coffee cups, using plastic lunch boxes and trays instead of paper bags, recycling wood products by finding second uses for these at site or by backhauling it to Baker Lake where it may be claimed and used by community members.

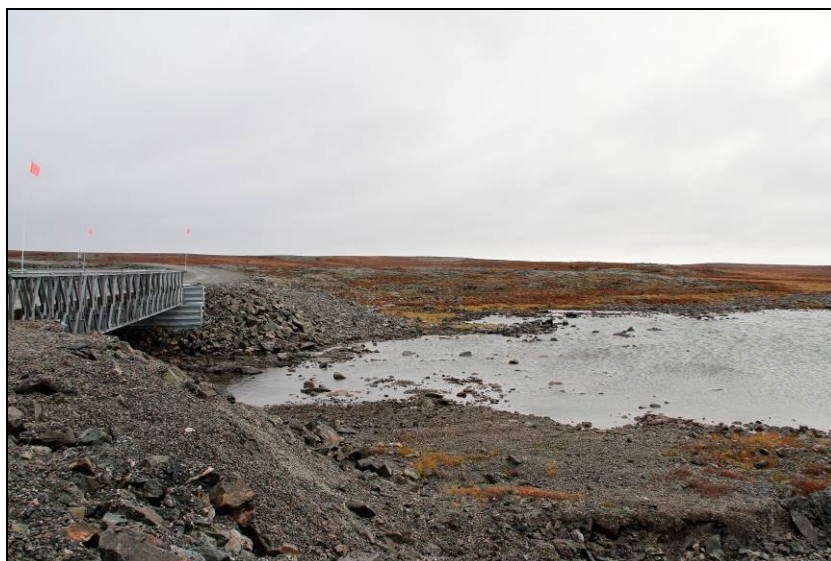
**Photo 20:** Bridge near kilometre 22

Mr. Buck indicated that clean-up of the spill that occurred near kilometre 22 of the access road in October 2010 was complete and the booms previously deployed in the watercourse had been removed in July 2013 (Photo 20). Mr. Buck confirmed that the site would continue to be monitored as part of AEM’s aquatic effects monitoring program.

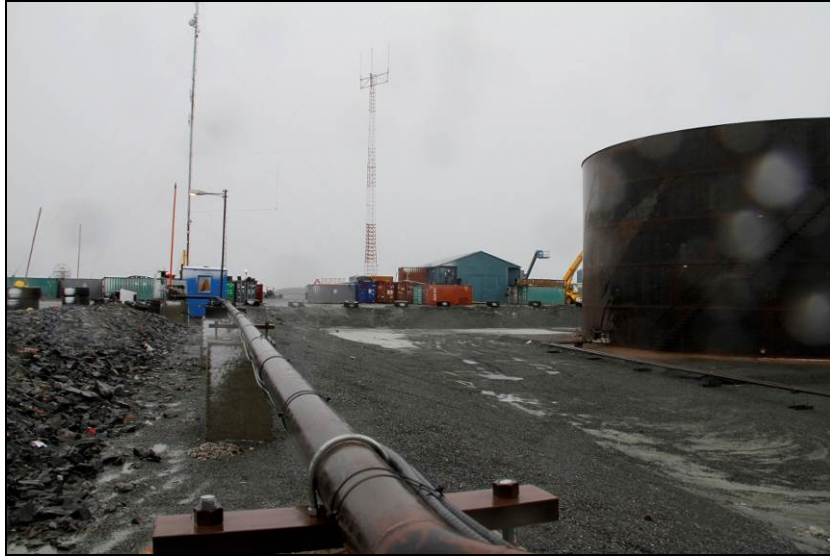
**Photo 21:** Meadowbank on-site fuel tank farm

During the 2013 site visit, the Monitoring Officer observed that all of AEM’s fuel and hazardous materials associated with the Meadowbank project appeared to be stored in a safe and environmentally protective manner (i.e. secondary containment at fuel storage areas and secure containment of hazardous materials; see Photo 21 and Photo 22).

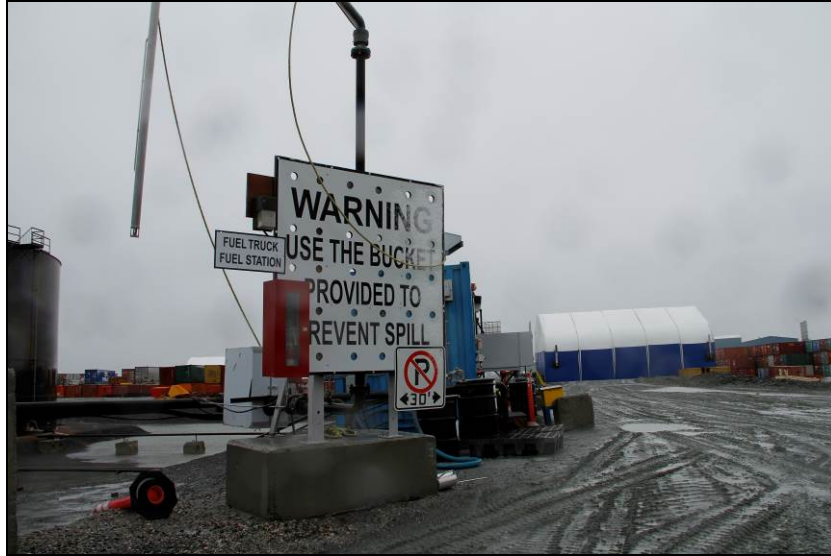
**Photo 23:** Meadowbank on-site fuel transfer station

The fuel transfer stations on site (Photo 23) and at the Baker Lake bulk fuel storage facility (Photo 24) appeared to be well contained and properly set up for the re-fuelling of vehicles. No hydrocarbon odours were noted at either the Meadowbank fuel tank farm or the Baker Lake bulk fuel storage facility. No sheen was observed on the water within the Meadowbank fuel tank farm or the Baker Lake bulk fuel storage facility.

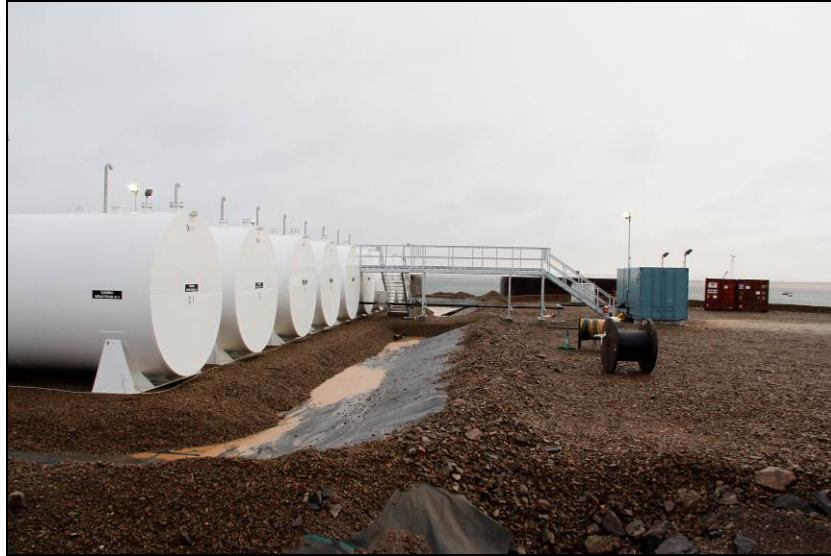
**Photo 25:** Jet-A pad at Baker Lake storage facility

The Monitoring Officer noted that a Jet-A pad had been installed near the Baker Lake bulk fuel storage facility and that it had 20 fuel tanks in place (Photo 25).

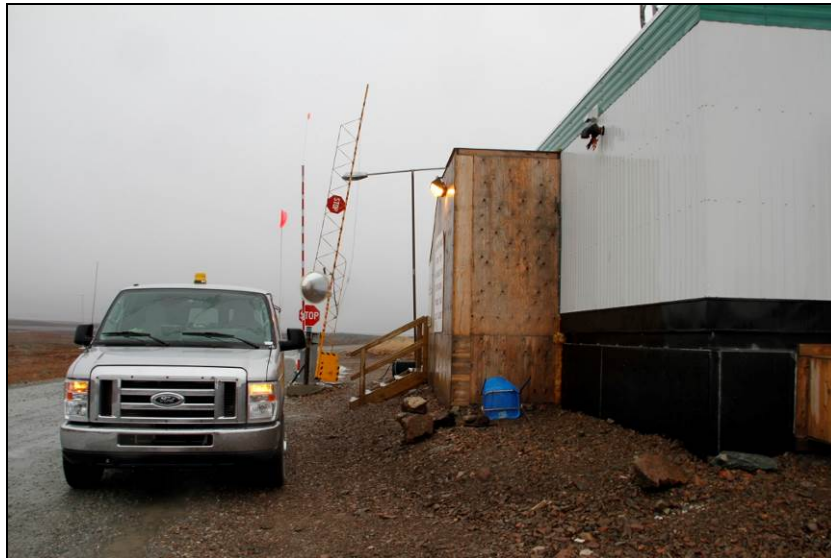
**Photo 26:** Gatehouse at kilometre 5, near Baker Lake

AEM maintains one gatehouse at kilometre 5 of the access road, and another gatehouse close to the entrance to the mine site and camp at Meadowbank. Both gatehouses are manned by guards who monitor the safety and security of all personnel using the road. All traffic is required to check in (via radio or in person) with the employee at the gatehouse prior to proceeding past either gatehouse along the road (see Photo 26). The AEM employee manning the kilometre 5 gatehouse maintains a daily logbook of all persons travelling the access road for non-mine use. Members of the public travelling along the road are required to sign-off an indication of having read AEM's *All Weather Private Access Road Safety Rules & Procedures for Road Access* policy prior to being granted access to the road.

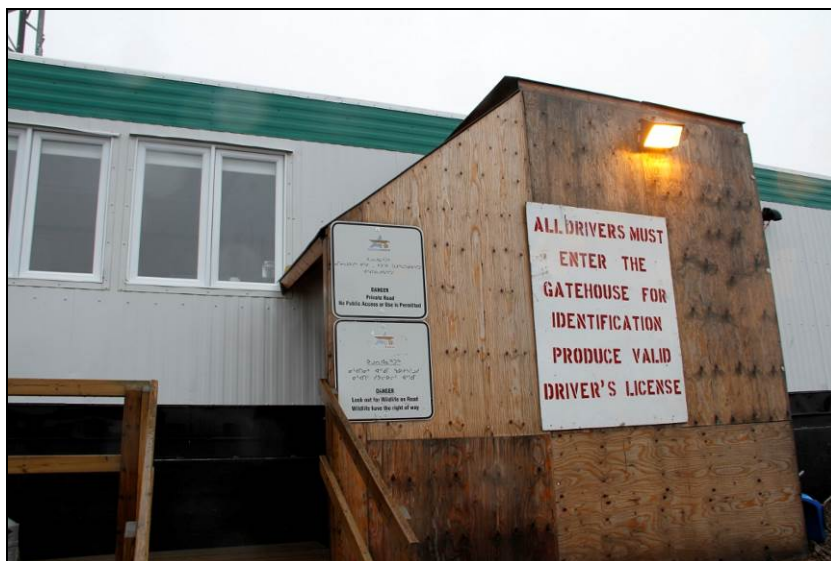
As per Condition 32(b), AEM submitted a copy of its updated Transportation Management Plan to the NIRB on May 13, 2010. One of the features of the access road as described within the plan is the placement of refuge stations every 10 kilometres. The Monitoring Officer noted that these refuge stations (emergency sea-cans) were not located on the road and was informed by Mr. Buck in 2012 that the sea-cans were removed because items within the stations were being stolen and that the refuge stations were not serving the original and intended purpose. The signs as required per Condition 32(c) were posted in both English and Inuktitut at the gatehouse (Photo 27), at each major bridge crossing (on the side of the environmental emergency sea-cans) and at every 10 kilometre intervals along the road.

**Photo 27:** Signs posted at gatehouse at kilometre 5

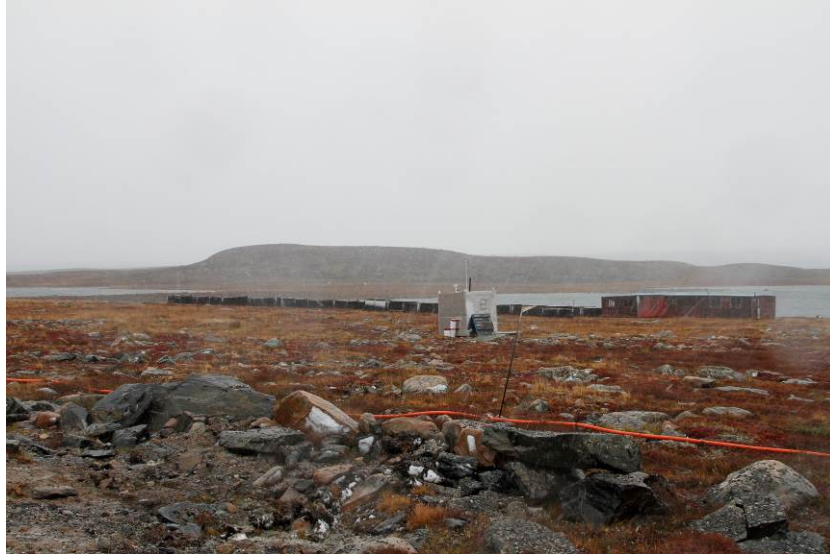
**Photo 28:** Air monitoring station

The air monitoring stations were installed by the end of October 2011 and monitoring started in November 2011 (see Photo 28). The partisol sampling stations required heated shelter and electricity in order to operate properly, and these were installed in 2012. During the 2013 site visit, Mr. Buck noted that an air monitoring station installed in 2012 near the Vault Lake road had been relocated. The road alignment to Vault Lake was modified from the original design plan which in turn required that the air monitoring station be moved to a location further away from the road.

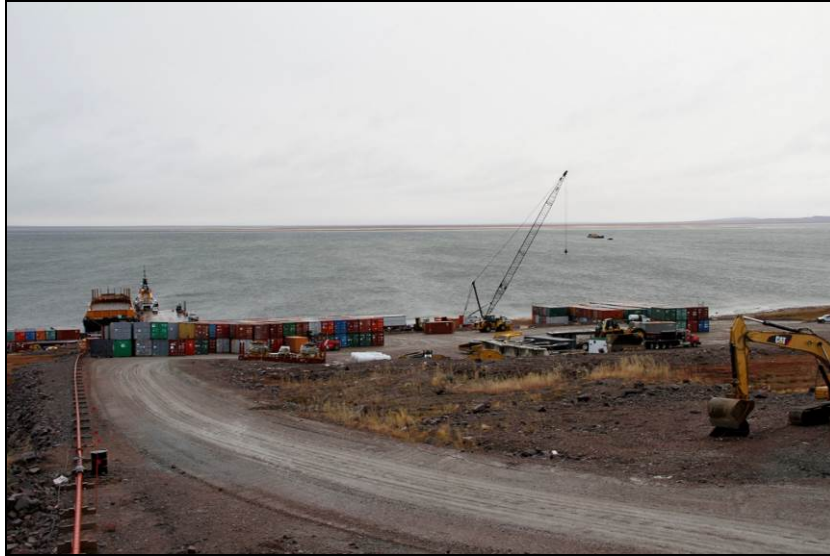
**Photo 29:** Bake Lake dock and laydown facility

During the visit to the Baker Lake bulk fuel storage facility/marshalling area, the Monitoring Officer noted that a security office was located at the shore with AEM employees on site. The Monitoring Officer did note that these areas were kept impressively clean with sea-cans well organized during the 2013 site visit (see Photo 29).
