Report: 2014 KIA Quarterly Reports

MEADOWBANK DIVISION

Production Lease KVPL08D280

2014 First Quarter Report

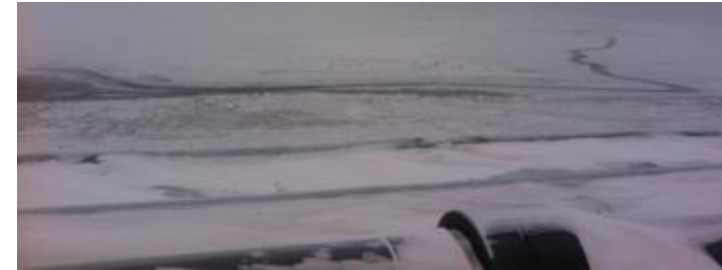
- It was observed that the tailings (slurry) was flowing over the tailings beach through long channels

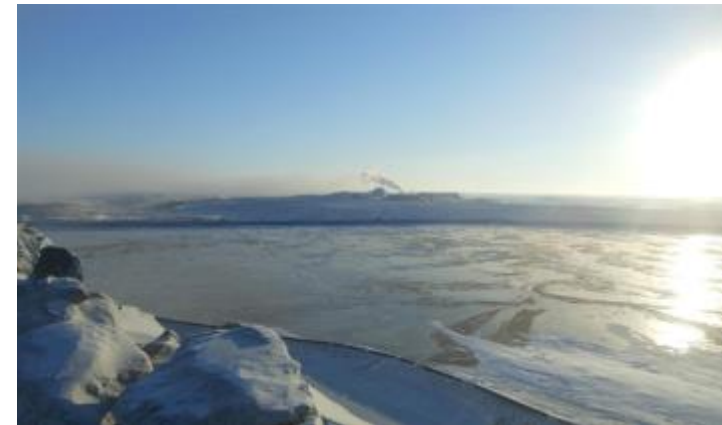
- Slurry was pumped to the mill by the reclaim pump
- It was also observed that the reclaim barge no longer floated (i.e. did not follow the ice elevation)
- Mill began running only with freshwater

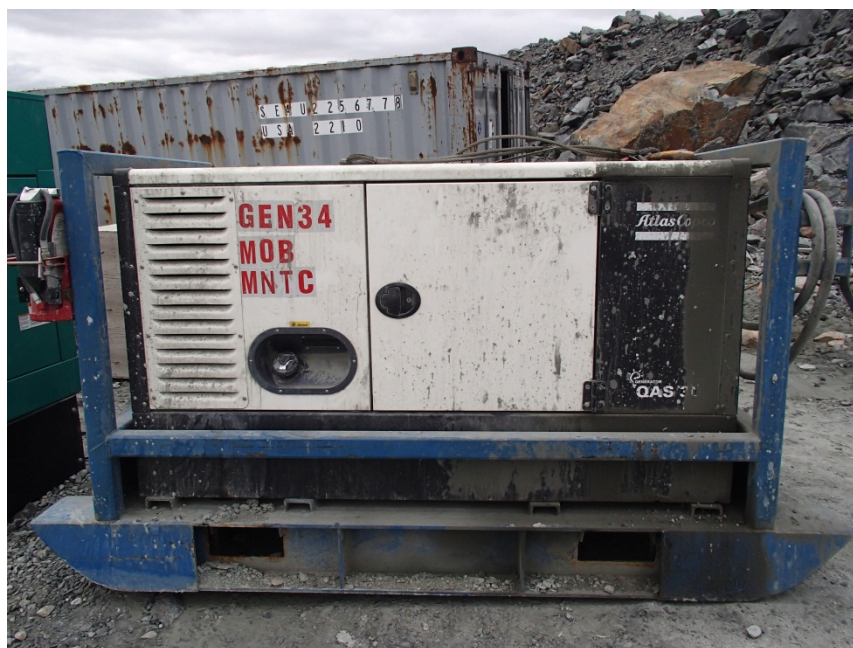
- 1- Measure the depth of the ice in the well – use existing well logs to document all activity. This is important for report preparation.
- 2- Ask for an electrician to plug the heat trace to the generator (Atlas Copco, QAS 30)

- 3- Monitor the ice and water depth every twelve hours or so.
- 4- Once the ice level has been melted to a depth of over 150 meters, we can start to purge.

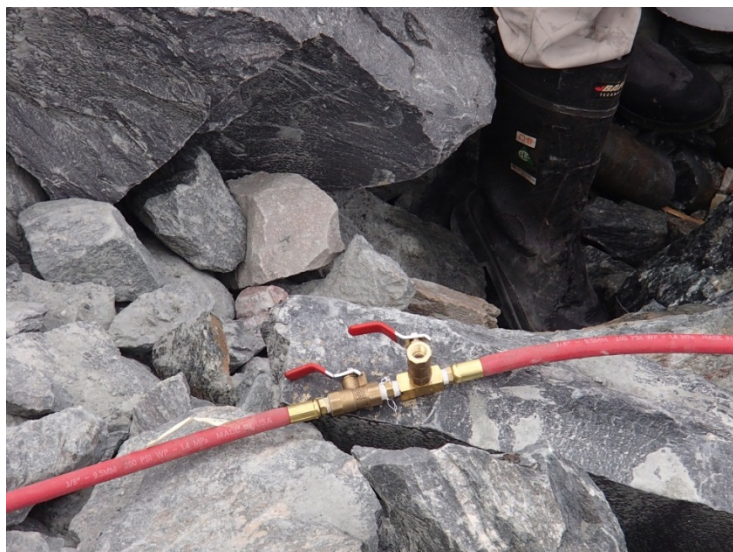
- 2- Place the 1 inch Waterra into the well to about 30 meters below the water level.
- 3- Place the rings (the smaller one first and then larger one after) onto the tubing and screw the fitting on the Waterra.
- 4- Connect the fitting to the red hose and then connect the red hose to the compressor.
- 5- Plug the compressor into the generator (make sure that the valves are close).

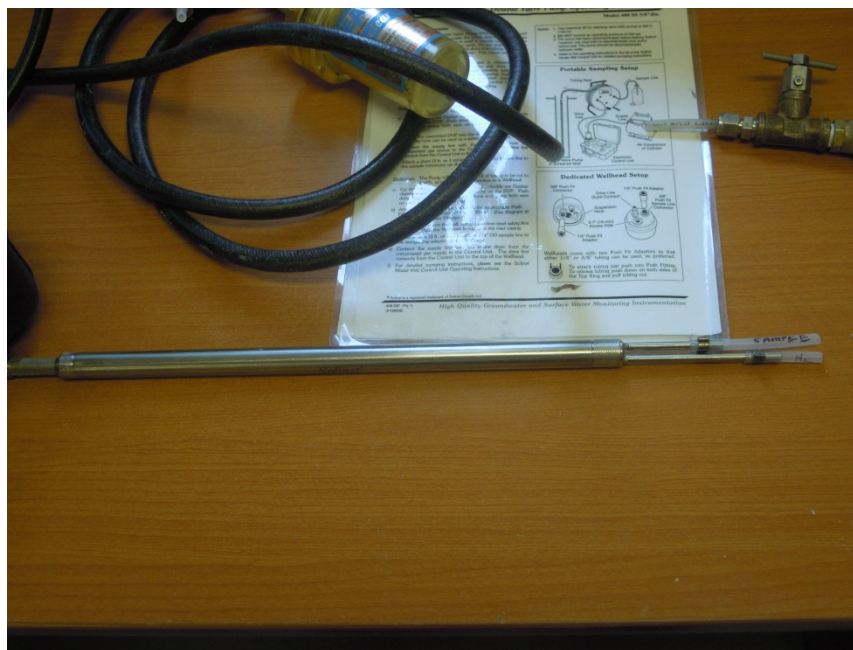
- 1- Place the ¼ inch double waterra line on the Solinst double valve pump.
- 2- Tighten the waterra with the rings

- 3- One Waterra line will be bring the sample water and one will send Nitrogen to the pump. Make sure to identify which line is the one for Nitrogen and which one is the line for water (longest metal tale on the pump is for nitrogen) (see photos).
- 4- On the nitrogen waterra line, place 2 rings and a bolt and place it on the 90°adaptr and the black hose with the moisture trap.

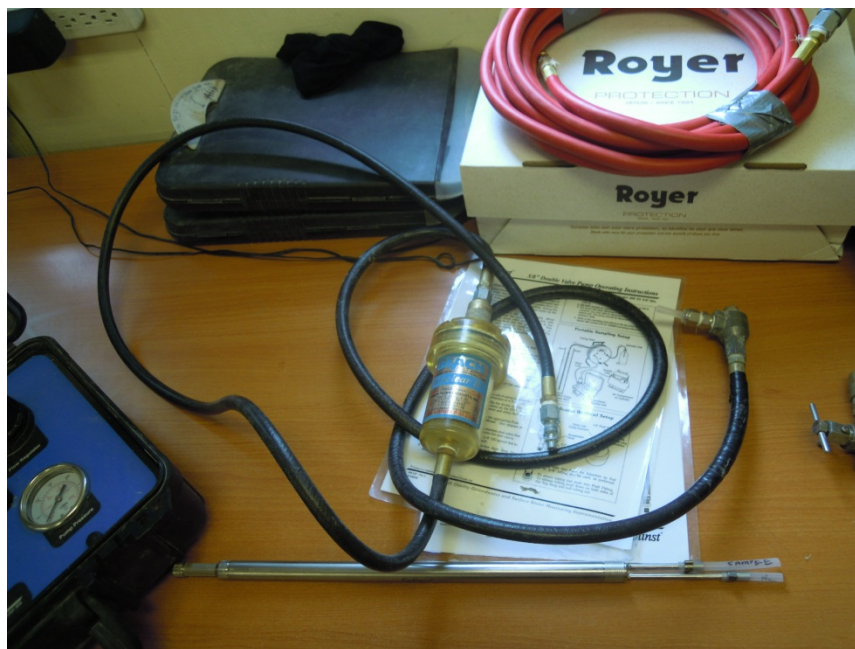
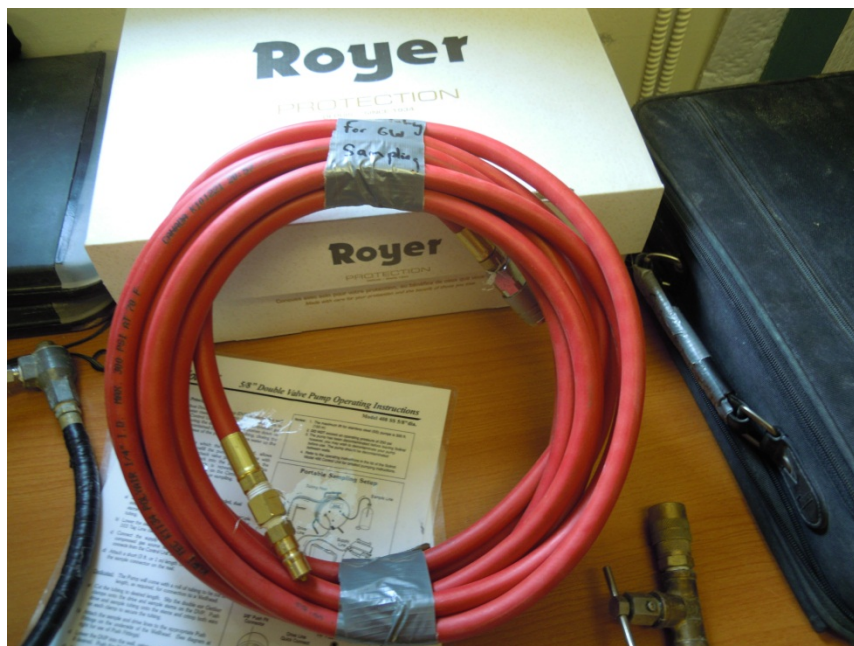
- 5- Connect the black hose to the Nitrogen control box (AIR OUT)
- 6- Plug the red hose to the control box (AIR IN).
- 7- Plug the other end of the red hose to the ``T`` regulator with the gauge.

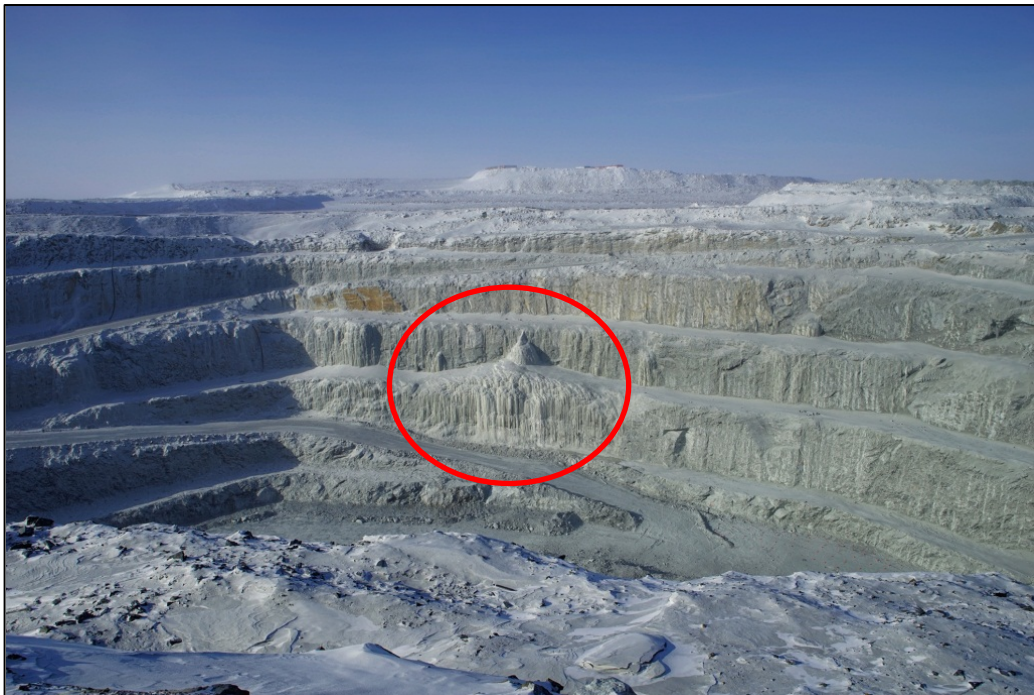
Figure 2-1: Goose pit West Wall

With the amount of ice present on the west walls in Goose pit, as shown in Figure 2-1, special attention must be taken when ice is removed from the walls. Periodically, ice removal is to be performed with an excavator to prevent any ice overhangs forming over the ramp.

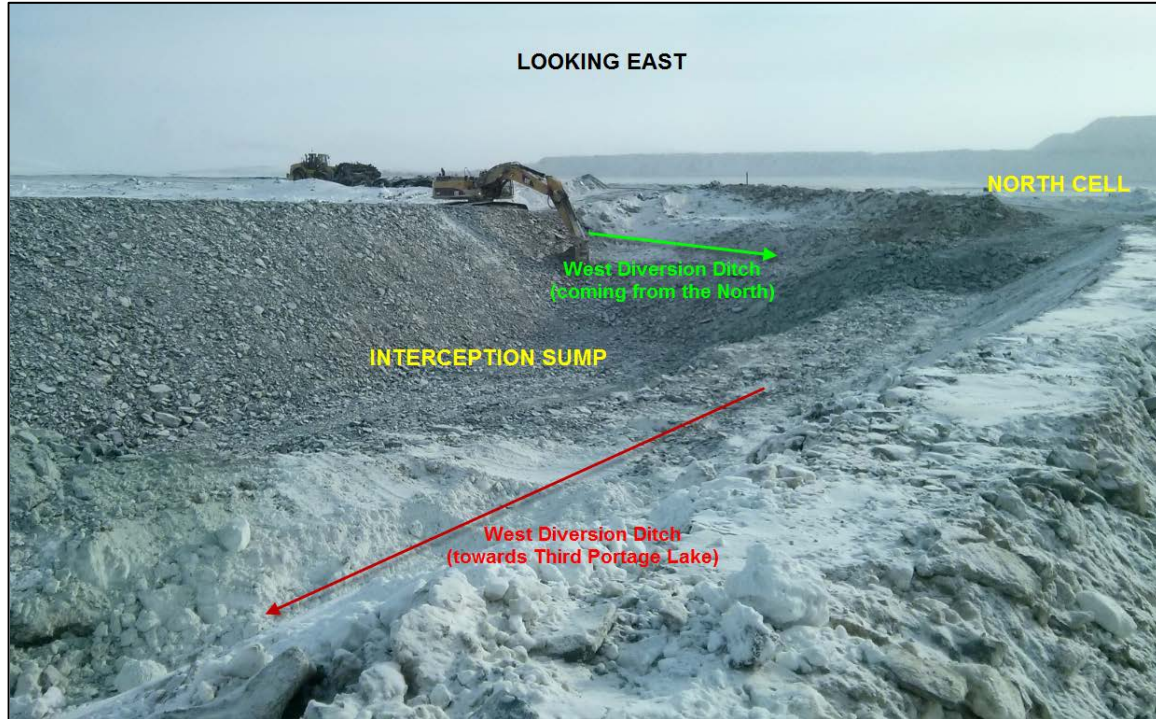
Figure 2-8: North Cell West Diversion ditch interception sump

As a further precaution AEM constructed a retention sump located at the west diversion ditch elbow location. The sump has a capacity of 3000 m³. The sump is designed to intercept water coming from the most critical parts of the West Ditch. Sample monitoring will determine if there is any seepage from the TSF or elevated TSS. If seepage is detected a temporary dam will be placed in the ditch downstream from the sump and a pumping system will be installed which would discharge the water from the sump to the TSF. These measures will prevent any contaminated water from reaching Third Portage Lake. This sump will also act as a settling pond to prevent water with elevated TSS from reaching Third Portage Lake. Daily inspections will be conducted during the freshet. Figure 2-8 shows the North Cell interception/settling sump after the completion of the construction.

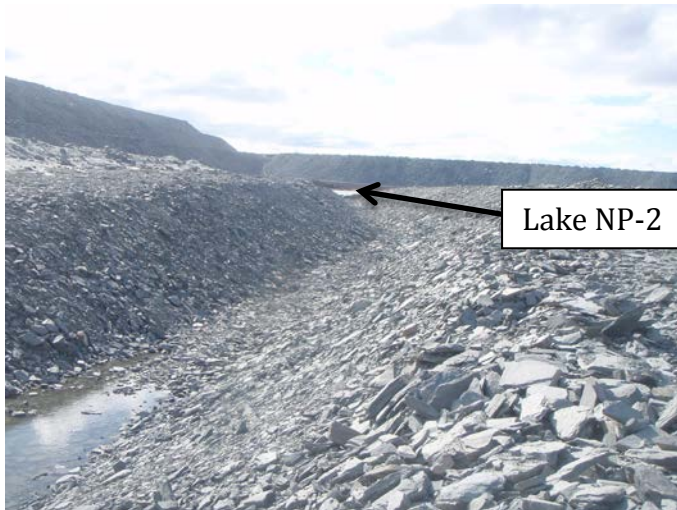
Photo 1: Channel between NP-2 Lake and Dogleg North Pond

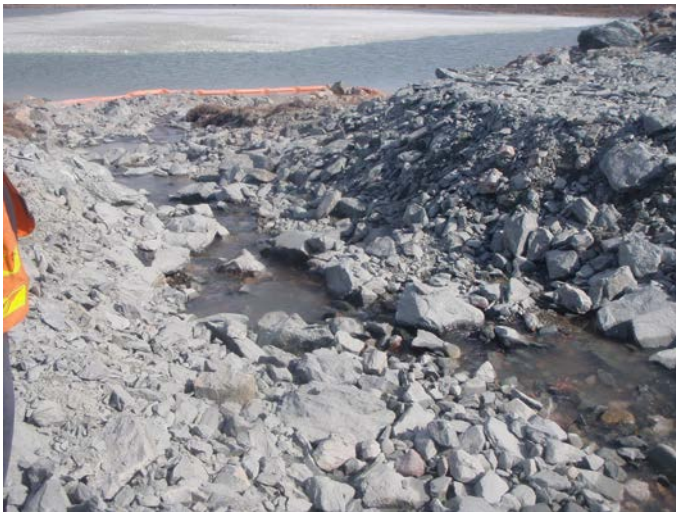
Photo 2: Channel entering in Dogleg North pond

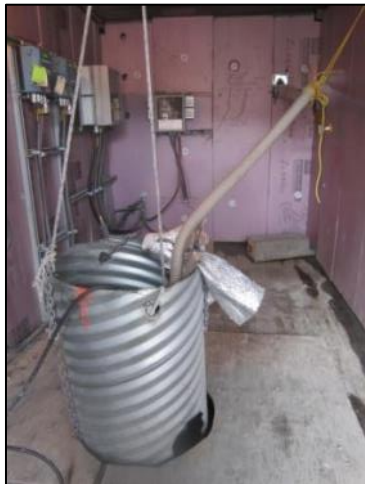
2.4 RSF SEEPAGE

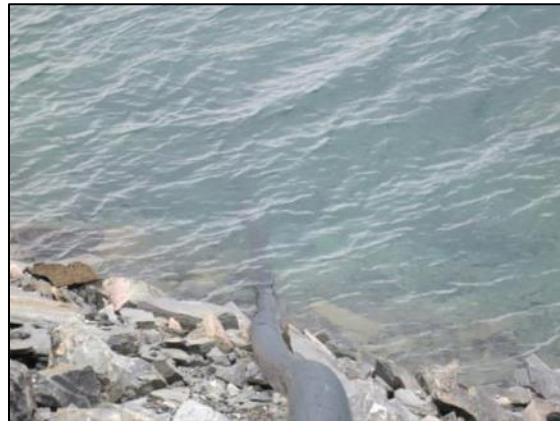
The Portage Rock Storage Facility (WRSF) will require weekly inspections around the perimeter beginning in mid-May to identify any seepage. As will be noted in the following section, seepage was identified in 2013 at location ST-16. In the event that additional seepage is observed from the RSF, it must be reported to the Engineering Department and samples must be taken to determine the water quality and source. A mitigation plan will be prepared and implemented if necessary.

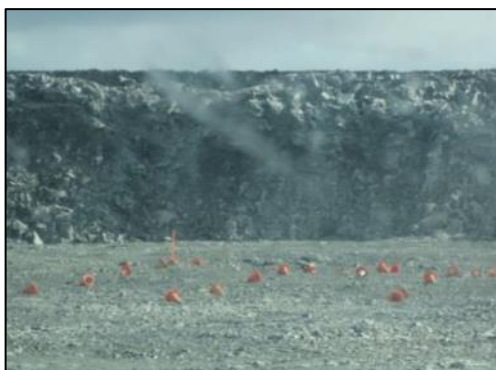
- b. AEM staff also noted that during 2014, the Proponent commenced mining of Vault pit with active blasting and drilling occurring at different locations throughout the pit (see Photos 16 and 17).

Photo 16: Overturned pylons denoting drill locations.

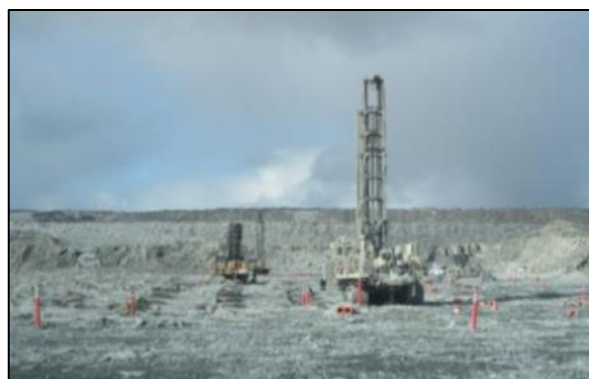
Photo 17: When drilling is completed, pylons will be overturned and placed in the holes.

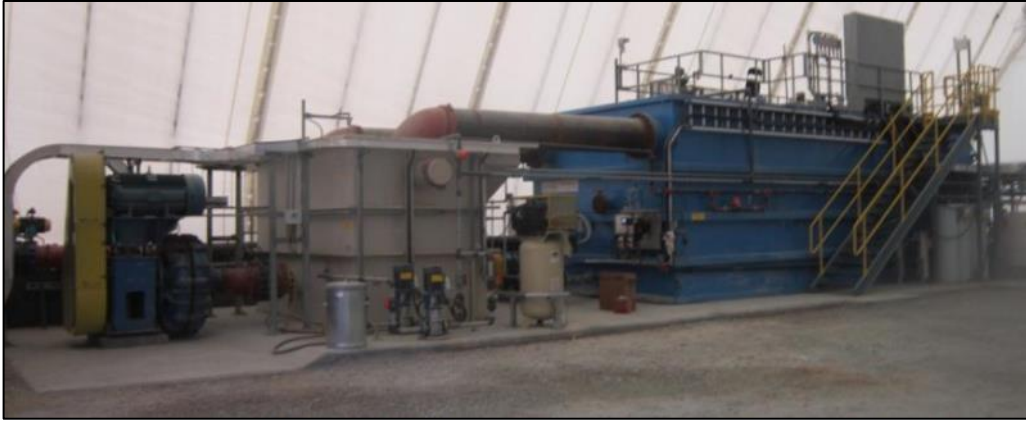
- d. The water treatment facility was not in use and was relocated to Vault Lake in anticipation of potential future needs (see Photo 21). The secondary camp, located on the Vault Road and near the Vault fuel farm, contains a secondary kitchen and would act as an emergency shelter for personnel working near the Vault pit infrastructure (see Photo 22).

Photo 21: Water treatment facility not in use, currently located near Vault pit.

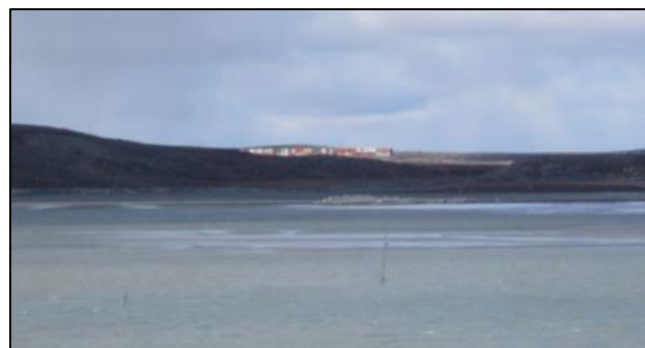
Photo 31: Thermistors installed in the tailings storage facility to measure freeze back.

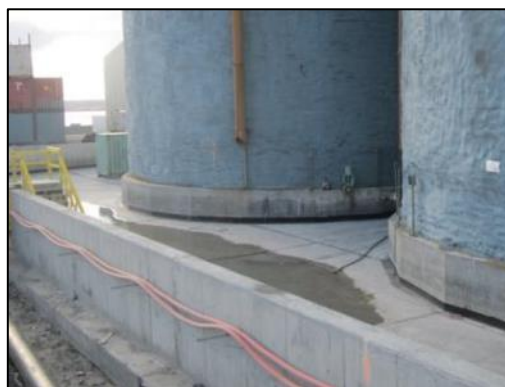
During the 2014 site visit, the Monitoring Officer observed that the fuel and hazardous materials associated with AEM’s Meadowbank project appeared to be stored in a safe and environmentally protective manner (see Photos 35-39). The Monitoring Officer noticed turbid water in the containment berm of the Jet-A pad at the Baker Lake storage facility (see Photo 36), however did not observe any noticeable sheen on water in any of the berms or discernable hydrocarbon odours at either of the Baker Lake facility or the Meadowbank site. The Monitoring Officer observed exposed liner-type material at the Meadowbank fuel tank farm (see Photo 37). AEM staff noted that this was likely not the liner itself but the material layer above the liner.

Photo 39: Treatment of cyanide tailings.

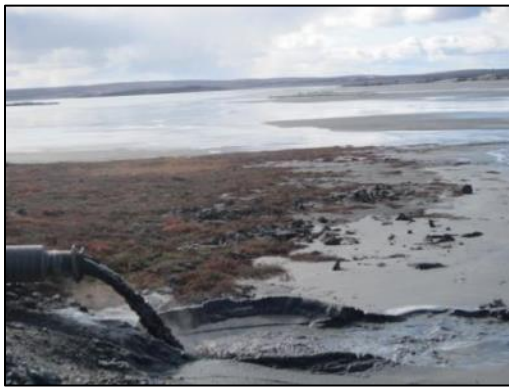
Photo 46: Outflow pipe at the tailings storage facility.

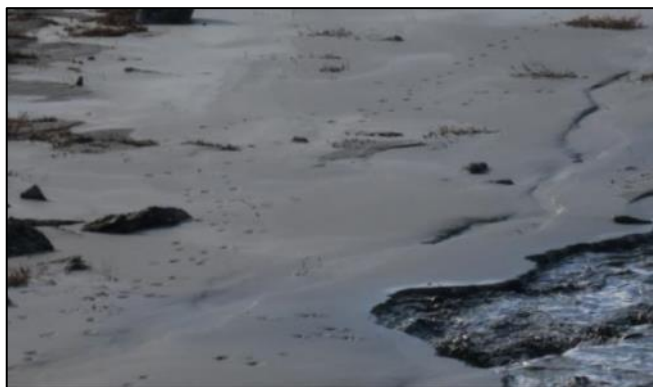
The Monitoring Officer observed wildlife tracks near the outflow of tailings into the tailings storage facility (see Photos 46 and 47). AEM staff discussed the use of "scare cannons" when spring bird migration commences and noted that these are then removed when no longer required, usually when birds begin their fall migration. In addition, AEM staff explained that stationary deterrents had been ineffective in deterring birds and that the "scare cannons" are repositioned every few days.

Photo 47: Wildlife tracks observed at the outflow pipe at the tailings storage facility.

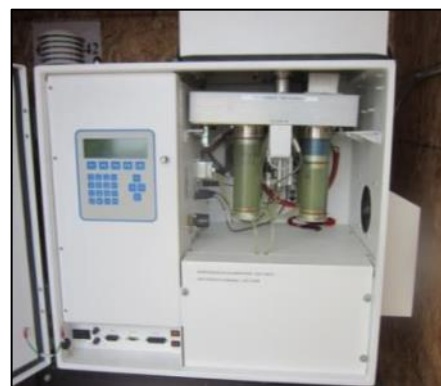
When the NIRB staff viewed the air monitoring and partisol sampling stations AEM staff noted that both dustfall and partisol monitoring occurs year round (see Photos 48 and 49).

Photo 49: Station for the sampling of total suspended solids in air.
