Report: Quarry 22

MEADOWBANK GOLD PROJECT

2014 Quarry 22 Report

Prepared by:
Agnico Eagle Mines Limited – Meadowbank Division

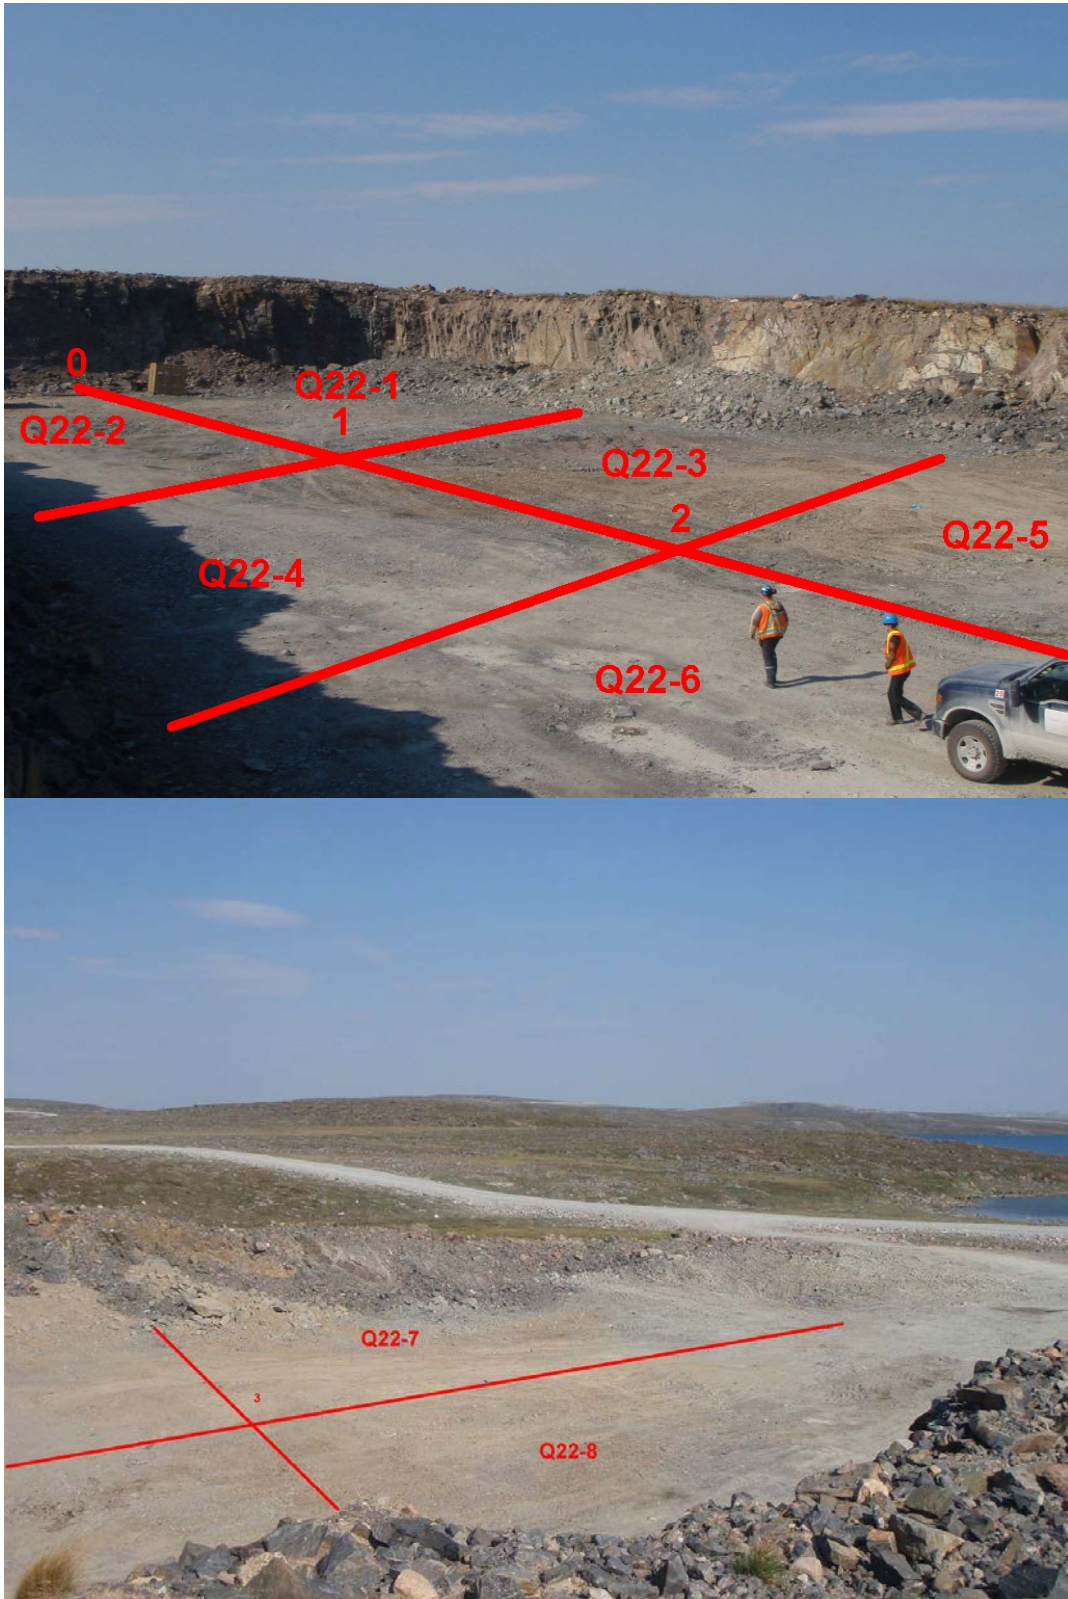
Area Delimitation Quarry 22

A grid was designed to divide the quarry in portions representing areas where contaminated material had been stored (Appendix B). As such, areas from 0 to 1 represent a smaller sampling area in size as more contaminated material was stored in this area (towards back/walls). Size increased as areas move from 1 to 2 to 3. Portions from 3 and beyond represented the largest in area. The surface included any material that was used for sloping along the walls (see 2.1 above). This area sampling design was adopted to ensure that the soil characterization was well assessed; in particular, in the areas that received most of the contaminated material.

Based on the degradation history of PHC's in the Meadowbank Landfarm AEM is confident that the natural degradation of Petroleum Hydro Carbon (PHC) related products is an effective remediation method. Therefore AEM proposes to scarify the remaining contaminated areas in Q22 during the summer of 2015 and conduct another round of sampling in the late fall before freeze up. Results will be compared to the 2014 data to determine the level of degradation. Once the results are analysed a further course of action will be developed which may include additional removal of material. AEM will ensure that runoff (if any) will stay within the site of the quarry during freshet and thus not impact any watercourses and/or the environment. AEM also proposes to add this item specifically to our weekly AWAR inspection. To date there have not been any impacts to water outside of this quarry.
