MEADOWBANK GOLD PROJECT

2015 Quarry 22 Report

Prepared by:
Agnico Eagle Mines Limited – Meadowbank Division

January 2016

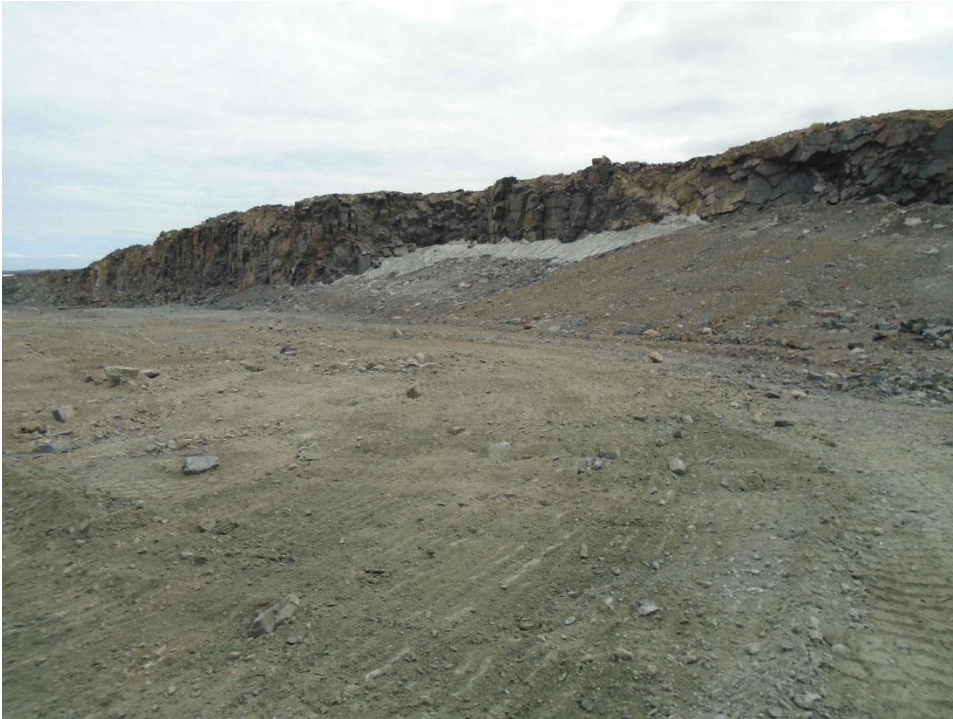
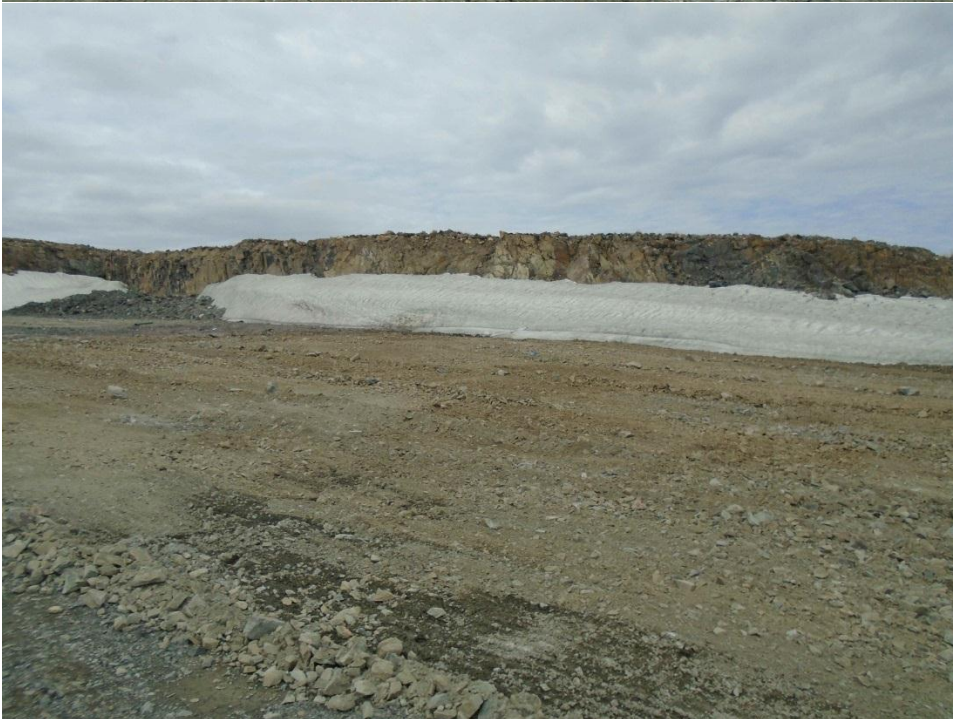
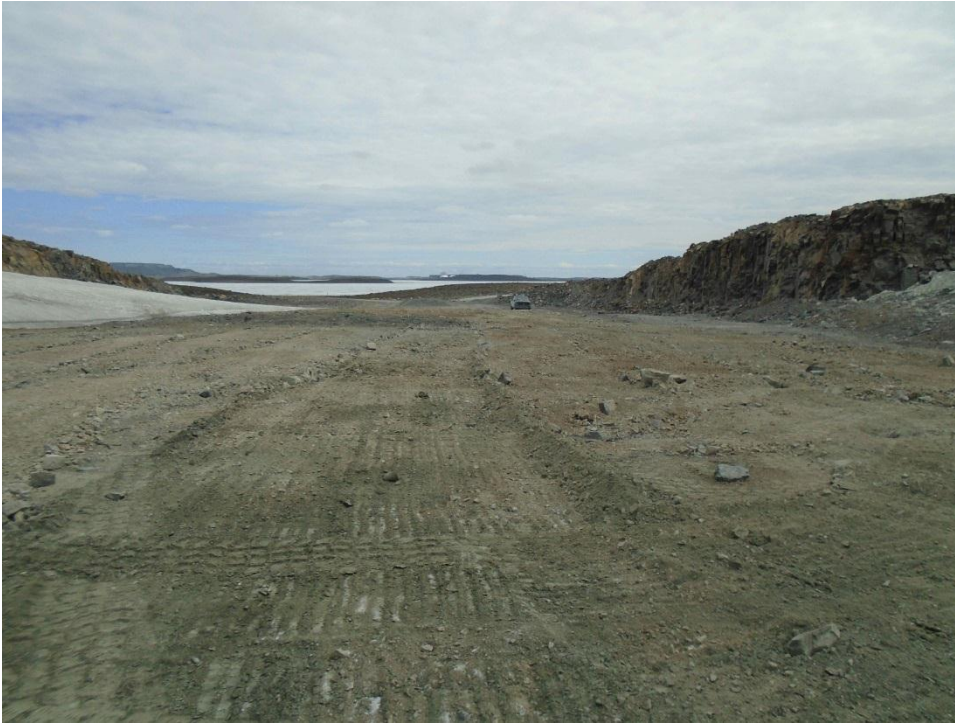
Appendix A

Photos after scarification

Taking into consideration the results from 2014, the 2015 workplan included scarifying the surface of quarry 22 with the back-end of a grader, thus allowing ground surface to be aerated which would increase degradation of PHC. The scarification work started on July 4th and extended throughout warmer months. On average it was done every second week from July to September (see photos, appendix A).
