### **Underground Fuel Line Report of Actions**

**Subject: Meadowbank Mine underground fuel line between fuel farm and power plant**

## **Meadowbank Mine Underground Fuel Line Between Fuel Farm and Power Plant**

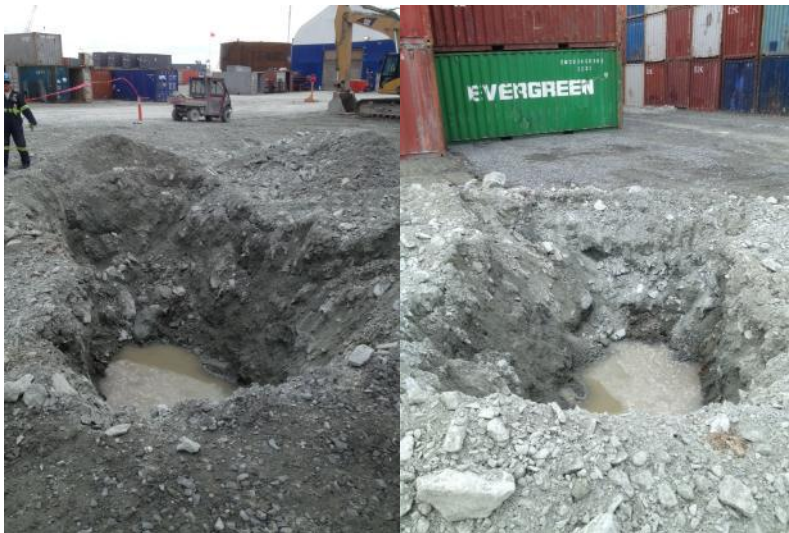
**Photos 1 and 2 – Excavation Fuel Line Hole B**

Soil testing for hydrocarbons was performed on site and also by an accredited lab (Multilab, Val d'Or). Excavation of three test pits along the lines was completed (Test Pit #1, Fuel Line Hole B, Fuel Line Hole C). The location of the test pits are presented on Figure 1. Soil samples were taken in these three test pits. The sample results are presented in Table 1. Photos 1 to 4 show the excavation of two test pits.

The testing on site was performed with a handheld meter (RAE Systems: PGM-7300, MiniRAE Lite: Portable Handheld VOC Monitor) by an AEM environmental technician or coordinator. For the three tests performed on site, all the results for hydrocarbons indicated 0 ppm. The field observations for the three test pits revealed no hydrocarbon type odors or any visual appearance of hydrocarbons.

For two of the three test pits, soil samples were also sent to Multilab (performed by subcontractor Maxxam Analytics) for hydrocarbons analysis. Results for both samples indicate no trace of hydrocarbons, as presented in Table 1.
