Meadowbank 2022 Thermal Monitoring Report

MEADOWBANK PROJECT

Thermal Monitoring Report

Prepared by:
Agnico Eagle Mines Limited – Meadowbank Division

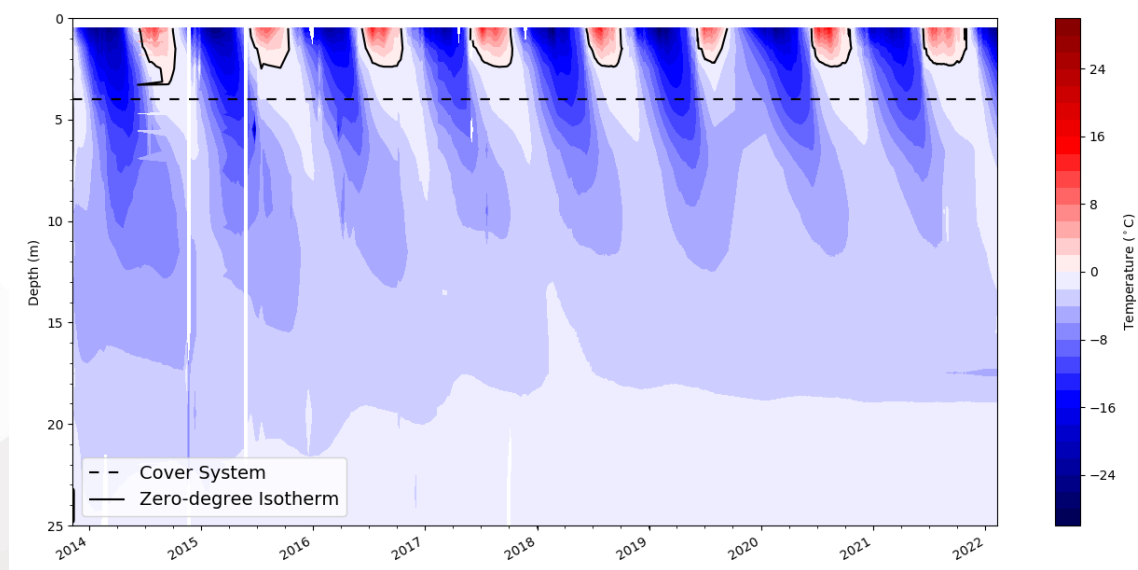
Figure 3: RSF-3 Thermistor String data between November 8, 2013 to February 8, 2022

The results for the aforementioned thermistors show the continued gradual shallowing of the zero isotherm through repeated years of monitoring. This would indicate that the RSF is continuing to freeze back but has not yet reached a state of equilibrium. Based on thermistor data, the depth of the active layer is approximately 3 m.

Figure 3 and Figure 4 illustrate the thermal performance of the installed thermistors RSF-3 and RSF-15. The dashed line indicates the location of the thermal cover system. Additional figures of thermistor data are included in Appendix A.

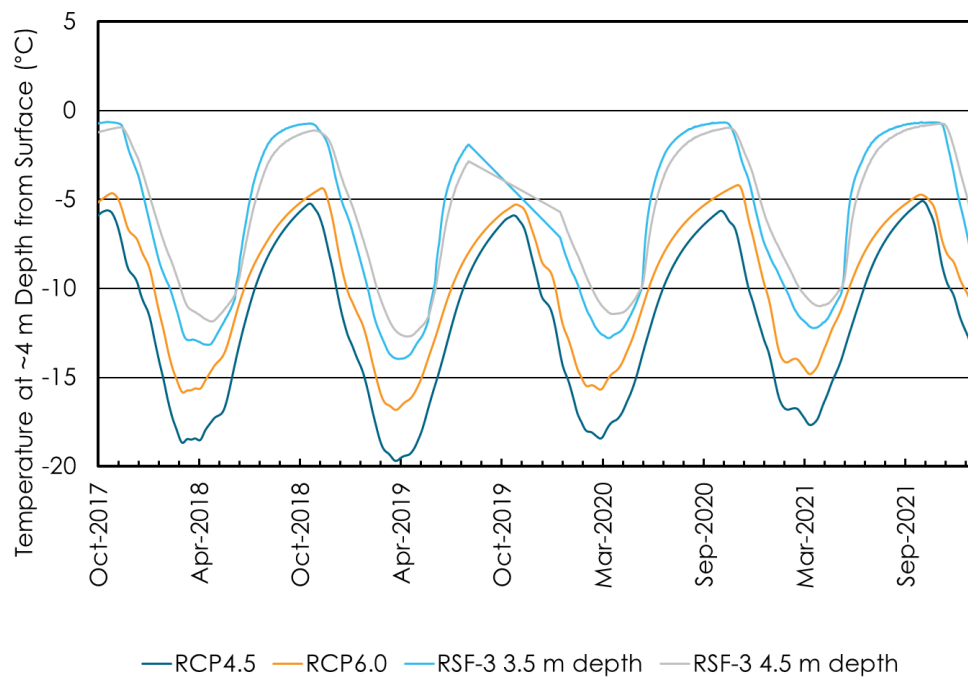
Figure 5: RSF-3 measured temperature at 3.5 m and 4.5 m depth compared to model predicted temperature at 4 m depth.

Recorded temperature at a depth of approximately 4 m was compared to simulated thermal model temperatures for RCP4.5 and RCP6.0 to assess the accuracy of the thermal model. Recorded and simulated temperatures follow the same seasonal trends and have similar amplitudes of seasonal temperature fluctuations though recorded temperatures are generally higher than those simulated. Recorded temperatures indicate sensors are equilibrating during the initial years post-installation; therefore, analysis of recorded and simulated data will focus on the data starting in 2017.

Throughout the period of record, RCP4.5 simulations have underestimated temperatures at a depth of 4 m, though the magnitude of seasonal temperature changes are similar to recorded data. RSF-3 recorded temperature at a depth of 4 m reached a maximum of approximately 0°C in the summer versus predicted maximum temperatures of approximately -5°C. RSF-3, shown in Figure 5, was used to calibrate the thermal model in 2016.

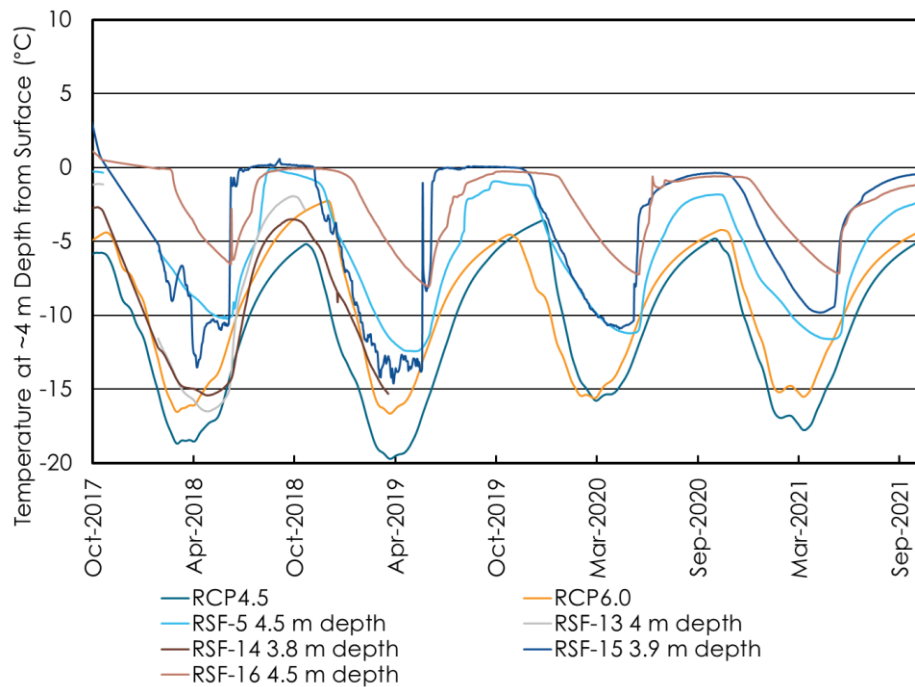
Figure 6: Simulated temperature at 4 m depth compared to thermistor recorded temperatures near 4 m depth at north facing slope locations.

Figure 6 shows the general trends in recorded and simulated temperatures at a depth of ~4 m on northern facing slope locations. RSF-13 and RSF-14 are located on the eastern portion of the north slope while RSF-15, RSF-16 and RSF-5 are located on the western portion of the north slope (Figure 1). Simulated temperatures show a good match to RSF-13 and RSF-14, with similar active zone depths and seasonal trends. It should be noted that data was recorded for RSF-13 and RSF-14 until 2019 at which time it appears the thermistors were no longer functional.

RSF-5, RSF-15, and RSF-16 were all installed in the same vicinity on the north facing slope. Simulated temperatures were lower than those recorded at RSF-5 though the match appears to be improving in 2018-19 in terms of the amplitude of seasonal temperature fluctuation observed. RSF-16 recorded temperature has less amplitude of seasonal temperature fluctuations compared to RSF-5 and simulated results. The lower amplitude of seasonal temperature fluctuation at RSF-16 could be due to the deeper installation depth but also could be due to variability in cover system and waste rock materials, and moisture conditions. The cause of sharp changes in RSF-15 recorded temperatures is unknown and could potentially indicate sensor error; however, these sharp changes seem to be less pronounced with time.

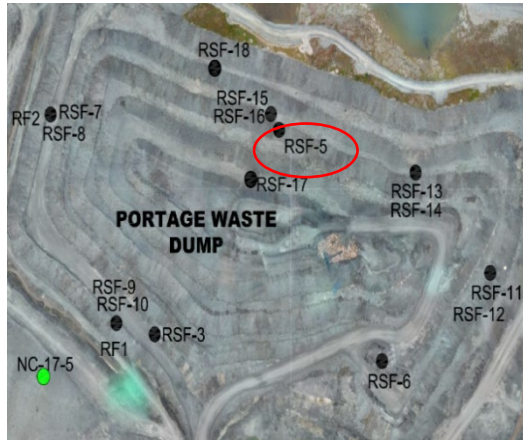
RSF-5

This instrument is broken and not sending data.
